Final Report

**Type B Accident
Investigation Board Report
May 24, 1998
Electrical Arc Blast
at the
Kansas City Plant**

Albuquerque Operations Office

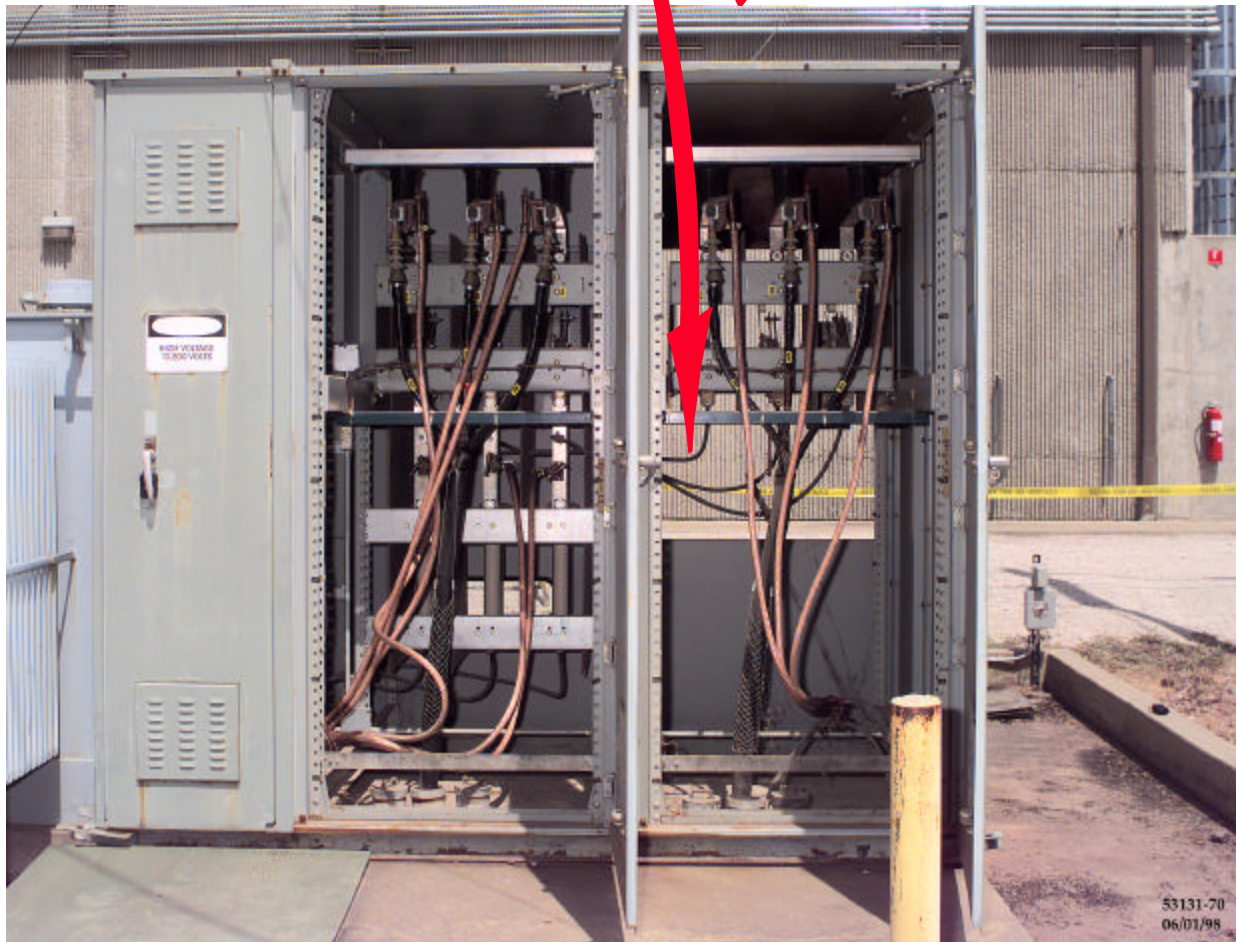
Figure 1-2: Back Side of Substation 37

protection for the HV switches is set at 240 amperes. Ground fault protection (GFP) is also provided and is set at 10 amperes / 6 Hertz. Figure 1-2 provides a view of the backside of Substation 37.

High Voltage Switch 57

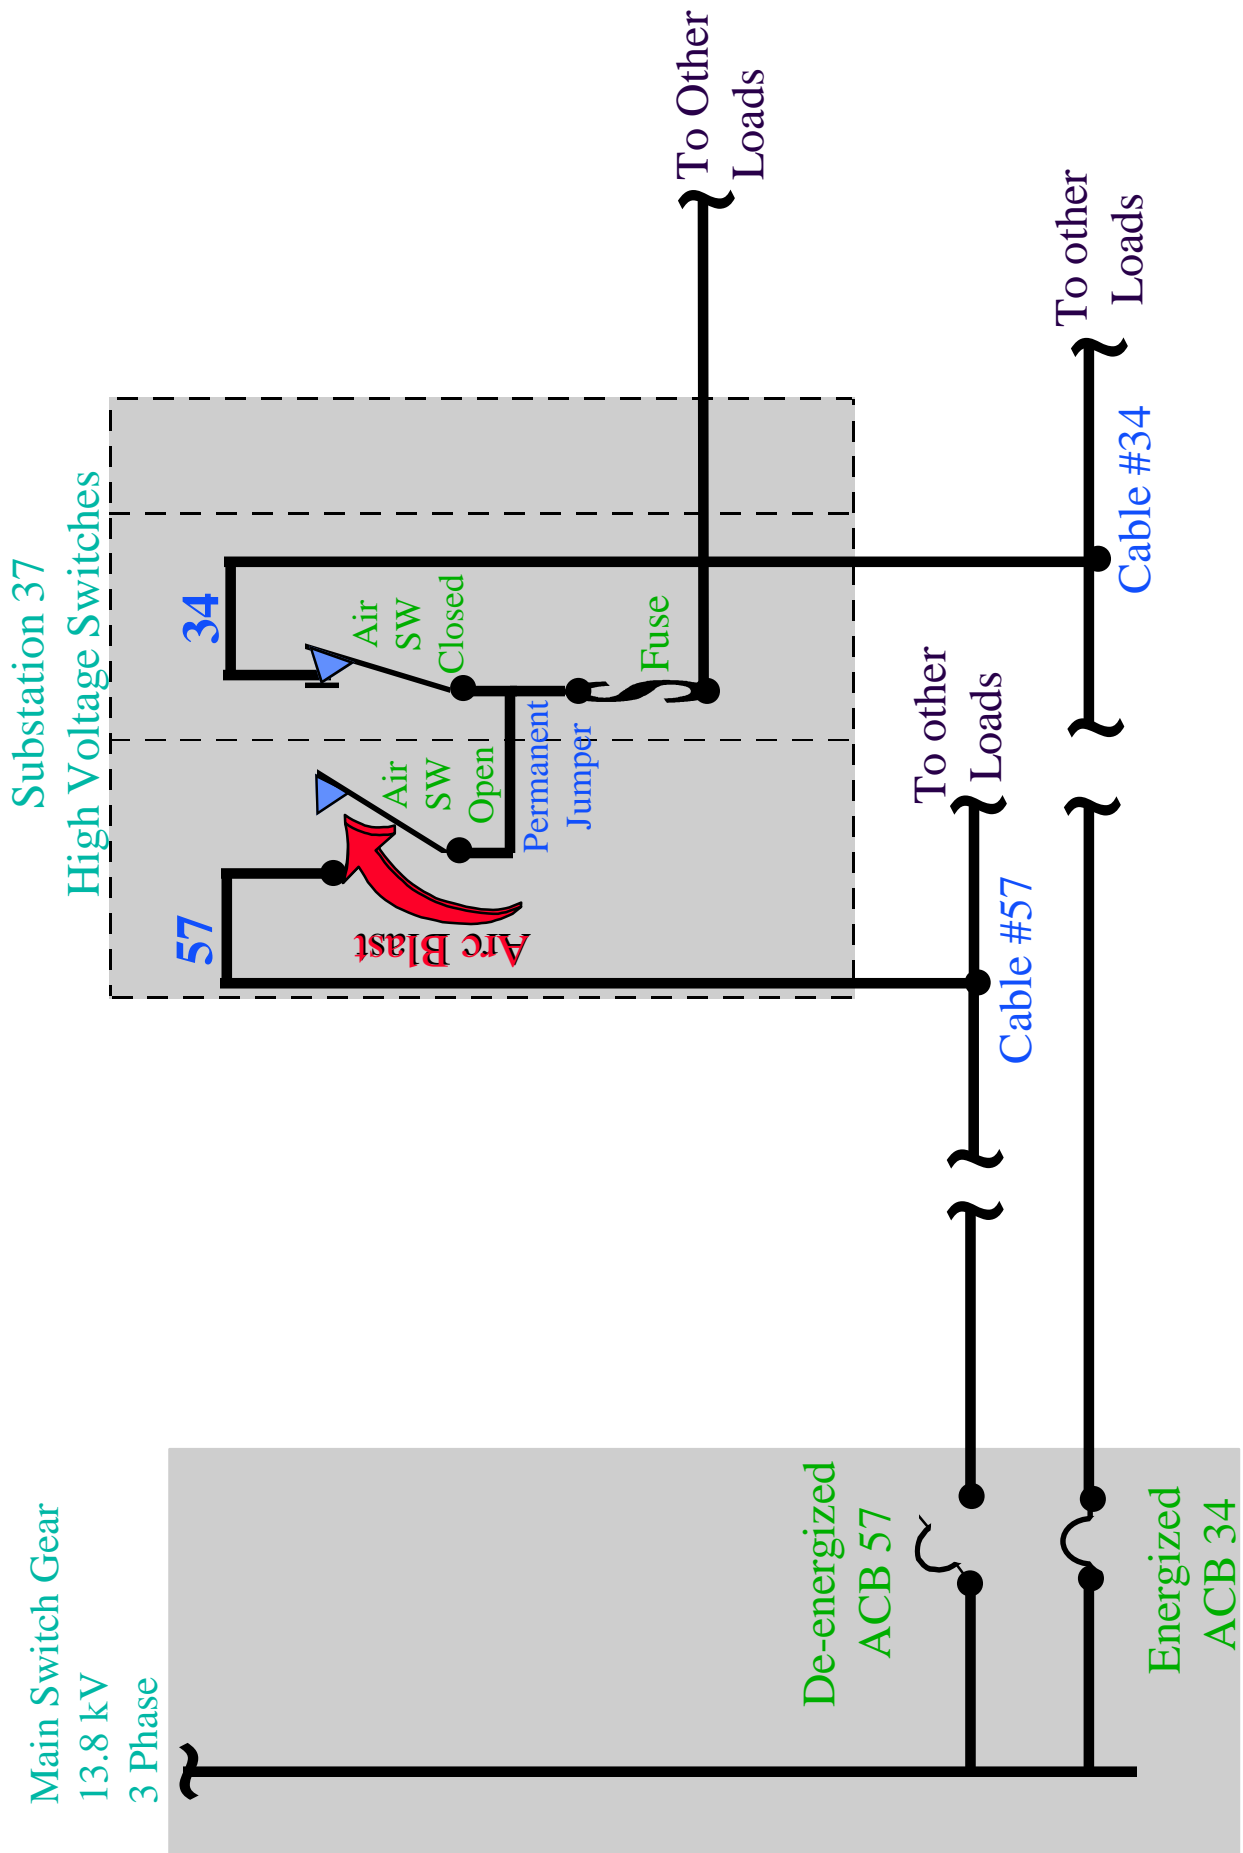
Figure 2-1: Diagram of Circuit Configuration at the Time of the Accident

The Cleaning Team performed switching operations at Substation 37.

The Cleaning Team performed switching operations at Substation 20.

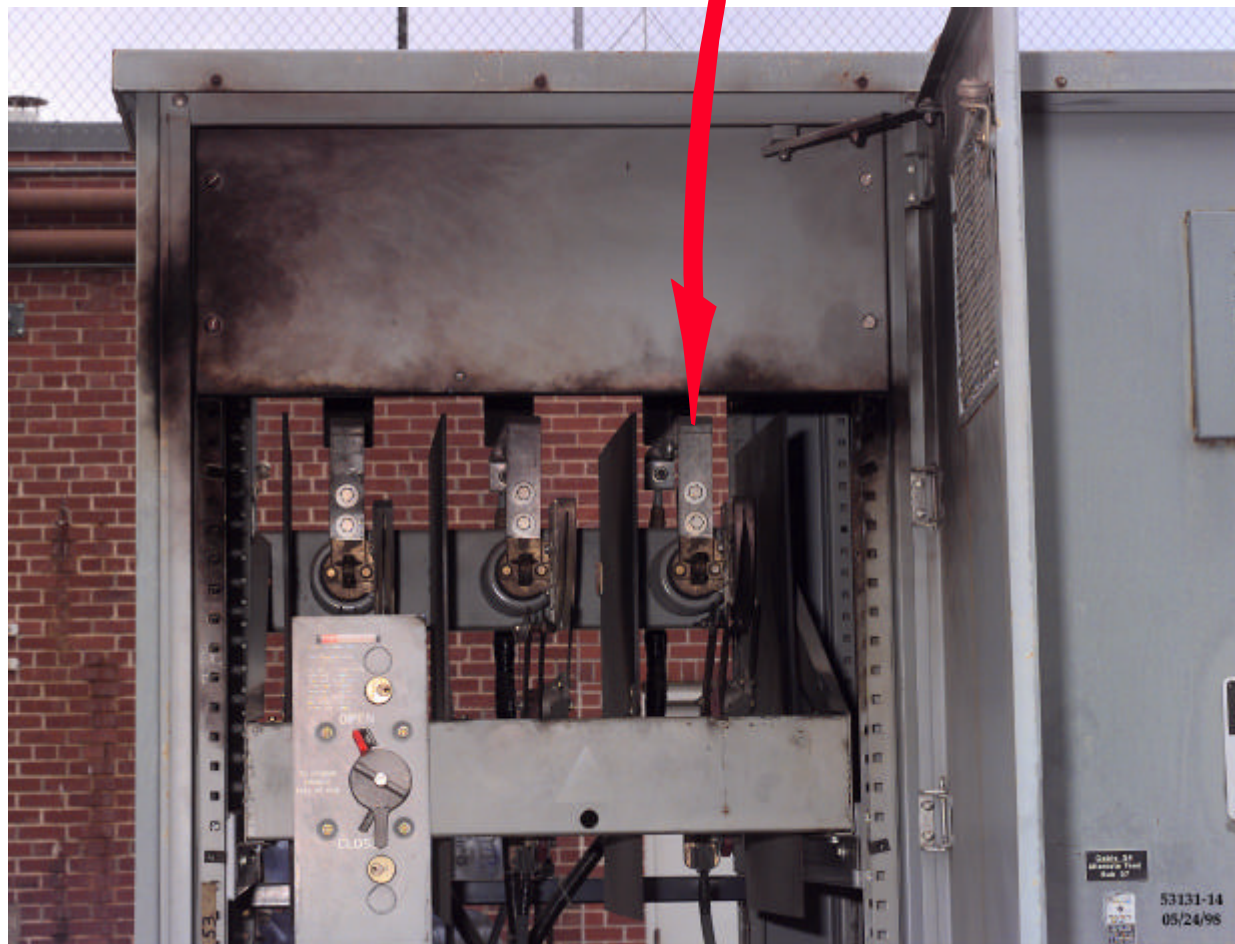
Figure 2-2: Front Side of Substation 37

**C-Phase of High Voltage
Switch 57**

1. The Board analyzed a sample found on the "C" phase switch knife blade. AlliedSignal FM&T/KC tested the sample and provided the Board an *Analytical Sciences Test Report*. This report stated that the sample was protein material from a human source.

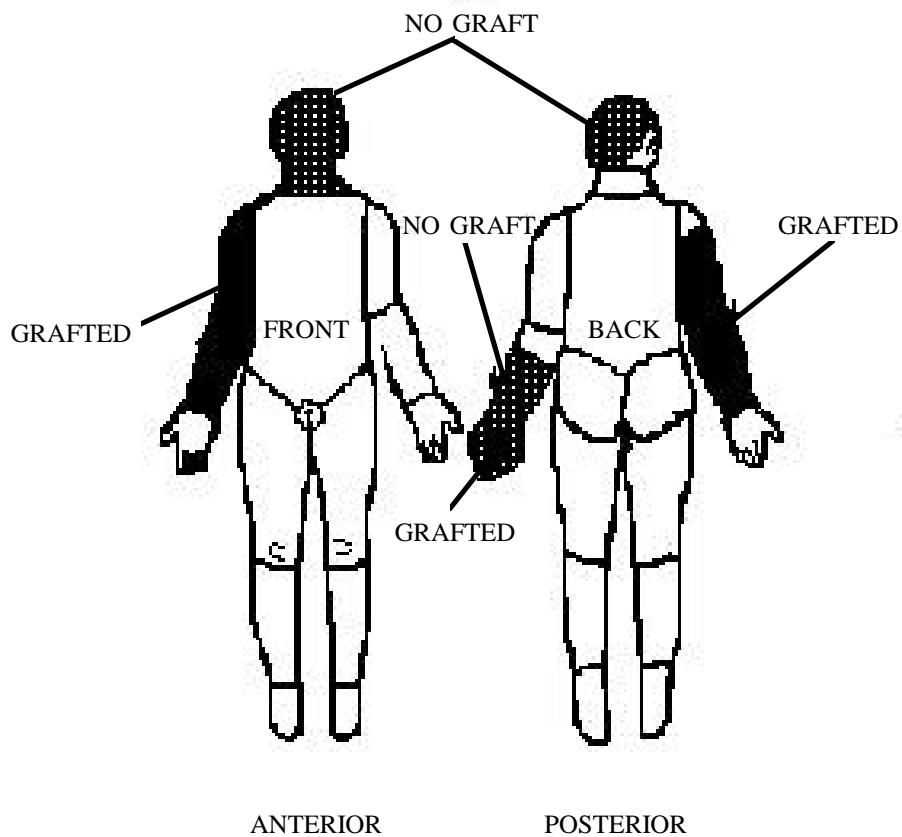
Figure 2-3: Burn Center Diagram Estimate

On Tuesday, May 26, 1998, Electrician #1 was upgraded to "fair" condition. Burned areas on his right arm and a portion of his left hand were re-classified as third degree burns. The remainder of the burns remained classified as first and second degree burns.

On Wednesday, May 27, 1998, the third degree burns required skin grafting (1.5% of the total body surface area) which ultimately included the upper right arm, right forearm and back of the left hand. Figure 2-3 identifies the areas of skin grafting.

Second-degree burns (14% of the total body surface area) primarily involved the head, neck, left forearm, back of left hand, right upper arm and right forearm.

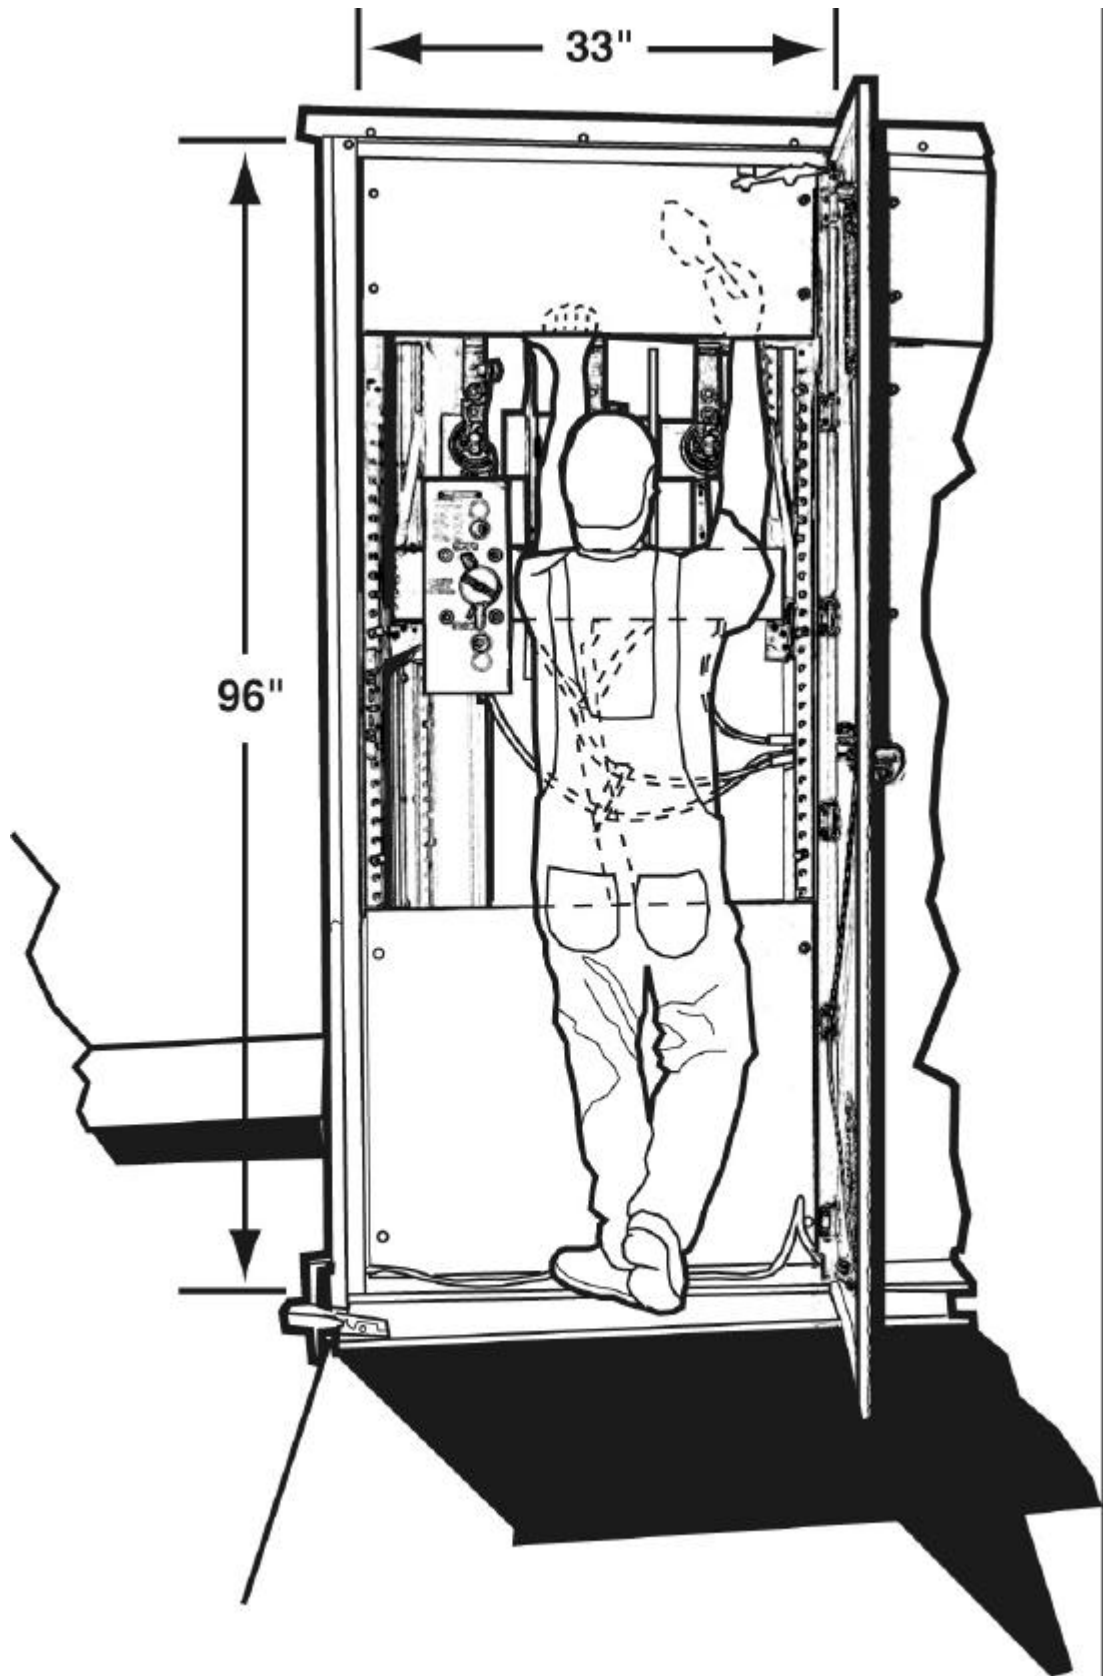
Figure 2-4: Estimated Position of Electrician #1 at the Time of the Accident

Based on the evidence identified, the Board believes Figure 2-4 shows a possible position of Electrician #1 at the time of the accident.

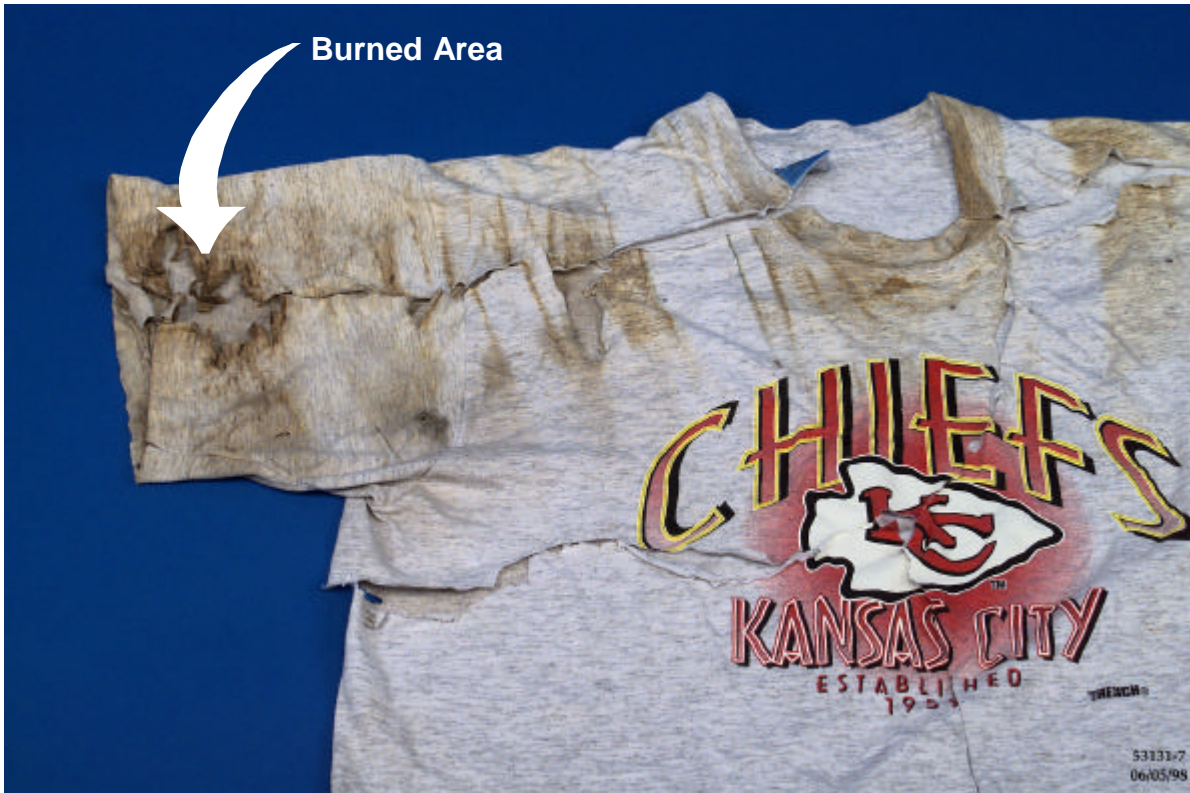
Figure 2-5: Tee Shirt Worn by Electrician #1

7. Electrician #1's 98% cotton tee shirt was burned and scorched on the inner edge of the right sleeve (See Figure 2-5).
8. Electrician #1 suffered third degree burns on his right upper arm in the immediate vicinity of the scorched tee shirt sleeve. He suffered second degree burns on his right, forearm head, neck, and face.
9. The polycarbonate safety glass lenses exhibited surface glazing, but no deformation (See Figure 2-6).
10. Previous testing documented the GFP cleared fault current in approximately 1/6 of a second. The GFP was set at 10 Amperes/6 Hertz.
11. The GFP tripped, de-energizing all three phases of the switchgear. The ACB overcurrent protection did not trip.

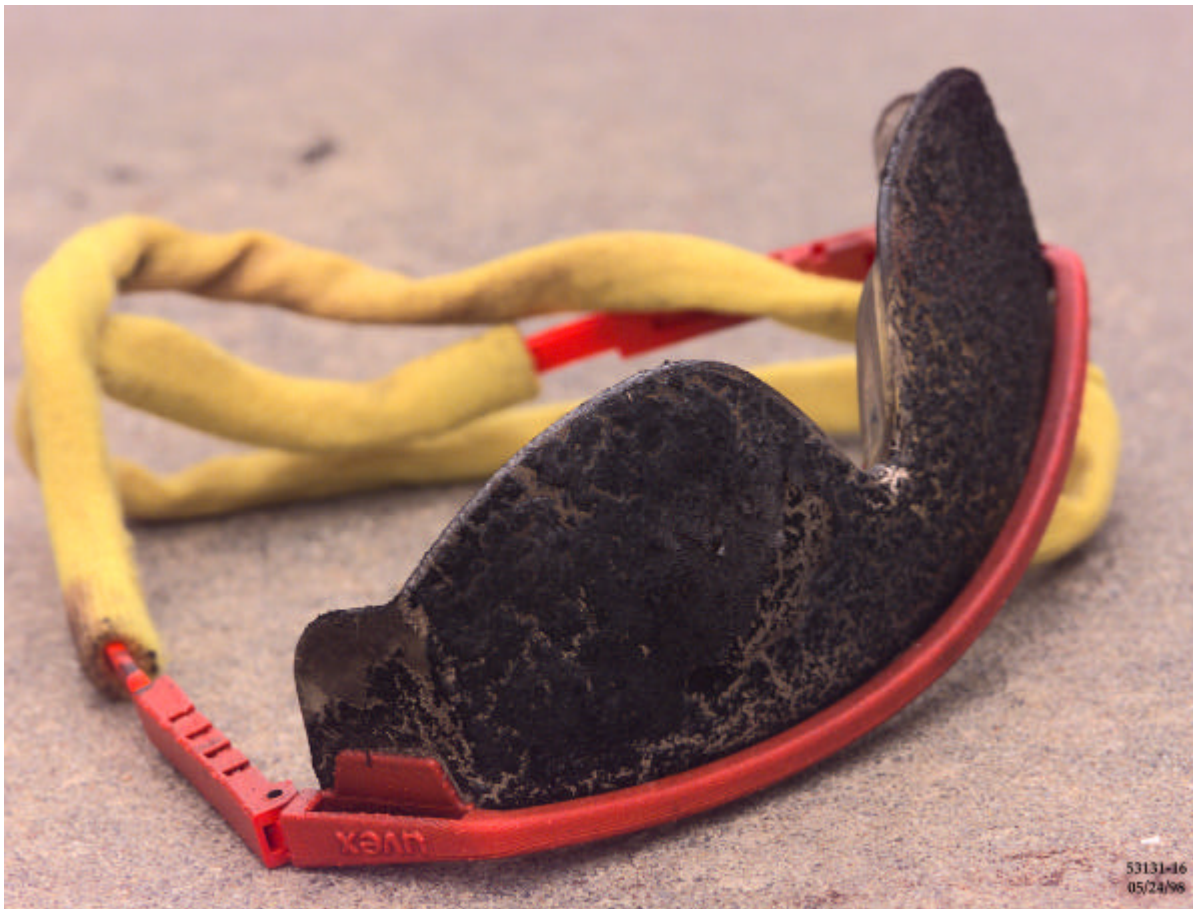
Figure 2-6: Safety Glasses Worn by Electrician #1

Electrician #1 was wearing safety glasses at the time of the accident and did not receive injury to his eyes. HV electrically insulated gloves were reportedly used by the electrician before the accident. The gloves were required for several outage activities, but were not required for cleaning operations on de-energized equipment.
