**Type B Accident Investigation Board Report
on the September 4, 1998,
Flammable Liquid Fire/Explosion
at Fermi National Accelerator Laboratory
Batavia, Illinois**

October 16, 1998

**Chicago Operations Office
U.S. Department of Energy**

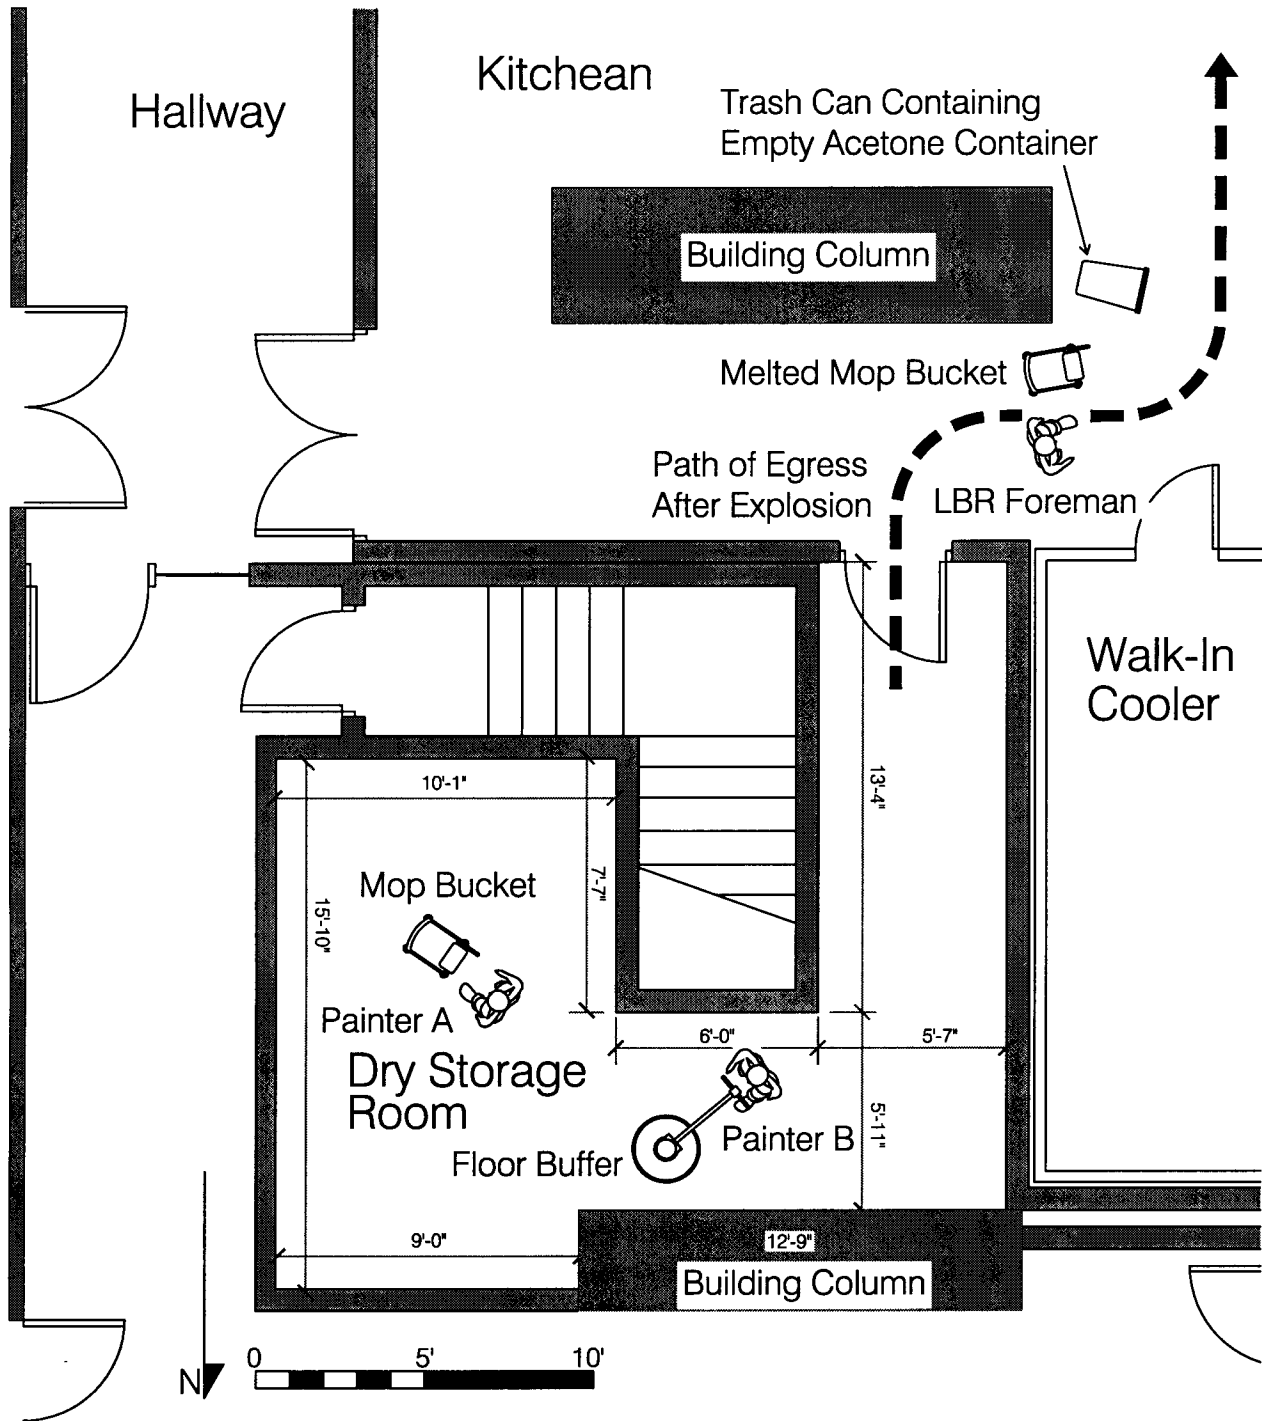
FIGURE 3 Layout of the Dry Storage Room Showing the Approximate Locations of the Contractor Foreman and Painters when the Flammable Liquid Fire/Explosion Occurred

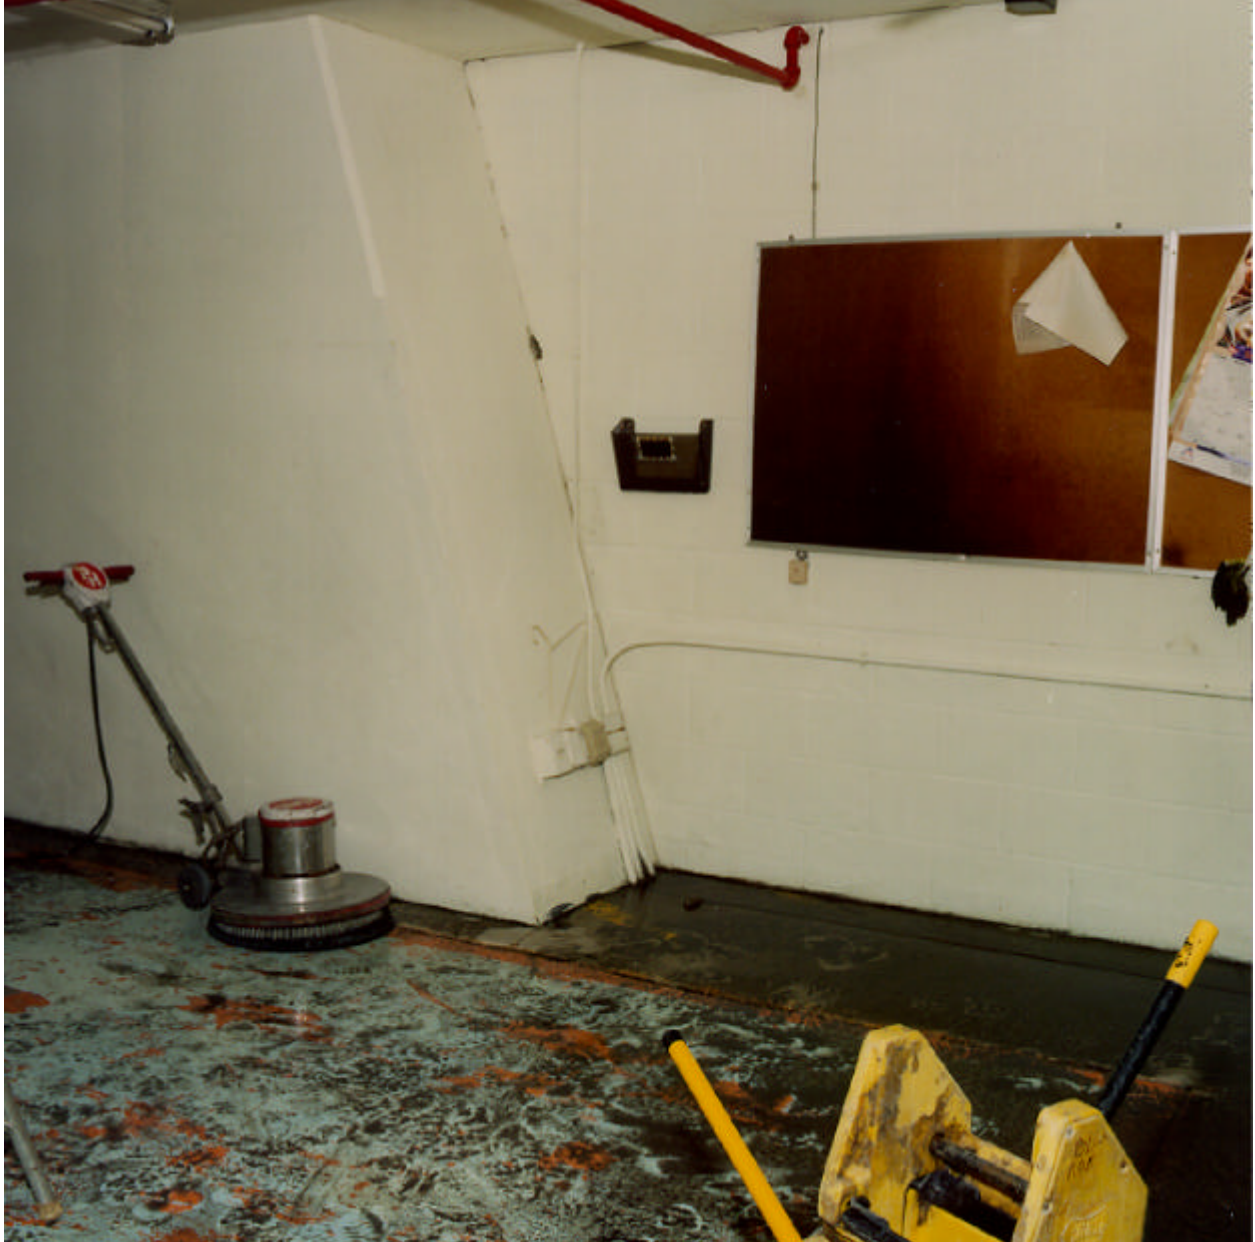
FIGURE 4 Photograph of the Dry Storage Room after the Accident. When the fire/explosion occurred, Painter A was standing near the yellow mop bucket in the foreground and Painter B was using the floor buffer in the background.

The severity of the explosion was indicated by visible structural damage to the north cinder block wall of the dry storage room. The wall was moved laterally at its top approximately one inch, damaging the suspended ceiling in the corridor outside the north wall. The ceiling tiles in the kitchen immediately to the south of the dry storage room were also dislodged and damaged.

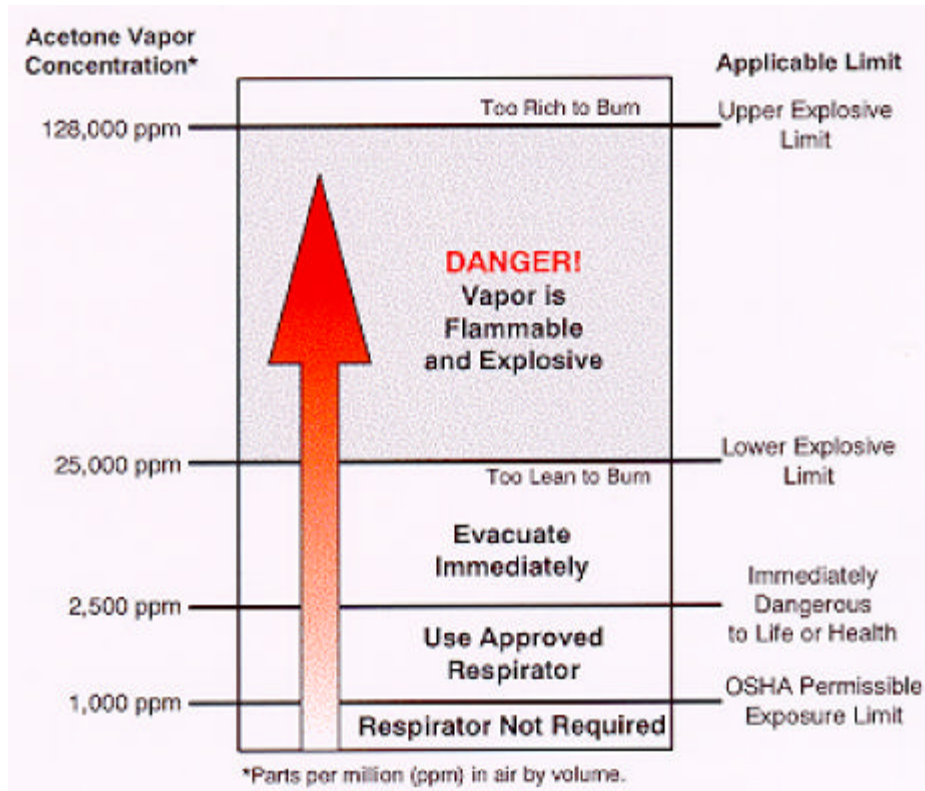
FIGURE 7 Hazards of Acetone Vapors in Air

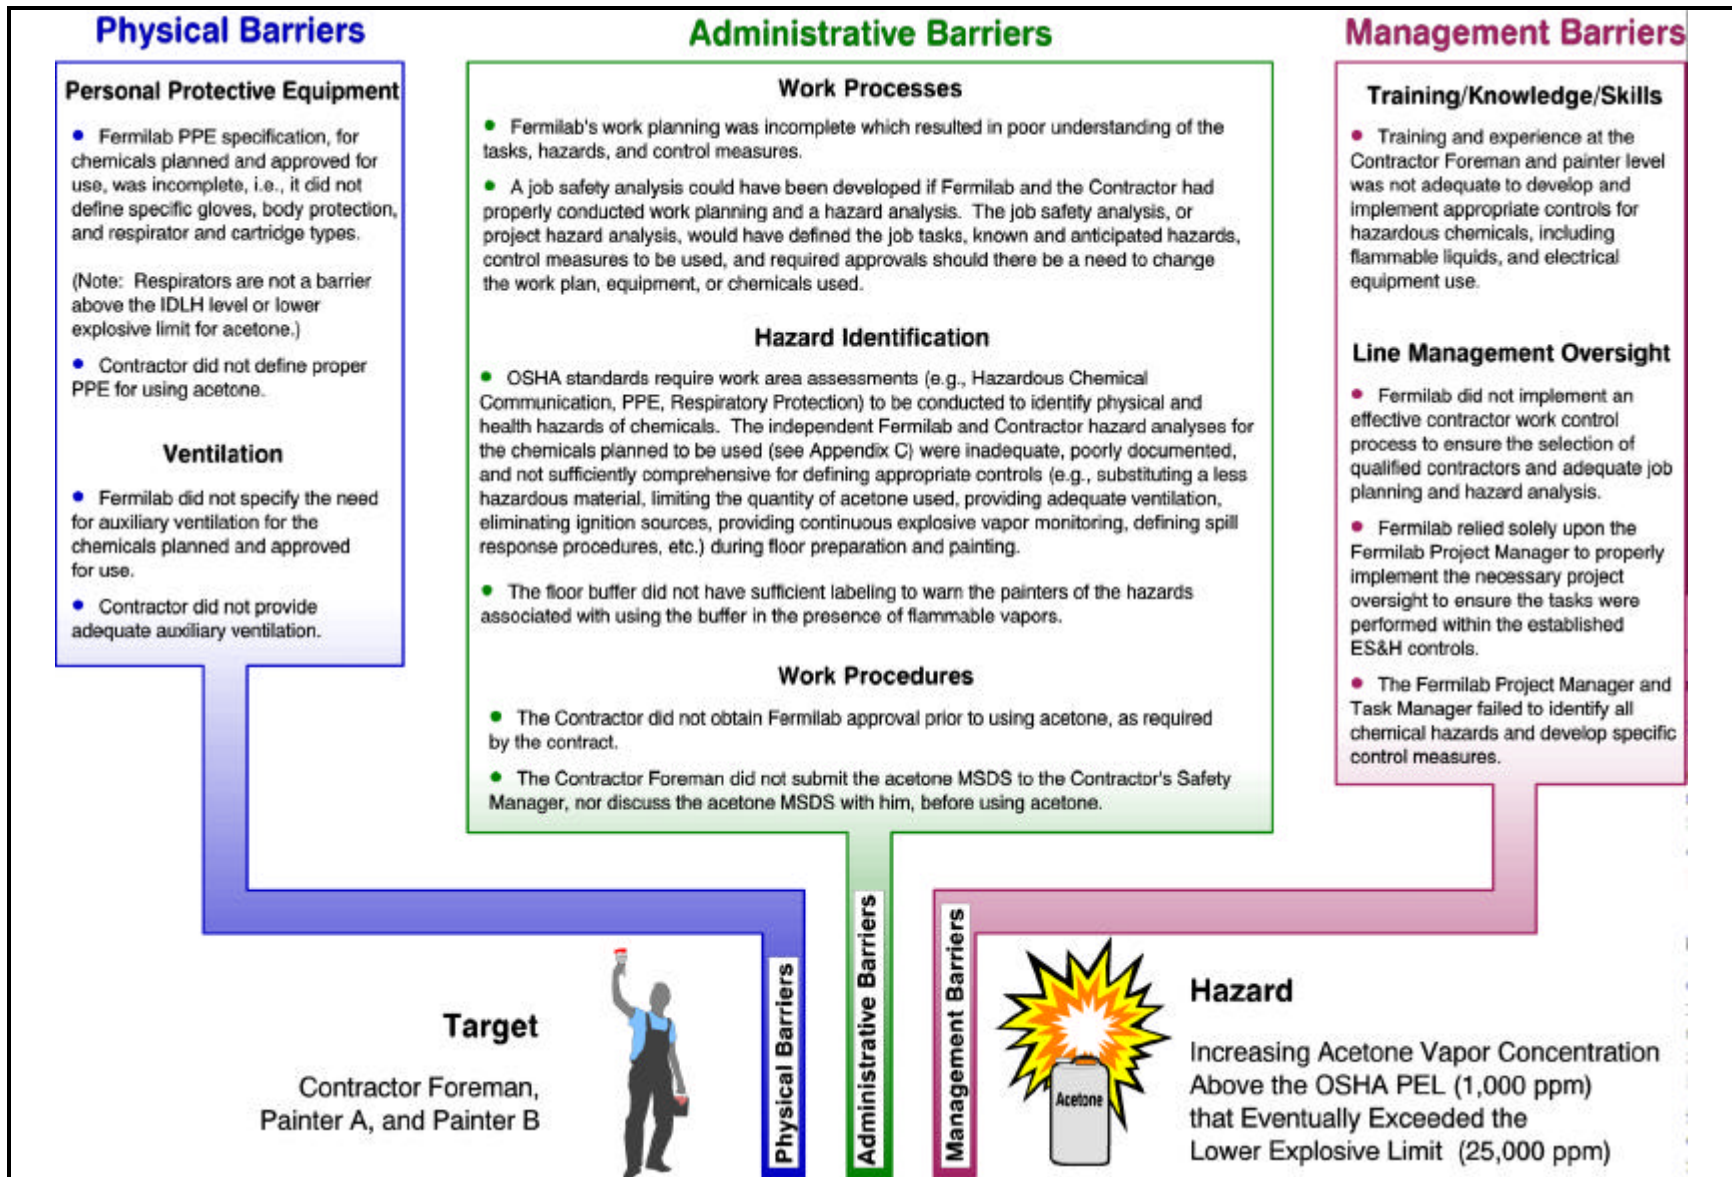
FIGURE 8 Barrier Analysis for the Accident
