**Type B Accident  
Investigation Board Report  
on the Worker Injury  
at the BNFL Inc.  
East Tennessee Technology Park  
Three-Building Decontamination and  
Decommissioning and Recycle Project  
Site**

Oak Ridge Operations  
U.S. Department of Energy

**May 1999**

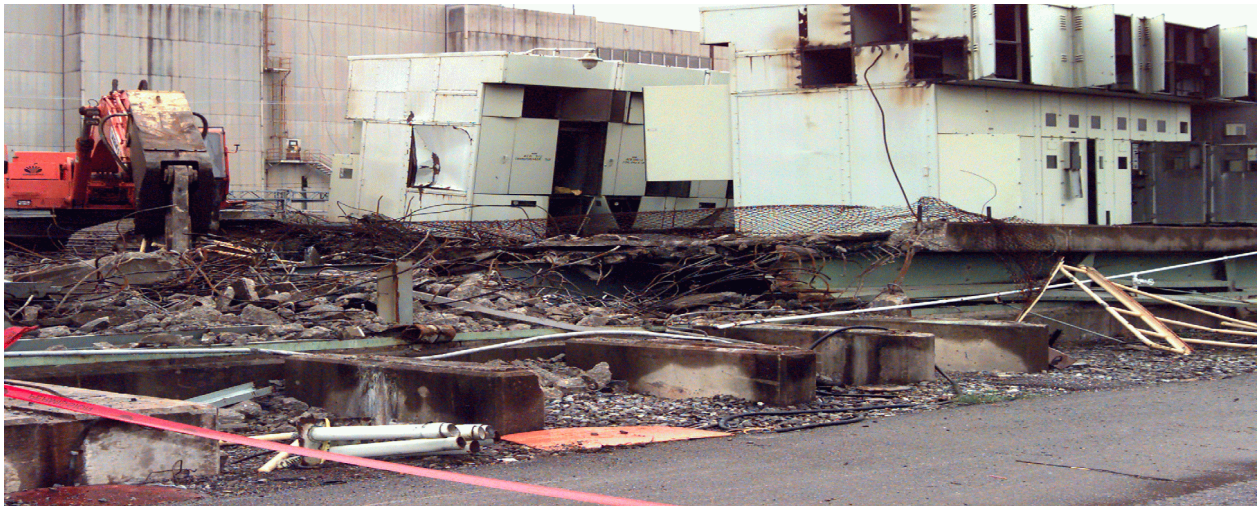
**Exhibit 2-1. Broad View of Accident Site at Building K-791 North Job Site (from NW to SE).**

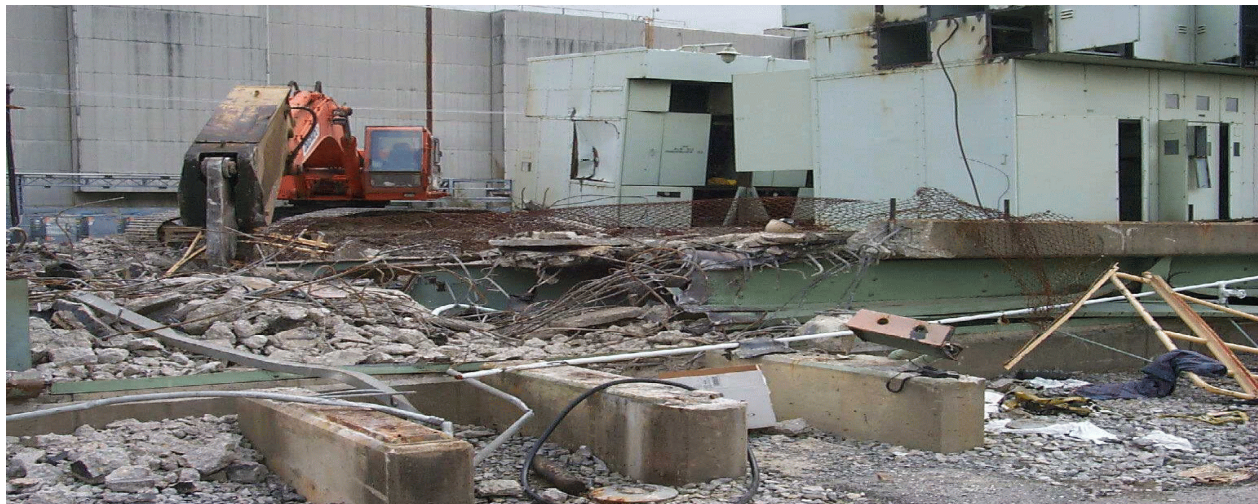
- Following the briefing at the job site, the IDM foreman returned to the site office, and the ironworkers began their task. The ironworkers began unbolting the buss bars in the top of the ACB cabinets and removing associated hardware in the lower section of the cabinets. The ironworkers used a manlift with a hydraulic boom and crew bucket (JLG) for access to the buss bars in the ACB cabinet tops.
- At 8:30 a.m., the trackhoe/shear pulled buss bars from the ACB cabinets using a steel wire choker. Another buss bar pull was made at 10:00 a.m. When not performing buss bar pulls, the trackhoe/shear was breaking concrete and removing metal from the roof slab on the east side of the ACB cabinets (see *Exhibit 2-2*).

**Exhibit 2-2. Near View of Accident Site at Building K-791 North Job Site (from W to E).**

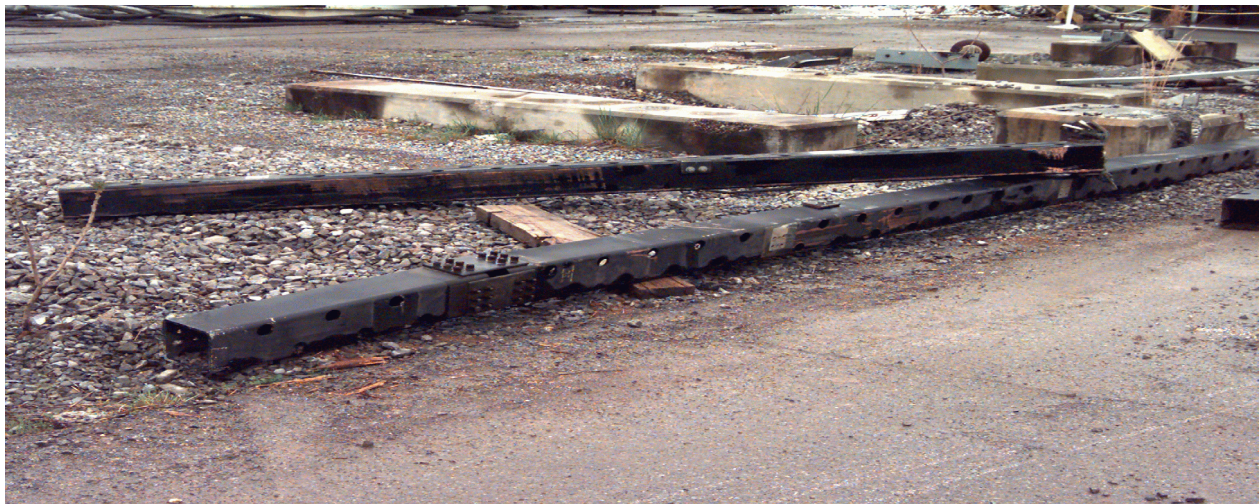
**Exhibit 2-3. View of Buss Bars that Blocked the Street.**

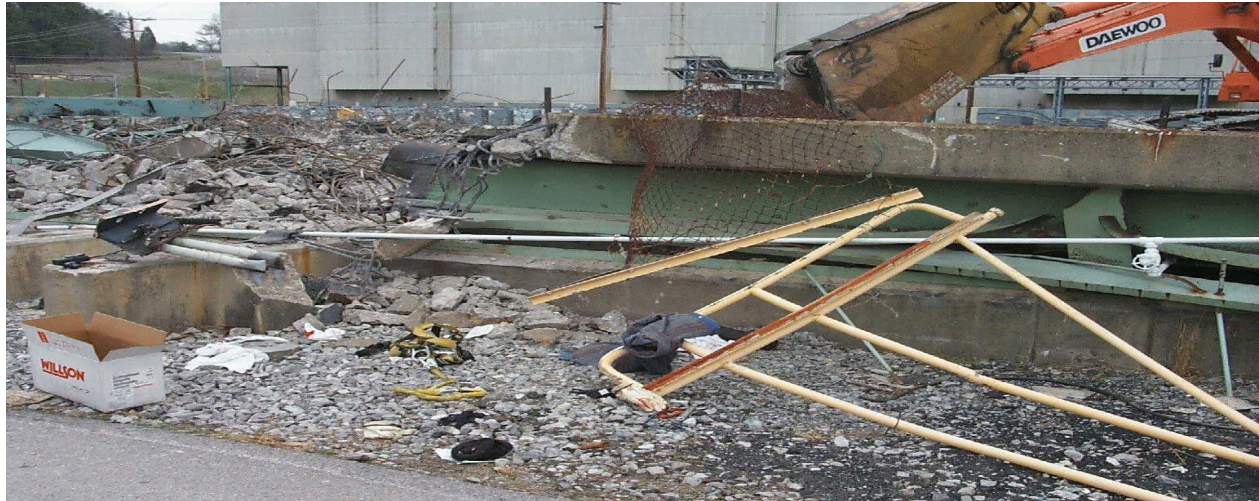
- The trackhoe/shear was attempting to bundle a section of chainlink fence with metal railing attached on each end for placement in a scrap metal pile. After the fence and railing were gathered into a bundle, the trackhoe/shear rotated in a counterclockwise direction to move the bundle to the scrap metal pile located beside the road. The trailing end of the fence became snagged on an obstruction, and approximately 30 feet of the fence plus the attached railing were pulled from the jaws of the shear. The remaining fence material and its associated railing were still in the grasp of the shear jaws. As the trackhoe/shear continued its counterclockwise rotation, the fence was stretched, and the trackhoe/shear operator noticed an increase in tension in the fence. The operator attempted to stop the shear but could not stop the rotation before the fence pulled free from the obstruction.

**Exhibit 2-4. View of Fence with Attached Railing.**

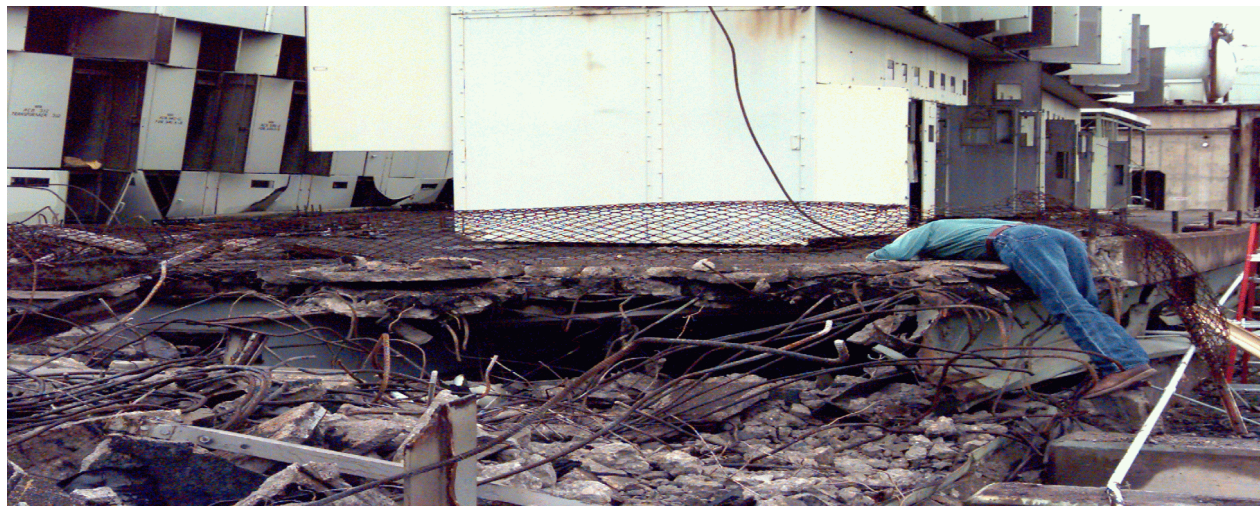
- At approximately 11:00 a.m., as the ironworker apprentice was attempting to egress the roof slab, the fence pulled free from the obstruction, and the trailing end flew over the boom and shear and struck him on the back of the head (see *Exhibit 2-4*). The fence knocked the ironworker apprentice's hardhat and safety glasses from his head, and he received scalp, ear, and

facial lacerations. He was knocked unconscious and fell facedown on the roof slab, with his lower torso and legs hanging over the edge (see simulation in *Exhibit 2-5*). The ironworker, who had egressed the roof slab ahead of the ironworker apprentice, was approximately 15 feet away at the time of the accident.

**Exhibit 2-5. View of Accident Scene with Simulation of Ironworker Apprentice.**
