Accident Investigation Report

Serious Personal Injury While Doble Testing

May 19, 1999

***Hayden Substation
Hayden, Colorado***

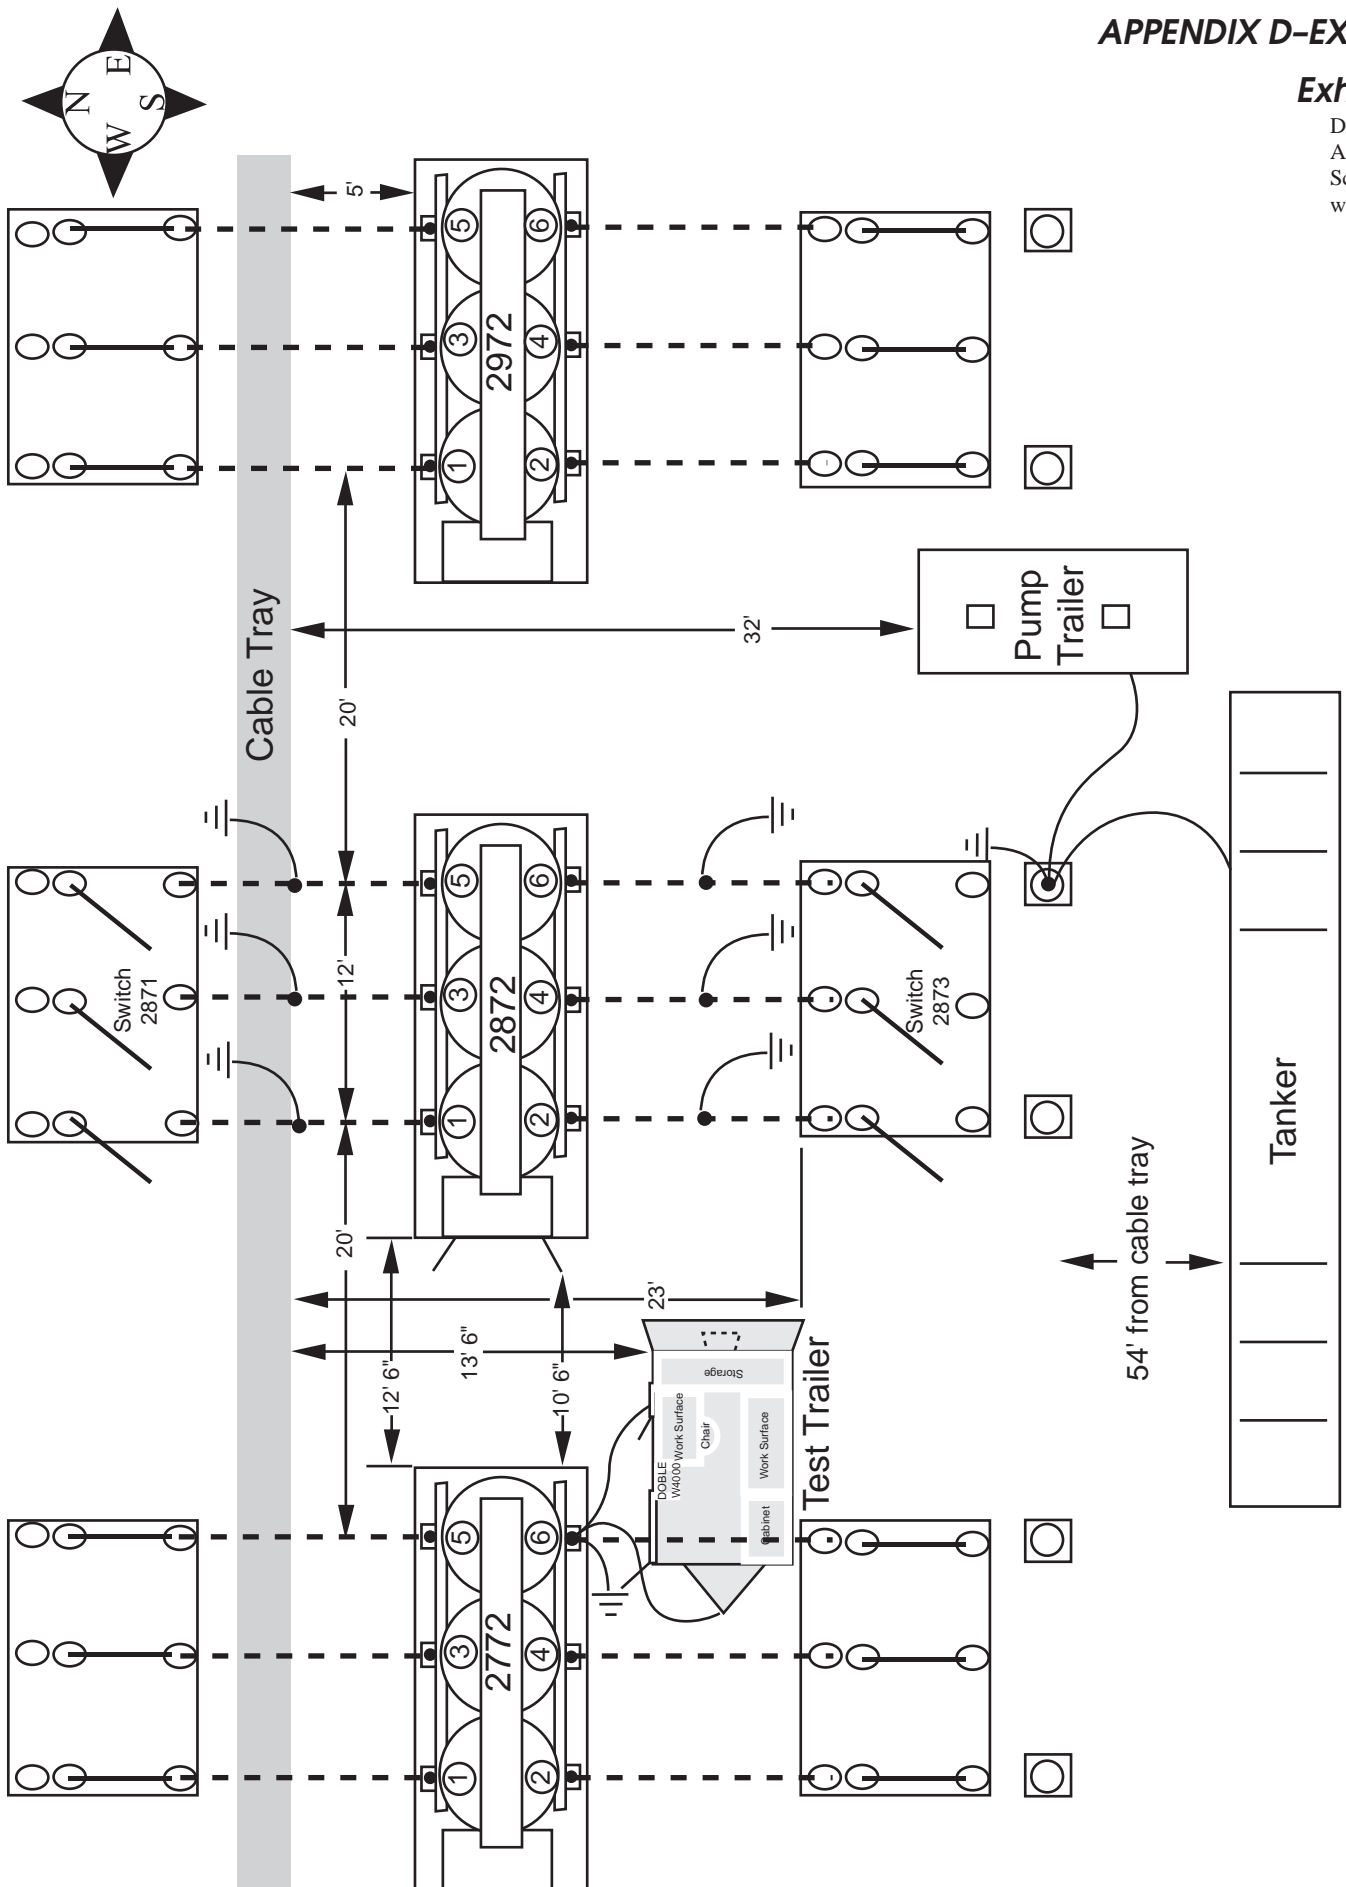
Exhibit A

Located in Routt County in northwestern Colorado, Hayden Substation is owned and operated by Western. The substation consists of 138-kV and 230-kV switchyards. At the time of the accident, the crew was performing Doble testing in the 138-kV switchyard on circuit breaker (BK) 2872, which was under Clearance C99-242. Adjacent BK 2772 and BK 2972 were energized. (See Exhibit A.)

A test trailer was 13 feet, 6 inches from the cable tray. The trailer containing Doble test equipment was southwest of BK 2872, south and southeast of BK 2772. (See Exhibit A.) The trailer contained a table and chair, in addition to a Doble test set and other equipment. All equipment was properly grounded.

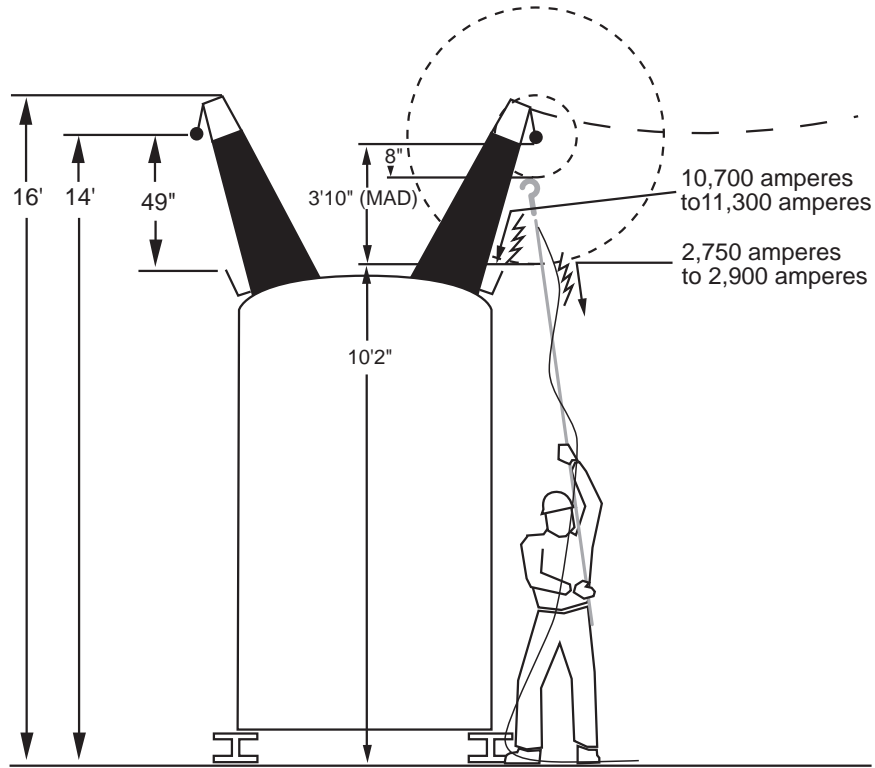
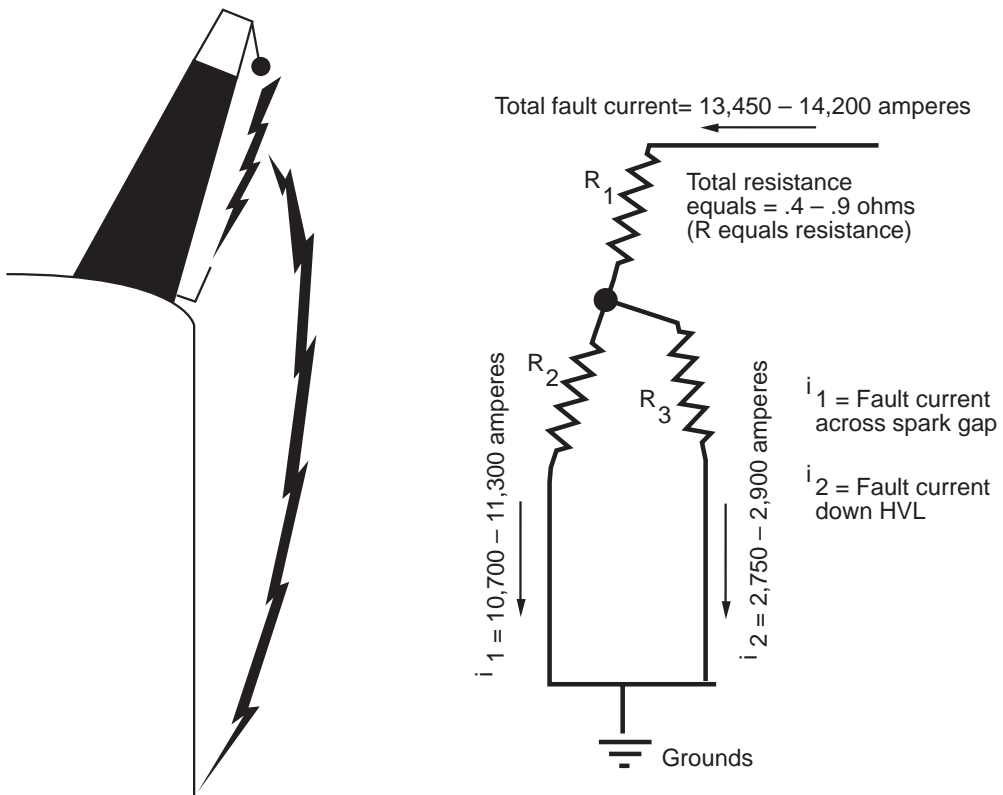
Exhibit B

The arc flashed down the HVL and launched the HVL's attachment hook from the end of the lead to approximately 120 feet from the fault location. The fault current down the HVL reached ground potential on the corner of the grounded circuit breaker, the grounded Doble test

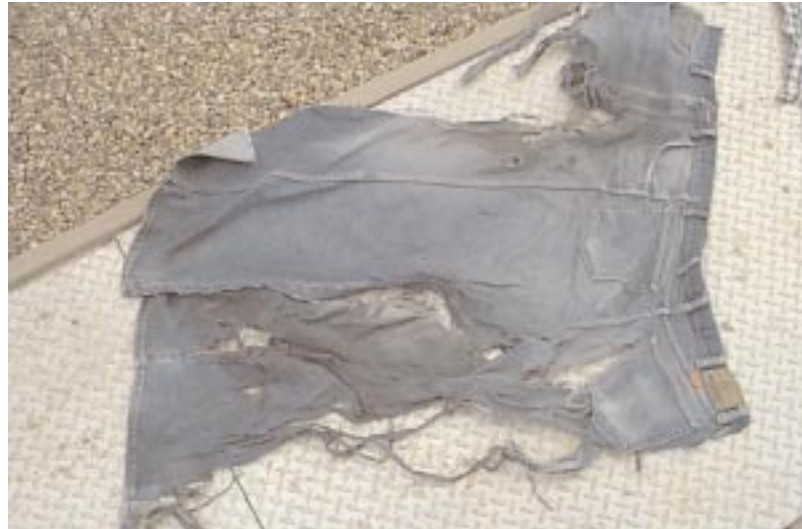
- Section 7.14.c was not complied with when the test procedures were not properly overseen.
- Section 8.7 of the PSSM and CFR 1910.269 (l) (6) (iii) were not complied with. Not all of Electrician 3's clothing was 100-percent cotton. His shirt was 35 percent cotton and 65 percent polyester. His pants were 36 percent polyester and 64 percent cotton. Electrician 3 was also wearing bib Carharts (100 percent cotton) over his clothing. All layers of clothing ignited. (See Exhibit C.) Since the 100-percent cotton coveralls ignited, the coveralls also contributed to the employee's injuries; therefore, wearing cotton clothing in this situation is in violation of OSHA (see above).

Electrician 3's pants
64 percent cotton
36 percent polyester

9. The proper clothing must be worn for work in energized substations. The strict interpretation of OSHA 1910.269 (l) (6) (iii) would require, based on this accident, employees to be in flame-resistant clothing.

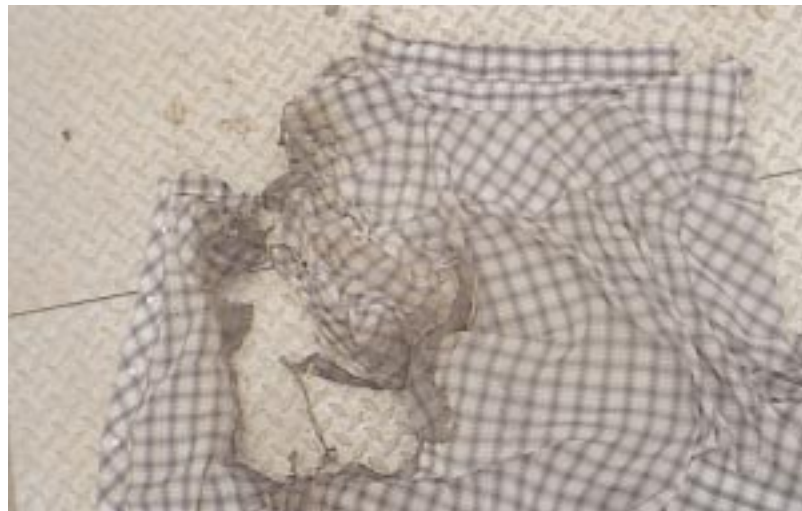
Electrician 3's shirt
35 percent cotton
65 percent polyester

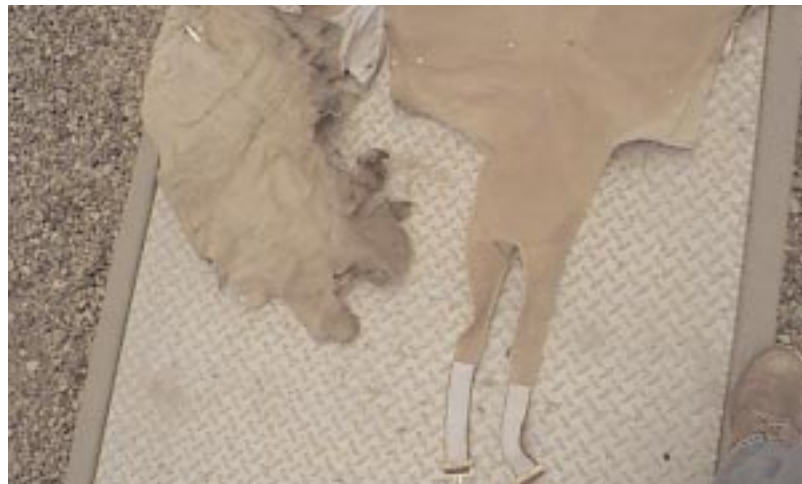
- Hazard or problem – not recognized. This applies to Western management either not fully understanding or recognizing the arc exposure hazards for work in substations yet, allowing employees to be exposed to this (unknown) hazard without wearing the proper apparel or enforcing the existing apparel requirement. Electrician 3 was wearing cotton/polyester blend pants and shirt that ignited and 100 percent heavy cotton bib-overalls (Carharts) that also ignited, contributing to an increase in his injuries.

**Electrician 3's bib
overalls (Carharts):**
100 percent cotton

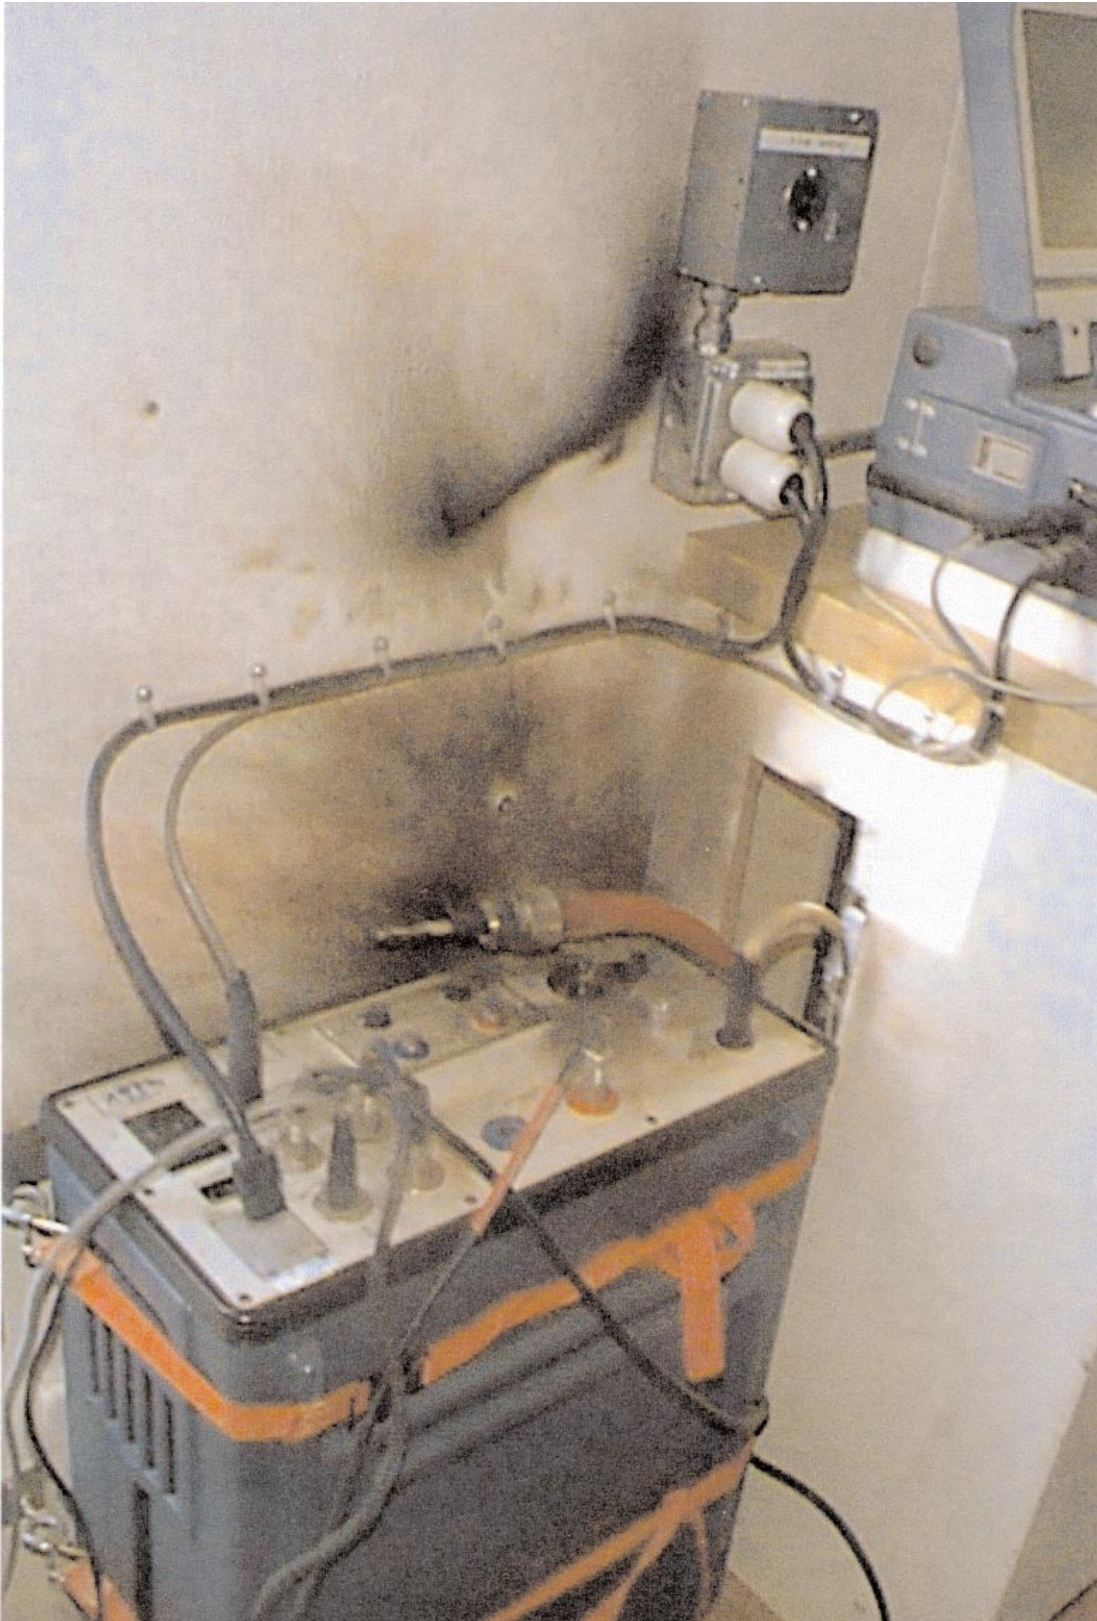
Exhibit D

equipment (see Exhibit D) and the grounded test trailer (see Exhibit A). The blast from the arcs caused Electrician 2 to fall from the ladder from a height of about 5 feet above the ground. Immediately following the explosion, the Acting Foreman turned and saw Electrician 3 fall to the ground with his clothing on fire. Fault current within the ground shield and the conductor of the HVL overloaded the Doble test equipment located in the test trailer, creating an explosion and causing Electrician 1 to fall to the floor. The trailer immediately filled with smoke following the explosion (see Exhibit E).

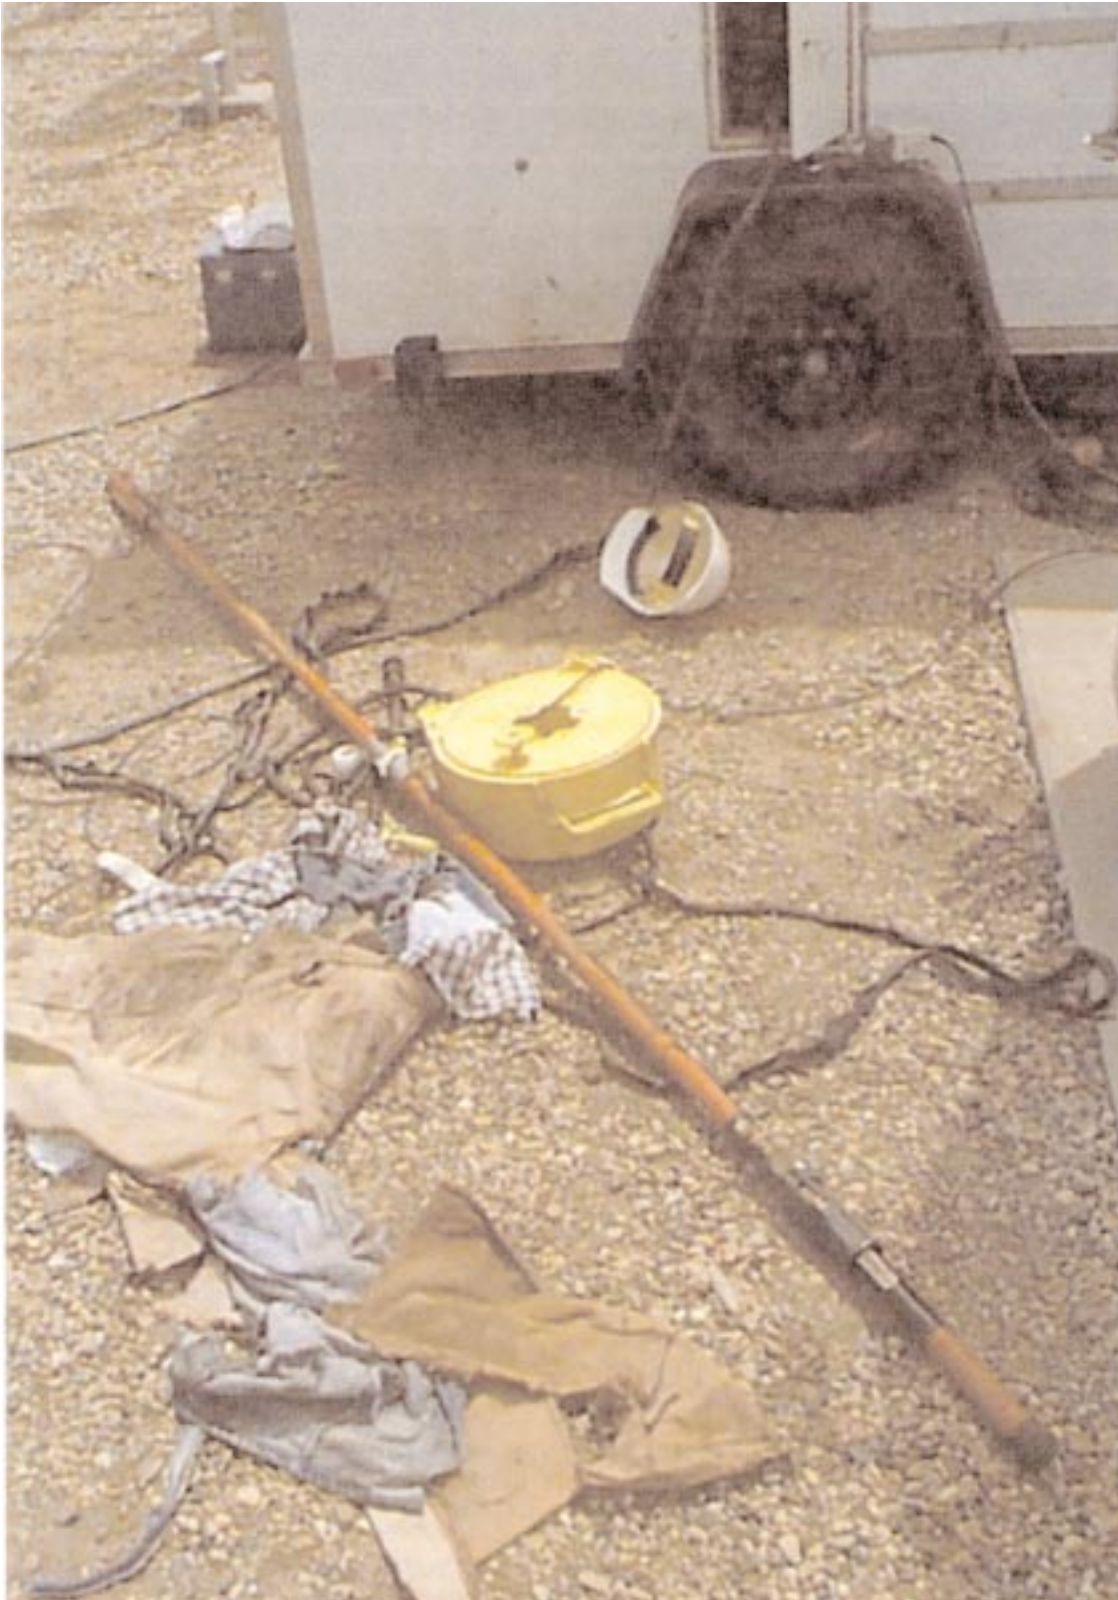
Exhibit F

As Electrician 3 was walking backward taking up the slack of the HVL, he held the hotstick in a nearly vertical position. With the grounded HVL still attached to the top of the hotstick, the hook of the HVL got within 8 to 10 inches of the spark gap located on the top of bushing 5 of the energized 138-kV BK 2772. It initiated an arcing fault to ground. (See Exhibits B and G.) The fault current had a magnitude between 13,450 and 14,200 amperes that split, with the majority (10,700 – 11,300 amperes) traveling to ground through the spark gap. The remaining fault current (2,750 – 2,900 amperes) flashed down the HVL, which was against the hotstick and Electrician 3, causing his clothing to ignite. (See Exhibits C and F.)

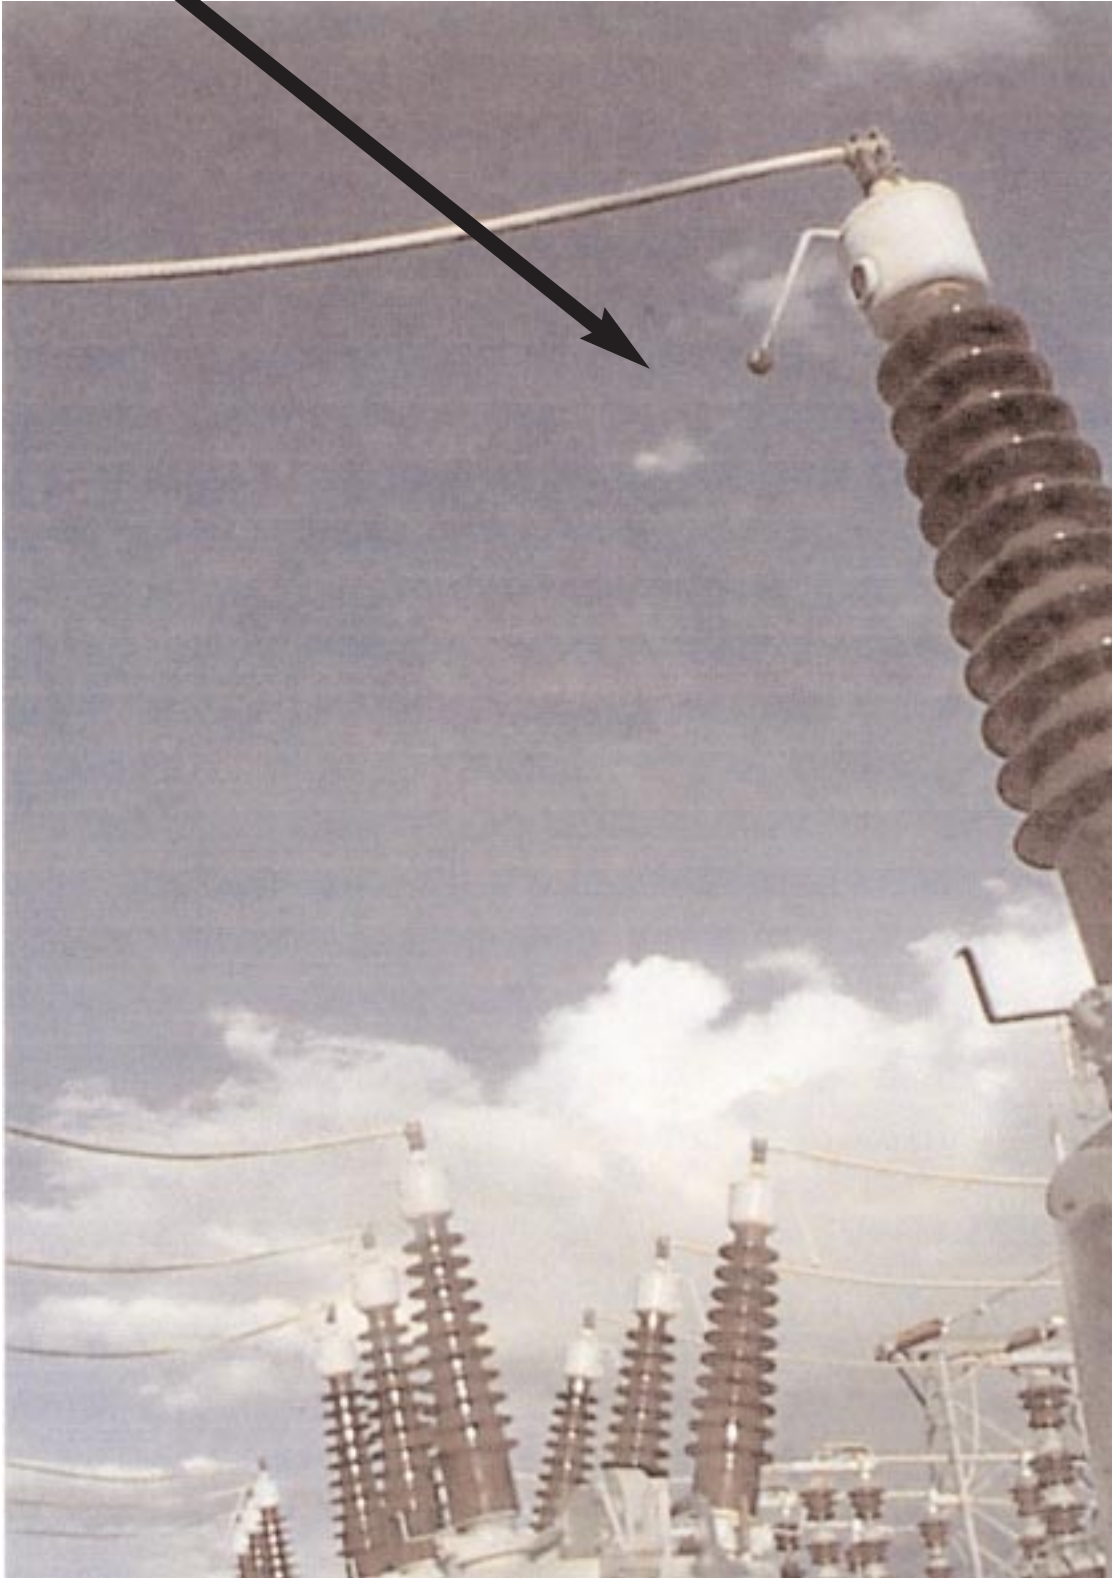
Bushing 5 BK2772
Spark Gap

- The fault was the result of encroachment of the minimum approach distance (MAD) on energized equipment near the top of bushing 5 on BK 2772.
- Neither the written job hazard analysis nor the tailgate meeting(s) properly addressed close working distances to energized parts, as adequate controls were not established to ensure that the electrician maintained the MAD to energized parts.

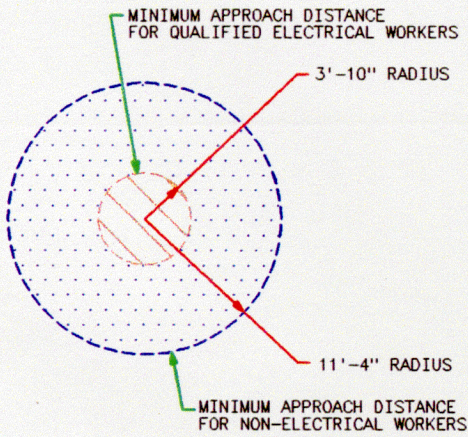
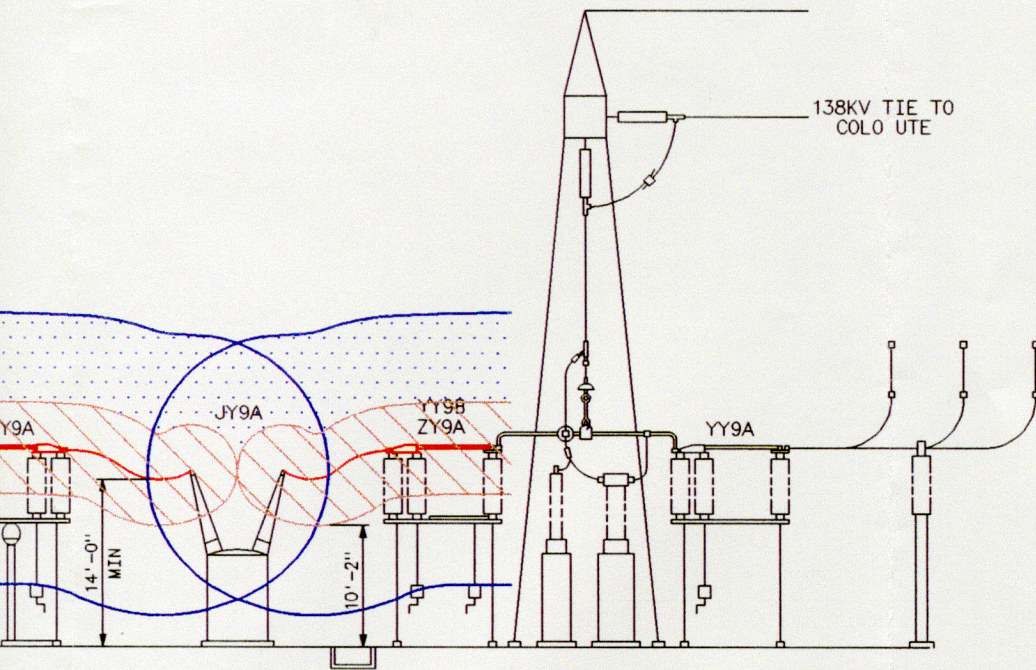
Exhibit H

Interviews with the crew indicate that the specific issue of working in close proximity to energized parts was never discussed as a potential hazard. Due to the location of the test trailer, the hazard was mitigated during the CSE on BK 2972. The trailer was parked on the east side of the breaker, which allowed relocating the HVL from one side of the breaker to the other while attached to the hotstick and maintaining minimum approach distances of energized equipment. However, for the CSE on BK 2872, the trailer was relocated to the southeast corner of BK 2772. Given the location of BK 2872 (between two adjacent energized bays), it would be extremely difficult to move the HVL around BK 2872 with the HVL attached to a hotstick held in the vertical position while maintaining minimum approach distances to energized parts. (See Exhibit H.)

When using a hot-stick to place or remove the high-voltage lead during Doble testing of breakers and transformers, it is recommended that the test lead be removed from the hot-stick and hand carried to the opposite side of the equipment to continue the testing. Once the worker is in a safe position, the test lead can be reattached to the hot-stick for continuation of the test on the opposite bank of bushings. This work practice will reduce/eliminate the risk of encroachment of the minimum approach distance to adjacent energized equipment.
