Type B
Accident Investigation Board Report
Of the November 1, 1999
Construction Injury
At the
Monticello Mill Tailings Remedial Action
Site
Monticello, Utah

December 1999
Albuquerque Operations Office
U.S. Department of Energy

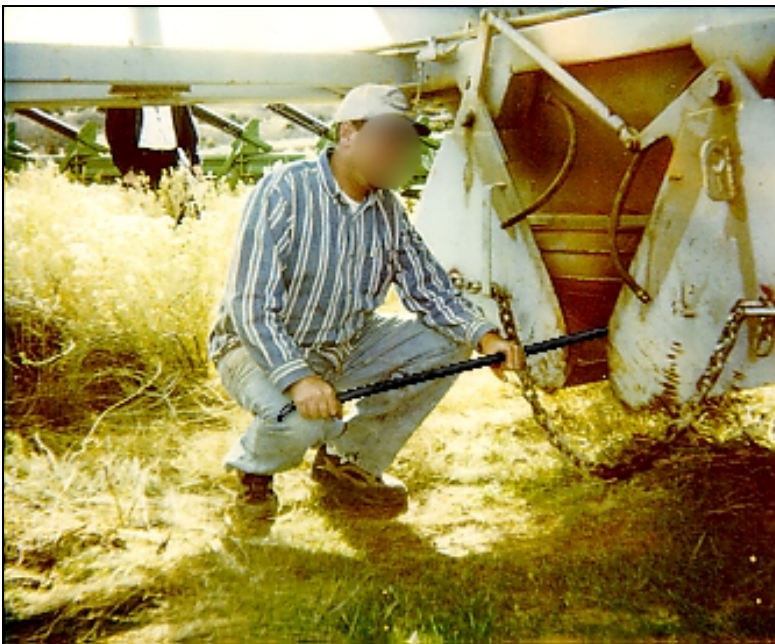
Figure 2-1 Reenactment of Accident

The accident occurred at approximately 11:18 am during rock delivery to the stockpile area at the Monticello Mill Tailings Remedial Action Site. The driver of a belly dump truck, Driver 1, delivered two loads of rock to the site earlier in the morning. Typically, the gates of a belly dump truck are operated from the inside of the truck cab, but on both trips Driver 1 had to stop, get out of his truck and manually pry open the belly dump gates using an iron bar approximately 1.25 inches x 4.5 feet. In order to pry open the gates, Driver 1 squatted between the rear tires and behind the belly dump gates, then placed the bar between the partially-opened metal gates and pried open the gates using his own strength. (See Figure 2-1)

On the third load, Driver 1 once again attempted to open the belly dump gates by using the iron bar. It was during this load that the gates opened and the weight of the rocks forced the iron bar upward, striking the truck driver on the right side of the head above the eye.

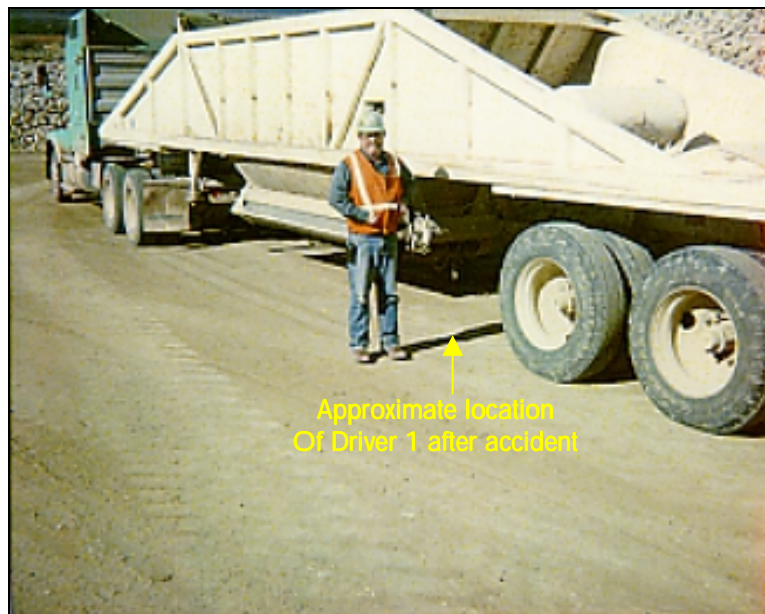
Figure 2-2 Belly Dump Truck at Accident Scene

Driver 1 was found within minutes of the accident by a Quality Control (QC) Inspector who was also in the area, and by Driver 2 who was unloading his truck on the other side of the stockpile area from where Driver 1 was located. Both of these men found the injured driver unconscious lying adjacent to the truck. Figure 2-2 shows a similar truck at the approximate location of the accident.

The belly dump truck used by Driver 1 was idle for about a year. This inactivity may have contributed to the failure of the pneumatic system to open the gates fully. Crowley did not own this vehicle. Crowley was also awarded another contract for earth- moving at the site, and so Crowley's in-use belly dump trucks were pulled from the material supply
