Type B Accident Investigation Board Report

**Arc Flash at
Brookhaven National Laboratory
April 14, 2006**

August 2006

**Brookhaven Site Office
U.S. Department of Energy
Upton, New York**

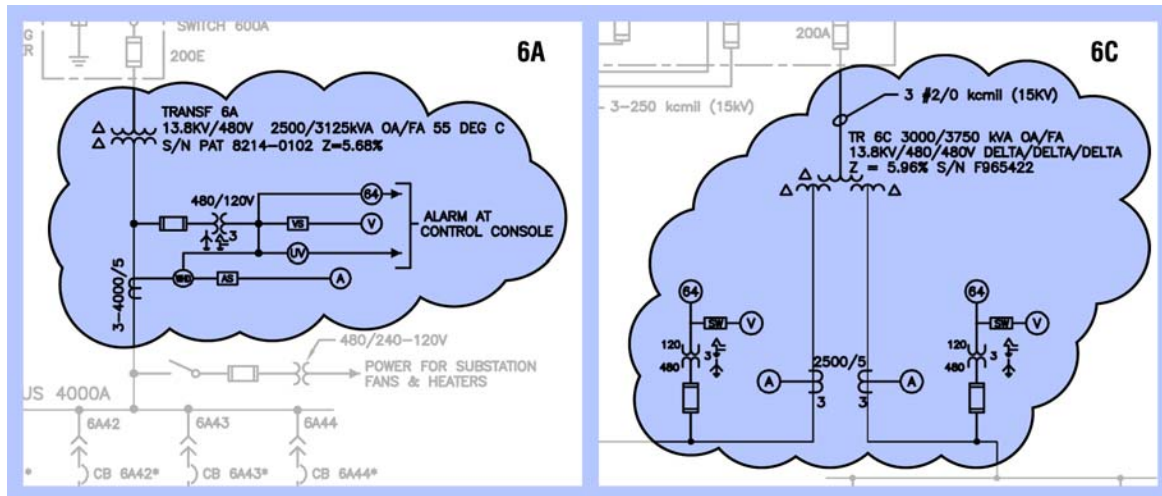
Substation 6C provides power to the electrical panel involved in the arc flash. This substation had a ground-fault detection relay installed, but it was inoperable because it did not have the required power source. The STAR control room and RHIC Main Control Room staff and the Chief Electrical Engineer were unaware that substation 6C did not have the capability to monitor ground-fault conditions. A surveillance of the voltages of substation 6C was performed 3 days before the accident; and, although a slight ground fault was recorded on the inspection form, no corrective action was taken. A ground fault on one of these cables resulted from a cut in the insulation and from the cable being submerged in a flooded manhole.

Figure 2-1. Circuit 64 designs for the 6A transformer (with alarm to control console) and 6C (without alarm to control console).

JON 2	<p>BNL needs to immediately verify that all ground-fault monitoring devices are connected to remote alarms in the RHIC Main Control Room.</p>	<p>BNL failed to ensure that ground-fault detector relays, as well as monitoring and alarm systems, were properly designed, installed, tested, and maintained.</p>
JON 3	<p>BNL needs to determine and review the specific factors by which RHIC and Plant Engineering design reviews and approval processes failed to ensure installation of a functional ground-fault monitoring and alarm system as specified in BNL standards and DOE requirements. Additionally, BNL needs to implement the corrective actions identified by this review to prevent recurrence.</p>	<p>BNL failed to ensure that a ground-fault monitoring system provided prompt notification to the Main Control Room for safe and reliable operation.</p>
JON 4	<p>BNL needs to improve the rigor and formality of the engineering design and design review processes to ensure that the functional specifications identified in DOE Directives and BNL standards are addressed.</p>

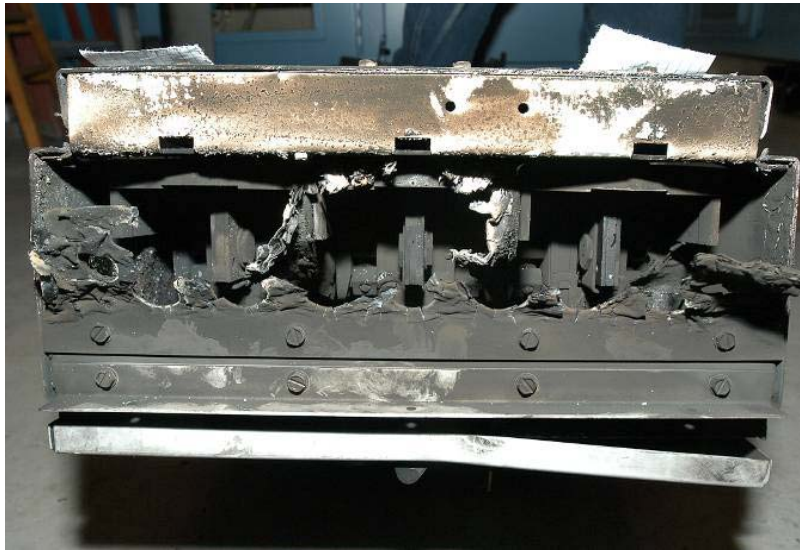
Figure 2-5. Bowed cover of Switch 3A

The inside of the two 400-amp switches 2A and 3A was coated with a thick layer of black soot. The switch components appeared from the front to be intact, except for thin plastic insulating sheets at the left end of the switches, opposite the load terminals. The left ends of the 400-amp switches were partially blown out, and the adjacent wiring insulation was melted from the heat of the arc flash. The vent panels on the ends of the switches were completely seared by the heat and blown off. The front covers were deformed and would have failed eventually if the fault persisted beyond the 0.2-second clearing time (see Figure 2-5 and Figure 1-4).

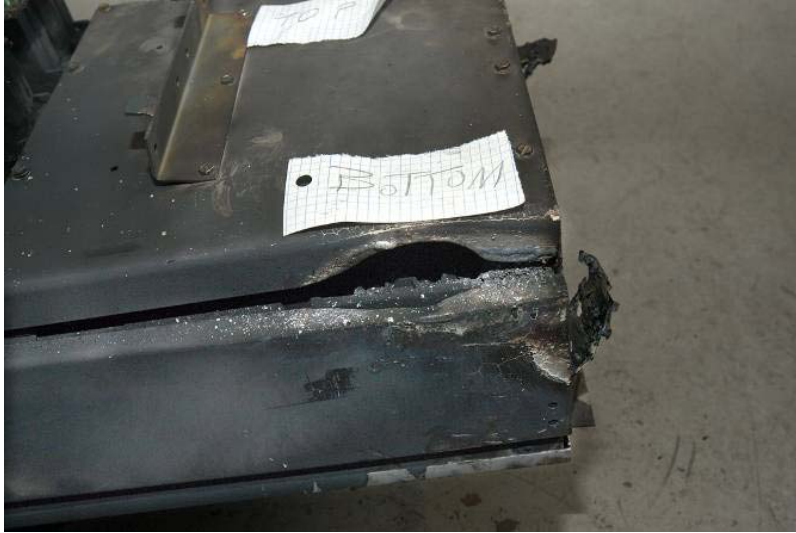
Figure 2-6. Back of switch 3A bus cover plate

The heavy-duty padlock and hasp likely restrained switch doors 2A and 3A from being forced open toward the C-AD electrical engineer. The back of the switches have aluminum bus bars that run the length of the switch and connect the spring-loaded contact jaws to the switching elements on the left side of the switch. The sheet metal plate that covers the bus bars had a semicircular hole melted in the top and bottom of the rear cover plates, as shown in Figure 2-6.

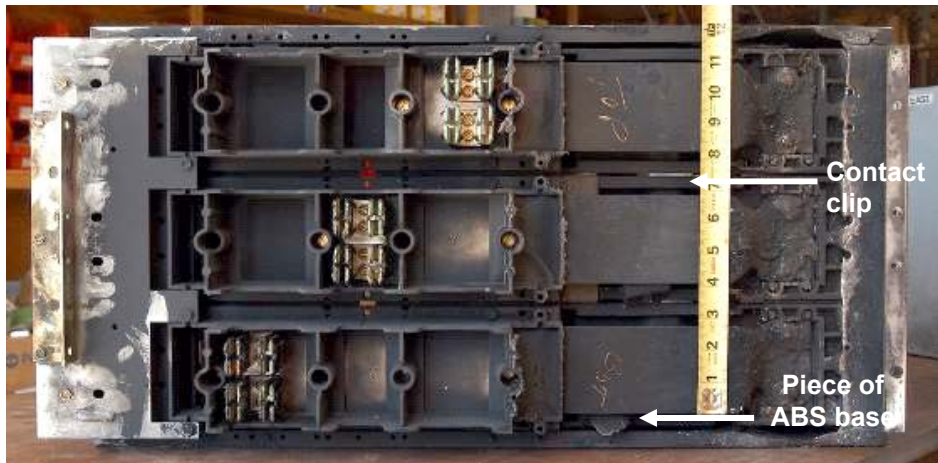
Figure 2-8. Damaged Switch 3A
(Note location of contact clip and piece of ABS base)

Figure 2-7 shows the bus on an undamaged switch in another location that was not involved in the accident. As shown in Figure 2-8, arcing heavily eroded the ends of the switch bus bars, and the head of the attaching bolts were melted. The arcing had enveloped all six busses of the two adjacent switches 3A and 2A.

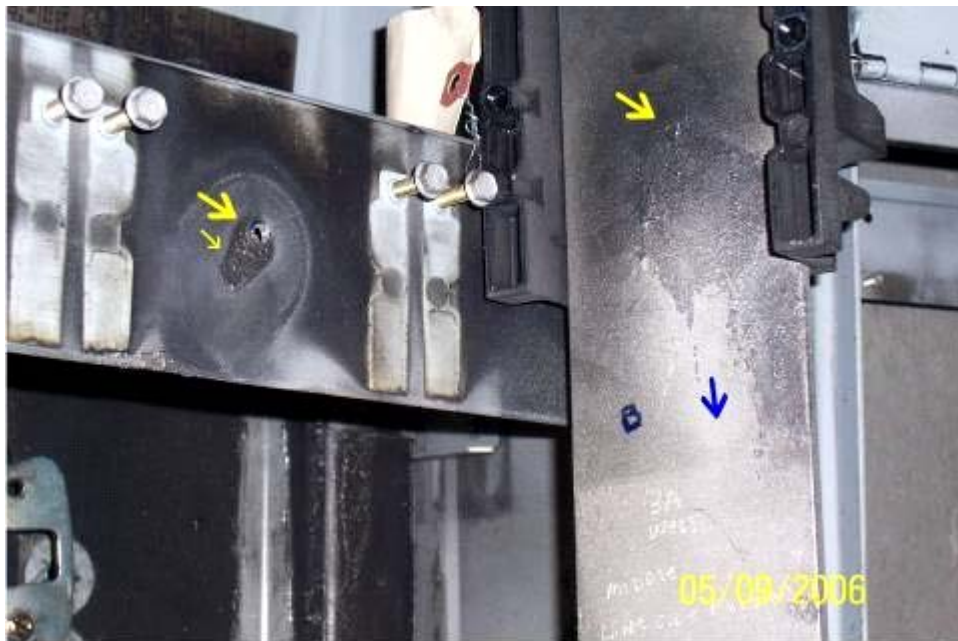
Figure 2-9. Evidence of arcing between base and Phase B Switch 3A

The removal of the bus bars disclosed that an arc had occurred between the aluminum bus and the adjacent steel switch frame. This was observed on the B-phase of switch 3A. (See small yellow arrow on Figure 2-9.) The bus bar is held about $\frac{3}{4}$ inch from the steel frame by its plastic support with two opposing screws (see yellow arrows on Figure 2-9), which are approximately $\frac{1}{2}$ inch apart (Figure 2-10). The screw end on the right (Figure 2-9) connects the bus bar to its plastic support and is in full contact with the 480-volt bus. The screw on the left (screw removed in Figure 2-9) holds a switch assembly on the front onto the steel support piece, and is at ground potential.

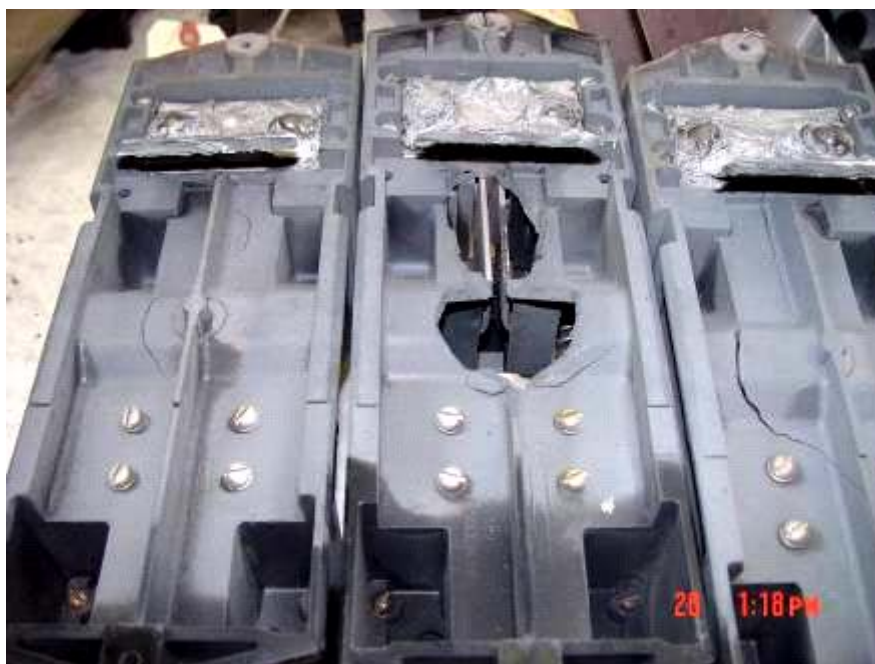
Figure 2-11. Switch 3A ABS base Phase B displaced piece

The removal of the bus bars also disclosed that on switch 3A the ABS base had failed and a circular piece was displaced (Figure 2-11). The ABS base holds the contact clips, which are used to maintain contact pressure for the moving and stationary contacts. The examination of switch 2A revealed that Base had been displaced and two of the contact clips were displaced (Figure 2-12), one of which could not be found. Upon examination of identical switches purchased at the same time as those for the STAR Magnet power supplies, cracks were found in a pattern similar to the switches involved in the arc flash, as can be seen in Figure 2-13.

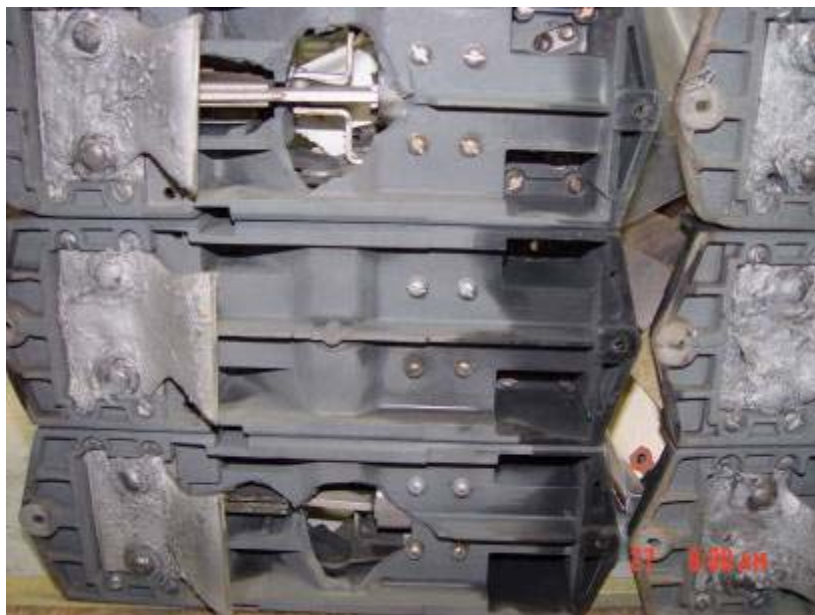
**Figure 2-12. Switch 2A ABS base Phase A and C displaced pieces
(Only one contact clip could be found)**

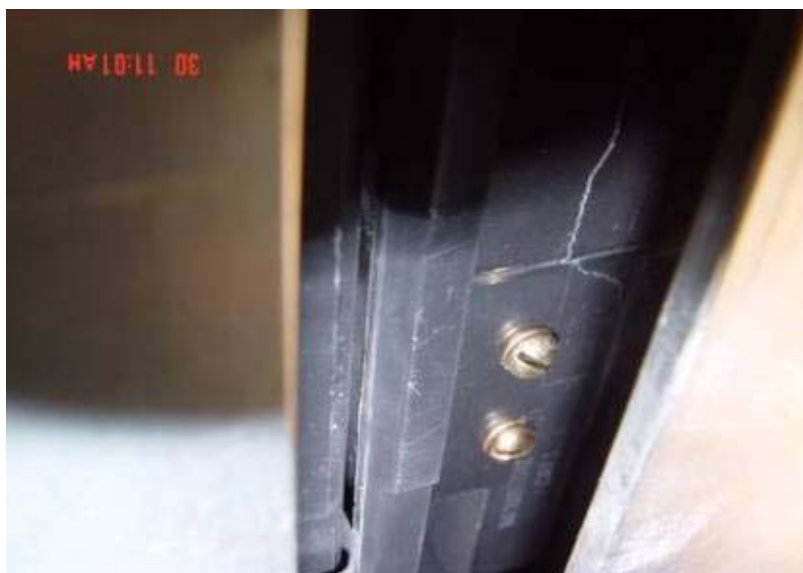
Figure 2-13. Crack developing in ABS base of switch not involved in the accident

JON 10	BNL needs to inspect all GE Spectra Series switches to ensure their mechanical integrity.	BNL failed to establish a preventive maintenance inspection program for fused-disconnect switches and ground-fault relays.
JON 11	BNL needs to establish a preventive maintenance inspection program for electrical distribution system equipment to include fused-disconnect switches and ground-fault relays.	
JON 12	BNL needs to establish a formalized project management process for arc flash calculations that establishes priorities, resources, and accountabilities.	BNL failed to implement NFPA 70E.
JON 13	BNL needs to conduct an independent effectiveness review of the implementation of the personal protective equipment and training requirements of NFPA 70E.	
JON 14	<p>BHSO needs to monitor the status of the corrective actions for the following:</p> <ul style="list-style-type: none"> • SC Energized Electrical Work Review; • BNL self-assessment of energized electrical work; and • Performance of BNL's effectiveness review. 	<p>BNL failed to adequately monitor the progress of its implementation of NFPA 70E requirements.</p> <p>BHSO failed to adequately validate BNL's implementation of corrective actions from BNL's self-assessment and the SC Energized Electrical Work Review.</p>

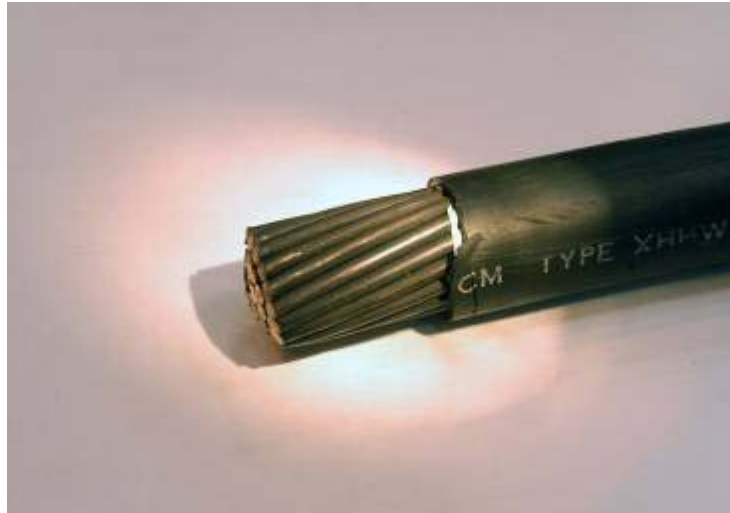
The feeder cables serving electrical panel PB-1 are enclosed in an underground conduit that runs between substation 6C (through a manhole) into Building 1006A. When the accident occurred, the manhole was flooded and the cable was underwater. The cables, which supply electrical power to panel PB-1, were tested, and a ground fault was identified in the C-phase feeder. The cable was tested with a 600-volt megger, and was found to have unacceptable leakage current to ground. The cable with the ground fault was removed for inspection. As shown in Figure 2-14, a nick was found in the cable insulation that contained a pinhole, exposing the copper conductor.

Figure 2-14. Damaged cable which was underwater in manhole from substation 6C to panel PB-1

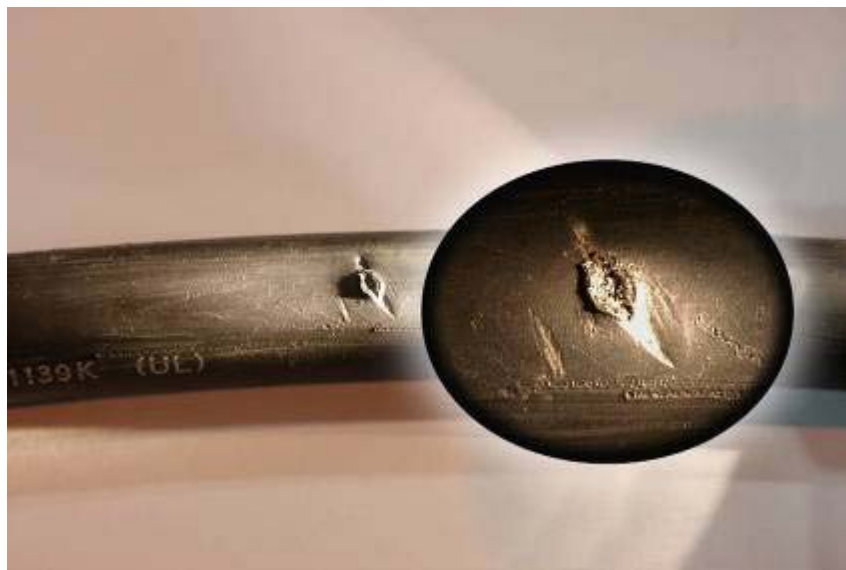
The pinhole was surrounded by a small, volcano-shaped mound of carbonized insulation. When the insulation was removed, the copper wire in the area of the nick was found to be oxidized and discolored (Figure 2-15), an indication that this condition had been present for an extended period of time. When the manhole was drained, the ground fault cleared. A new cable was installed and no ground faults were detected.

Figure 2-15. Damaged cable with oxidized copper

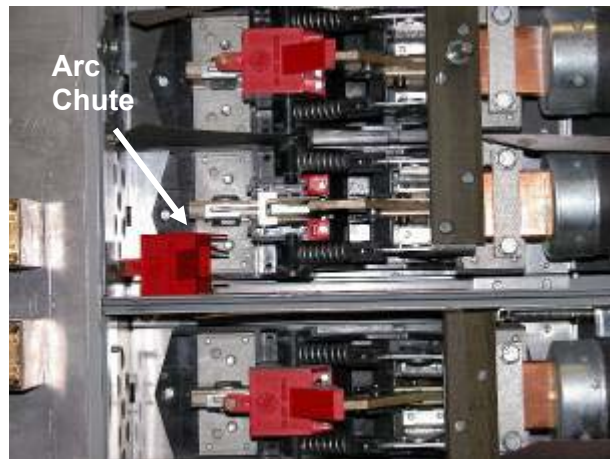
observed damage to the switches by the failure of the ABS Base led to the inspection of other Spectra 400-amp fused-disconnect switches at BNL. These inspections identified cracking of the ABS Bases of the switches that were installed at the same time as those in panel PB-1. BNL has subsequently removed a switch from service and cycled the switch. The ABS Bases cracked, but failed to release the contact clips, after more than 4,000 switch operations. BNL inspected all of the GE Spectra-type switches in use and found that the arc chutes were broken on a 600-amp switch and the arch chute had been displaced on one switch. (See Figure 2-16)

Figure 2-16. Loose arc chute from 600-amp Spectra-fused disconnect switch

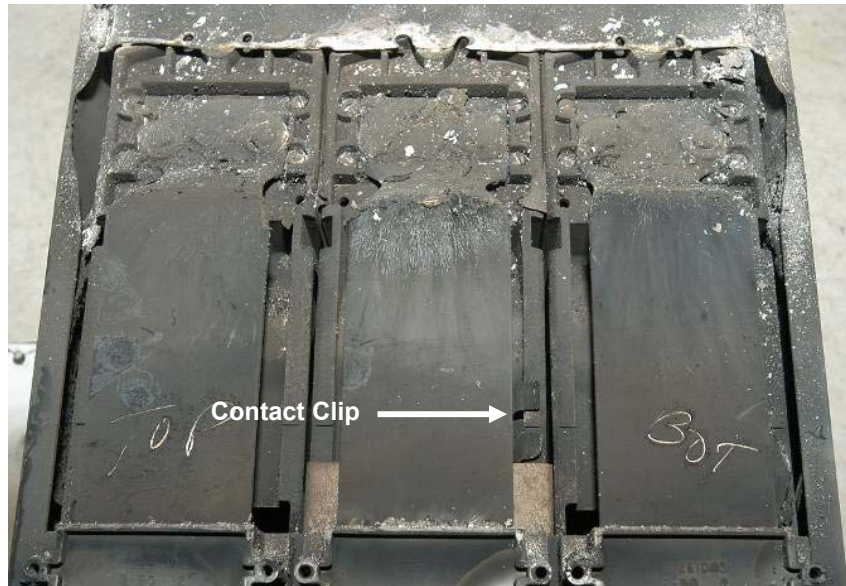
A single contact clip of switch 3A was found on the side of the phase B bus after the switch was removed from panel PB-1 (Figures 2-17 and 2-18). The contact clip from switch 3A was partially damaged by arcing, as shown in Figure 2-19. On switch 2A, which had two pieces of the ABS base displaced (Figure 2-20), only one of the contact clips could be found. There was no evidence that the contact clips from either switch 2A or 3A had contacted the buses; however, this could not be proven with any certainty. Had the contact clip from switch 3A caused the arc flash, it might have been completely destroyed in the ensuing arc, but evidence of arcing would have been left on the aluminum bus at the point of contact. No such evidence was seen, and the bus bar would have been damaged where grounding occurred.

Figure 2-17. Switch 3A (note location of contact clip)

Figure 2-18. Location of contact clip on Switch 3A after backing plate removed

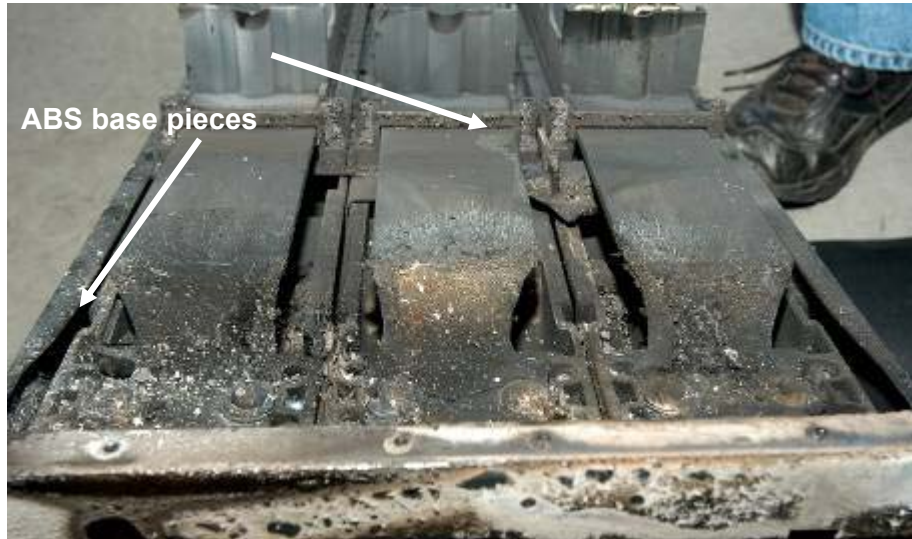
Figure 2-20. Switch 2A (note the ABS base pieces)
