**Type B
Accident Investigation
Board Report**

**Bechtel Jacobs Company LLC
Employee Fall Injury on
January 3, 2006,
at the K-25 Building
East Tennessee Technology Park
Oak Ridge, Tennessee**

February 2006

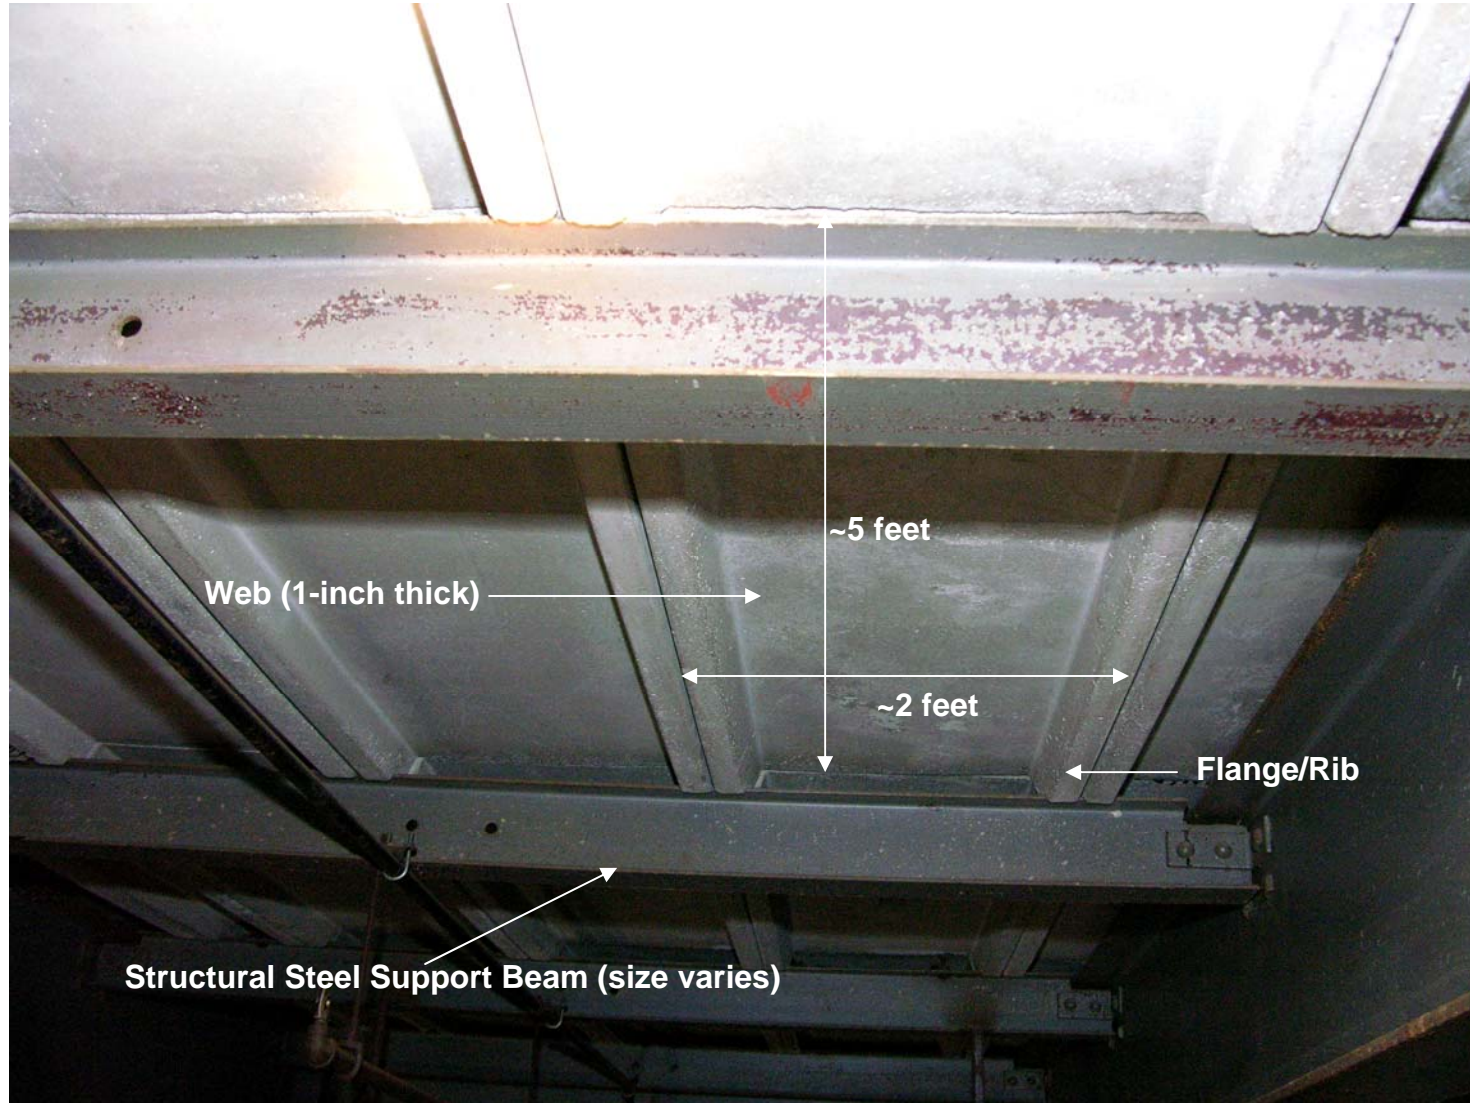
Figure 1-2. Underside view of the operating floor concrete panel layout/installation

(Note: This photograph is not typical of the condition of the concrete panels and is included only to reflect the typical installation.)

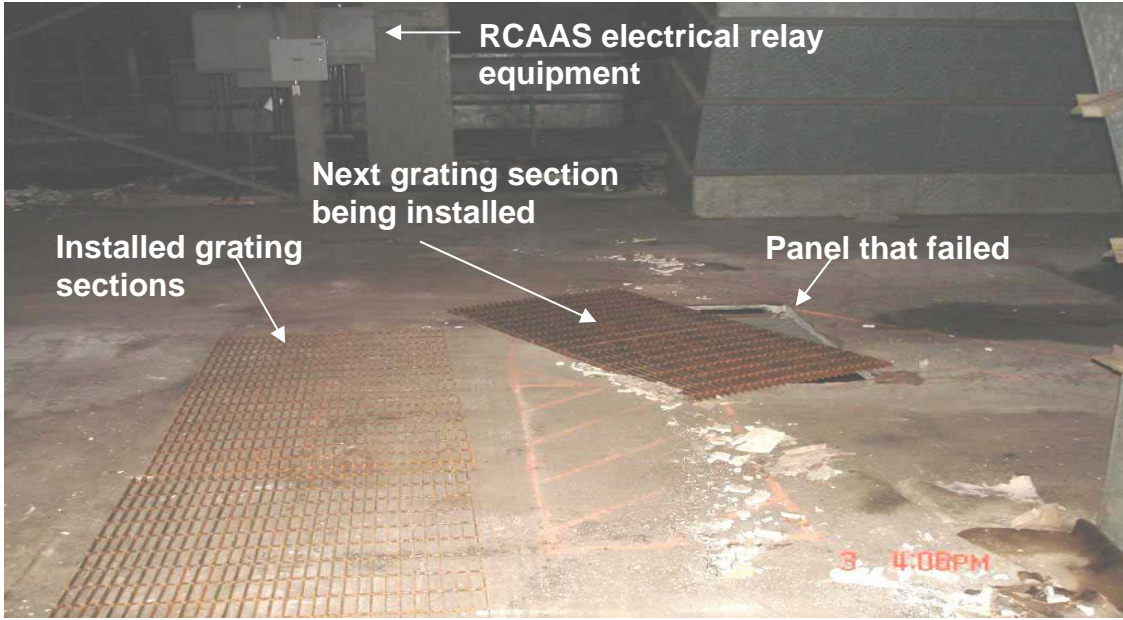
Figure 2-4. Accident scene – view from the operating floor.

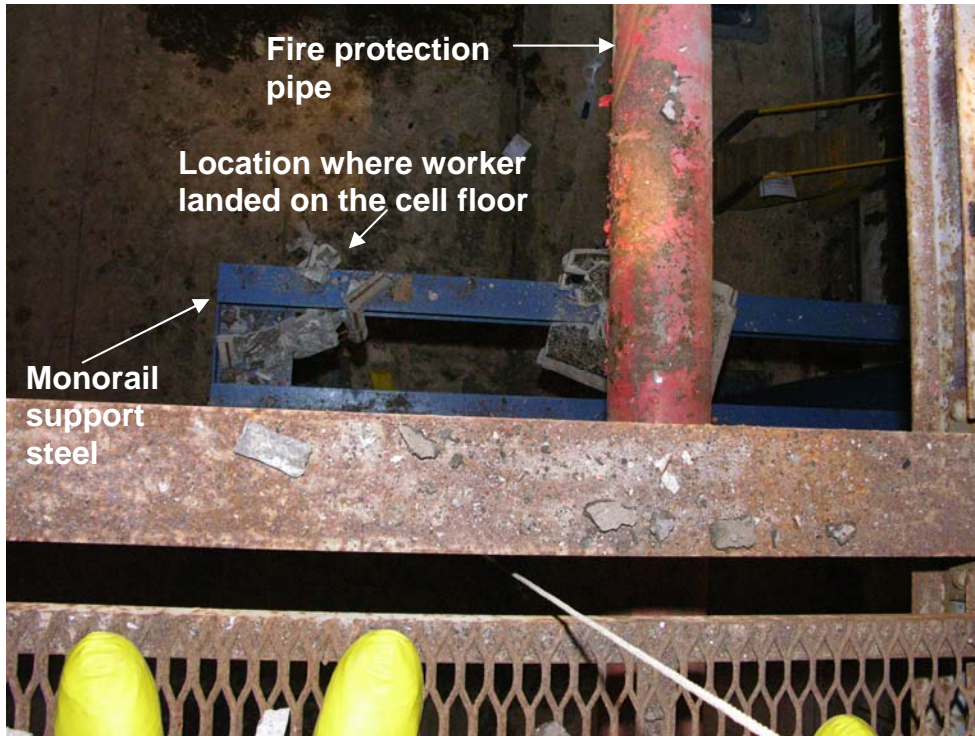
Figure 2-5. Accident scene – view looking down from the pipe gallery catwalk.

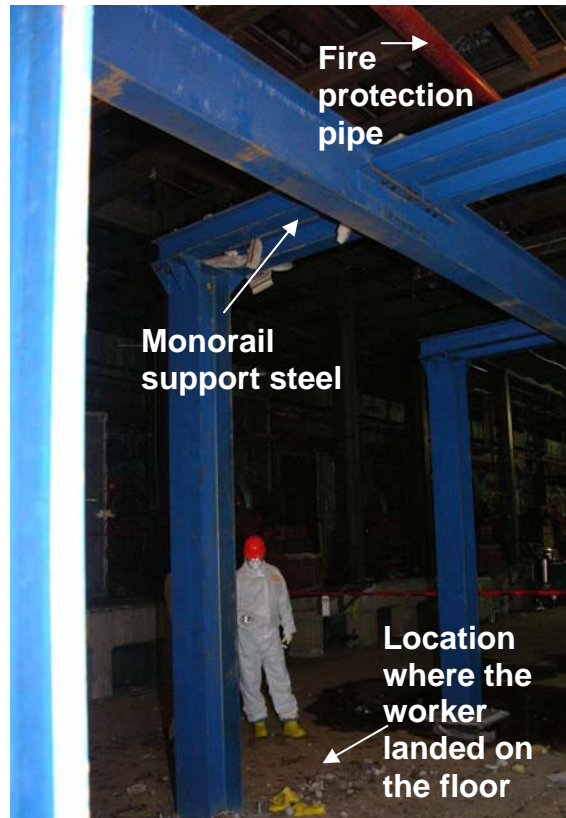
Figure 2-6. Accident scene – view from the cell floor.

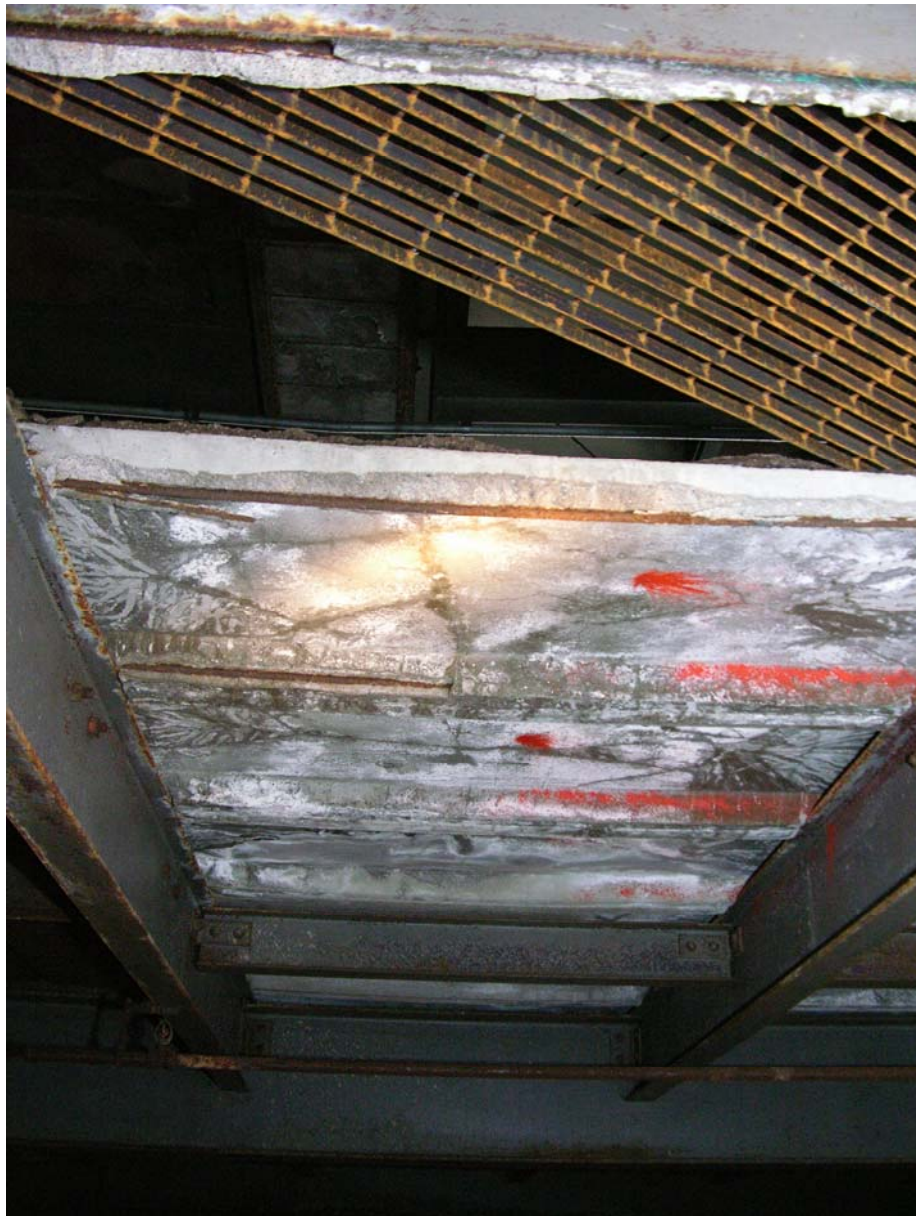
observed 2 to 3-inch pieces of concrete falling from the operating floor to the cell floor below. Also, on November 20, 1997, Fire Protection Specialists observed cracks in the operating floor which were 2 to 3 inches wide and 5 to 20 feet long. These were observed in several locations. Both of these occurrences were documented in Occurrence Report EM-ORO-LMES-K25ENVRES-1997-0005.

Figure 3-2. Degraded floor panels and the accident scene viewed from the pipe gallery catwalk below.

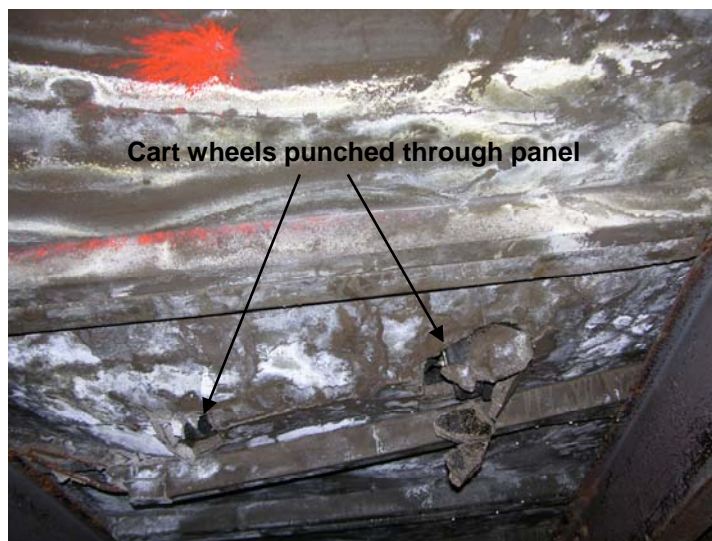
them across the operating floor using steel carts with four small, hard rubber wheels/tires. The loaded cart weighed approximately 240 pounds. While pushing the cart across the floor, the two front wheels “punched” through one of the floor panels. Based on discussions with the BJC Structural Engineer, the panel had not been identified as a degraded panel by the previous visual inspections. Figure 3-3 supports this fact. At this point, BJC restricted all access to the operating floor, and no one was allowed on the floor without fall protection. In addition, BJC initiated actions to develop a plan whereby personnel could access the RCAAS electrical panels and the fire protection equipment to perform inspections, tests, and surveillance and maintenance activities.

Figure 3-3. Cart wheels punched through the operating floor viewed from below.

Ultimately, the team decided to use 1-inch steel grating due to its load-carrying capacity, ease of installation, and ability to span between the structural steel members. The design consisted of (a) installing grating in a manner overlaying the existing concrete panel floor such that the ends of the grating were directly above the structural steel beam, (b) lashing the grating panels together with steel cable and crimps, and (c) installing stanchions and plastic chains to serve as a visual boundary for personnel using the steel grating as a walkway. Upon completion of the grating installation, Engineering personnel were to review and approve the installation.

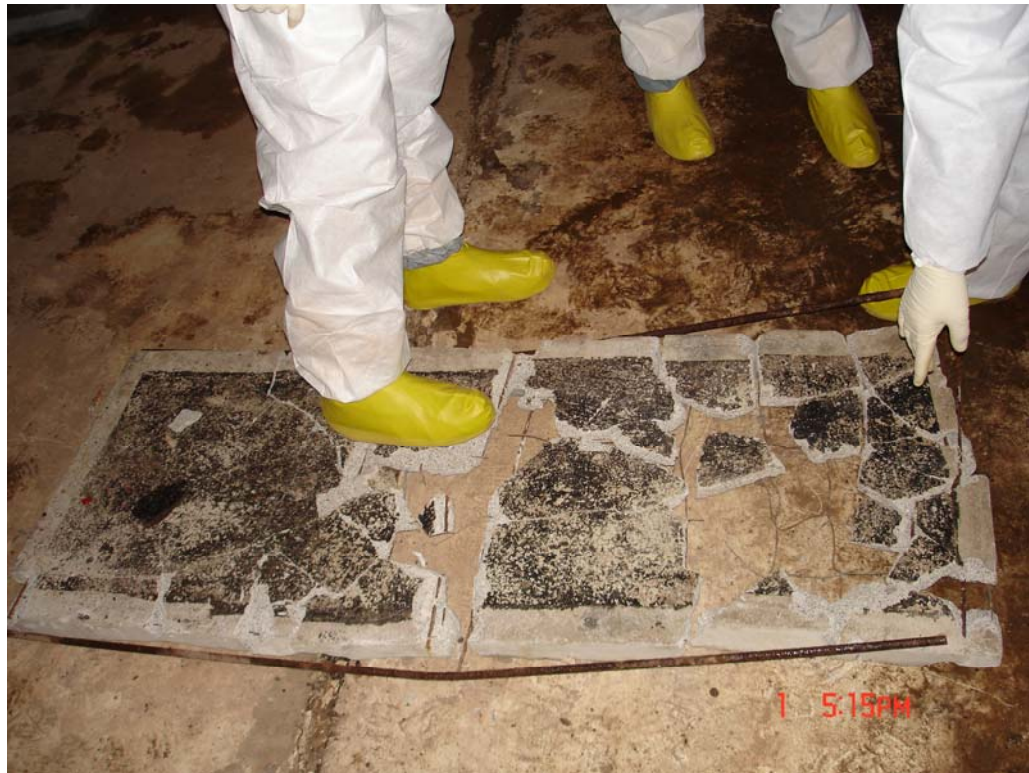
historical documents, as well as recent events, indicate the operating floor panels are in poor condition, the Board did not attempt to conduct physical testing of the failed panel or any other panels on the operating floor. The panel that failed on January 3, 2006, had been previously identified as a degraded panel based on the contractor's visual inspections and markings. Figures 3-4 and 3-5 are views of the reconstructed panel. In addition, visual inspections and photographs of portions of the failed panel support the conclusion in the visual inspection report that the panel was degraded. The longitudinal rebar in each flange was corroded to the point that the flexural strength of the panel was nonexistent and the concrete surrounding the rebar had spalled (broken apart).

Figure 3-4. View 1 of the reconstructed panel.

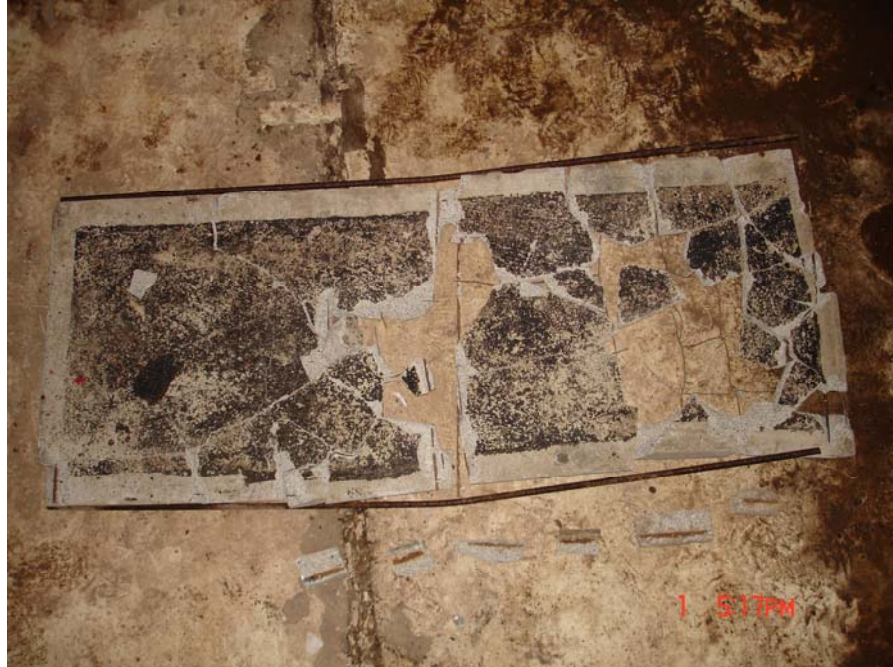
Figure 3-5. View 2 of the reconstructed panel.

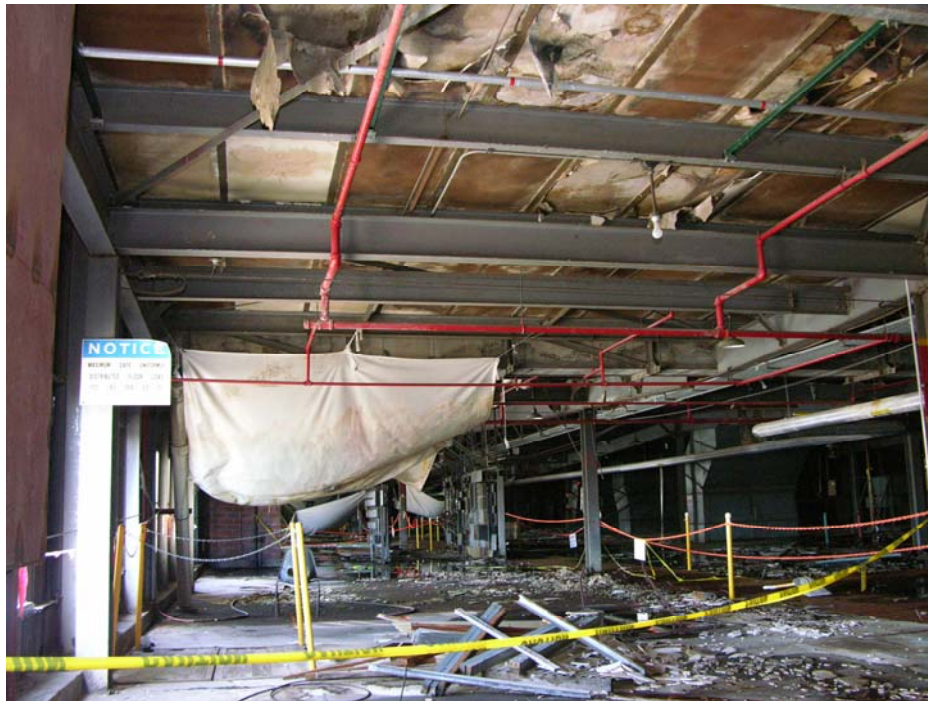
- *The failed panel had little or no load-carrying capacity due to deteriorating conditions caused by the infiltration of water and exposure to extreme environmental conditions.*
- *The lack of roof maintenance in the K-25 Building is the major contributor to the floor panel deterioration.*
- *There were no engineered barriers that met Title 29, Code of Federal Regulations, Part 1926.502(b) to prevent personnel from stepping off the grating.*
- *The contractor's report recommendation that "General foot traffic access is acceptable for the entire operating floor within Bldg. K-25. Care should be taken to avoid the marked panels." provides a false sense of security relative to the structural integrity and load-carrying capacity of the floor panels.*

Figure 3-6. Deteriorated roof viewed from the operating floor.

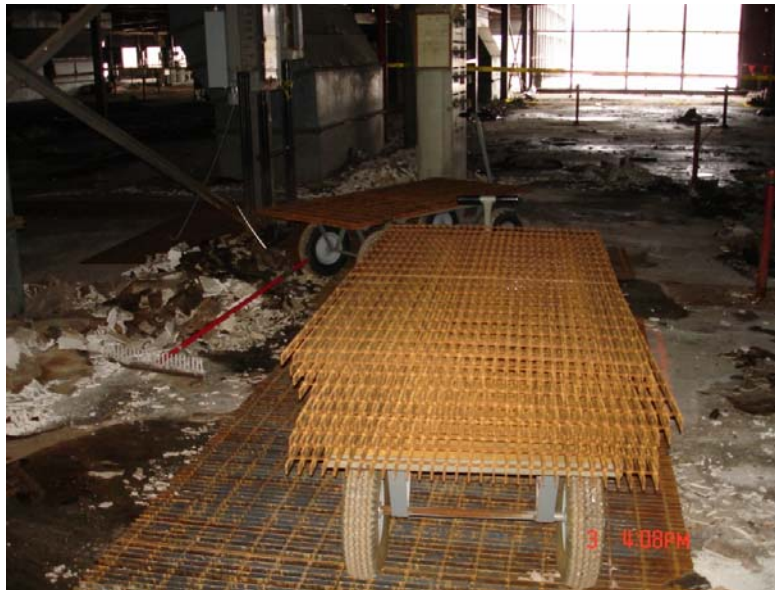
Figure 3-8. Overloaded cart at the accident scene.
