**Type B Accident
Investigation Board Report
For the January 11, 2006,
Personal Injury During Table Saw Use
at the
Heyrend Way Facility
Idaho Falls, Idaho**

February 10, 2006

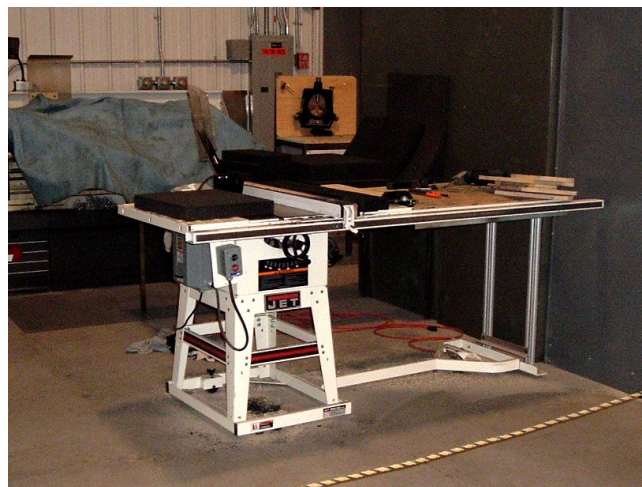
Figure 1. Table Saw at Accident Scene.

The table saw assembly consisted of a Jet Model JSTS-10JF table saw with a Biesemeyer Delta T-Square fence and a Jet integral blade guard assembly that was intended to meet the requirements for a blade cover, anti-kickback pawls, and kerf spreader. The blade in use was an Oldham Pro Series Carbide 40-tooth carbide tip 10-in. smooth cut combination blade. The blade had recently been replaced and was in near-new condition. The table insert was a standard insert supplied by the manufacturer. After about six months of use, the original push stick that was delivered with the saw was replaced by a replica fabricated in the shop. The push stick had been in use for about five years and was still serviceable. The saw was purchased new in 2000 when the facility was first opened.

At the time of the accident, one of the anti-kickback pawls was missing from the blade guard assembly. The workers were aware of this condition but continued to use the saw without repair or mitigative action. The Board could not determine how long this condition had existed. During the plywood ripping operation, the blade guard assembly was in place and in use.

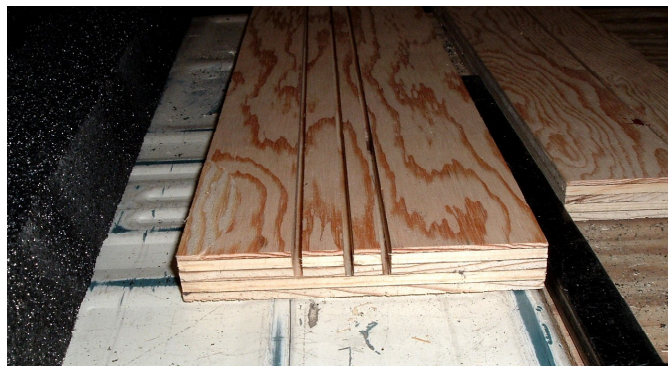
In the next step of the process, the Technician again used the table saw to put three dado cuts into the plywood. To accomplish this, the table saw blade guard assembly had to be removed. The Technician had another facility employee instruct him in the process for removal of the blade guard assembly. The Technician then removed the blade guard assembly and completed the dado cuts of the plywood. The dado cuts consisted of a single pass with the 1/8-in. wide combination blade already in use.

Figure 2. Sample of Plywood Dado Cuts.

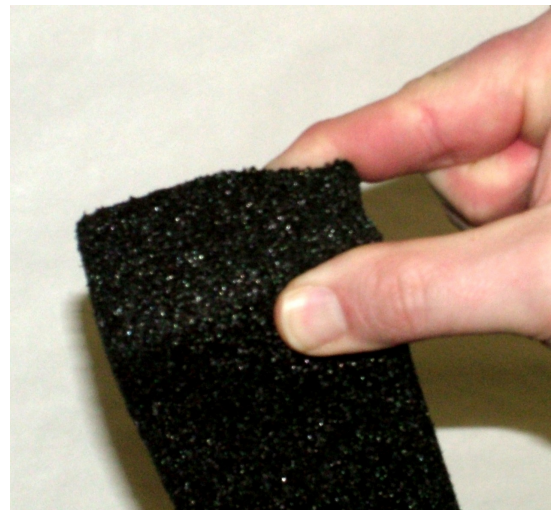
Figure 3. Flexibility of ETHAFOAM 900®.

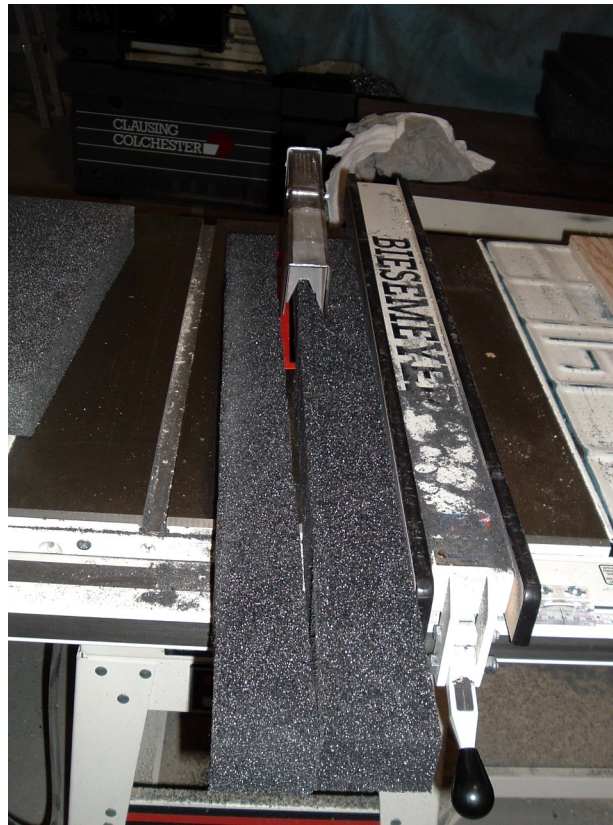
After a scheduled break, the Technician proceeded to rip cut the ETHAFOAM 900®. The blade guard assembly was not re-installed prior to this operation. The Laboratory Custodian observed the first cut of the ETHAFOAM 900® before leaving the Technician but did not notice that the blade guard assembly was missing. The Technician noted that the ETHAFOAM 900® was difficult to control while cutting with the table saw. While cutting the final piece of ETHAFOAM 900®, it became more difficult to control, and the Technician stopped using the push stick prior to completion of the cut. He placed both hands on the scrap portion (material on the side of the blade opposite the rip fence) of the material, leaving the product piece between the saw blade and rip fence unrestrained. Within several inches of completing the cut, an unexpected movement of the material occurred, and his right hand contacted the rotating saw blade. Based on the available physical evidence, the Board concluded that a kickback of the ETHAFOAM 900® occurred as part of the final accident sequence. Because no one witnessed the

Figure 4. ETHAFOAM 900® Fits Under the Blade Guard Assembly.

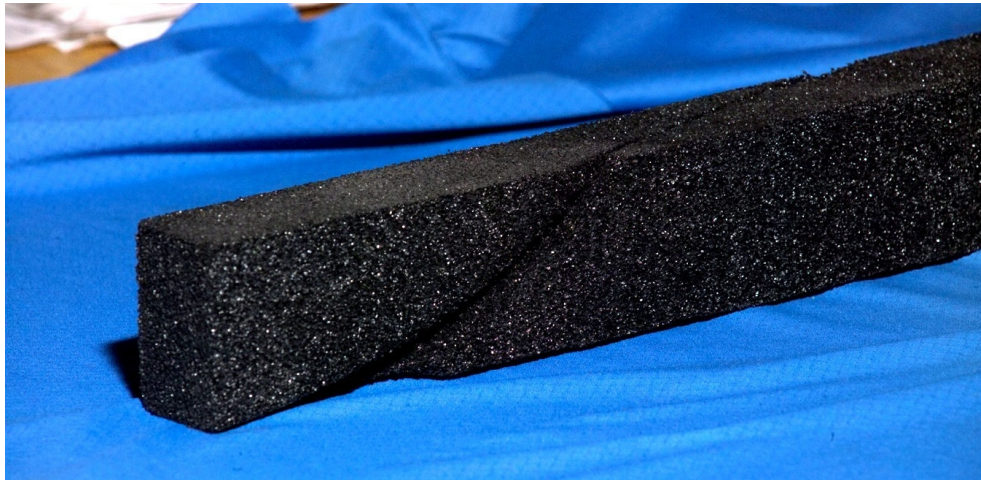
Figure 5. ETHAFOAM 900® Cut at Time of Accident Shows Evidence That Material Kickbacked.
