**Type B Accident Investigation of the  
Americium Contamination Accident  
at the Sigma Facility, Los Alamos  
National Laboratory, New Mexico  
July 14, 2005**

**January 2006**

**National Nuclear Security Administration  
United States Department of Energy  
Washington, DC 20585**

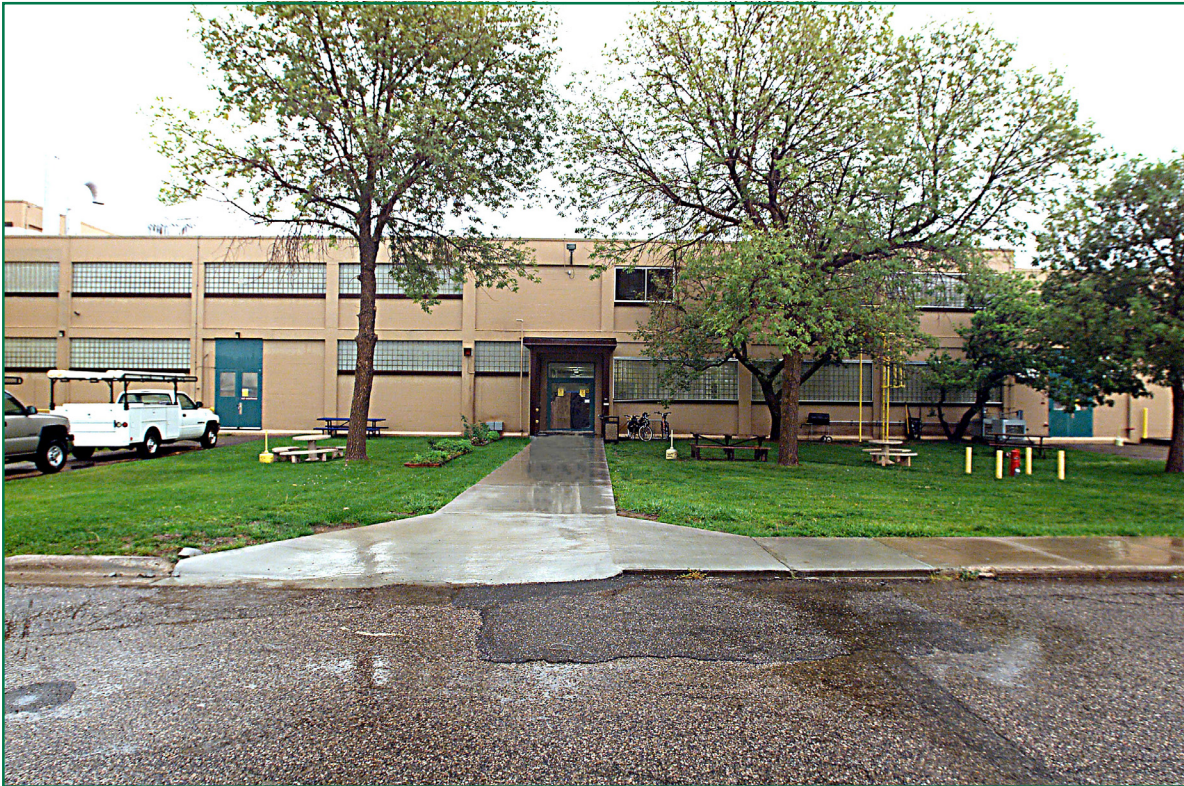
*Exhibit 1.2-1 The Sigma Facility building in which the contamination was released.*

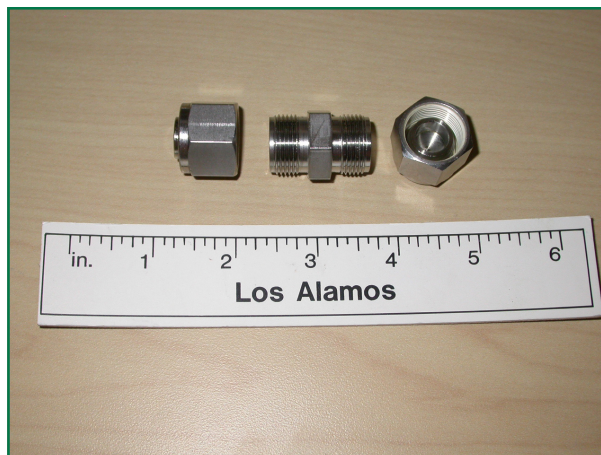
Exhibit 2.1-2 The uranium nitride pellets were contained within Swagelok® couplings and sealed with end caps to maintain an inert atmosphere.

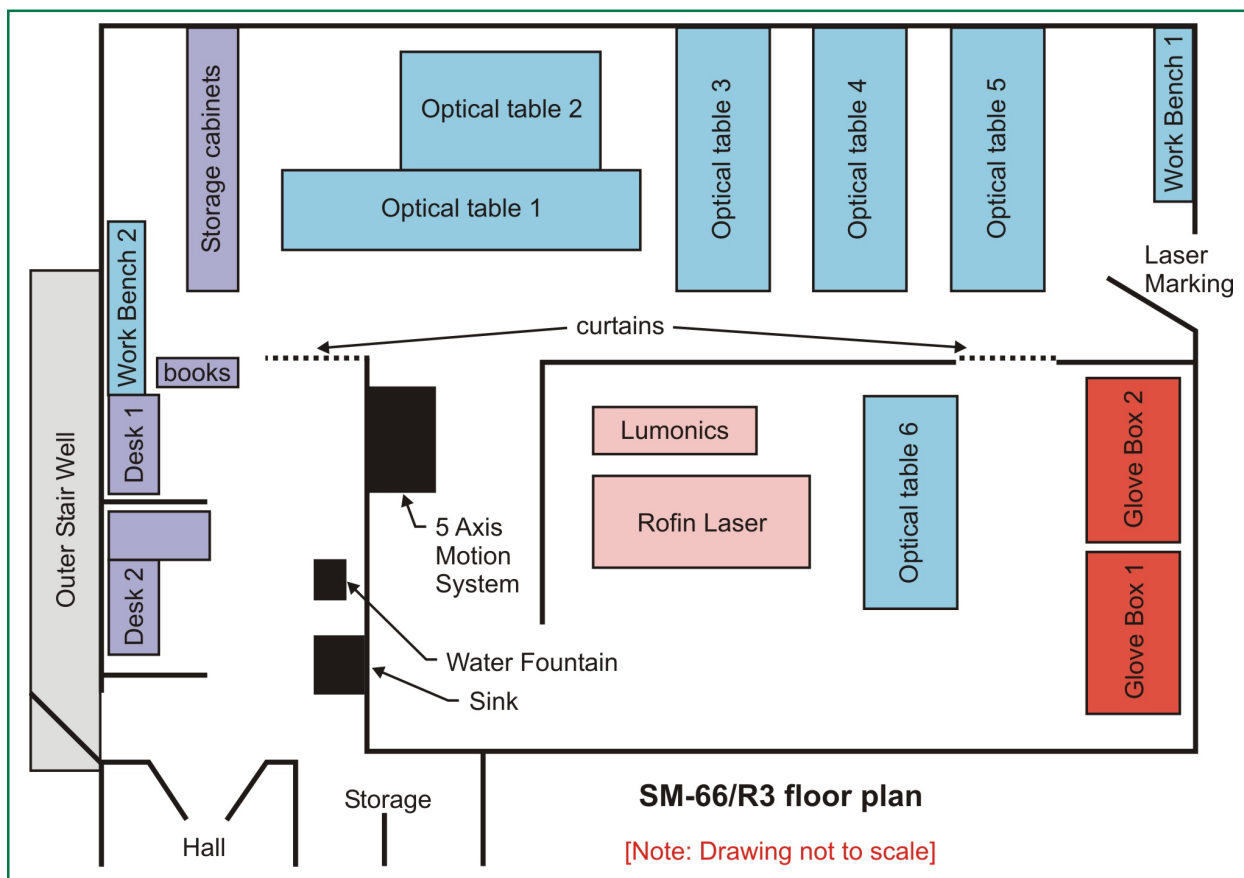
Exhibit 2.1-1 The floor plan for room R3 in the Sigma Facility. The Swageloks® were placed into glovebox 1.

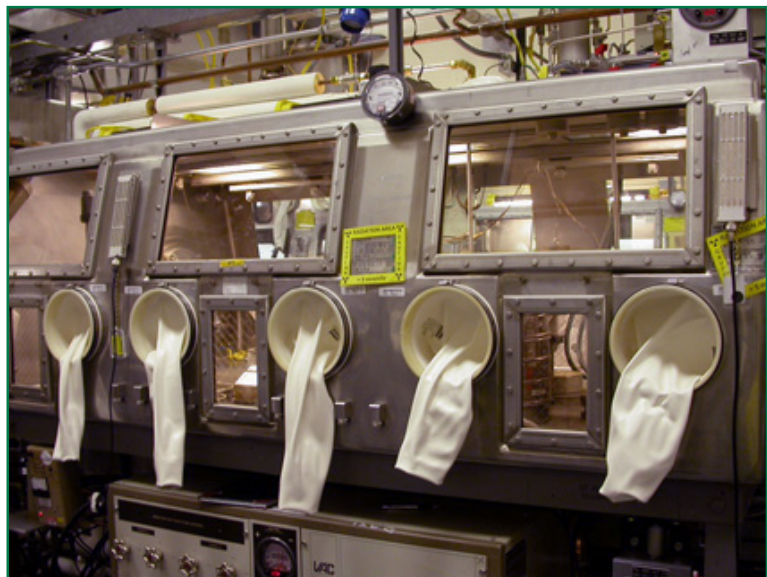
*Exhibit 2.3-1 Glovebox G138, where the uranium nitride pellets were loaded into the Swagelok® couplings.*

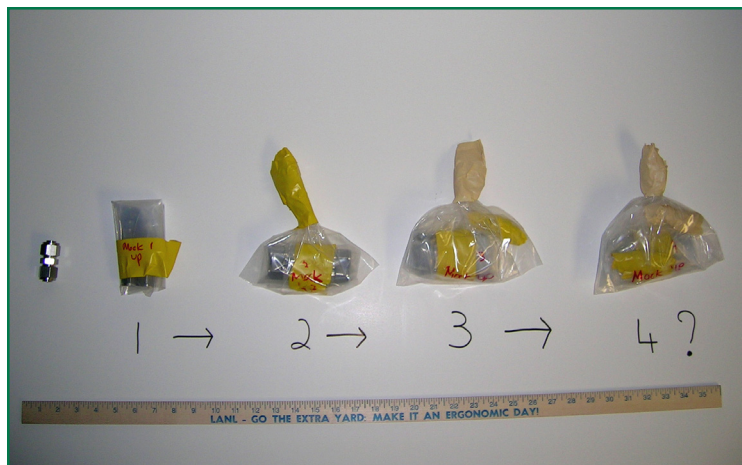
*Exhibit 2.3-2 A simulation of the sequence of packaging the Swageloks® in plastic bags. It was later determined by LANL that only three bags were used.*

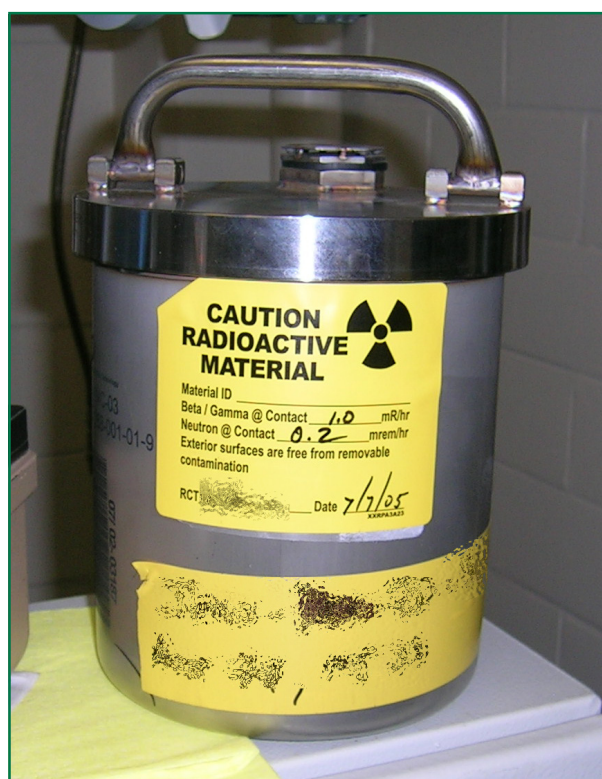
*Exhibit 2.3-3 The Hagen can that was used for transferring the uranium nitride pellets from PF-4 to Sigma.*

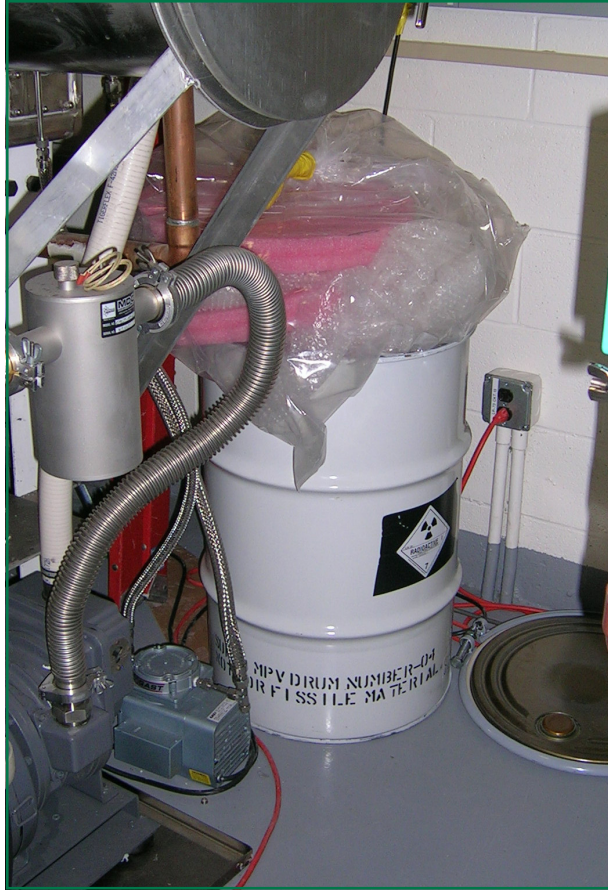
*Exhibit 2.3-4 The Type A shipping drum and packing material that was used to transfer the uranium nitride pellets to Sigma. The drum was found in room R3 behind glovebox 2.*

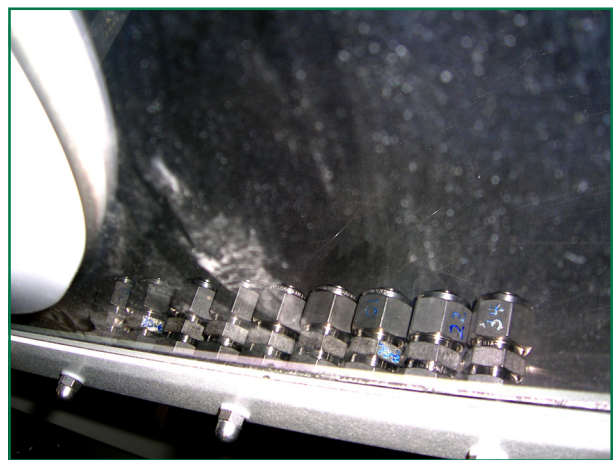
*Exhibit 2.3-5 The Swagelok® containers found inside the laser-welding glovebox in R3. Note that the Swageloks® were marked with serial numbers for the individual pellets.*

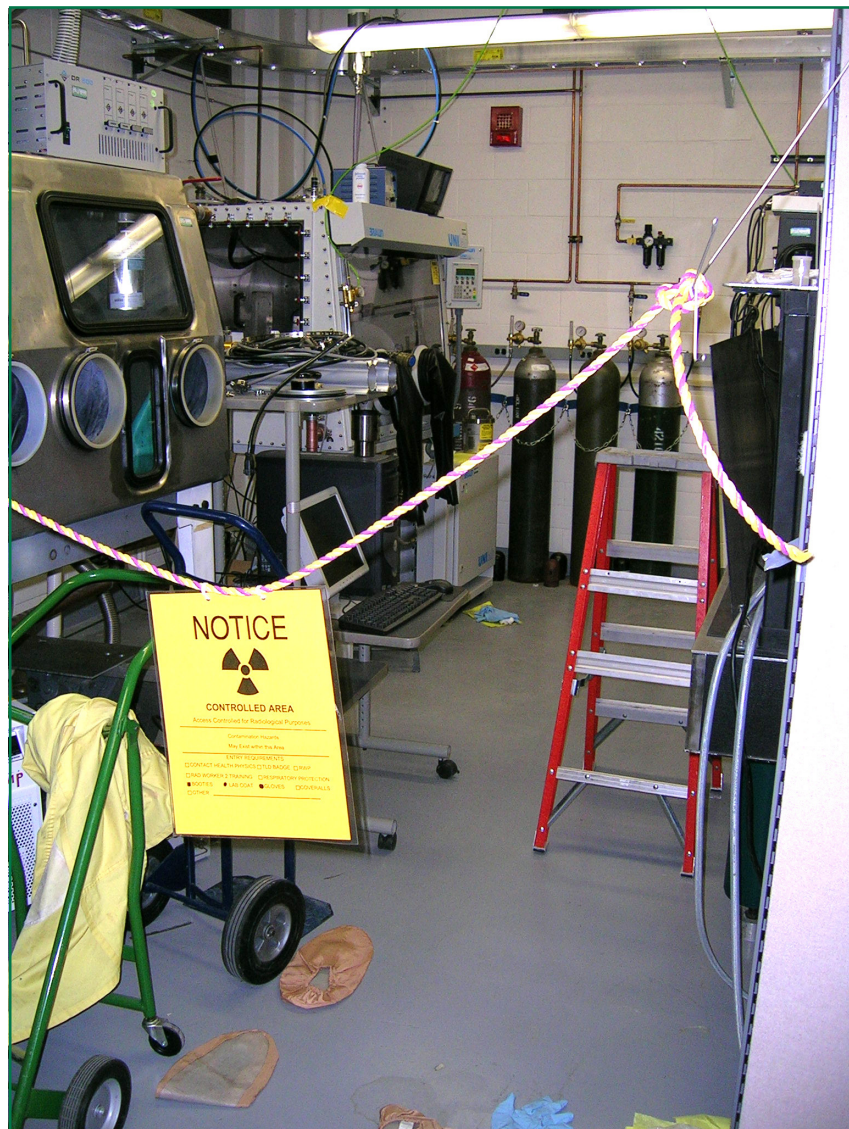
*Exhibit 2.6-1 The general work area of R3 where the accident occurred. The laser-welding glovebox is the box in the far corner of the room. Opposite to it is the optical table where W-1 initially placed the plastic bags. (The posting, anti-contamination clothing, and ladder were introduced during response activities.)*

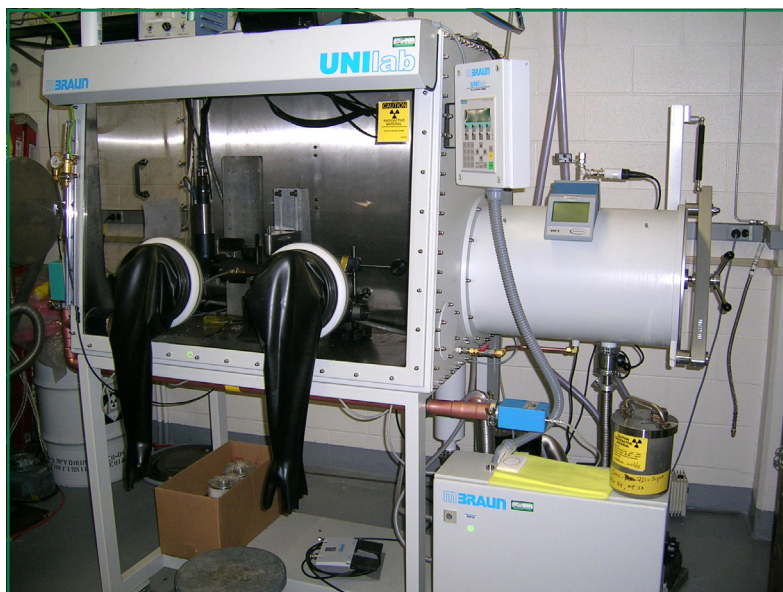
*Exhibit 2.6-2 The laser-welding glovebox in room R3 as found during initial re-entries by LANL. The chamber on the end of the glovebox is the antechamber through which items are passed in and out of the box.*

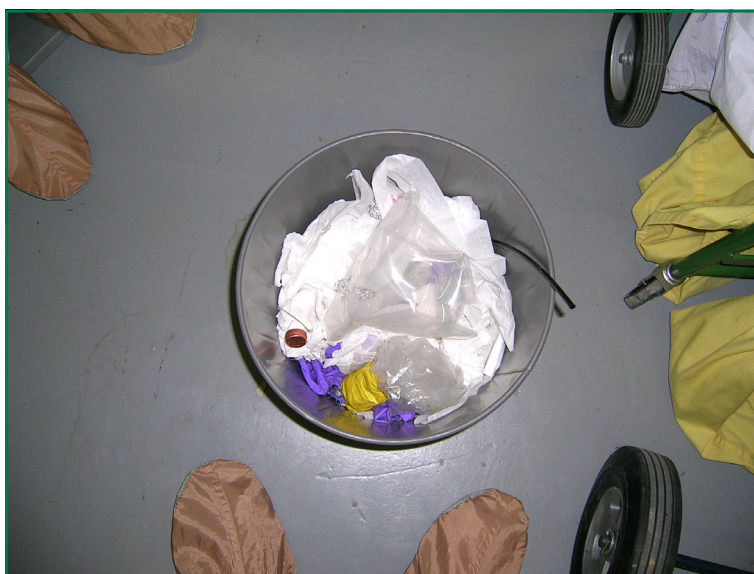
*Exhibit 2.6-3 The trashcan where the radioactive material tag was discovered. The taped bags are the packaging material used to contain the Swageloks. Also note the discarded small brass can, which is one of the tamper indicating devices.*

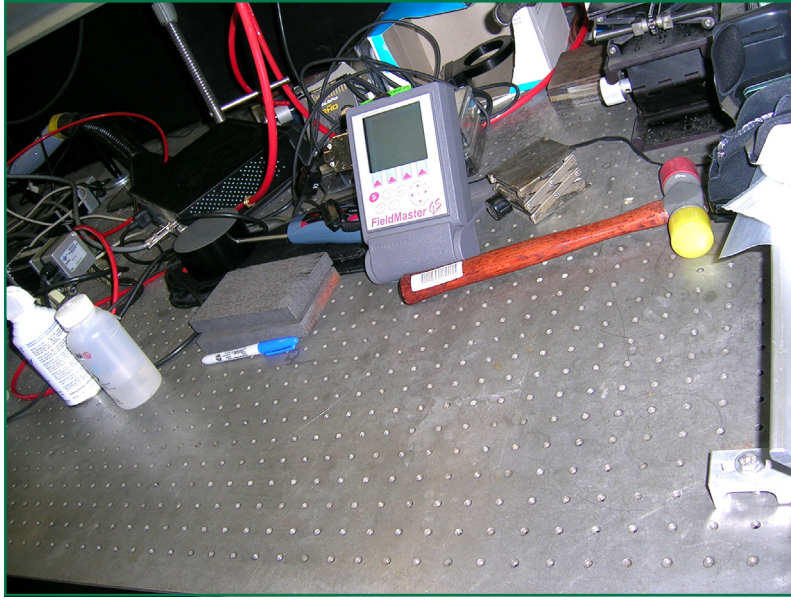
*Exhibit 2.6-4 The optical table in R3 where W-1 placed the plastic bags before disposing of them. High levels of contamination were found in this area of the table.*

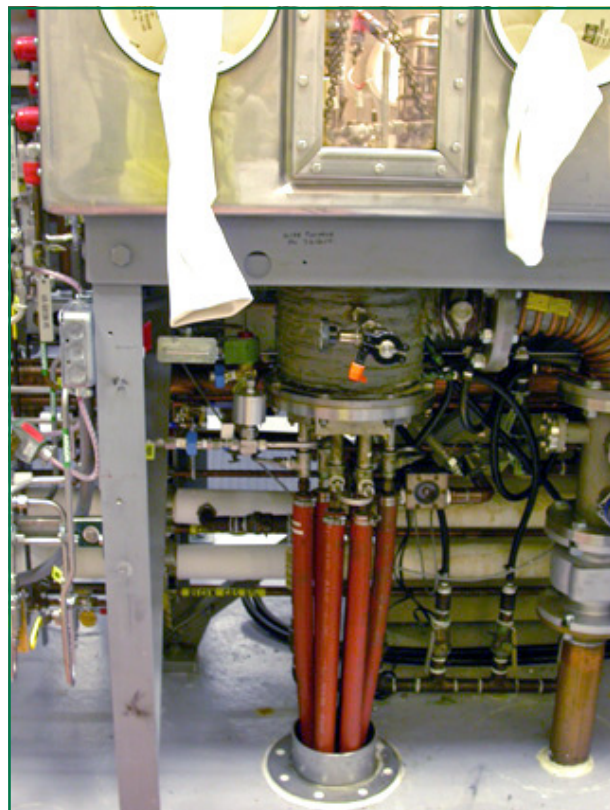
The main operation performed in G138 is to bake the pellets in a sintering furnace. NMT-11 noted that during the baking of the actinide pellets in the sintering furnace, they have found that a significant fraction, as much as 20-30%, of the americium is volatilized from the pellets and plates out on surfaces inside the furnace. The furnace is mounted such that it forms a well in the floor of G138, and the furnace lid is lifted off the furnace in order to remove the pellets (see Exhibits 2.9-1 and 2.9-2). NMT-11 informed the Board that the work area in G138 where the Swageloks® were loaded with the uranium pellets was right next to, and downstream in the ventilation flow path from, the furnace.

*Exhibit 2.9-1 An exterior view of the furnace in the floor of glovebox G138 in PF-4.*

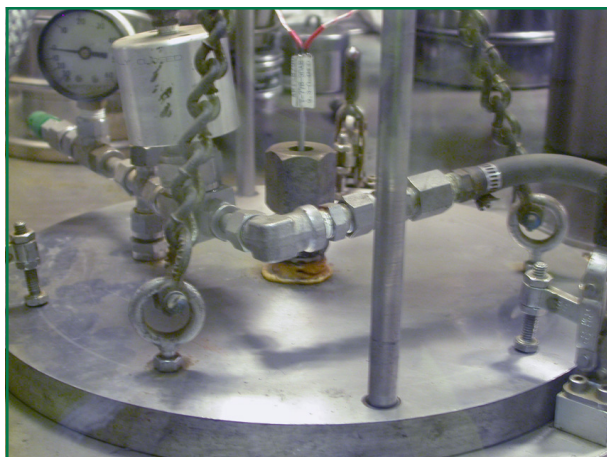
*Exhibit 2.9-2 The lid of the furnace in the floor of G138, viewed through the glovebox window.*

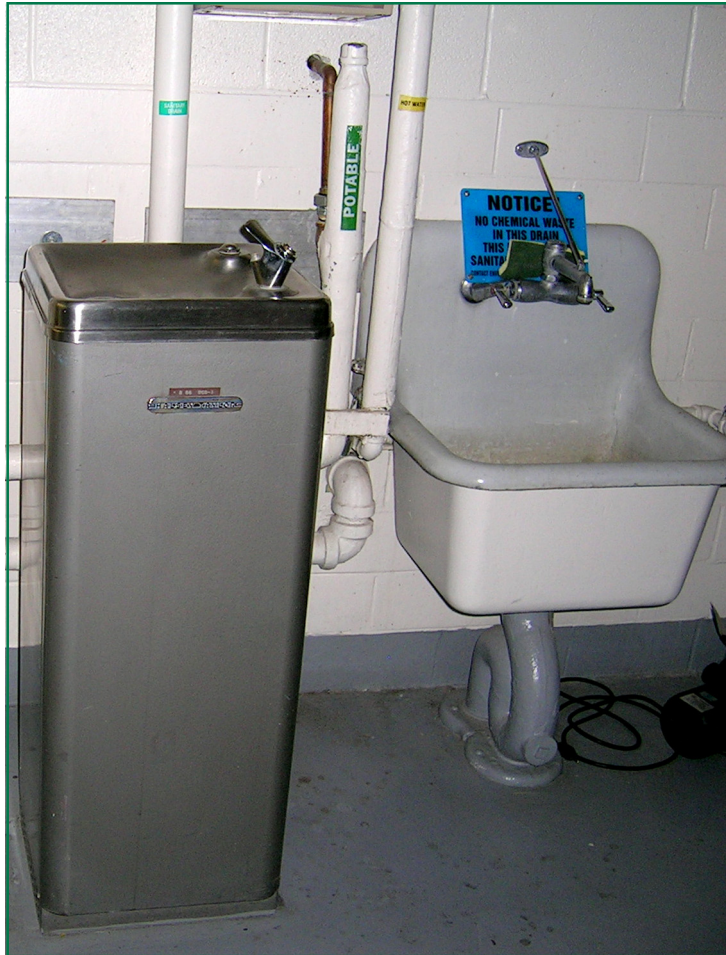
The Board also noted that there is a utility sink in R3 near the exit (see Exhibit 2.9-3). The initial LANL surveys had detected high levels of contamination in the sink, on the faucets and on the paper towel dispenser, and spots were found on the floor under the towel dispenser. As a follow-up, LANL had located and surveyed all mops and other cleaning equipment in the facility, but found none that were contaminated. LANL had also determined that the janitor normally responsible for that area had been on vacation during the period of the event, so it was unlikely that the room had been cleaned or the floors mopped between the accident on July 14 and its discovery on July 25. The Board questioned W-1 regarding this observation, but W-1 could not recall having washed his hands in the sink at any time during this period. However, interviews with other staff indicated that it was normal for workers in the room to wash in that sink.

*Exhibit 2.9-3 The utility sink found to be contaminated in R3. The drinking fountain was not contaminated.*
