**Type B Accident Investigation  
of the July 31, 2006,  
Fall From Ladder Accident at the  
Lawrence Livermore National Laboratory,  
Livermore, California**

**October 2006**

**National Nuclear Security Administration  
United States Department of Energy  
Washington, DC 20585**

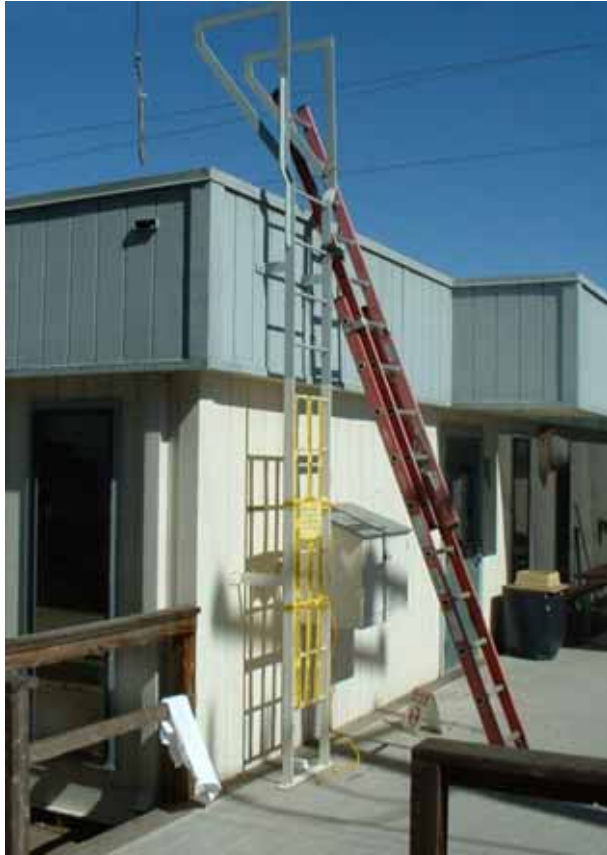
T6179 is a single story wood framed modular building approximately 60 ft. x 77 ft. (3904 sq. ft. net area) installed at LLNL in 1985. It houses approximately 17 Radioactive and Hazardous Waste Management (RHWM) personnel who are part of the Environmental Protection Department (EPD) within the Safety and Environmental Protection (SEP) Directorate at LLNL. These RHWM personnel work in the field with various LLNL organizations helping them process their waste for disposal. The building contains offices, meeting rooms, work areas, and restrooms. Only administrative and office tasks take place in this building. The front (west side) of the building along the street is landscaped, the south side of the building has an asphalt driveway, the north side has an asphalt access path and the fourth, east-facing side is flanked by a "Trex" deck, installed around 1989. T6179 and T6178 share a fabric shaded area covering the deck between them, which provides for an employees' lunch area. The ladder from which the injured employee fell is located at the southeast corner of the building, attached to the east wall, with its base on the "Trex" deck (See Figures 1.2-1 and 1.2-2).

*Figure 1.2-1: The scene of the accident. The extension ladder was added after the accident to provide temporary roof access. Barely visible on the right side of the fixed ladder is the rope that the worker used to lift his tool bag onto the roof.*

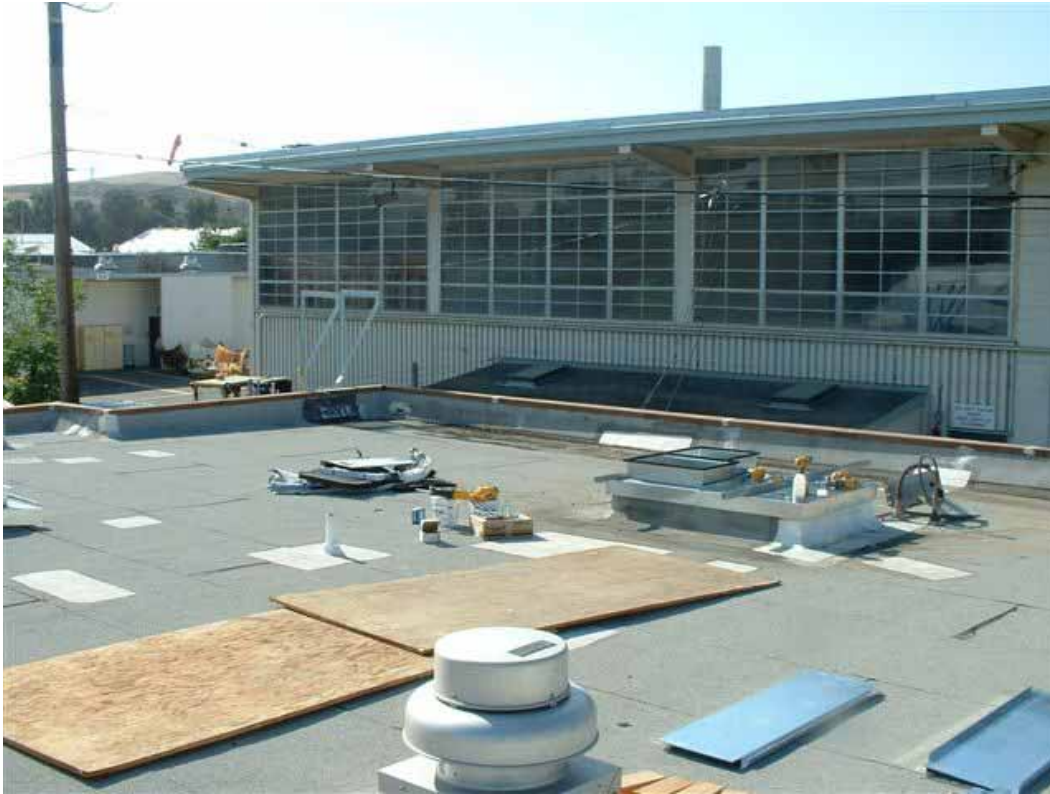
Figure 1.2-2: The roof of the building where the accident occurred, showing the ladder walk-through to the roof and general work area. The location of one of the air conditioning units is visible, although the unit was removed at the time the photograph was taken.

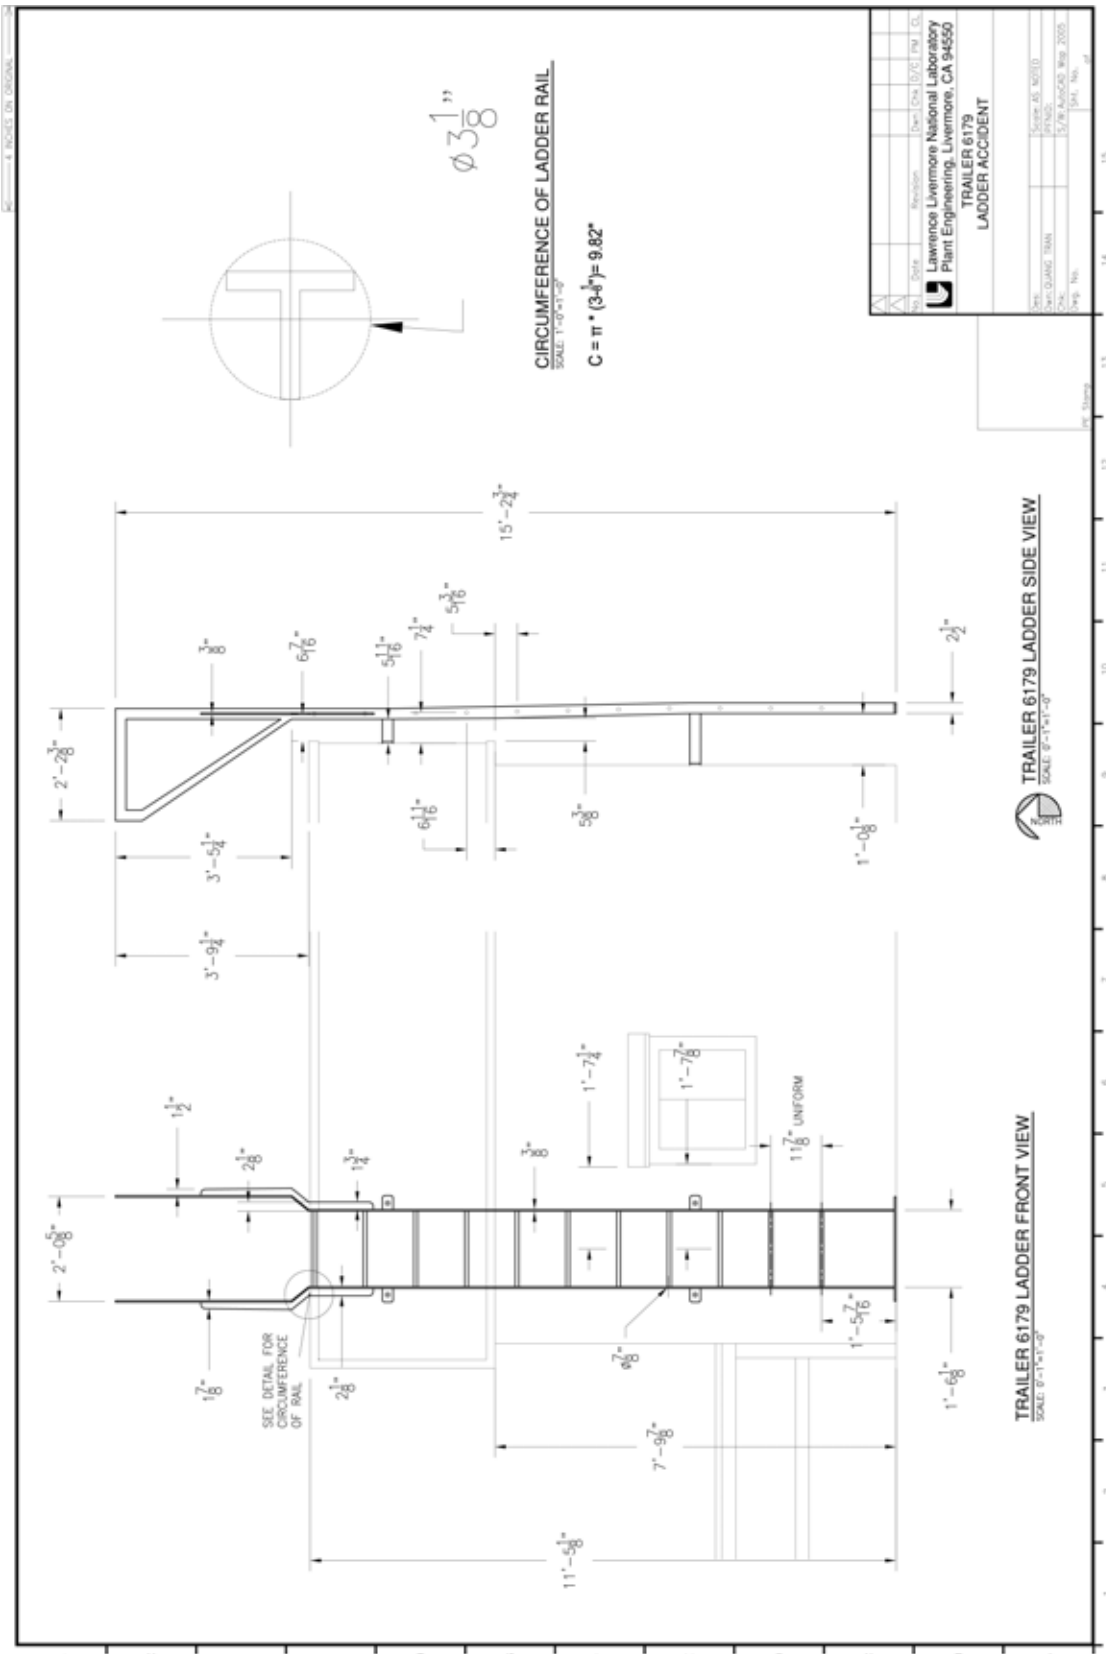
In evaluating the accident scene, the Board conducted a detailed examination of the ladder itself. The Board determined that the ladder was not in compliance with Occupational Safety and Health Administration (OSHA) requirements in at least four areas (a more complete discussion of this ladder evaluation is contained in Section 3.1.5). The Board believed that two of those non-compliant conditions could have resulted in a misstep similar to what E-1 experienced. Outside of the ladder itself, the Board did not find any foreign obstruction that could provide a reasonable explanation for the initial misstep. The two non-compliant conditions that the Board believed could cause such a misstep were: (1) about two-thirds of the way up the ladder there was an overhanging section with a part of the building trim that intruded roughly one-half inch inside of the seven-inch minimum clearance that OSHA requires behind the ladder (the overhang is visible in Figure 1.2-1); and (2) the first rung of the ladder was about 17.5 inches above the ground level, 5.5 inches above the OSHA requirement for rung distance (See Figure 2.5-1).

Figure 2.5-1: Detailed drawing of the as-found configuration of the fixed ladder mounted to the building.

Regarding the first condition, the building overhang and trim piece was determined to be almost eight feet above the deck. For E-1 to contact this piece with his foot, his head would have clearly been above the roof level at that point. Therefore, the Board believed that it was unlikely that it contributed to the accident, although it could potentially cause a similar accident.

Regarding the second condition, the height of the first step was not uniform with the rest of the steps, which were uniformly spaced at about 12 inch intervals, as required by OSHA. Consequently, the Board considered the possibility that the non-uniform spacing could have confused E-1 as he climbed the ladder. Given the Board's estimate of where E-1 was in the climb, it was reasonable to consider that E-1 could well have been reaching for the third step on the ladder. If this was the case, then it was likely that E-1 would be making his first full stride on the ladder, and his motion would have been influenced by the non-uniform distance of the first step. Consequently, E-1 would tend to overreach on the third step due to the difference in the distance between the two spans. This overreach would lead to E-1 striking the top of his foot on the bottom of the rung above the one he was aiming for, unbalancing him and causing him to miss the rung he was reaching for with his hand.

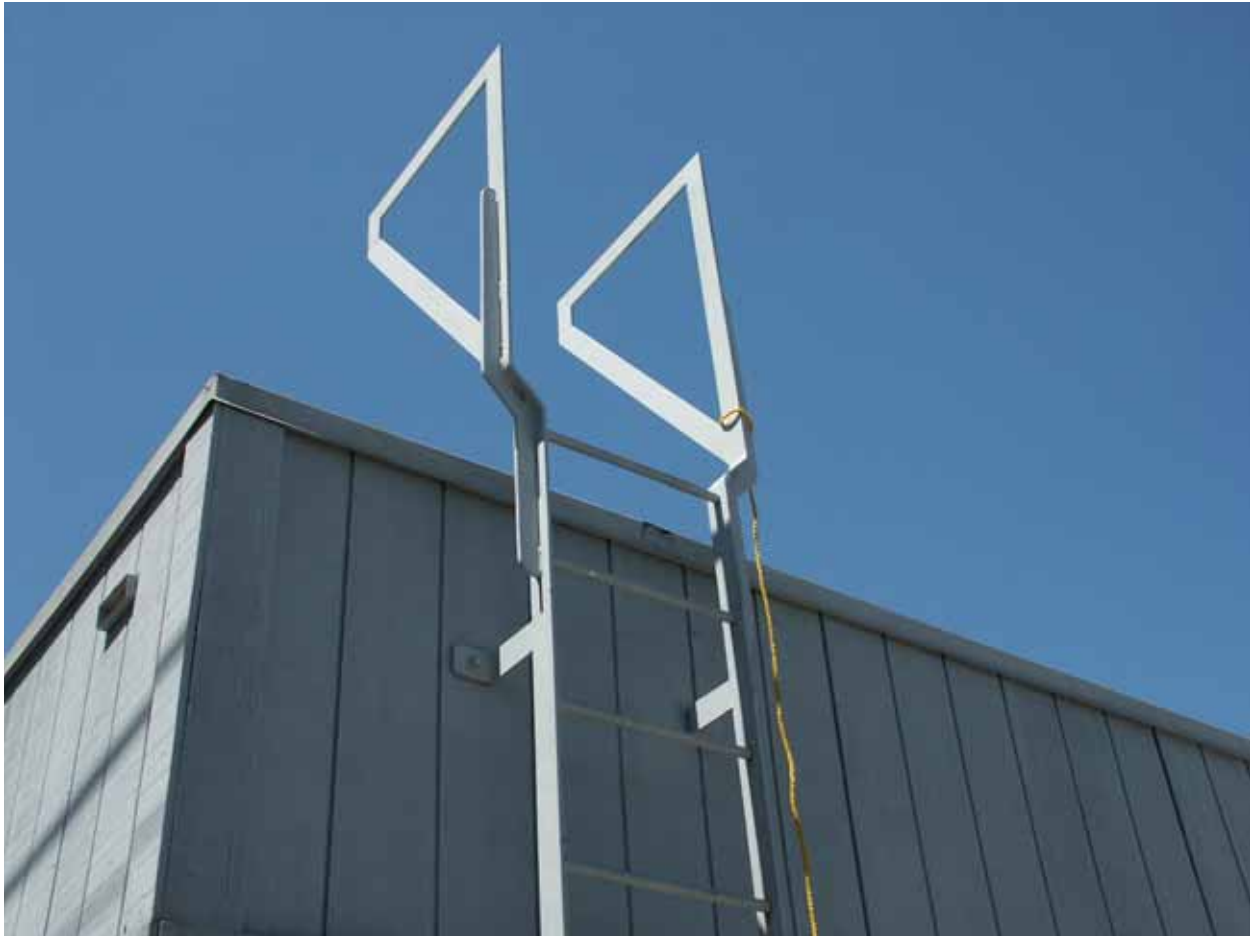
Fall protection was identified in Trade/Service IWS documents but was not recognized and implemented for this work activity. (Fall protection was not required for climbing the ladder, but would apply for working on the T6179 roof.) The ES&H Manual conditions requiring fall protection were not adhered to. In addition, the Board determined that The ES&H Manual conditions requiring fall protection were not consistent with OSHA requirements and published interpretations.

The Board concluded that LLNL's implementation of the OSHA fixed ladder and fall protection requirements and standards were ineffective and not consistent with those requirements.

Figure 3.1.5-1: The walkthrough section of the ladder showing the angle-iron configuration of the side rails.
