TYPE B ACCIDENT INVESTIGATION  
OF THE  
MARCH 20, 2003  
BUILDING 752 STAIR INSTALLATION  
ACCIDENT  
AT THE  
SANDIA NATIONAL LABORATORIES,  
NEW MEXICO

**April 2003**

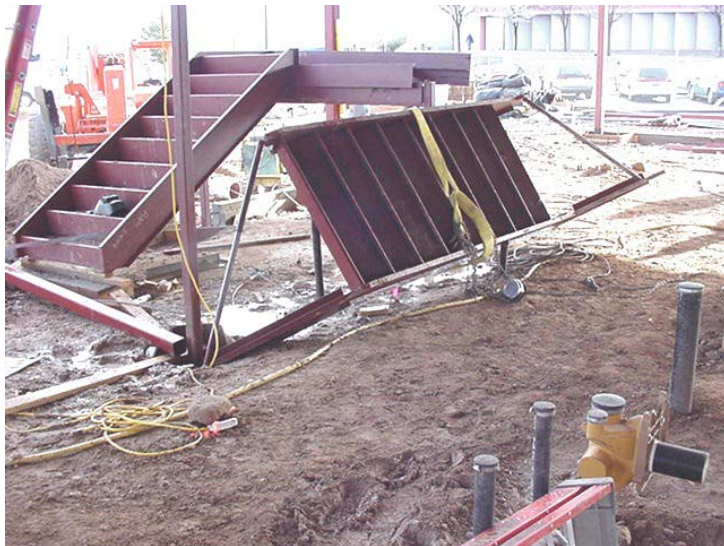
(See Figure 1) After the stair section had been hoisted to the necessary height and while it was being positioned, the temporary hoisting beam that had been supporting the hoisting equipment and the stair section slipped from its position on the angle iron framing the rooftop stairwell opening. The temporary hoisting beam fell to the second floor where it struck the foreman's hardhat and then his foot before it continued to the ground level where it imbedded itself into a small mound of loose earth and came to rest without causing further damage (see photo at left).

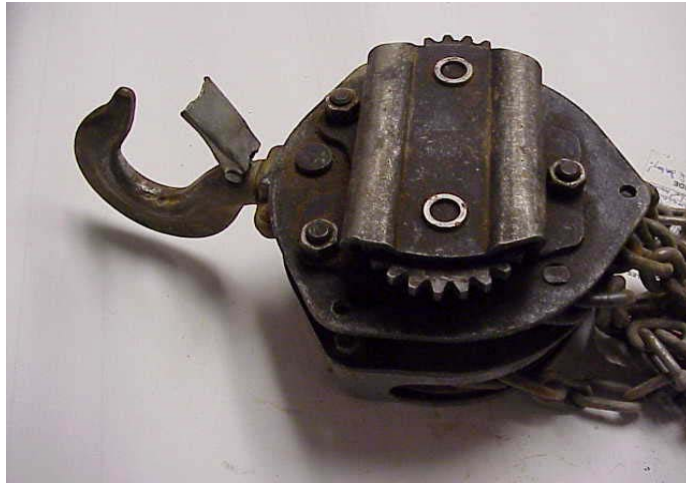
The Board observed that the chain fall did not have a cover (see photo at left) identifying the load rating or manufacturer's name. The hooks were stamped or marked "1T," suggesting a one ton capacity. For the Board, Sandia successfully load-tested the chain fall at one ton. The Board noted that the safety latch on the load hook was damaged and the load block hook was spread 15%, which is in excess of the rejection criterion. Gaps in the material of the throat of the hook suggest that the hook was poorly cast, presenting an opportunity for failure. The dry-type

brake disks were coated with grease, but apparently had no affect in this case. Although the Board determined that the deficiencies found with the chain fall did not contribute to the accident, the chain fall should have been removed from service prior to this lift.

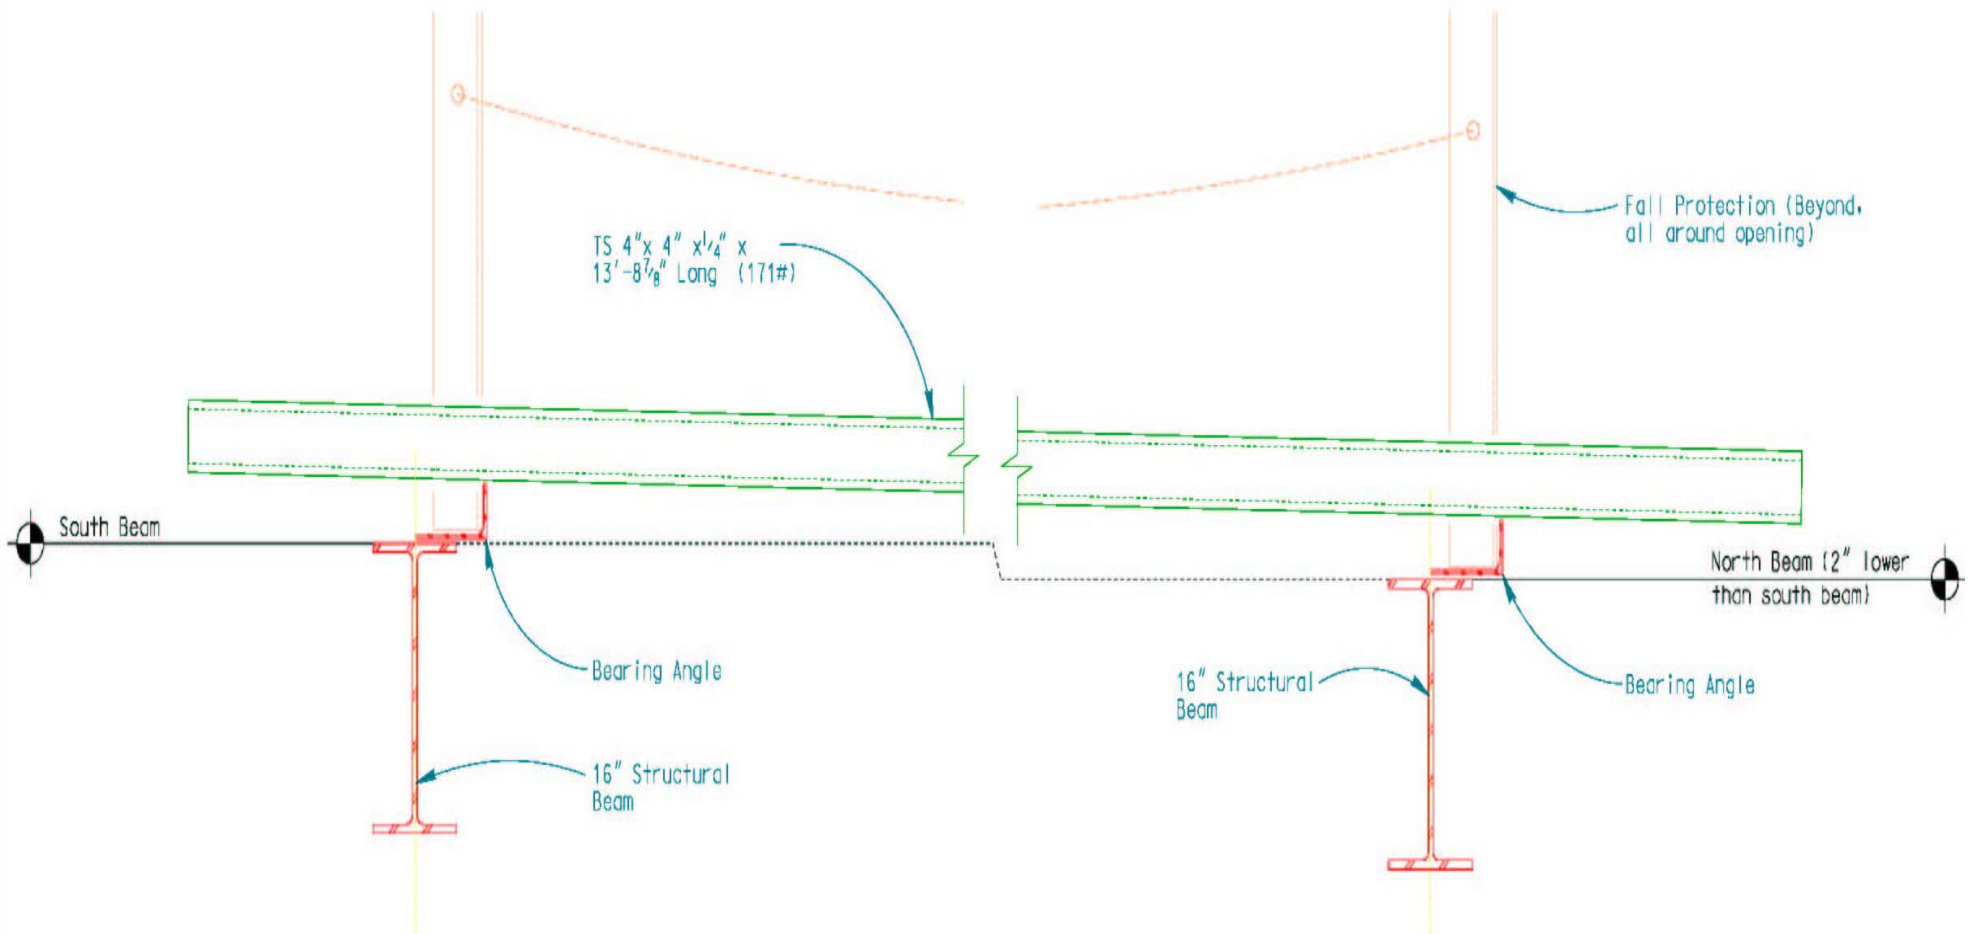
Figure2 – Temporary Hoisting Beam  
(At Roof Elevation)

1.7% slope from the north edge to the south edge of the opening. Tack welds, clamps, or other securing devices were not used to affix the temporary hoisting beam.

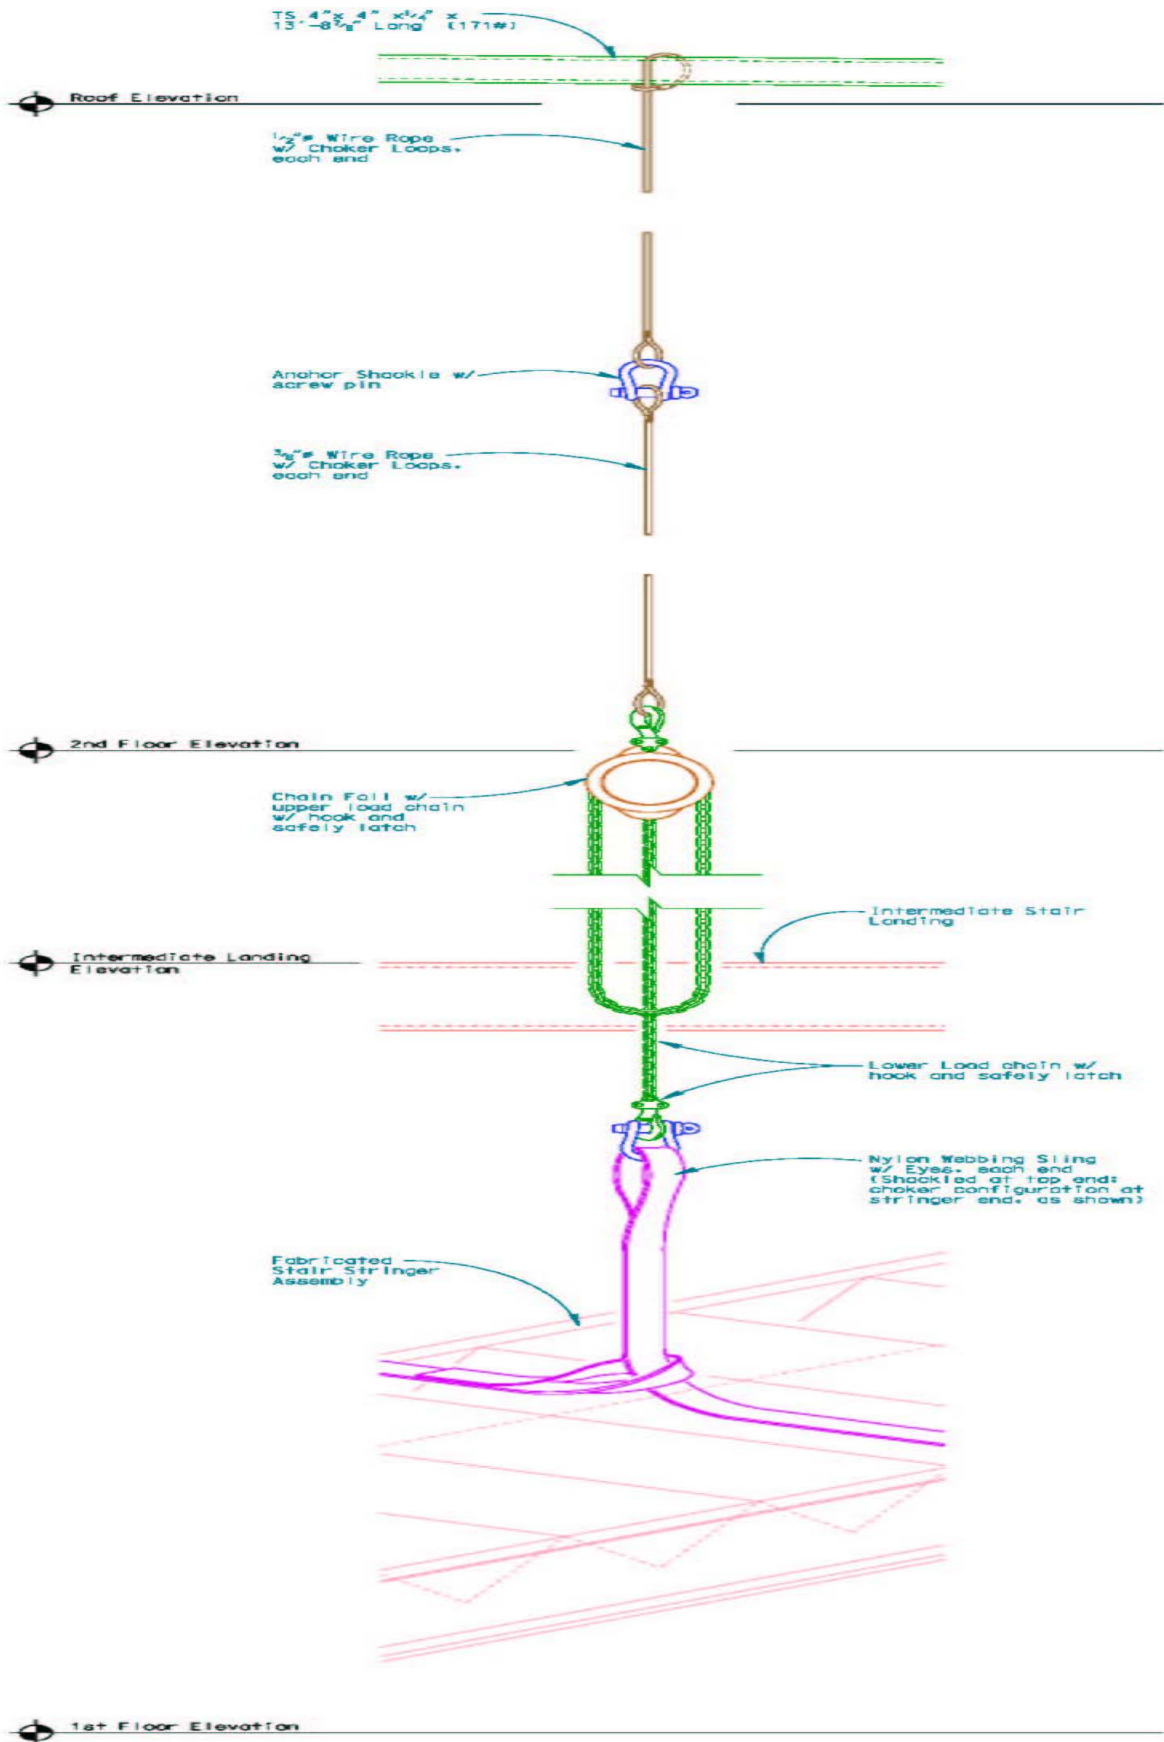
Figure 3 – Rigging Sequence

From the temporary hoisting beam, two wire rope slings were attached in series (see Figure 3) by a shackle. The top sling was placed in a choker configuration around the temporary hoisting beam. The 1-ton chain fall suspension hook was placed into the eyelet of the bottom wire rope sling. A four-inch synthetic sling was placed in a choker configuration around the stairway section and attached with a shackle to the lifting hook of the chain fall.
