**U. S. Department of Energy  
Oak Ridge Operations Office**

**Type B  
Accident Investigation  
of the April 8, 2003  
Electrical Arc Blast at the  
Foster Wheeler  
Environmental Corporation  
TRU Waste Processing Facility  
Oak Ridge, Tennessee**

***May 2003***

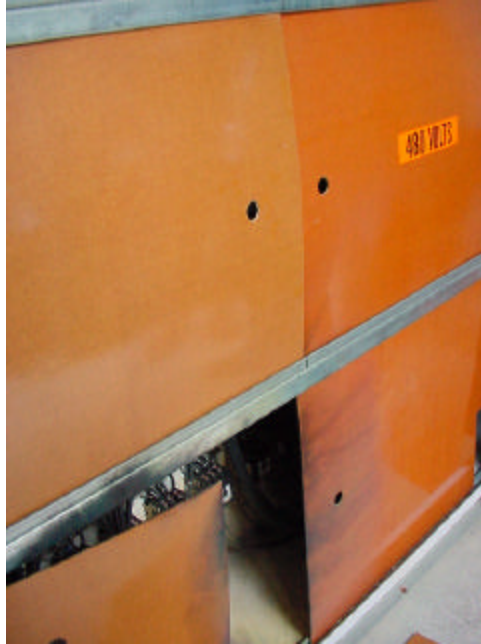
**Exhibit 2. Dislodged Micarta Insulating Panel**

The operators then checked the 120-Volt (V) power source supply located in the electrical equipment building. The breakers were still in the on position and supplying power to the boiler control circuits. At this time, the operators opened the two breakers (#28 and #30) for the 120V power in the Motor Control Center (MCC) power distribution panel to totally de-energize the separate control power source to the boiler. Next, the operators entered the boiler building and noticed that the boiler control panel doors were open and one 480V insulating panel (identified as “micarta” by electricians) was lying on the floor. (See Exhibit 1.) The remaining insulating panels of the boiler electrical panel were still in place but dislodged from their normally installed location. (See Exhibit 2.)

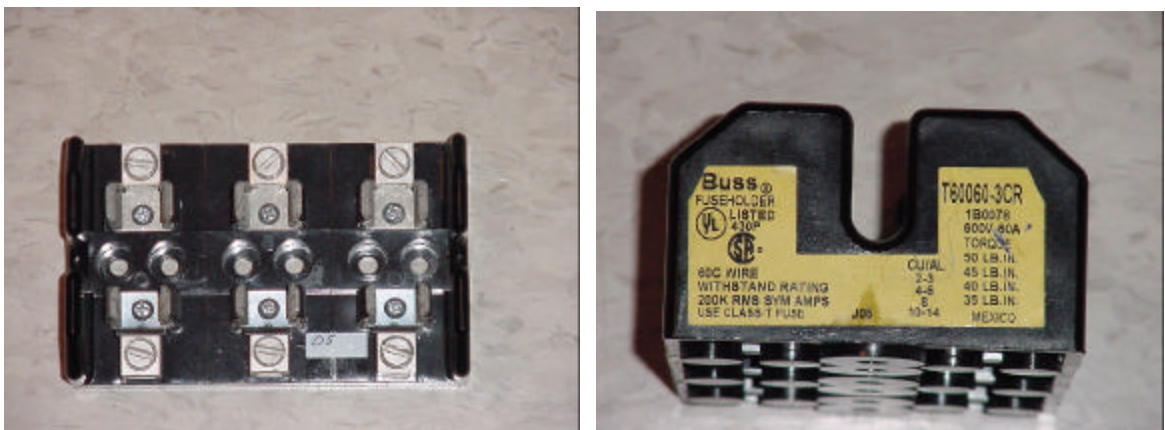
**Exhibit 3. Fuse Block**

The fuse blocks were manufactured by the Bussman Company. (See Exhibit 3.) The Bussman Company recommended the use of #6 American Wire Gauge (AWG) or, with a safety factor, #4 AWG for connections, based on design specifications, application, and panel components, as stated in the *Bussman Electrical Handbook* and as taken from the 2002 NEC Table 310.16. (See the following web address: <http://www.bussman.com/library/docs/spd02/SPBSection04.pdf>.)

The original factory design shows #6 AWG on the drawings, but FWENC and Precision Boilers, Inc., representatives maintained that this was a mistake in the drawings and that the intent was to use #8 AWG. The fact that #8 AWG had been installed instead of #6 AWG was noted in March 2003 during a detailed inspection of the electrical panel following the first incident. The corrective action for this finding was to change the drawings to show #8 AWG as being “as constructed.” The *FWENC Receipt Inspection Report*, ultimately completed on November 20, 2002, documents that the boiler meets “PO, drawing, specification requirements.” An inspection by the FWENC Electrical Supervisor, documented on November 20, 2002, also does not identify an issue with #8 AWG being installed instead of #6 AWG. (See Appendix C to this report for copies of the FWENC records documenting this issue.)

FWENC NCR 2003-TRU-078, dated March 12, 2003, states that “Power wiring from bus bars to fuse blocks is #8 AWG. Vendor drawing WD-B011003 (Part of T-UT-52-A-EE-001) shows that wire as #6 AWG.”

On March 18, 2003, FWENC DCN TRU-DCN-EE-074, Revision 1, was issued with a note to “Notify boiler supplier of contactor and wiring problem. Have him correct and resubmit WO-B011003 (Part of T-UT-52-A-EE-001). Note 3 from #6 AWG to #8 AWG, as delivered.”

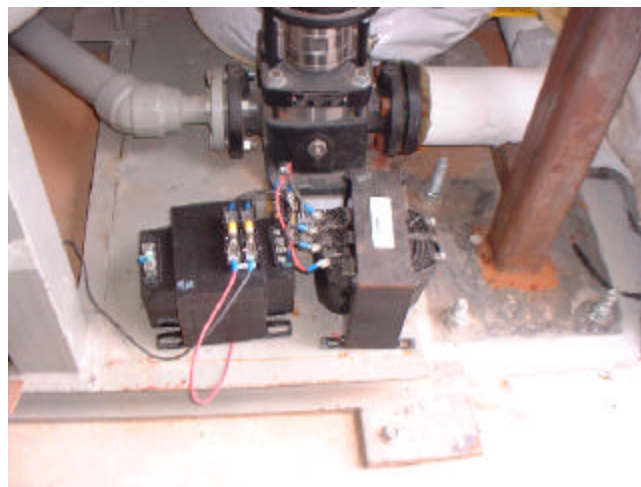
**Exhibit 4. Two of the Removed 120V Control Transformers**

- Added a 120V external power source to the control panel inside the boiler electrical panel.
- Removed the 480V to 120V transformers installed by the manufacturer in the electrical panel to provide 120V power to the control panel. (See Exhibits 4 and 5.)
- Installed a Square D Class 9001 on/off selector switch with legend. The switch was mounted on the side of the control cabinet above the emergency stop switch. The purpose of the switch is to provide control of the 120V power source to the control panel at the boiler electrical panel.

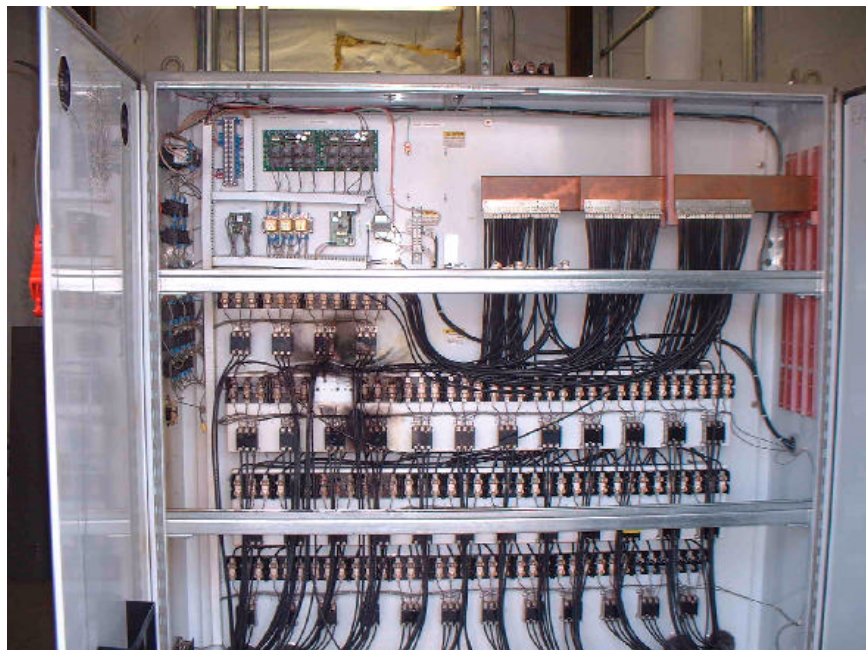
**Exhibit 6. Installed Unistrut®**

- Installed support channels (Unistrut®) necessary to support the insulating barrier material. (See Exhibit 6.)

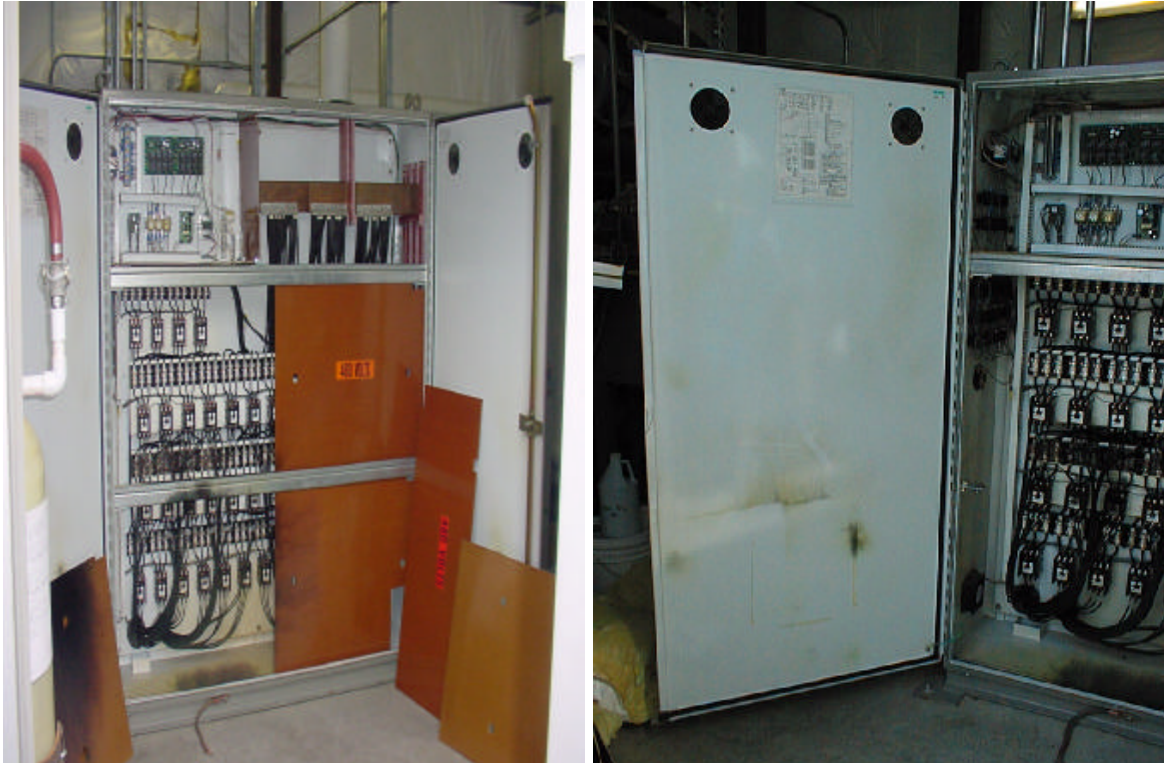
**Exhibit 7. Sliding Panels, Vent, and Fan**

- This DCN defines the installation of eight fixed insulating panels to segregate the worker from the 480V power source. The specification for the barrier material to be installed is 600V, 1/8-inch insulating boards.
- The insulating material plate dimensions specified in the DCN do not provide vent access for the cabinet fans (bottom) or the exhaust vents (top). (See Exhibit 7.)

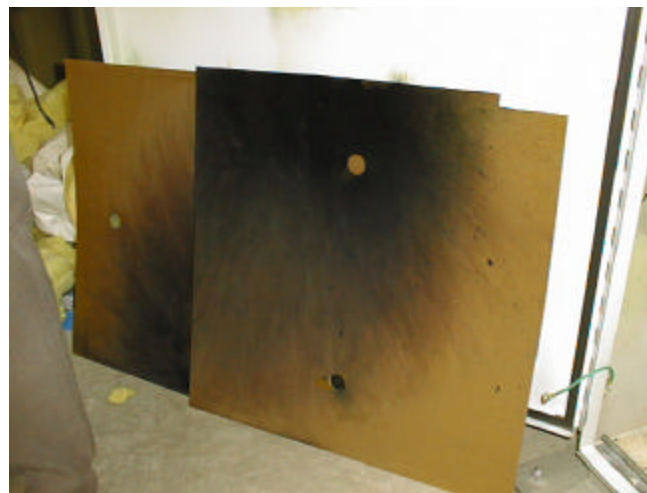
**Exhibit 10. Panels After Arc Blast**

A power loss was experienced at 0330 hours in the boiler room. When the operators investigated, they noticed the condition explained in Section 2.1, “Event Description.” The investigation of the event revealed that a phase-to-phase fault had occurred inside the boiler panel. This developed into a three-phase fault due to the ionized gases and the 480V clearances. This phase-to-phase short resulted in the copper vaporization and spray inside the panel. (See Exhibit 10.)

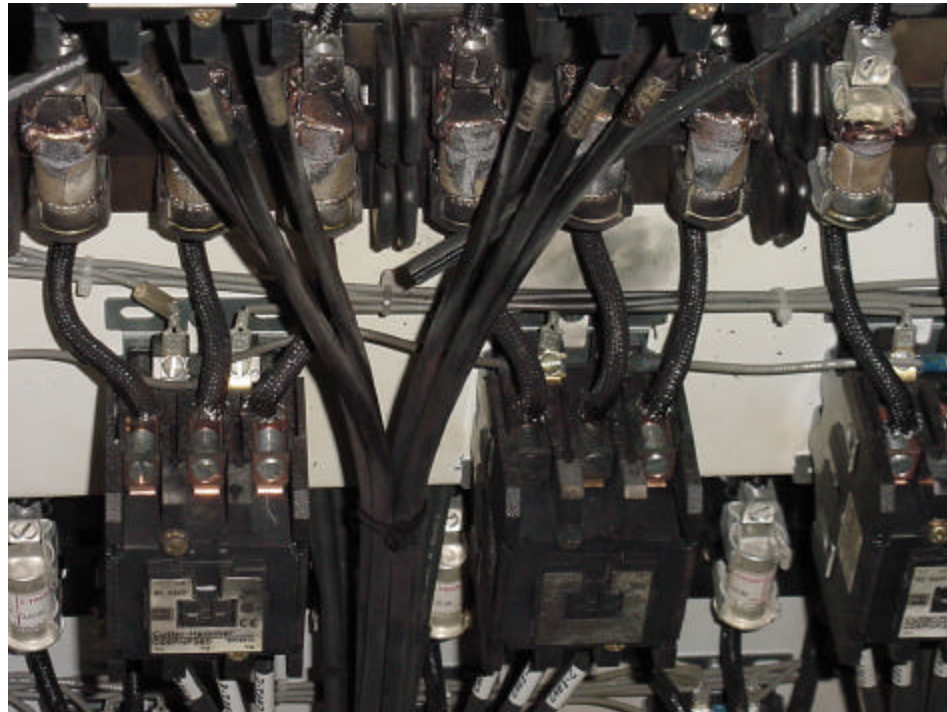
**Exhibit 11. Damaged Fuse Blocks**

This condition was evident after both events. These copper vapors are easily sprayed and can result in additional short circuits, such as those seen on the other fuse blocks in the electrical control panel. (See Exhibit 11.)

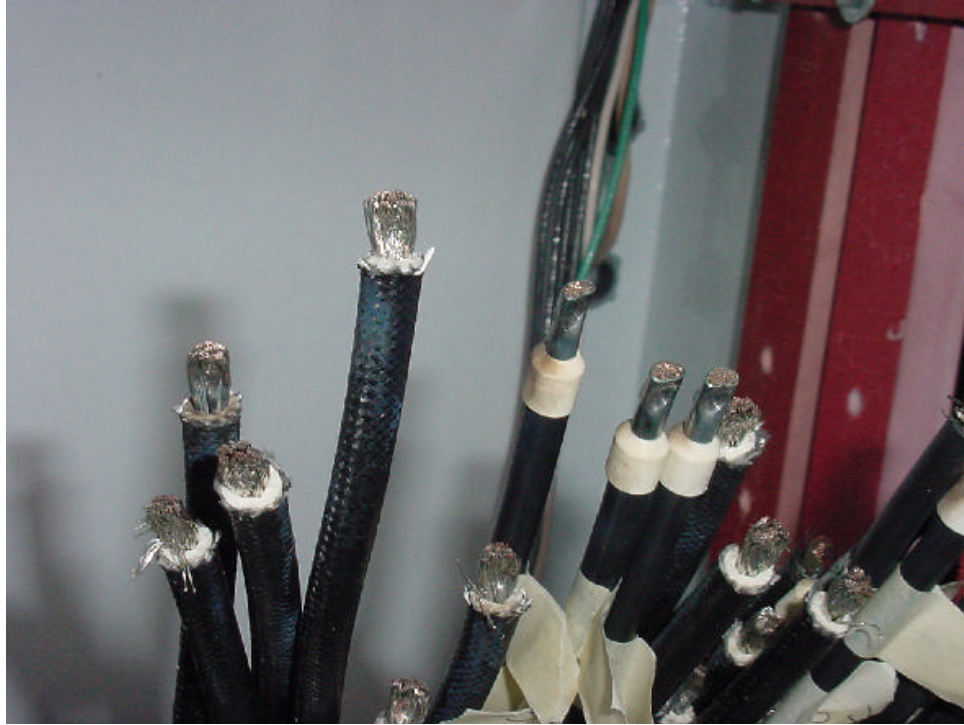
**Exhibit 12. Wire With Crimping Sleeves and Without**

The original assembly by the manufacturer used crimping sleeves (see Exhibit 12) on the wire connected to the busbar. The purpose of the crimping sleeve is to provide protection to the individual strands of copper in the connector. In addition, the crimping sleeves maintain the cohesiveness of the individual strands within the conductor so that the electrical load can effectively be transmitted via all strands in the conductor.

Modifications to the type of wire (see Exhibit 12), connectors, and contactors, (the 50-amp contactors that were built to International Electrotechnical Commission standards were changed to 60-amp contactors), etc., were changed after the first event without approval of the manufacturer of the equipment. (See Exhibit 13.) A second power switch was also installed in the control panel on the 120V power supply that was not shown in Revisions 1, 2, or 3 of the boiler operation procedure.

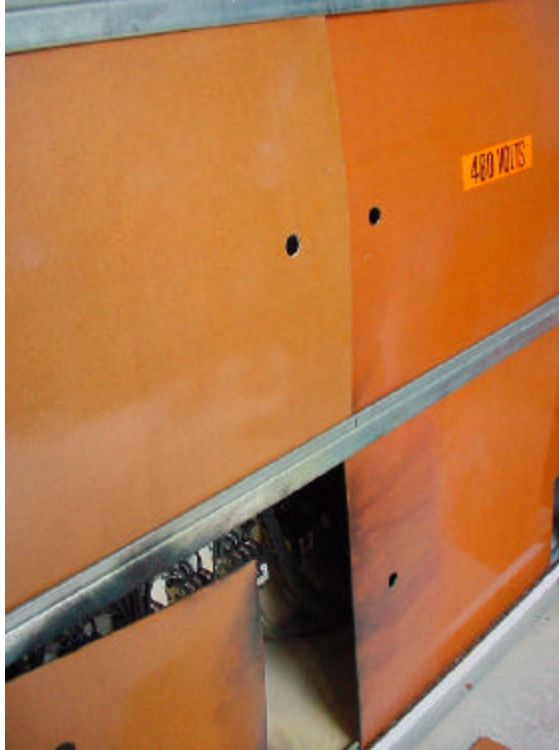
**Exhibit 14. Micarta Insulating Panel**

Further, the installation of the micarta insulating panel (see Exhibit 14) resulted in the reduction of the manufacturer's ventilation system and increased the amount of heat inside the panel. With the temperature in the boiler room being estimated between 90°F and 95°F, the temperature inside the panel can be assumed to be notably higher.
