**Type B
Accident Investigation
Board Report**

**Subcontractor Employee
Personal Protective Equipment
Ignition Incident
on February 18, 2003
Bechtel Jacobs Company LLC,
East Tennessee Technology Park,
Oak Ridge, Tennessee**

March 2003

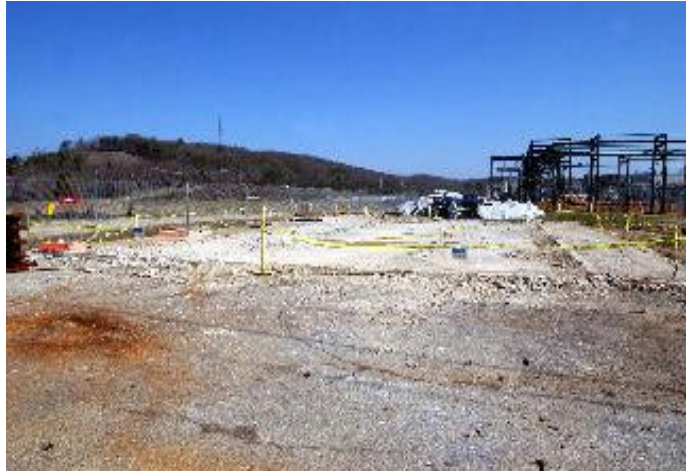
Figure 1. K-1302 Pad at ETTP

On February 18, 2003, an employee of MACTEC Constructors, Inc. (MACTEC) was working on the K-1302 pad at the East Tennessee Technology Park (ETTP). The employee was using a cut-off machine with an abrasive wheel to cut rebar when the sparks ignited the 100% cotton anticontamination (anti-c) coveralls and the plastic bootie on his right leg. The ignition was evident by the smoldering Personal Protective Equipment (PPE). The smoldering PPE was extinguished, and no injuries were sustained from this incident. MACTEC is a subcontractor to Bechtel Jacobs Company LLC (BJC). Figure 1 is a photograph of the K-1302 pad.

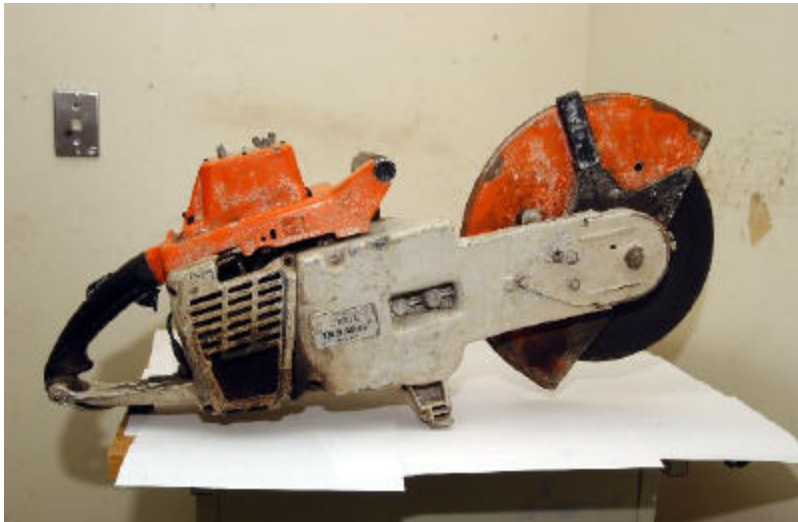
Figure 2. Stihl Cut-Off Machine

On May 16, 2002, MACTEC had a burnthrough incident on the knee of a pair of FR MarGard® disposable, flame-retardant, anti-c coveralls while using a Stihl Model TS 510 AV Cutquik® cut-off machine. (See Figure 2.) Use of the cut-off machine was allowed to continue when MACTEC decided to use conventional cotton, fire-retardant coveralls for

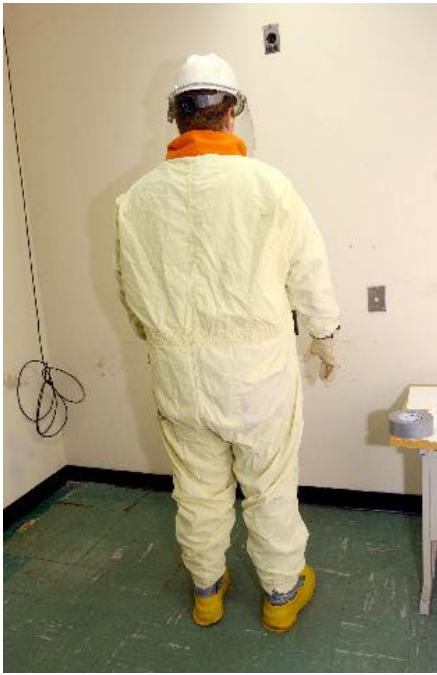
incorrect position.) This technique allowed the resultant sparks to strike and ignite the PPE on Laborer-1's right leg. The Board has determined that Laborer-1 used this technique due to a physical impairment from a previous (nonjob related) double compound fracture of his left arm. This injury limits use of Laborer-1's arm. The manufacturer's safety manual for the Stihl Model TS 510 AV Cutquik® cut-off machine states that the authorized technique to use the machine is to put the right hand on the throttle (for both left- and right-hand dominance), position the machine to the right of the body (the same as if using a chain saw) to prevent the sparks created during use from igniting the operator's clothes, and only use the machine in a vertical cutting motion to prevent catastrophic failure of the abrasive wheel by excess lateral forces.

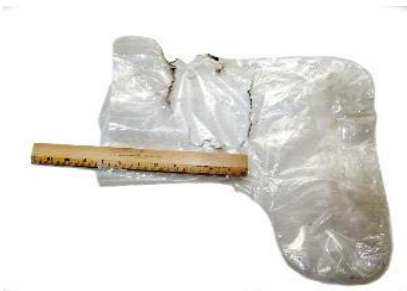
Figure 5. Burned PPE - Clear Plastic Bootie

At approximately 9:00 am, both laborers noticed that Laborer-1's plastic bootie was smoldering. Laborer-1 patted the smoldering pant leg with his gloved hand, and Laborer-2 used the water-pump sprayer to extinguish the same area. The smoldering anti-c PPE was successfully extinguished, even though Laborer-2 was not trained as a fire watch and the water-pump sprayer had been supplied for dust control. The sprayer was a model PCT-25, 2½-gallon, pump-tank

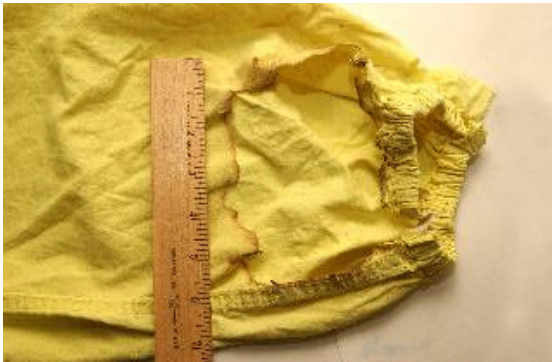
Figure 6. Burned PPE - Anti-C Pant Leg

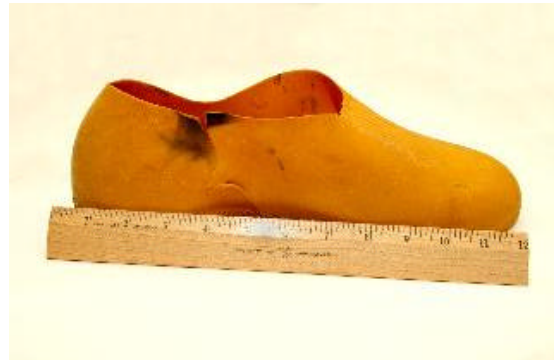
Figure 7. Burned PPE - Shoe Scuff

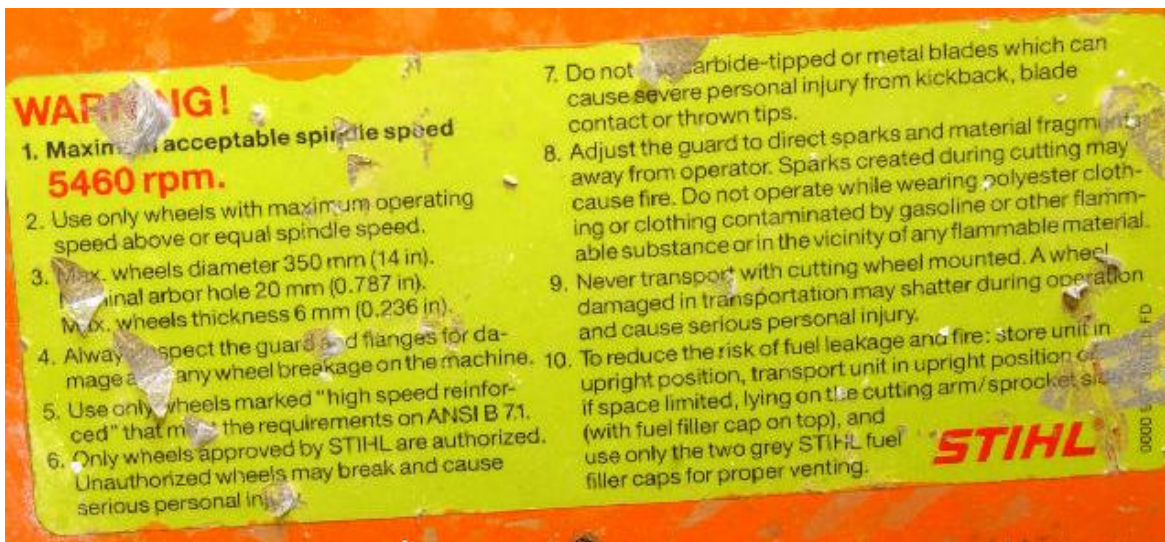
MACTEC held a POD Meeting at the beginning of every workday in which the scope of work for that day was reviewed and tasks were identified and assigned to the workers. At the February 18, 2003, POD Meeting, the rebar removal job was assigned to Laborer-1 and Laborer-2. They were informed that the work did not require a hot work permit. A discussion had been held the previous evening to ascertain if Laborer-1 was comfortable using the cut-off machine. The manufacturer's safety manual for use of the cut-off machine was not available and, therefore, was not reviewed. In addition, the lessons learned from previous use of the cut-off machine were not discussed, nor was the warning label on the grinding wheelguard noted or read. (See Figure 11.)

Figure 8. Warning Label on Cut-Off Machine

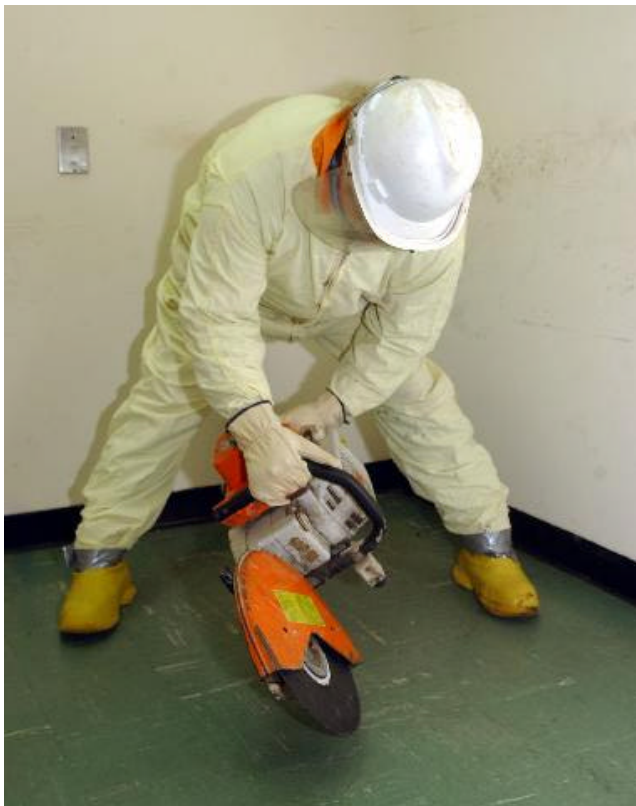
Figure 10. Laborer Demonstrating Use of Cut-Off Machine (Held in Incorrect Position)
