**U.S. Department of Energy  
Portsmouth/Paducah Project Office**

**Type B Accident Investigation Report**

**THE JULY 12, 2007  
FORKLIFT AND PEDESTRIAN ACCIDENT  
AT  
THE PADUCAH GASEOUS DIFFUSION PLANT**

**April 2008**

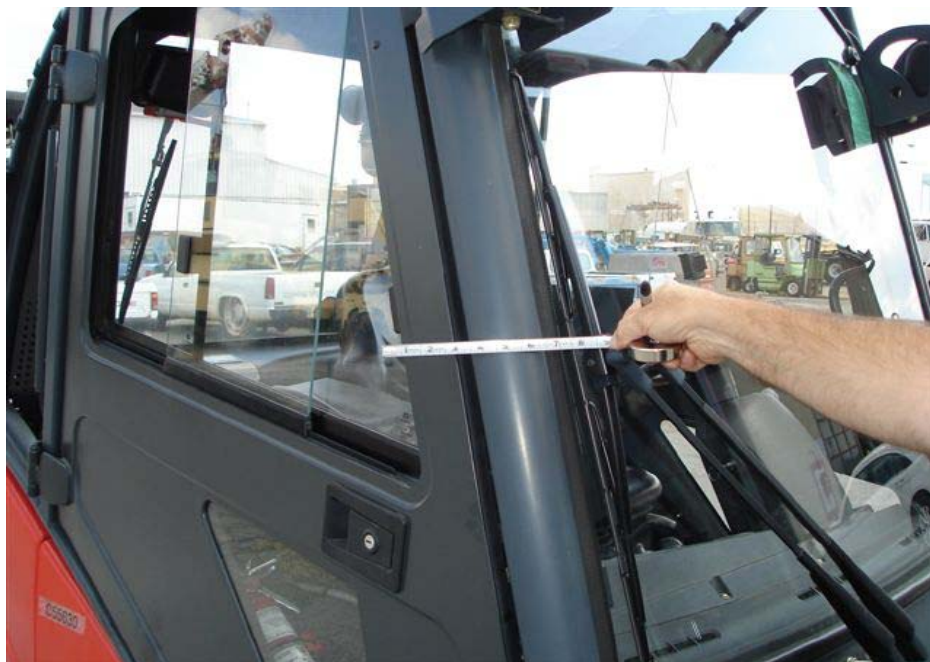
The forklift involved in this incident possessed features with the potential to impair operator visibility. The roll cage of the forklift is supported by substantial posts on either side of the front windshield with the potential to create a blind spot. The wiper blade rests, when not in use, near the right side of the forklift windshield near the roll cage post adding to the width of the blind spot. It also has black plastic doors with plastic see through windows. The black plastic boundary around the window also increases the blind spot associated with the roll cage posts. A clipboard near the right post also can limit visibility.

Measurements were taken to determine the extent of the blind spots created by the roll cage and the black plastic doors. The width of the roll cage post was approximately 4 inches. The black, plastic boundary around the window next to the post was approximately 4.5 inches. Including the obstruction to view added by the windshield wiper, the total obstruction was estimated to be approximately 8 inches (see Figure 2.3-2). In this view, the driver’s seat is almost entirely obscured.

**Figure 2.3-2. Linde Forklift Depicting Field of View Impairment**

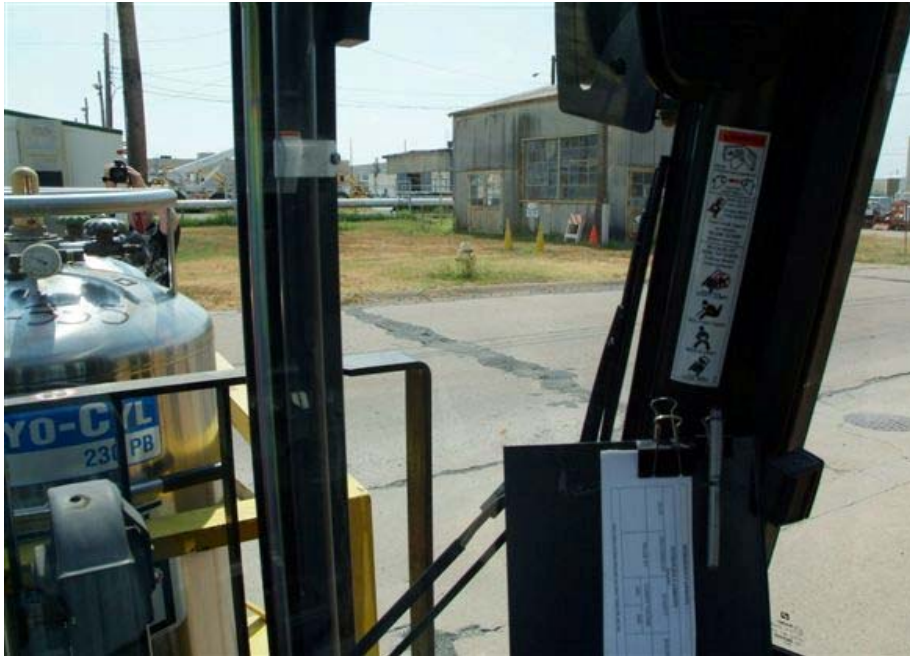
The forklift mast when tilted backwards decreases the width of the window of visibility between the mast and the windshield support column, window frame, and windshield wiper. A photo of the right side of the forklift was taken to demonstrate the full extent of the blind spot created by the combination of the roll cage post, door, windshield, wiper, and clipboard. Related photos are shown in Figures 2.3-3 through 2.3-5. In Figure 2.3-3, there was an individual standing approximately 10 feet away who could not be seen by the driver.

**Figure 2.3-3. Inside the Forklift Cab Showing Field of View Impairment From the Windshield Wiper, the Post, and Door Frame**

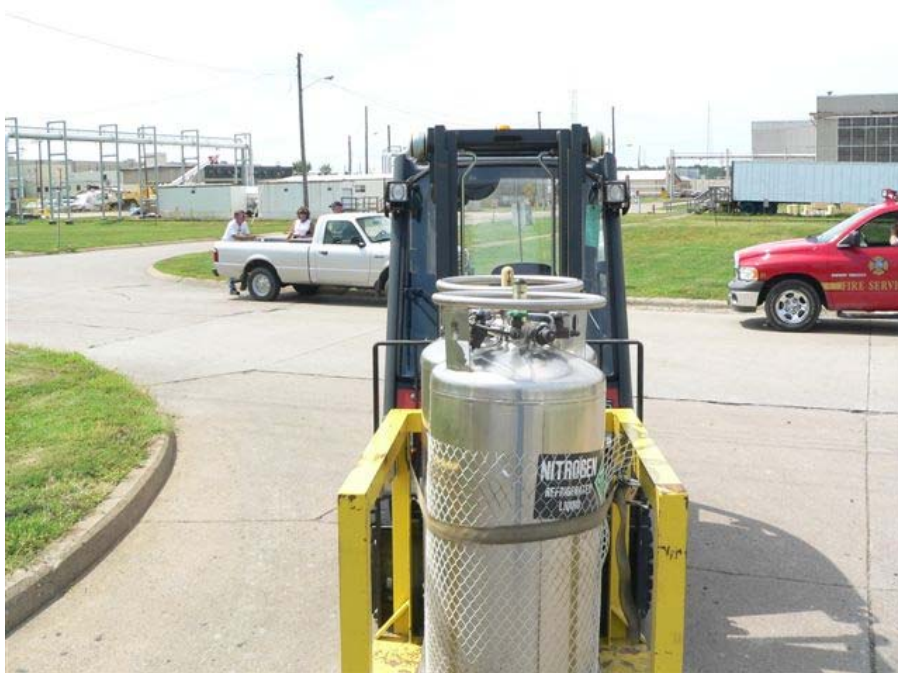
**Figure 2.3-4. Front View of Forklift Showing Mast Pillars and Roll Cage Post**

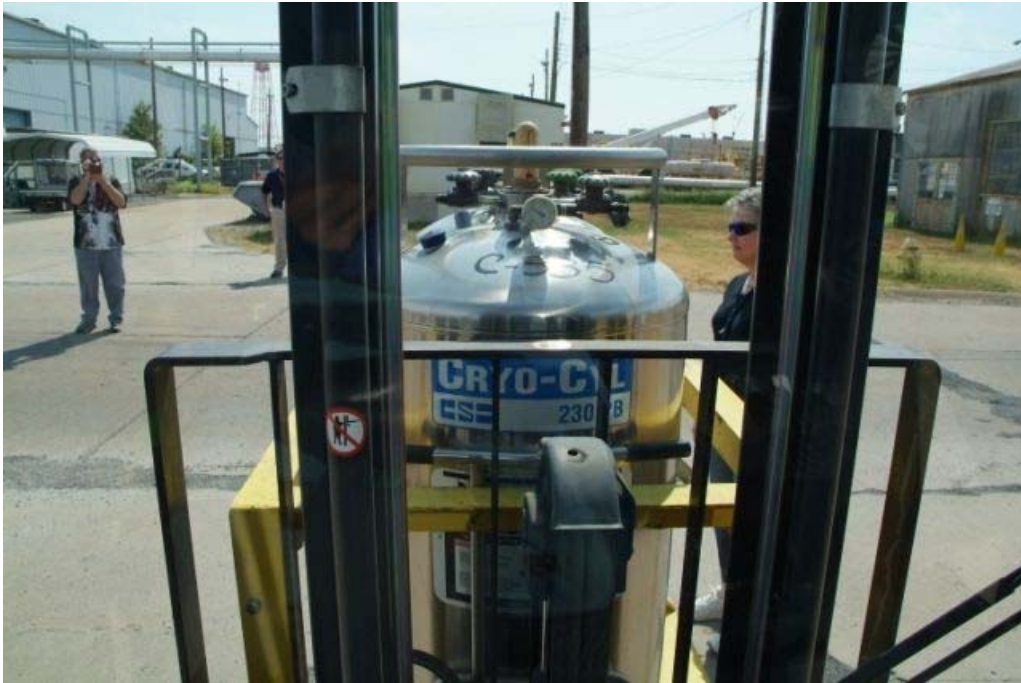
**Figure 2.3-5. View in the Direction of Travel, Obscured by the Dewars and Mast Pillars**

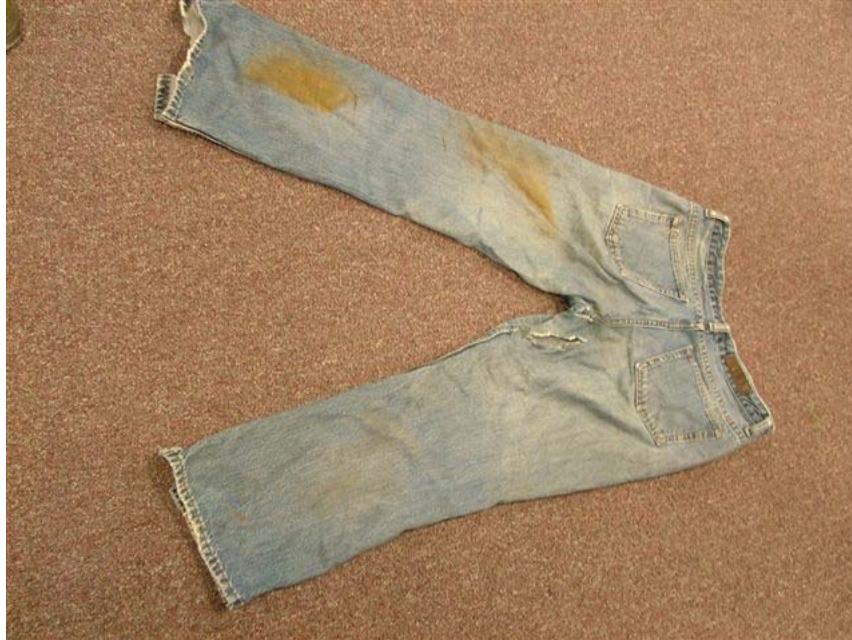
**Figure 2.4-1. Pedestrian’s Pants Showing Rust Marks on Left Leg**

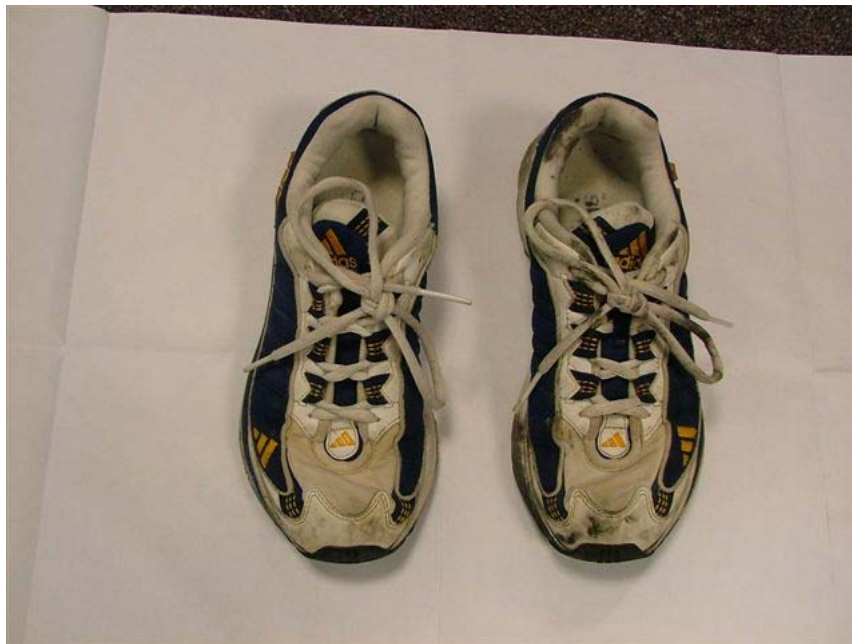
**Figure 2.4-2. Pedestrian’s Shoes Showing Black Scuff Marks on Left Shoe**

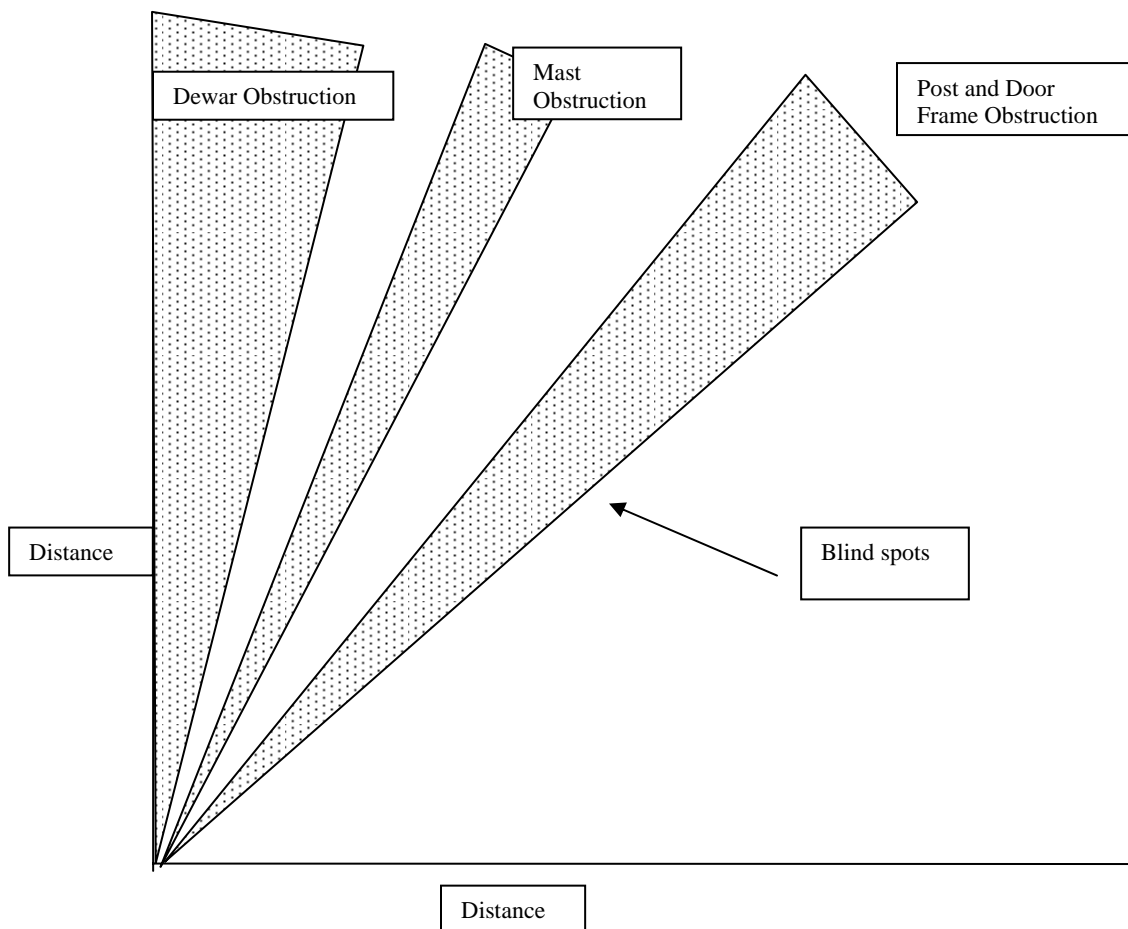
The forklift visibility issue discussion in section 2.3.2 indicates that the driver had a field of view impairment located at approximately 38 degrees from the driver's point of view. Further analysis by the Board revealed the blind spot from the forklift design created a field of view impairment which extended from approximately 31 degrees to 44 degrees to the right of the path of travel. Figure 3.3.2-1 represents obstructions to the driver's field of vision from the dewars, the forklift mast, and the post and door frame.

**Figure 3.3.2-1. Driver's Field of View From Forklift Seat**

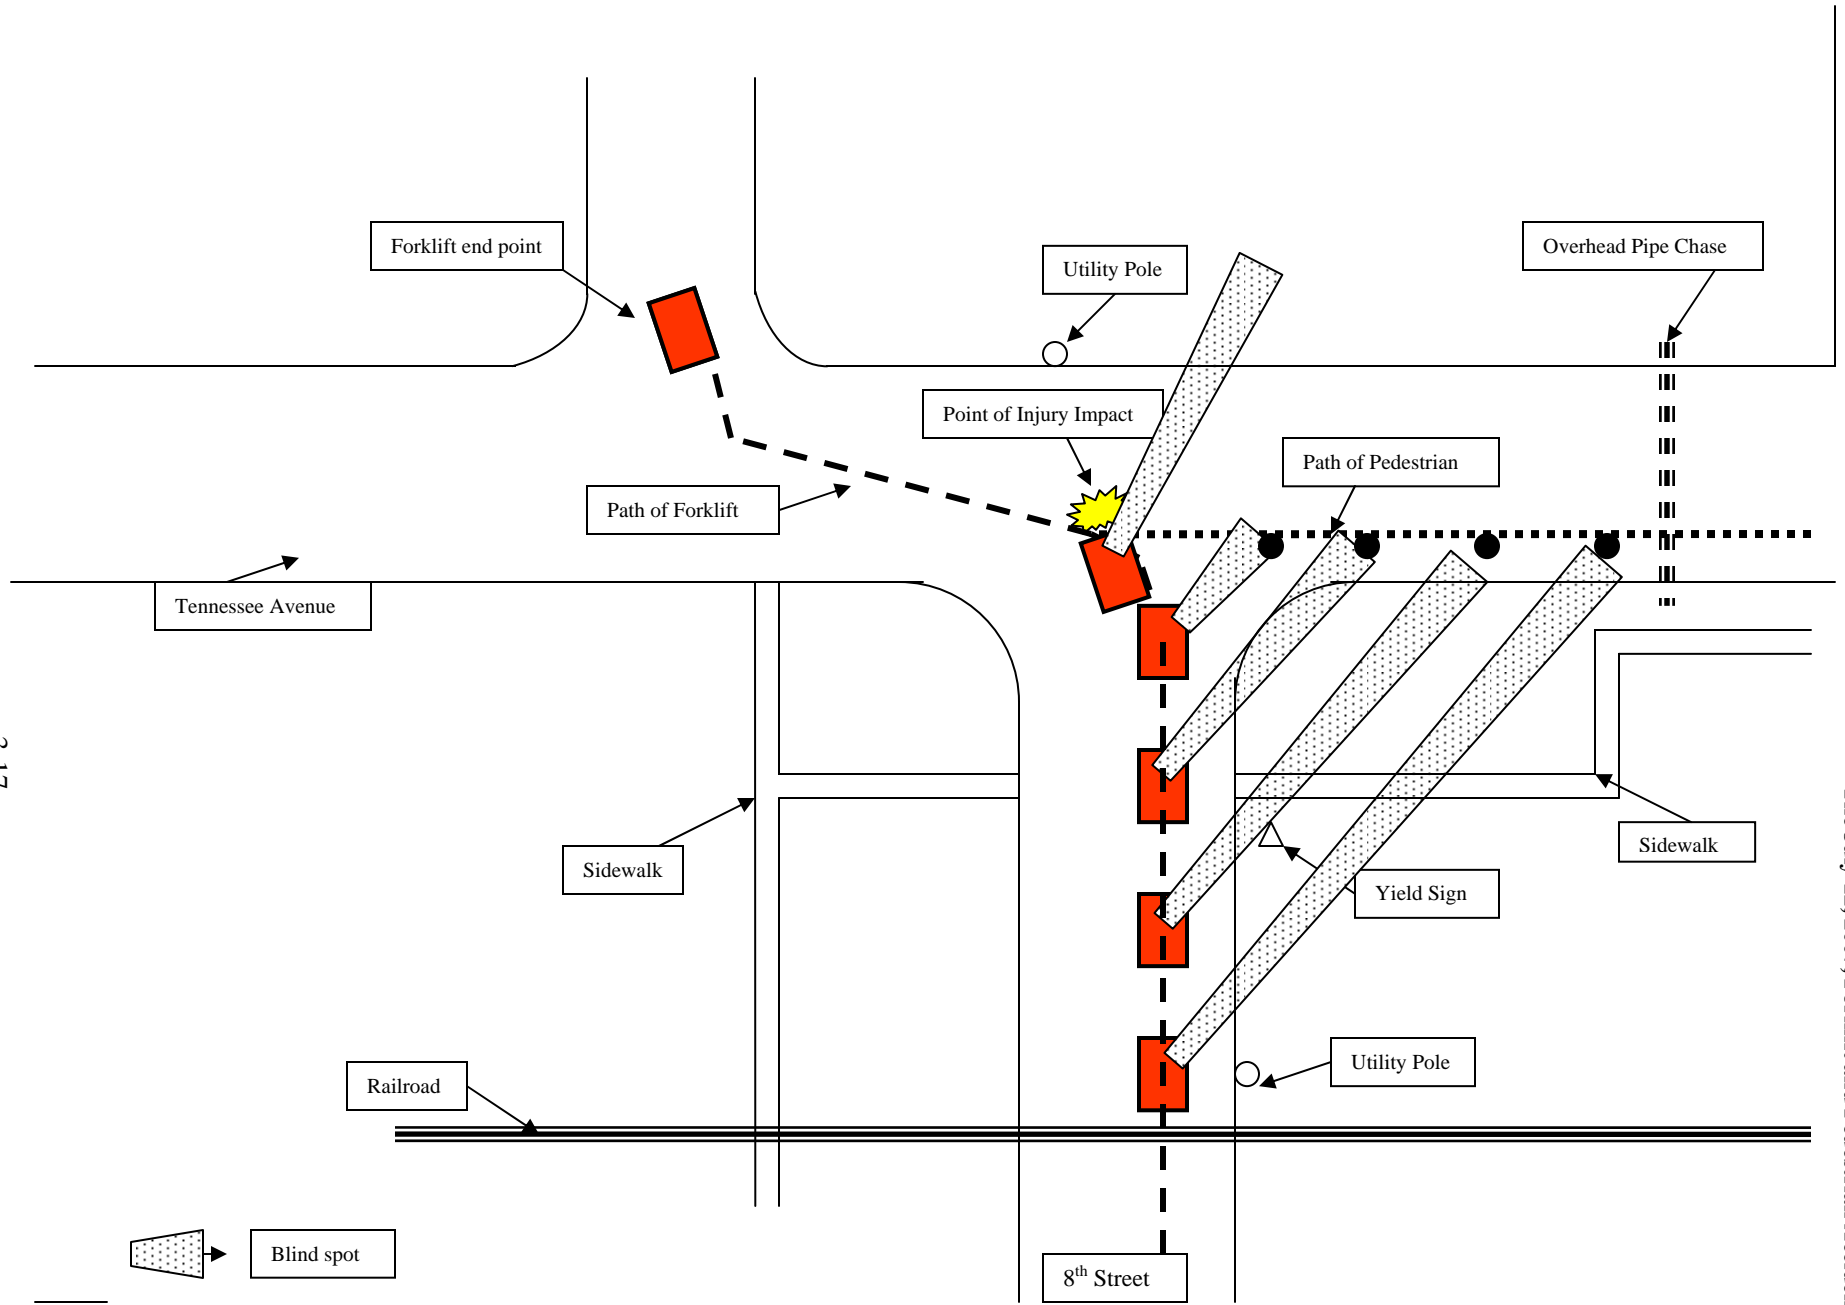
Since the driver and the pedestrian were both maintaining a constant direction of travel and the same relative speed, the Board concludes (if the driver did not physically move to look around the field of view impairment) that the driver could have looked to the right several times and not observed the pedestrian until seconds before the collision. A graphical representation of this possibility is shown below in Figure 3.3.2-2.

Figure 3.3.2-2. Pedestrian Masked by the Forklift Blind Spot

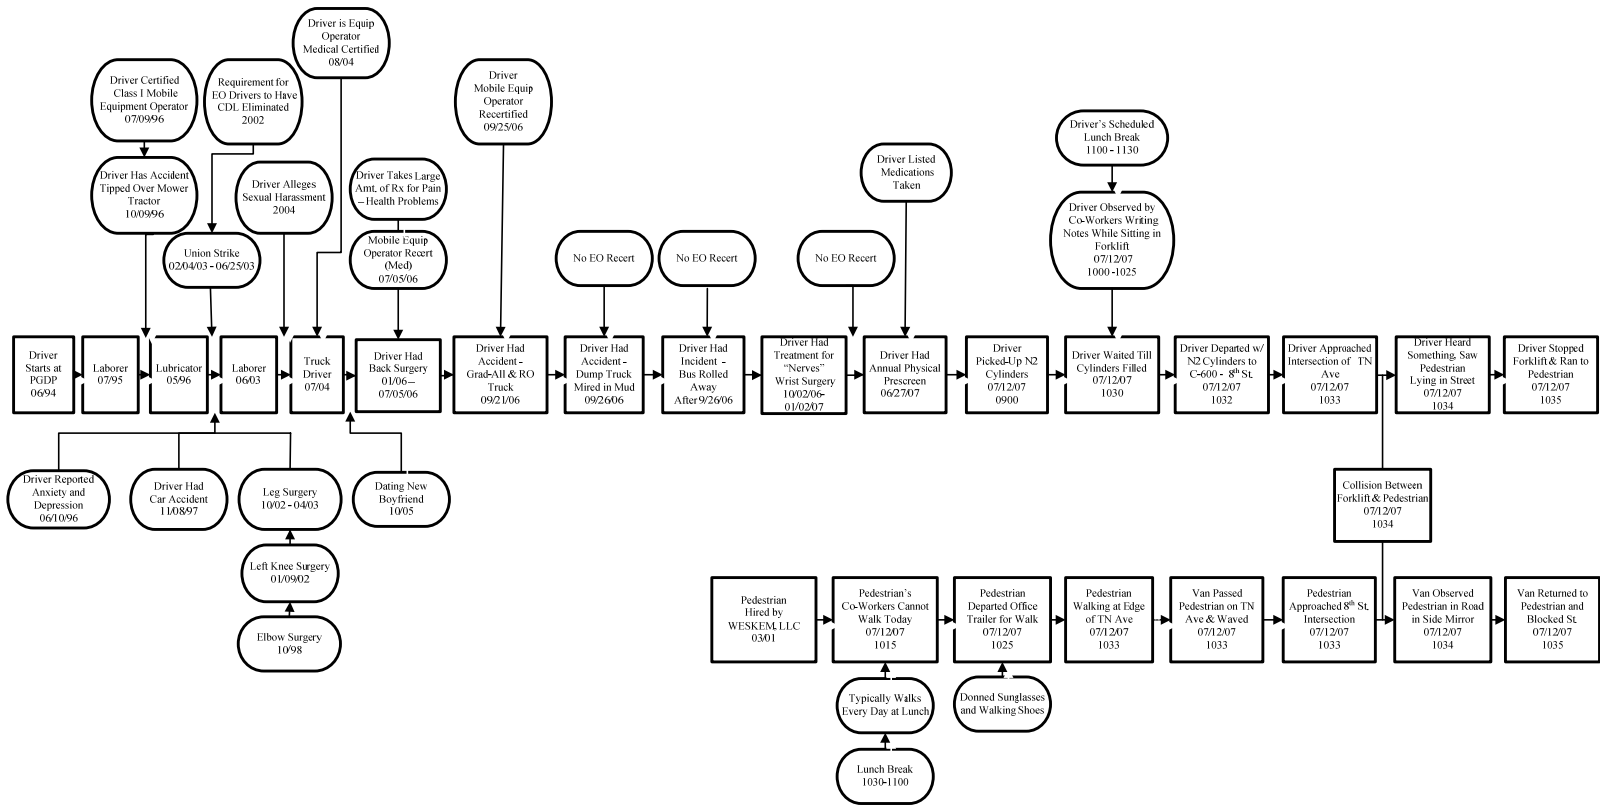
Events & Casual Factors Chart  
Figure 4.1-1

Because the E&CF wall chart contained a huge amount of detailed information, the wall chart was eventually condensed to represent a fairly high level of information that would serve as a useful diagram to understand the events and conditions that contributed to the accident. This resulted in two separate diagrams, see Figures 4.1-1 and 4.1-2.
