Type B
Accident Investigation Board Report
On the February 25, 2009
Abdominal Injury
To a Passenger in an Electric Cart
Waste Isolation Pilot Plant
Carlsbad, New Mexico

April 2009

U.S. Department of Energy
Carlsbad Field Office

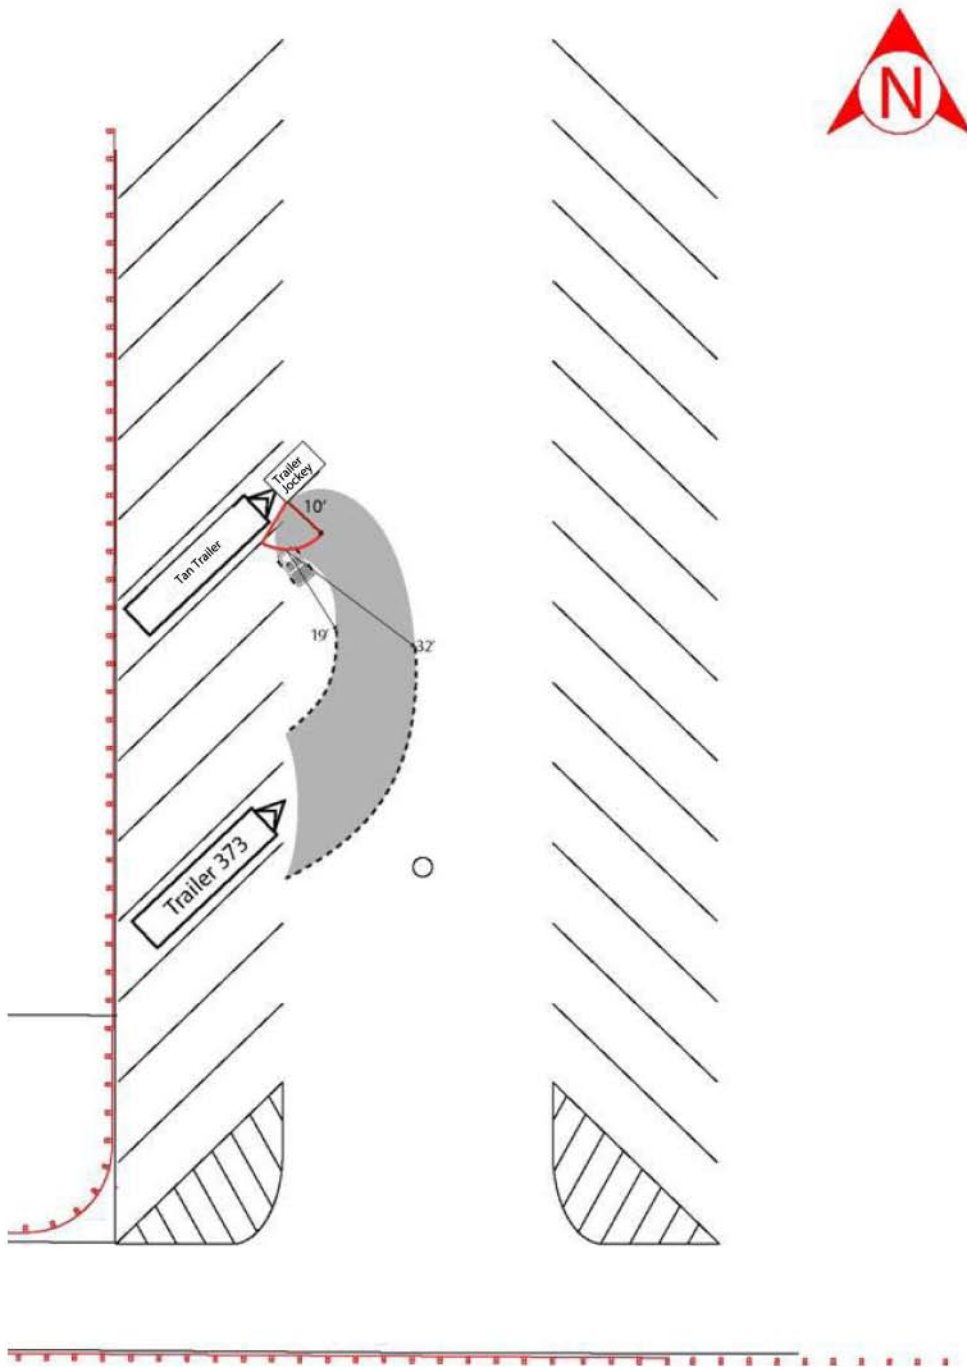
Figure 3: Schematic of the Accident Scene

The Electric Cart Driver then returned to the electric cart and backed up approximately 6 feet from the trailer jockey. The Electric Cart Driver made a looping turn to the right to travel to Trailer 373, which was four spaces to the south. An illustration of these activities is found in Figure 3. When completing the looping turn, the Electric Cart Driver was heading straight onto Trailer 373, as illustrated in the figure. About 6 feet from the trailer, the Electric Cart Driver attempted to stop the cart by pressing the brake pedal. The electric cart slowed, but the accelerator seemed to stick and

A couple of seconds later, the Electric Cart Driver was able to push the electric cart back approximately 2 feet. After the electric cart was pushed back, the Front Seat Passenger exited the electric cart. The Passenger complained of pain, stumbled, and fell onto the parking lot area. The Electric Cart Driver noted the Front Seat Passenger was having difficulty breathing and the Rear Seat Passenger, a trained Mine Rescue Responder, began primary medical care.

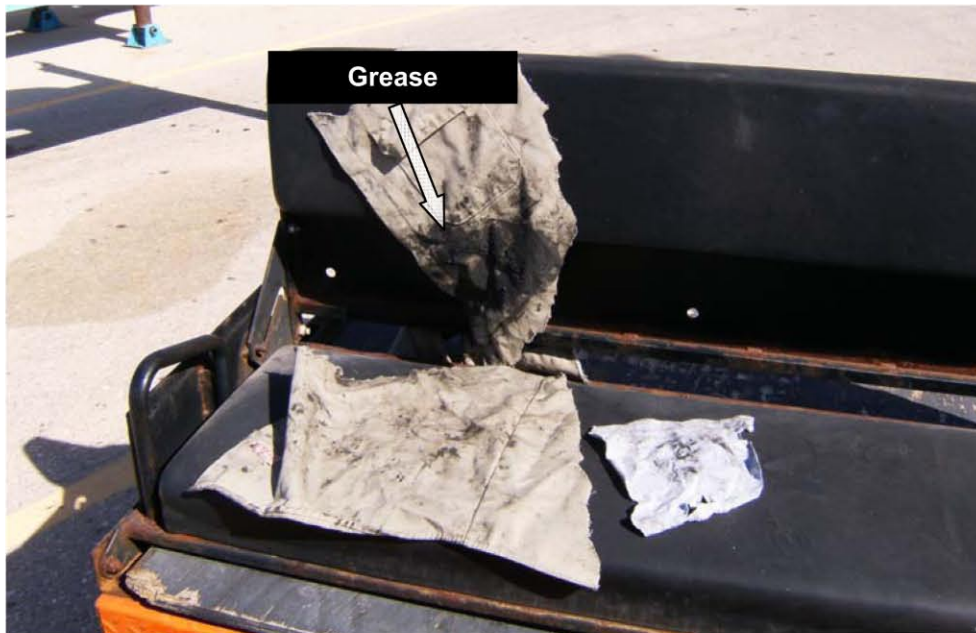
Figure 5: Shirt Worn by Injured Worker (cut/torn as part of primary medical care)

Figure 5 shows the injured worker's shirt, with grease marks just below the front pocket resulting from being pressed against the light bar.

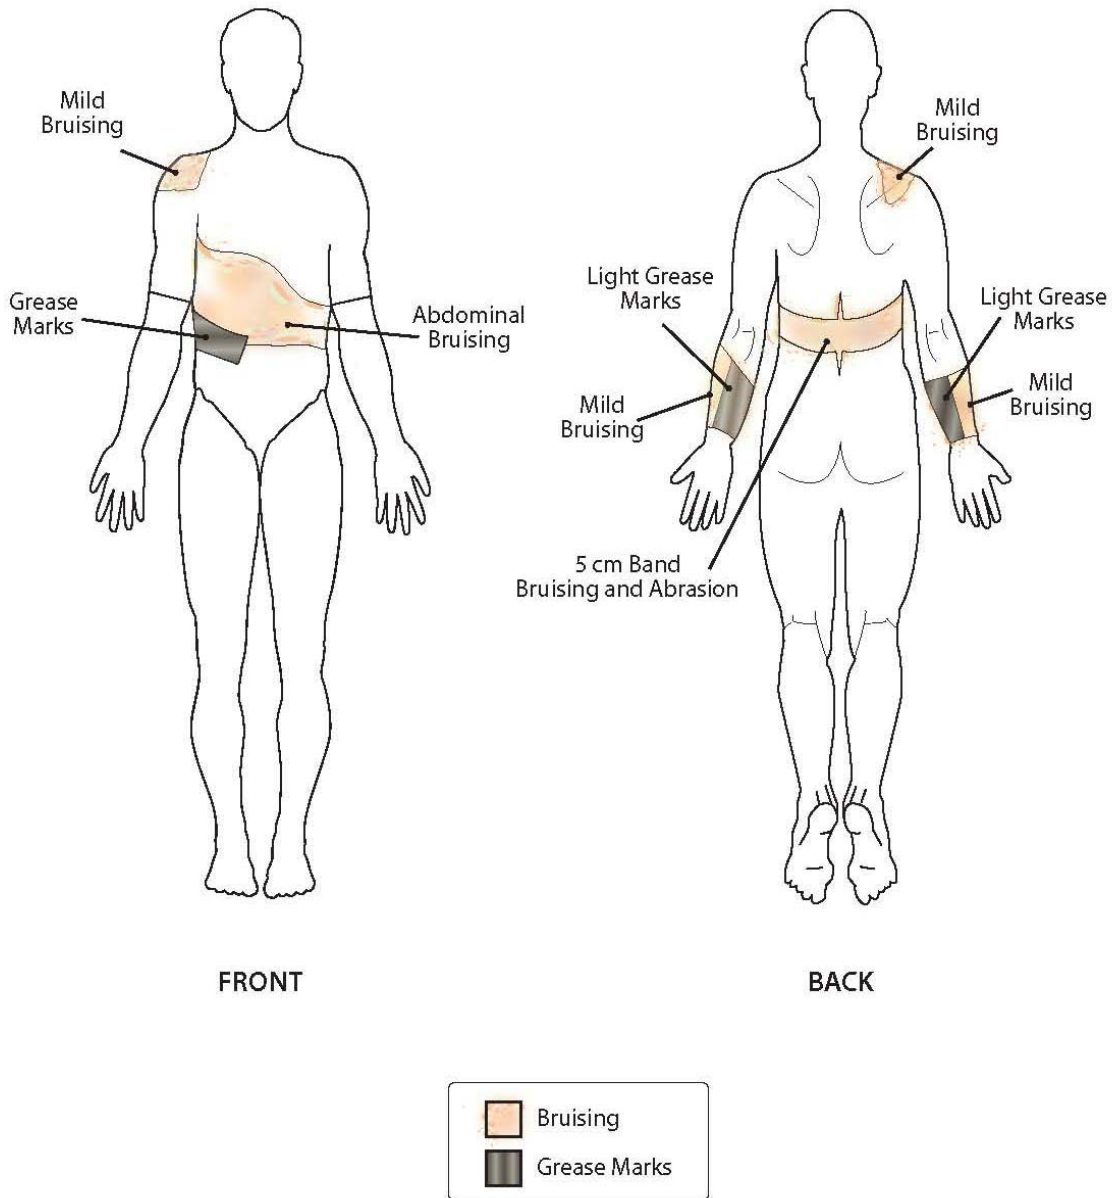
Figure 6: Schematic of Passenger's Injuries

As an immediate action, the WTS management requested that the site nurse, a Waste Handling Manager, and a Human Resources representative be present at the Carlsbad Medical Center to provide case management services for the injured worker and to serve as an interface between the medical staff, the injured worker, and the injured worker's family. The site nurse contacted the WTS Occupational Physician to provide information on the accident and the condition of the injured worker. When the injured worker was transferred to Lubbock, the site nurse traveled to and remained at the hospital for the first three days after the accident. During the entire hospitalization, a WTS manager remained in Lubbock to interface with the injured worker and the family and to support all of their needs. The site nurse prepared the schematic in Figure 6, which shows the bruising and red marking on the injured worker's torso.

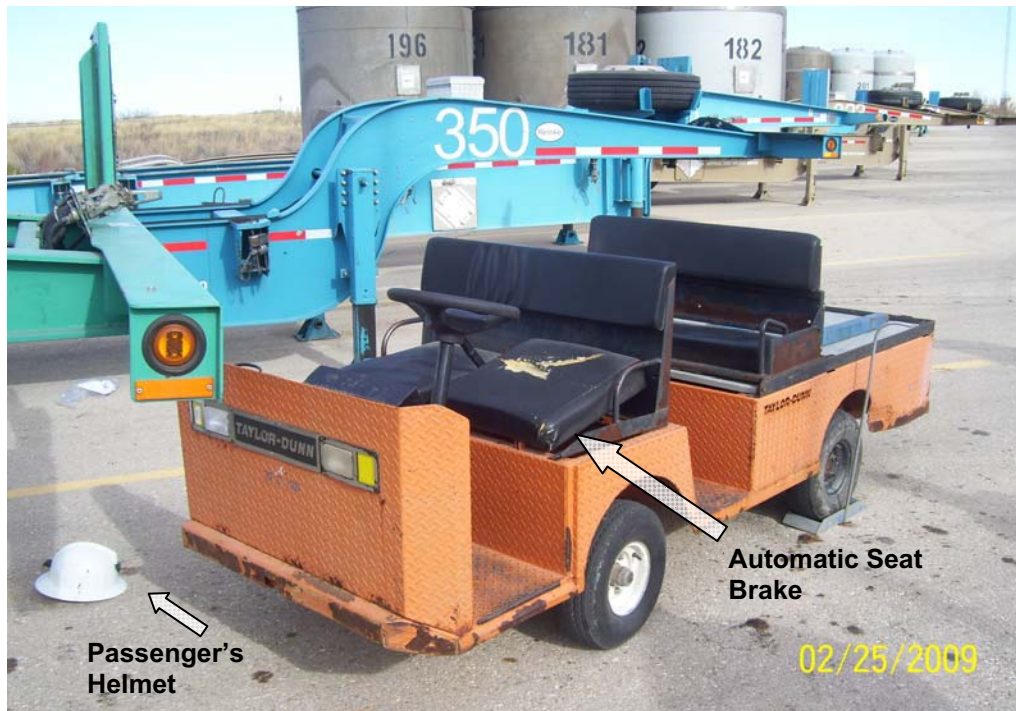
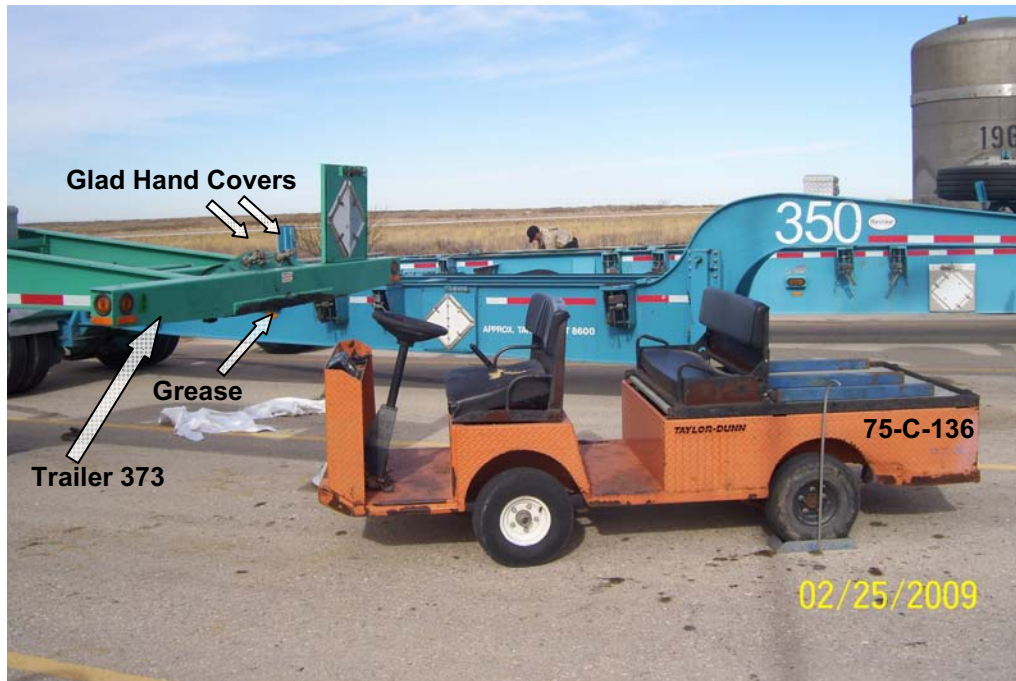
The electric cart involved in the accident, 75-C-136, was a Taylor Dunn Model B0-210 36 Burden Master. This electric burden and personnel carrier, shown in Figures 7 and 8, was obtained in 1999. There are about 143 electric carts on the site, with approximately 50 operated on the surface. Some of the units have a cab and cowl configuration; however, 75-C-136 did not have the cab and cowl option. Without that option, the electric cart can potentially travel under any protruding loads or, in this case, a TRUPACT trailer. This type of electric cart presents a potential caught between hazard for any obstacle that is 45 inches or higher.

Figure 7: Taylor-Dunn Cart Involved in Accident (showing angle related to trailer)

Figure 8: Taylor-Dunn Cart Involved in Accident (from the front of the trailer)

The chain drive of Electric Cart 75-C-136 was subsequently inspected and it was found that the chain was loose on the gear drive and could not be adjusted. WTS replaced the chain, the brakes, and the steering column top bearing on Electric Cart 75-C-136, and repeated the above electric cart tests on April 1, 2009. The results of these tests identified that the electric cart came to a complete stop when the cart was accelerating at low, medium, and high speeds and the brake was engaged. Based on information provided by the manufacturer, “The brake performance is not changed by a misadjusted or worn out drive chain. Additionally, the drive cannot develop any more torque with a misadjusted or worn out drive chain than with a correctly maintained drive chain. The truck [sic] would not lurch due to a misadjusted or worn out drive chain if the brake pedal is held firm.”

<p>The Board concludes that the combination of the accelerator being depressed and the existing conditions of Electric Cart 75-C-136 (loose drive chain and worn brake linings) resulted in an override of the braking system.</p>
--

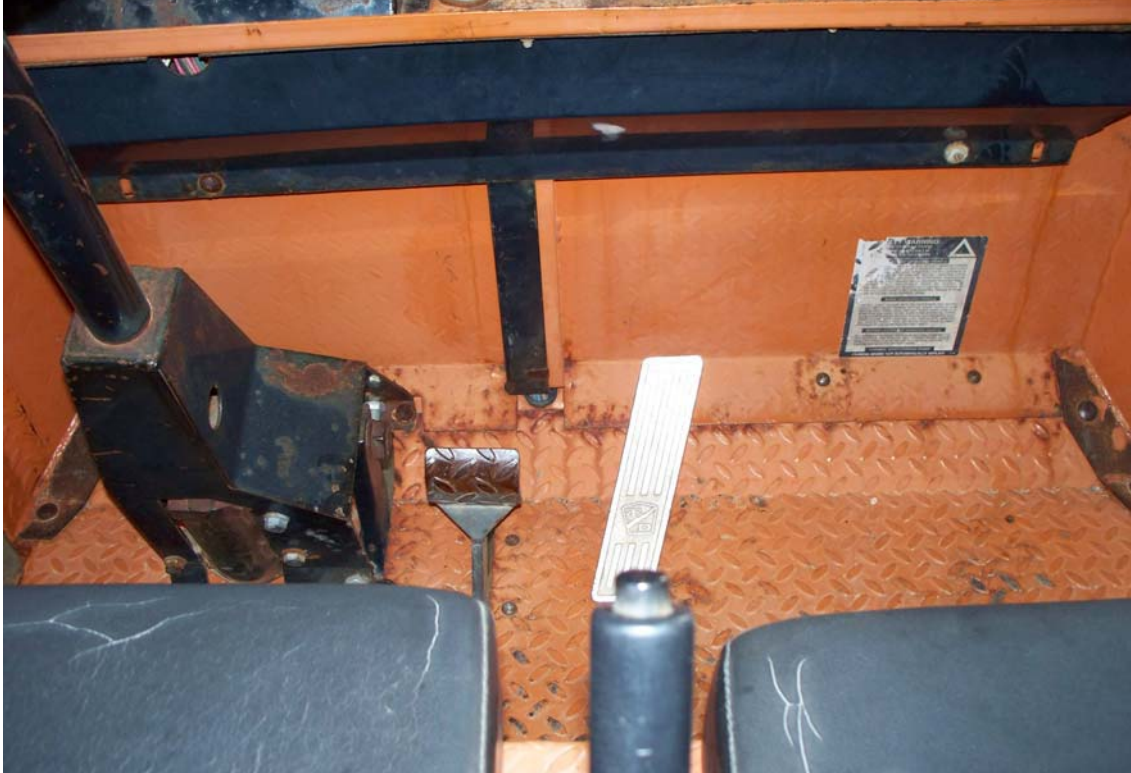
Figure 9: Cart Accelerator Pedal

One design feature of the electric cart is that the accelerator pedal extends off-center into the passenger's foot area. The electric cart width is 42 1/2 inches and the bottom of the pedal is located on the passenger's side, 19 1/2 inches from the edge of the passenger's side. The top of the pedal extends further into the passenger's side. In discussions, many of the workers stated they have witnessed and even placed their own foot on the accelerator pedal while riding as passengers in the electric carts. However, this information was not brought formally to management prior to this accident. Figure 9 is photo of the pedal arrangement in the electric carts.

The Board concludes that the designed location of the electric cart accelerator pedal contributed to the accident.

Conclusions	Judgments of Need
<p>The designed location of the electric cart acceleration pedal contributed to the accident.</p>	<p>WTS needs to install the manufacturer's approved retrofit for the electric cart accelerator to prevent inadvertent engagement by the passenger.</p>
<p>Maintenance of the electric carts did not include the periodic drive chain adjustment, as well as the semi-annual and annual maintenance items established by the manufacturer.</p> <p>The combination of the accelerator being depressed and the existing conditions of Electric Cart 75-C-136 (loose drive chain and worn brake linings) resulted in an override of the braking system.</p>	<p>WTS needs to incorporate and implement the manufacturer's recommendations in the maintenance and servicing of the electric carts.</p>
<p>A Job Hazard Analysis has not been performed for surface electric cart use and, as a result, the appropriate controls were not implemented.</p> <p>Spotter activities were not analyzed for the hazards associated with the task to ensure appropriate controls were implemented, and were performed for some 34 months past the WTS documented endpoint.</p> <p>Overall implementation of Integrated Safety Management Systems for the use of electric carts was insufficient.</p>	<p>WTS needs to enhance its job hazard process to analyze task-level activities based on a formal risk-based approach, as a part of its Integrated Safety Management System program.</p> <p>WTS needs to evaluate the continued need for the spotter activities. (This Judgment of Need is consistent with the WTS recommendation from its initial investigation.)</p>

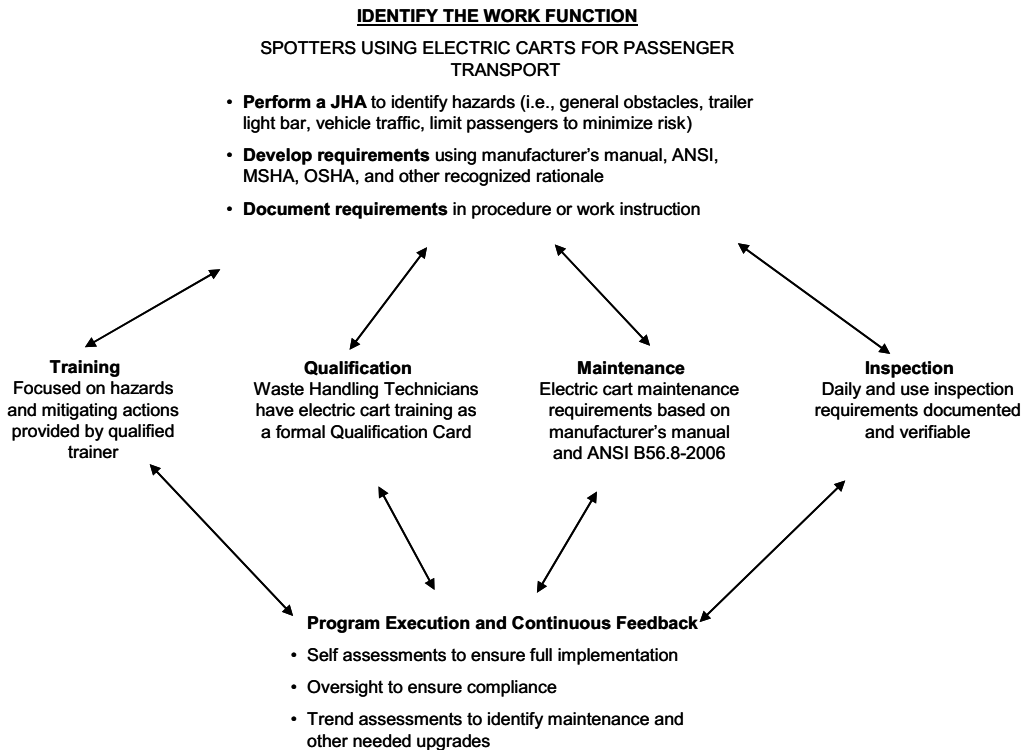
Figure 10: Integrated Safety Management System Steps for Use of Electric Carts

WTS has not applied Integrated Safety Management System core functions and guiding principles in the use of electric carts for performing work on the surface. Figure 10 provides a schematic of the Integrated Safety Management System steps that should have been in place for the use of electric carts with the surface activities at WIPP as they relate to the accident.
