Motorcoach Run-Off-the-Road and Rollover
U.S. Route 163
Mexican Hat, Utah
January 6, 2008

NTSB/HAR-09/01
PB2009-916201

Highway Accident Report

Abstract: About 8:02 p.m., mountain standard time, a 2007 Motor Coach Industries 56-passenger motorcoach with a driver and 52 passengers on board was traveling southbound, descending a 5.6-percent grade leading to a curve to the left, 1,800 feet north of milepost 29 on U.S. Route 163. After entering the curve, the motorcoach departed the right side of the roadway at a shallow angle, striking the guardrail with the right-rear wheel and lower coach body. The motorcoach traveled approximately 350 feet along the foreslope, with the right tires off the roadway. The back tires lost traction as the foreslope transitioned into the drainage ditch. The motorcoach rotated in a counterclockwise direction as it descended an embankment. The motorcoach overturned, struck several rocks in a drainage ditch bed at the bottom of the embankment, and came to rest on its wheels. During the 360-degree rollover sequence, the roof of the motorcoach separated from the body, and 50 of the 53 occupants were ejected. Nine passengers were fatally injured, and 43 passe

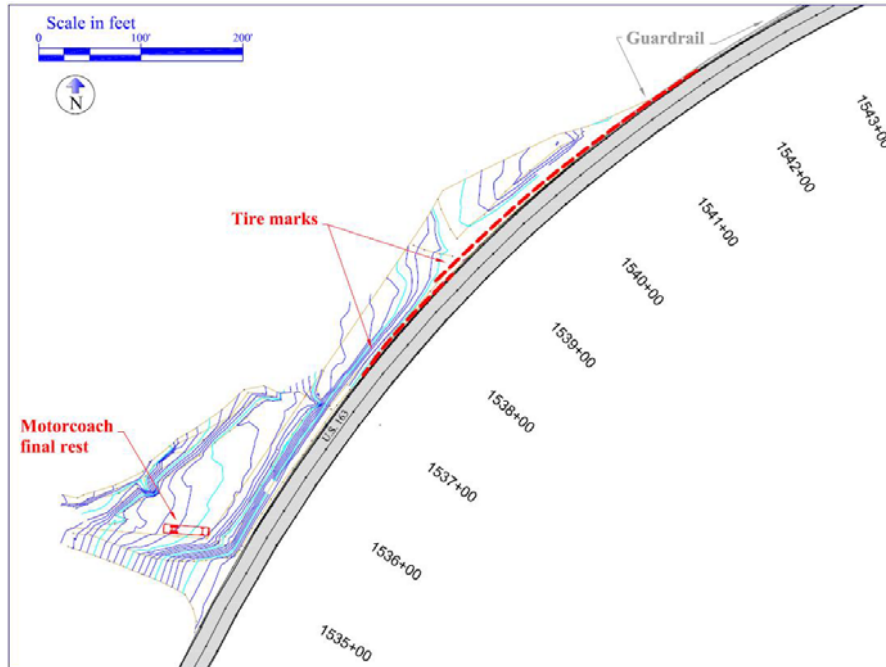
Figure 2. Scene diagram showing tire marks (dashed plow marks show the tire tracks gradually departing the road).

After several miles of downhill road and just before milepost 29, U.S. 163 begins a gradual, long curve to the left. Shortly after entering that curve, the bus departed the right side of the roadway at a shallow angle. There were no skid marks on the highway, and no other vehicles were involved in the run-off-the-road event. Evidence of tire marks was found along the guardrail for 61 feet before the guardrail came to an end.⁴ Two sets of tire marks on the side slope showed the front tires were tracking nearer the top of the embankment, and furrows from the rear tires were found further down the embankment. Tire marks are shown in figures 2 and 3.

⁵ Survey information in figure 2 shows the plow marks of the tires departing the pavement at station number 154,200 and ending at approximately station number 153,850, a difference of 350 feet.

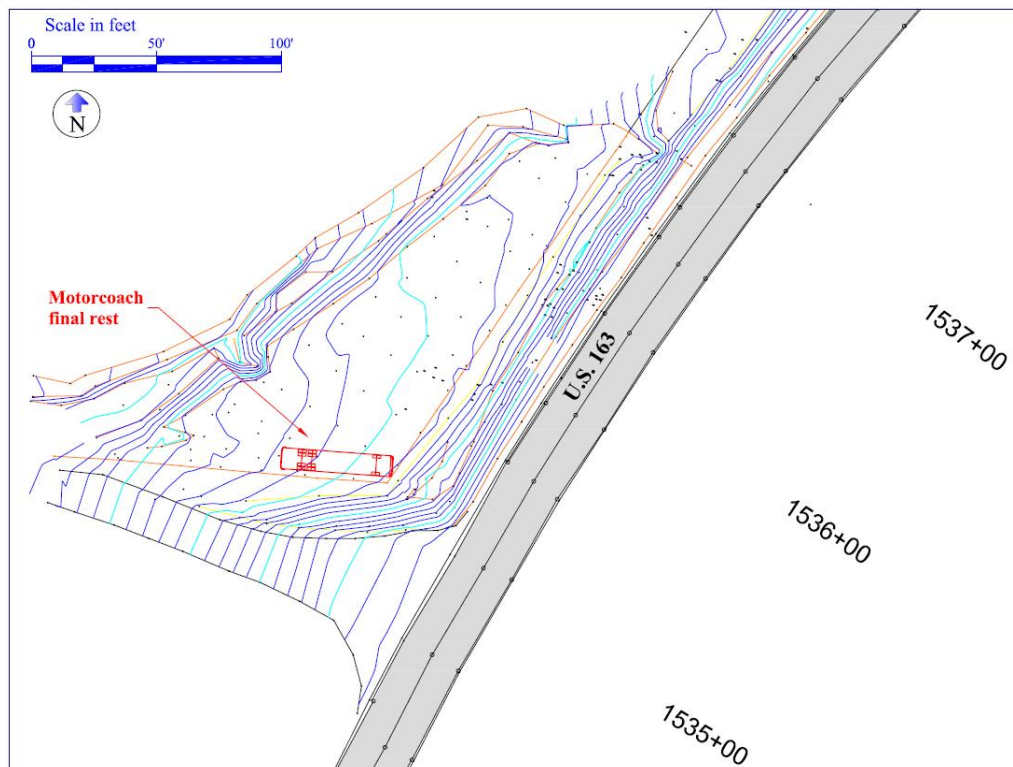
Figure 4. Position of accident motorcoach at end of rollover sequence (topographical contour lines indicate steepness of the embankment or slope; the closer the lines, the steeper the slope).

After departing the roadway, the motorcoach traveled approximately 350 feet before the rear wheels went off the embankment.⁵ The rear of the motorcoach rotated counterclockwise, with the front of the motorcoach facing perpendicular to the roadway.⁶ The motorcoach overturned, rolling to the right, and struck a rocky drainage ditch at the bottom of the embankment approximately 10 feet lower than the roadway. During the rollover sequence, the roof separated from the bus body at the point where the vertical posts attached to the base of the window sash along the right side and, subsequently, the roof separated from the motorcoach. During the accident sequence, the motorcoach impacted the ground and completed a full rotation (360 degrees) before coming to rest on its wheels. Figures 4 and 5 show the accident motorcoach in its final location after the accident.

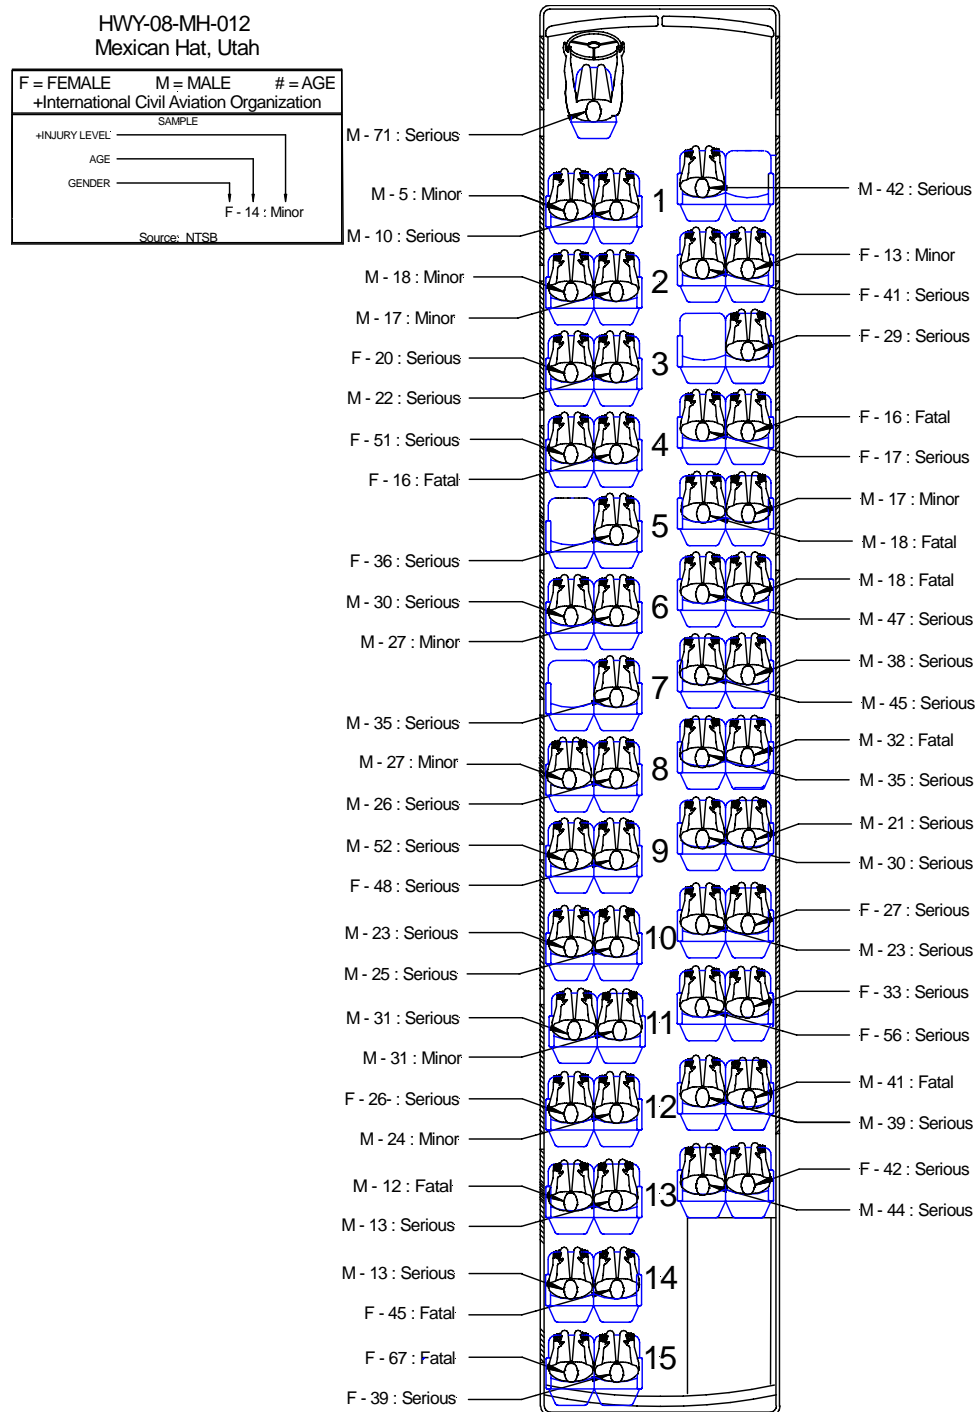
Figure 6. Seating diagram.

As a result of the accident, 9 passengers sustained fatal injuries, 34 passengers and the driver sustained serious injuries, and 9 passengers received minor injuries. Figure 6 shows the seating locations and injury patterns of motorcoach occupants.

Of the 24 passengers who were seated on the right side of the motorcoach, 5 sustained fatal injuries (4 of 5 of these occupants were seated next to windows), 17 sustained serious injuries, and 2 sustained minor injuries. Of the 28 passengers who were seated on the left side of the motorcoach, 4 sustained fatal injuries (3 of 4 of these occupants were seated in the last three rows), 17 sustained serious injuries, and 7 sustained minor injuries.

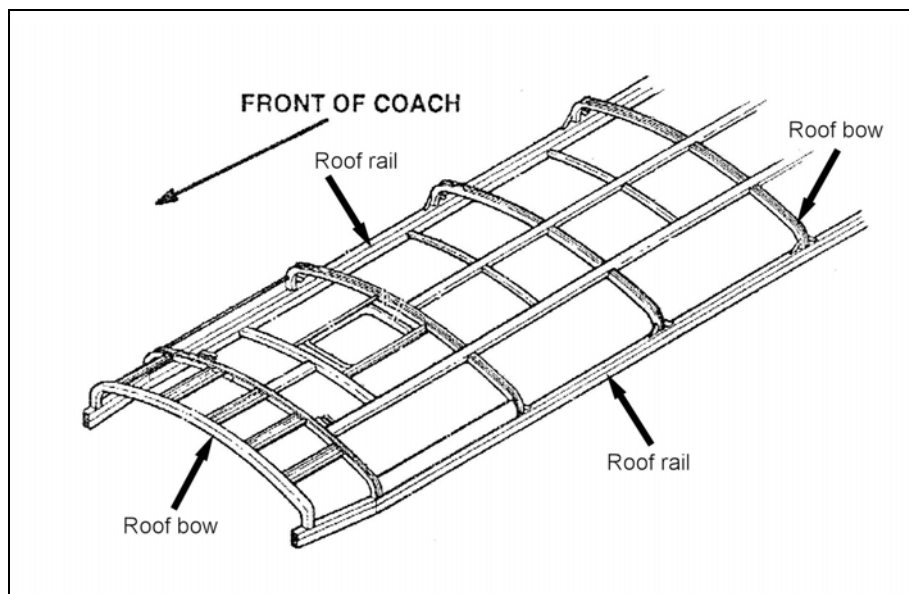
Figure 8. Motorcoach roof design. (Source: MCI.)

According to an MCI representative, the accident motorcoach, as well as others that MCI manufactures, was constructed using a monocoque-type frame. Monocoque construction offers a weight advantage and is commonly utilized in motorcoaches and van-type semitrailers, in which the sides of the vehicle bear a substantial part of the load in shear. The roof panel was made of aluminum and secured to the stainless steel roof bows using structural adhesive; the edges of the panel and the periphery of the roof hatches were riveted. The roof had five longitudinal supports running from the front-upper structure to the rear-upper structure. The roof was supported by eight stainless steel posts on each side, which extended vertically from the belt rail to the roof rail and were welded at the belt rail and again at the roof rail. Although not a single continuous tube, the eight vertical posts continued across the roof, becoming roof bows. Figures 8 and 9 illustrate segments of the motorcoach's roof and side construction.

The roof of the motorcoach became detached from the body during the rollover. The motorcoach rotated about its longitudinal axis, rolling over 360 degrees to its right, and approximately 180 degrees about its vertical axis, stopping on its wheels facing east. During the rollover, the right side of the motorcoach's roof, at the lower edge of the window sill (sash rail) and vertical support posts for the window, became separated from the body. At final rest, the motorcoach was right side up, with the roof lying on the ground near the motorcoach, top side down. The windshield glazing and all windows along both sides of the motorcoach were displaced during the rollover.

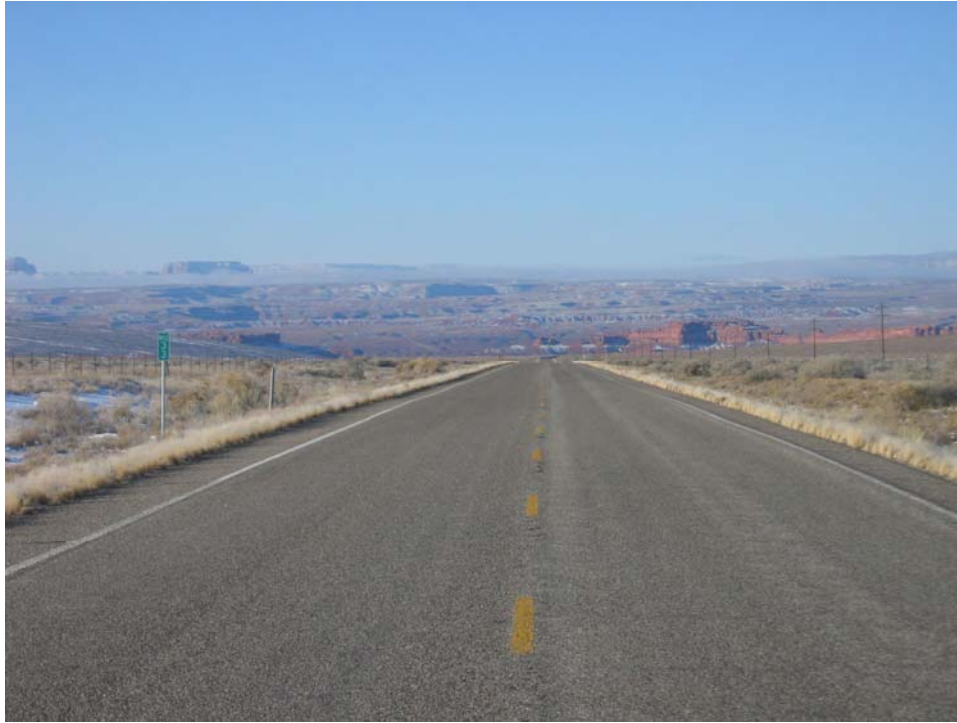
Figure 10. View of descending road grade, 4 miles before the accident site.

horizontal curve that was well marked with chevron curve signs⁵⁴ and a 35-mph speed advisory warning. Beginning 4 miles before the accident site, about milepost 33, the highway begins a gradual descent,⁵⁵ as shown in figure 10. The immediate approach to the curve where the accident occurred is a long, straight downgrade (1,200 feet long with a 5.6-percent downgrade), as shown in figure 11.

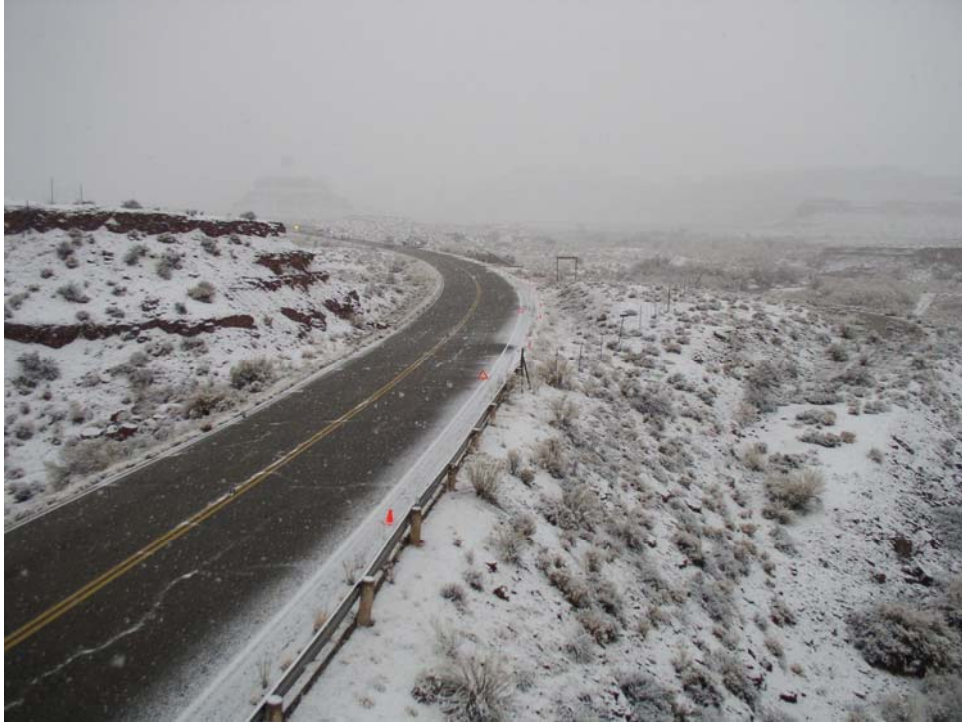
Figure 11. View of descending road grade in the direction of travel, immediately preceding the accident curve.

⁵⁵ For more than a mile (6,400 feet) preceding the curve where the accident occurred, the highway averages a 4-percent downgrade.

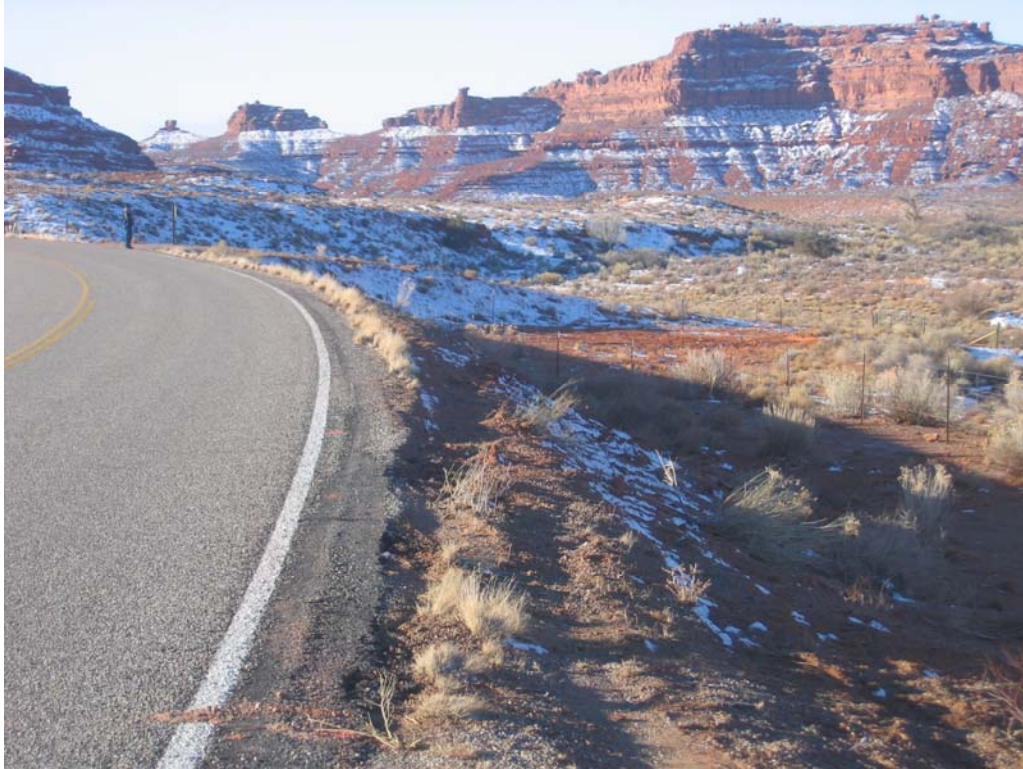
Figure 12. View of accident curve.

The accident occurred on a long left-hand curve that extends for nearly one-third of a mile (1,641 feet) at milepost 29. The curve, shown in figure 12, has a spiral transition and a 1,400-foot radius resulting in a 4-degree curve. The curve had a 6-percent superelevation or bank. A curve warning sign is posted on the right-hand roadside approximately 750 feet in advance of the curve.⁵⁶ The curve warning sign does not have a posted advisory speed warning sign. The posted speed for the area is 65 mph.

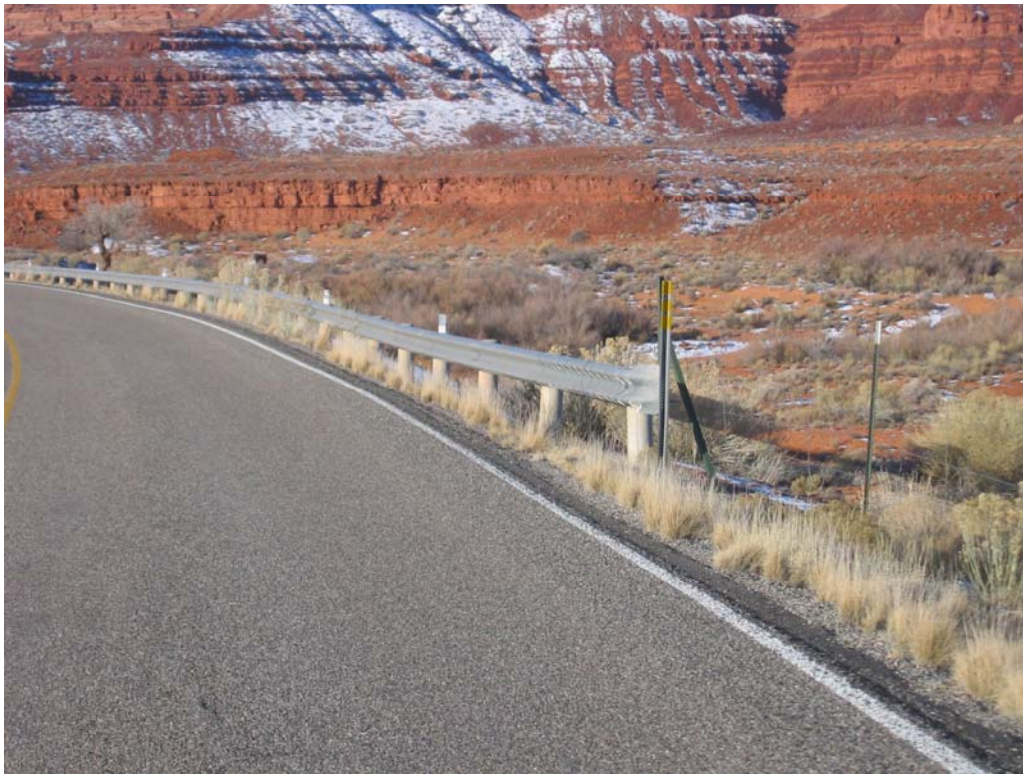
Figure 13. View of guardrail.

vehicle running off the road onto the slope would likely overturn. The existing guardrail had no end treatment.⁶²
