**National Transportation Safety Board**

**Carlsbad, New Mexico**  
**August 19, 2000**

**Pipeline Rupture and Fire**  
**El Paso Natural Gas Company:**  
**Gas Transmission Line No. 1103**

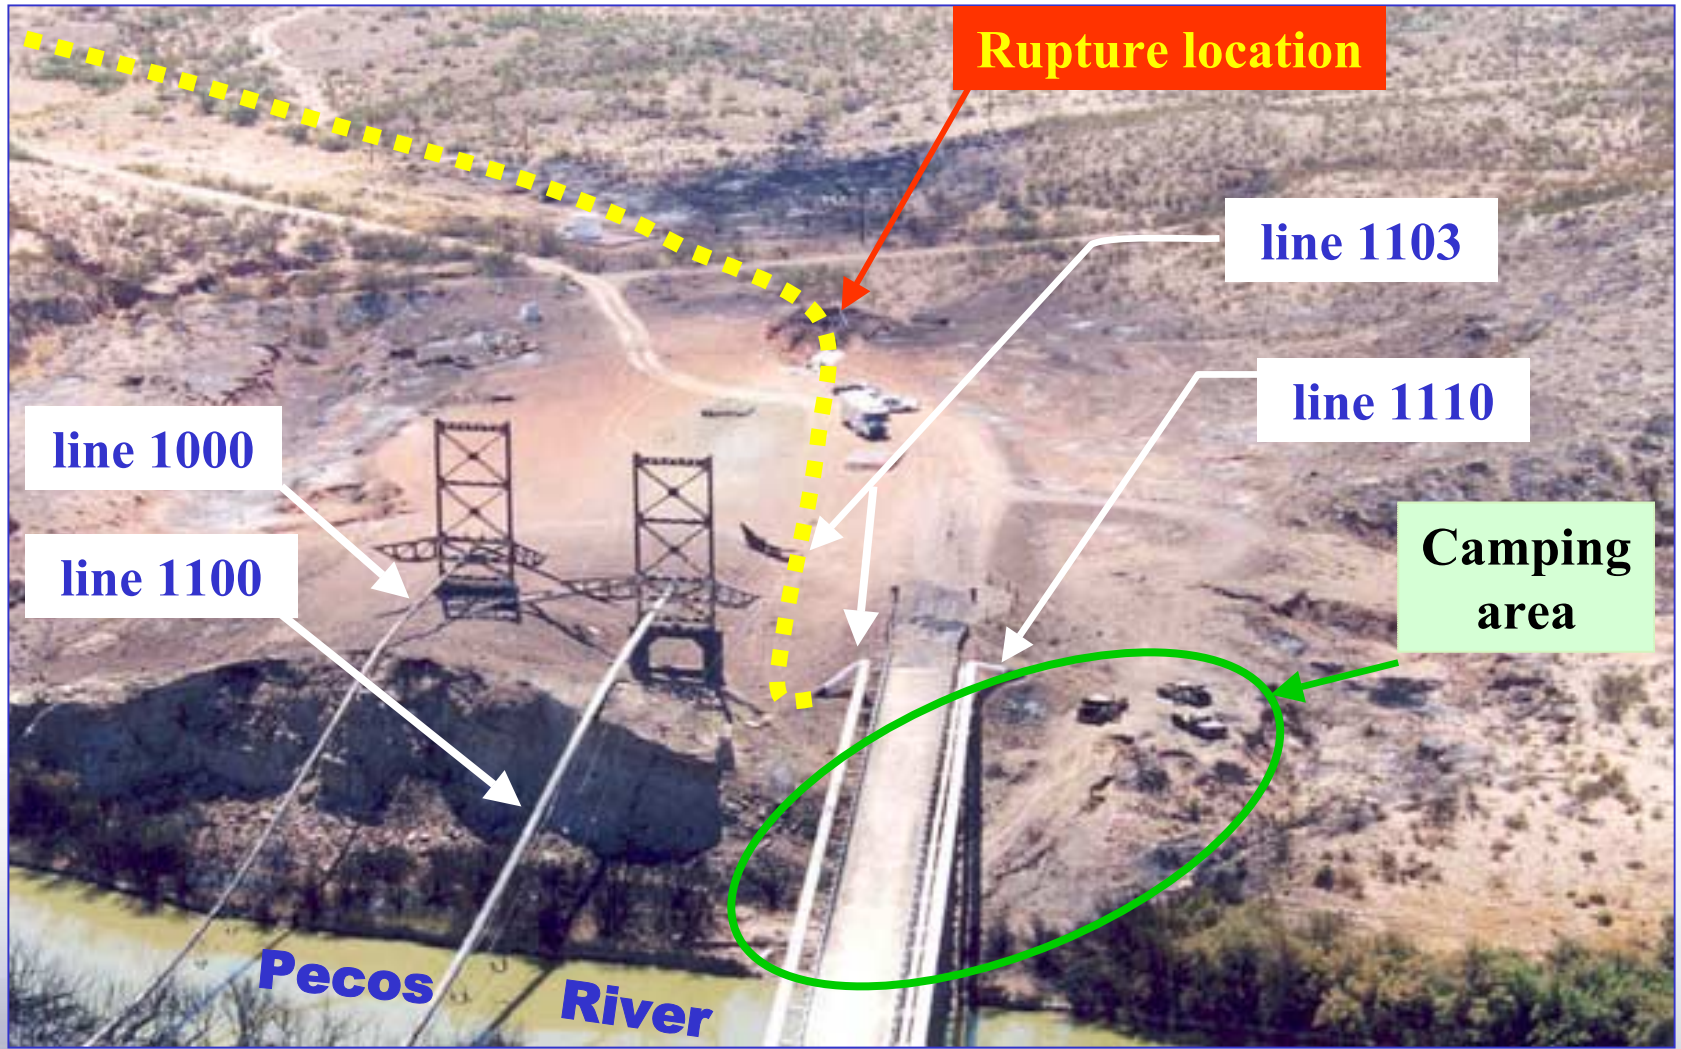
**Rupture location**

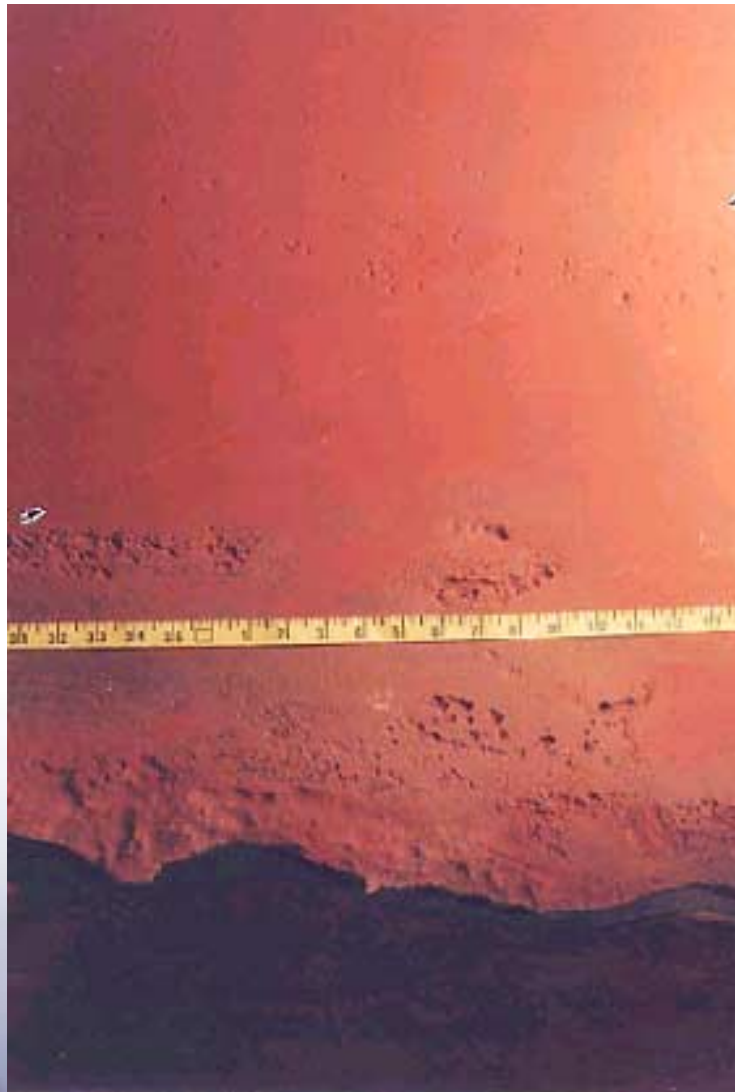
# Photograph Showing Pitting Damage

**Severe internal corrosion**

Pitting corrosion  
(isolated pits)

Patches of  
interconnected pits

Area of severe  
corrosion damage

Fracture (6 o'clock)

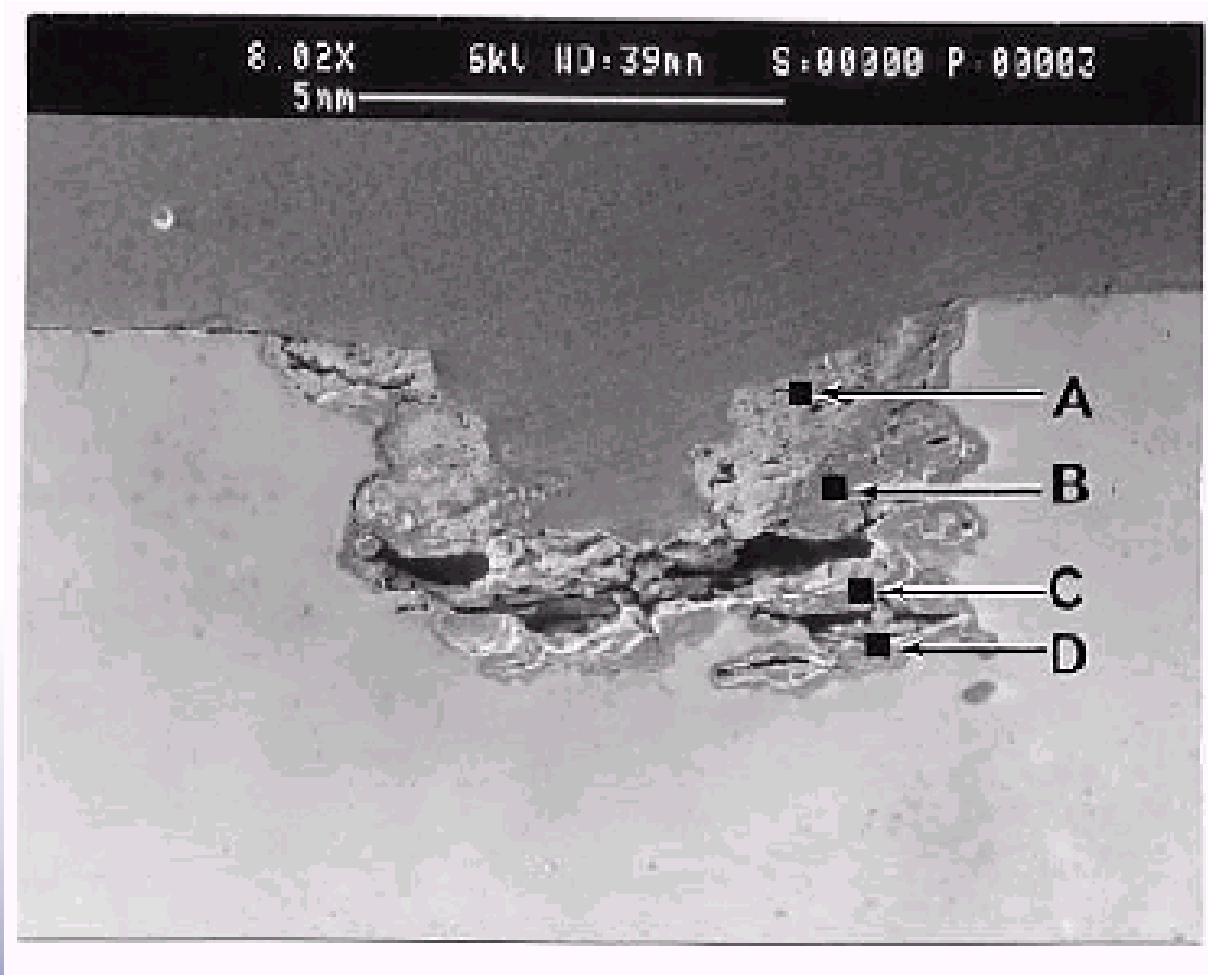
# Scanning Electron Microscope Photograph

- **Electrolyte ( water )**
- **Carbon Dioxide ( CO<sub>2</sub> )**
- **Hydrogen Sulfide ( H<sub>2</sub>S )**
- **Oxygen (O<sub>2</sub>)**
- **Chloride ( Cl<sup>-</sup> )**
- **Microorganisms**
