NATIONAL TRANSPORTATION SAFETY BOARD

Fire & Explosion Group Factual

Accident Number: NYC07MA162
Location: Sanford, Florida
Date: 7/10/2007
Registration number: N501N
Vehicle: Cessna 310R

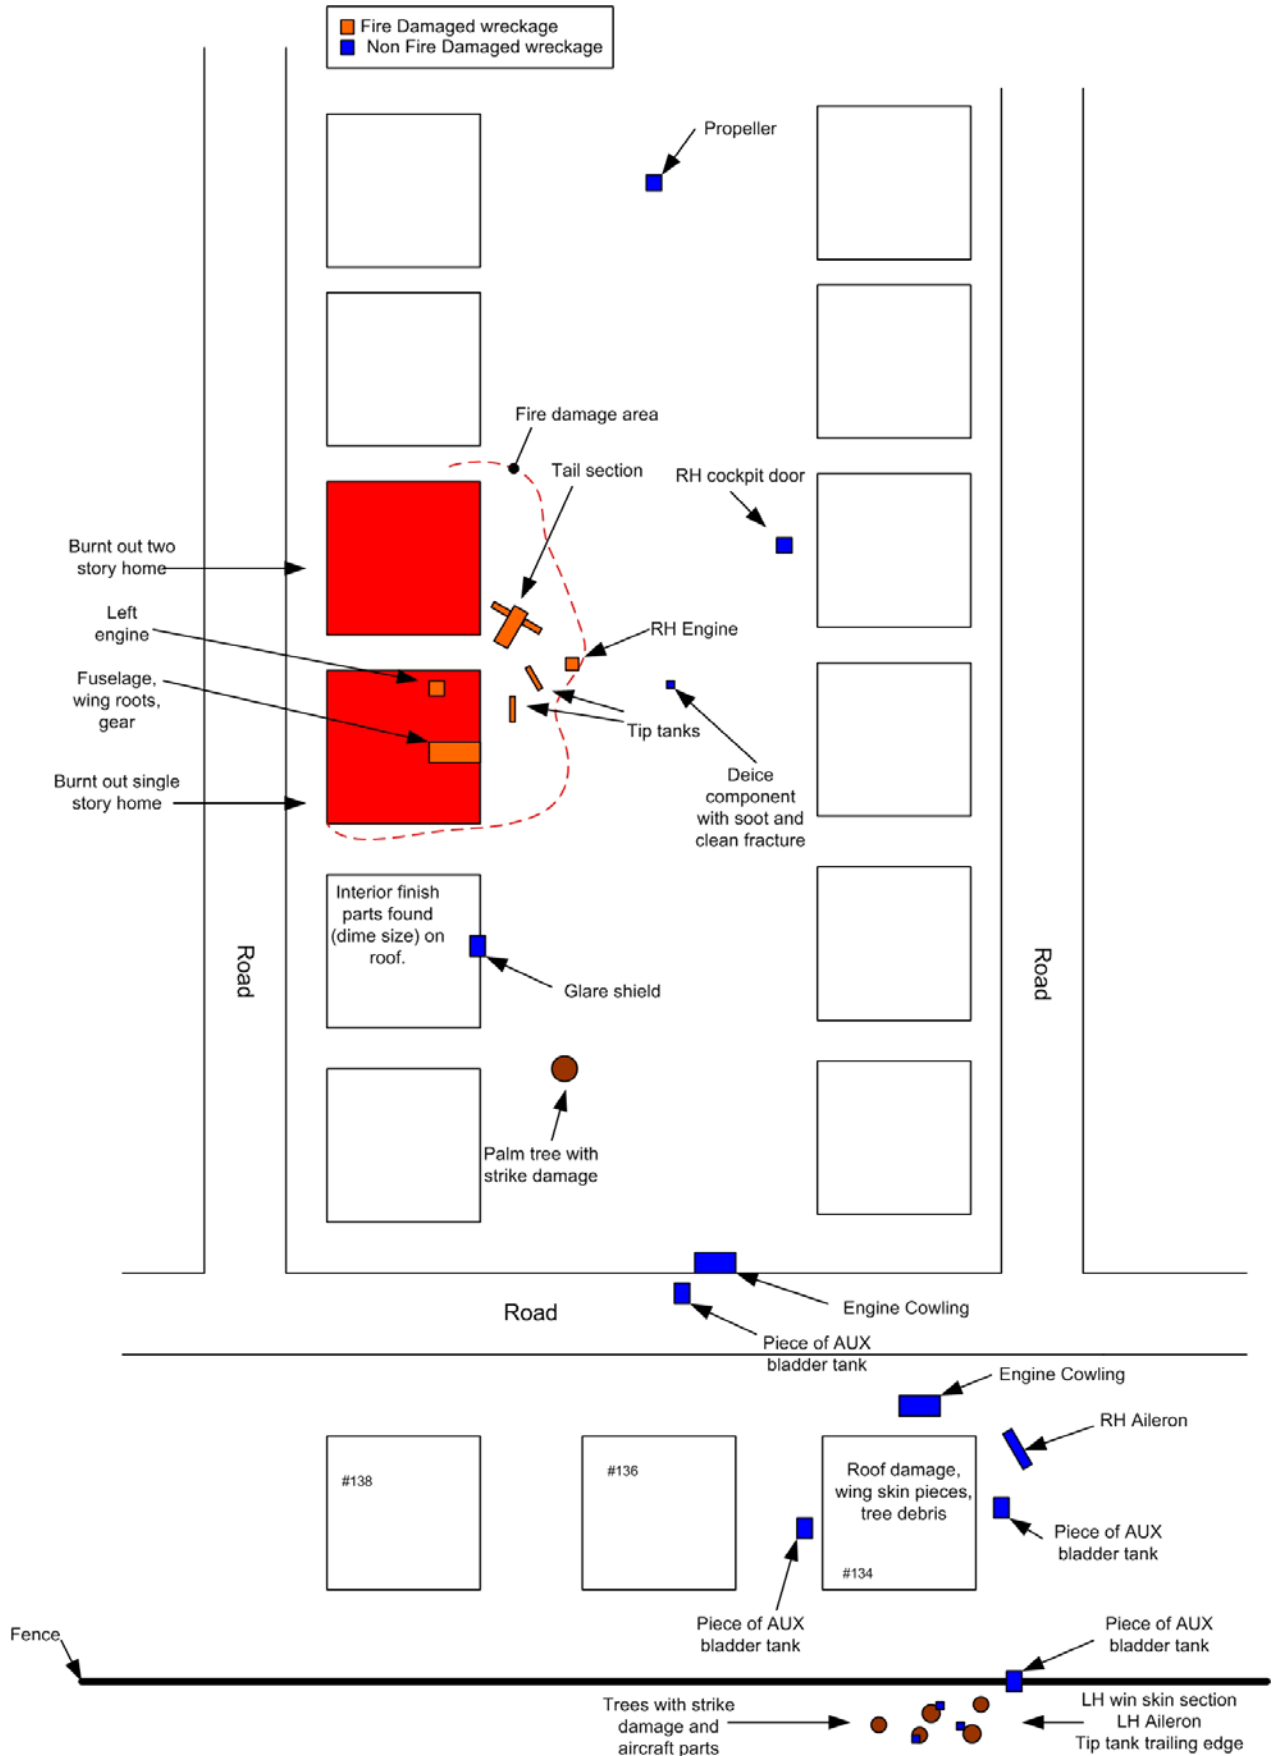
Figure 1: Accident site plan. (Not to scale)

The scene of the accident was located in a residential development (Figure 1). The aircraft wreckage was scattered over a large area due to the fact that the aircraft sustained impact with trees prior to the final impact with a single level, single-family home in the development. The aircraft first impacted a row of trees along the border of the residential development and then it impacted a large palm tree within the confines of the development prior to impacting the home (Figure 2). Parts of the aircraft also impacted a two level home adjacent to the single level home. The fuselage and bulk of the wing structure ended up inside the single level home while the tail section, which had separated from the rest of the aircraft, was found leaning up against the two level home. Parts of the aircraft were also found in the space separating the two homes. A post crash fire ensued which consumed the two homes.

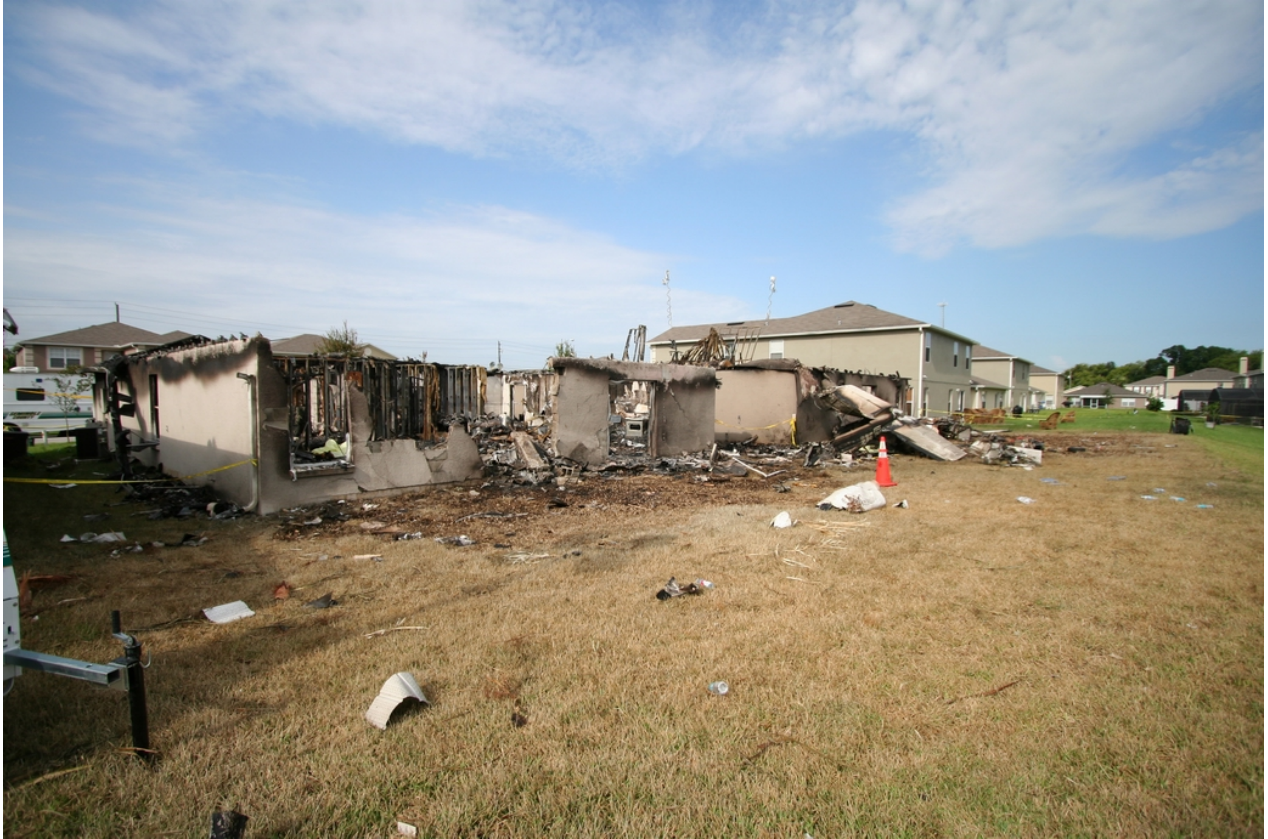
The parts of the wreckage found at the final impact location were involved in a post crash fire. The fuselage and bulk of the wing structure was found inside the single level house. Large portions of the fuselage structure had melted and collapsed. Debris from the structure of the house had fallen on top of the fuselage and they had become intertwined. The severity of the post crash fire precluded any determination of fire damage and patterns that could be identified as being a result of an in flight fire. The tail section of the aircraft was found leaning up against the adjacent two level home and it was also within the area of the post crash fire. There were no fire patterns or any other evidence of an in flight fire on the tail section. A close examination of the parts found in the post crash fire zone did not turn up any evidence of broom strawing of aluminum components which would indicate that the parts were severely heated before being shocked by the impact forces. The majority of the aircraft's wiring and electrical systems were found with the fuselage inside of the single level home. The insulation on the wiring was missing and the conductors themselves were covered in soot and had become brittle. The wiring was examined for evidence of electrical failures in the form of pitting and beading, which would result from electrical arcing. The wiring did not show any signs of such failures with the exception of a few small sections of stranded wire and a bundle of stranded wires, which terminated at a female connector plug on one end and was severed on the other. The single wires and wire bundle were retained for close examination at the Safety Board's material's laboratory. The results of those examinations can be found in a separate laboratory factual report. The aircraft's combustion heater was also found inside the single level home with the rest of the fuselage. The combustion heater was severely damaged by the post crash fire and could not be established as a source of ignition.

Figure 2: Final impact location of accident aircraft.
