NATIONAL TRANSPORTATION SAFETY BOARD

MATERIALS LABORATORY FACTUAL REPORT

Report No. 07-116

Place : Sanford, Florida
Date : July 10, 2007
Vehicle : Cessna 310R, N501N
NTSB No. : NYC07MA162
Investigator : Joseph Panagiotou

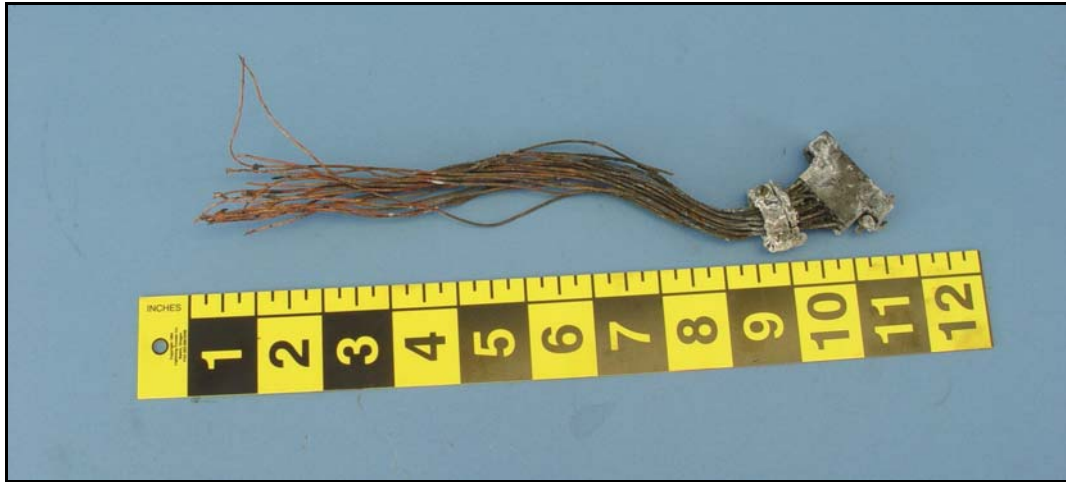
The wire bundle consisted of approximately 12 inches of wire terminating at a female plug connector (Figure 1). Based on the type of the connector on the end of the wire bundle, Cessna representatives indicated that it is most likely from the Navigation/Communication radios and would go into the back of the Nav/Com radio rack. The wire bundle had been exposed to a post crash fire. The wires and connector plug were heavily damaged by fire. The connector had become friable but was still mostly intact. The wires had become brittle. The connector had positions available for 26 conductors, although 23 were in use. The insulation was missing from the wires with the exception of small flecks of charred insulation remaining in an area approximately 2 inches from the end with the female plug connector. All the wires in this bundle appeared to be the same size, 0.046 inch in diameter. The end of the wire bundle opposite the connector exhibited beading and other resolidification after melting. Globules of re-solidified copper were found to have fused multiple

Figure 1. Wire bundle with female plug connector.

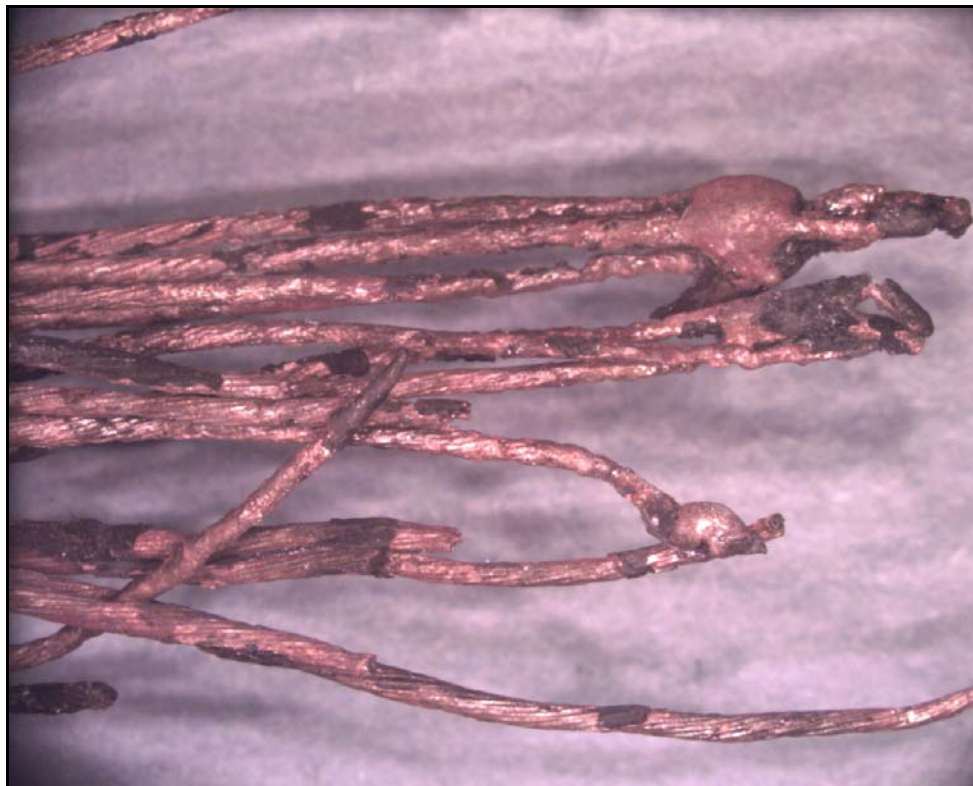
wires together as well as having formed single beads on the ends of some wires (Figure 2). Large portions of these wires also exhibited strand fusing¹.

Figure 2. Beading on end of wire bundle.

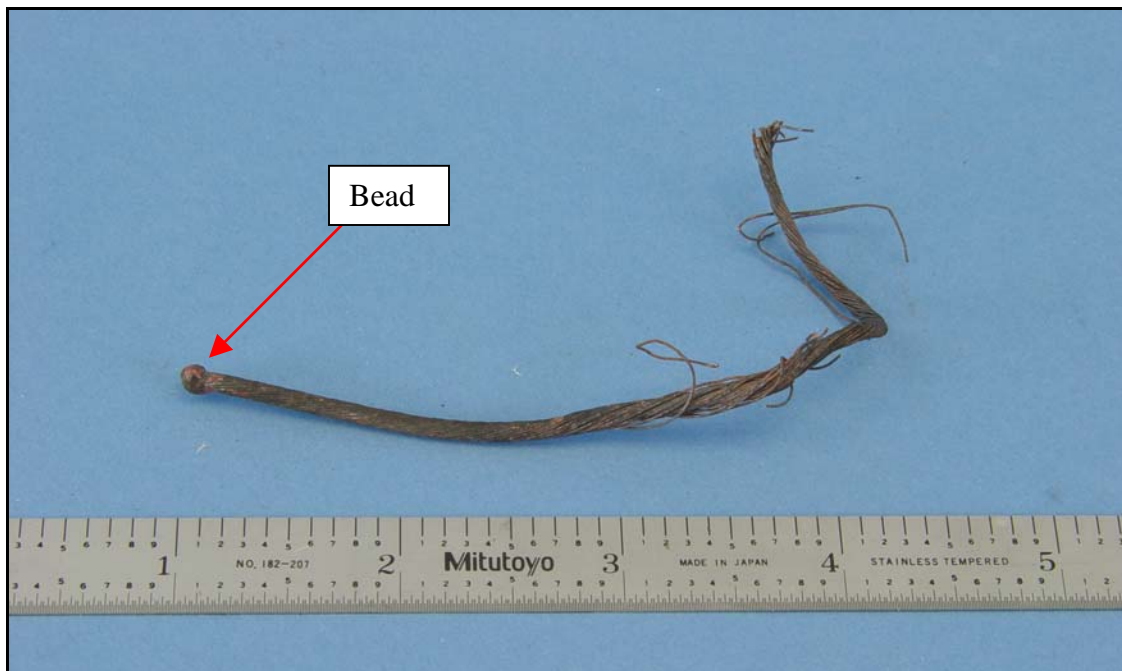
The strands of wire consisted of 3 separate small sections of wire, each approximately 3 to 4 inches long, with no end termination. Two pieces were 0.041 inch in diameter, and the third was 0.090 inch in diameter. The two smaller gauge pieces of wire had small globules of melted metal stuck to them and exhibited strand fusing. The larger gauge piece of wire had a large bead at one of the ends (Figure 3) consistent with arcing and did not exhibit strand fusing. It is not known what components or systems in which these wires were originally installed.

Figure 3. Wire with bead from arcing.

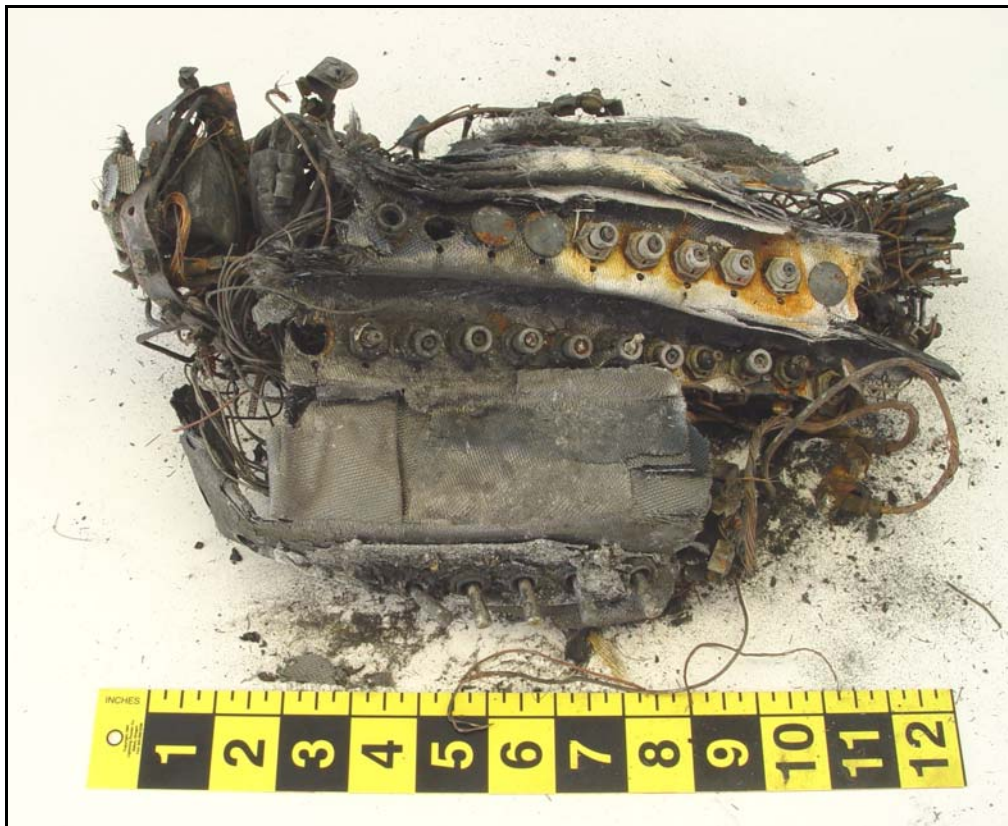
A section of the circuit breaker panel was recovered on scene (Figure 4). The fire and impact forces heavily damaged the circuit breakers present on this section of the panel. The mechanical latches

for the circuit breakers were damaged to the point where it was not possible to make a determination of whether or not they were open or closed at the time of the accident. All the wiring behind this portion of the circuit breaker panel was examined for evidence of electrical damage. No beading, pitting, or other signs of electrical faults were observed.

Figure 4. Portion of circuit breaker panel.

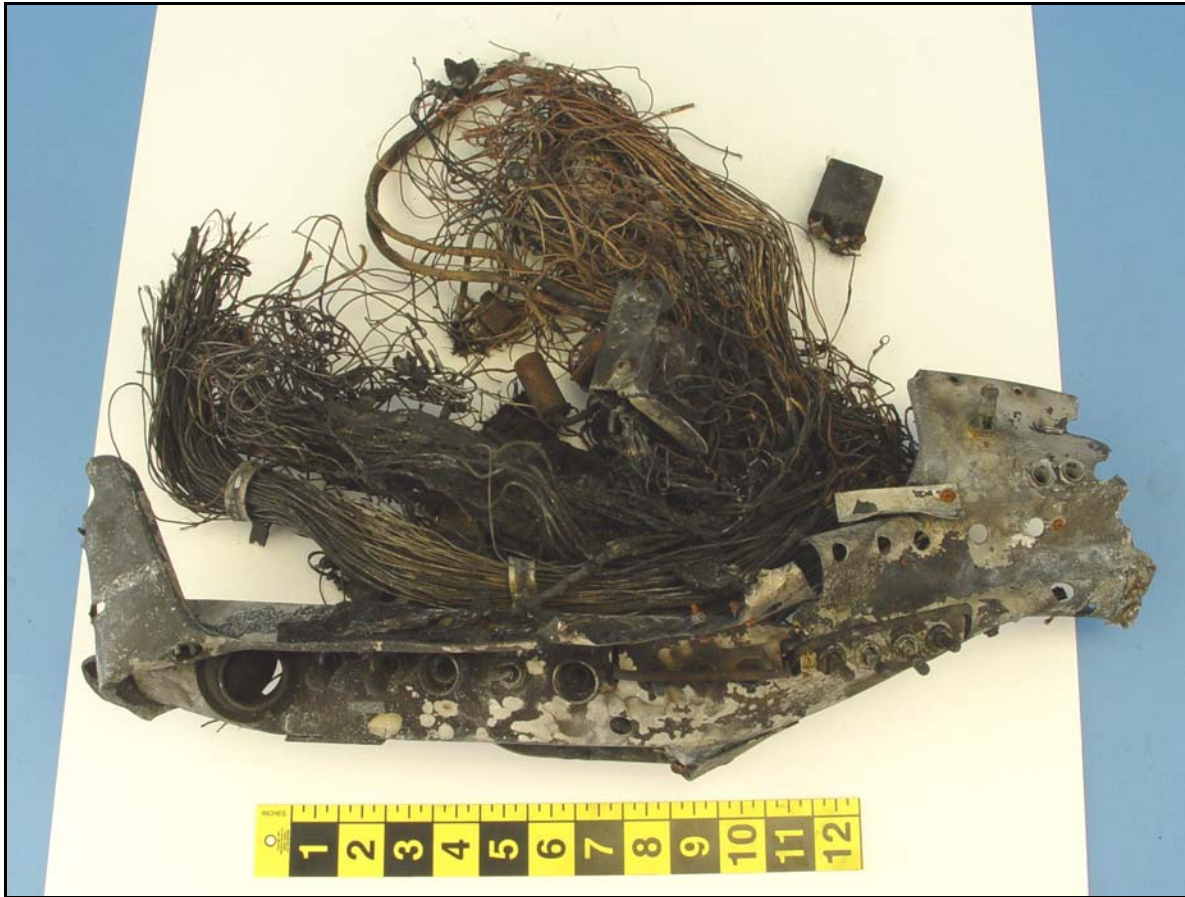
The portion of the instrument panel that was recovered was from the bottom left hand side of the instrument panel (Figure 5). This portion included the ventilation nozzle and the starter and generator switches as well as the main power switches. Due to the impact forces and subsequent fire damage the condition of the switches was such that a reliable determination of their position prior to impact was not possible. The aluminum structure of the switch panel was heavily fire damaged and was missing its painted finish. The wiring that remained connected to the switch panel had lost all of its insulation leaving the wires bare. Plastic that had melted and re solidified was found adhering to the wires in some locations. No beading, pitting, or other sign of electrical failures was observed among these wires.

Figure 5. Lower Left portion of instrument panel.

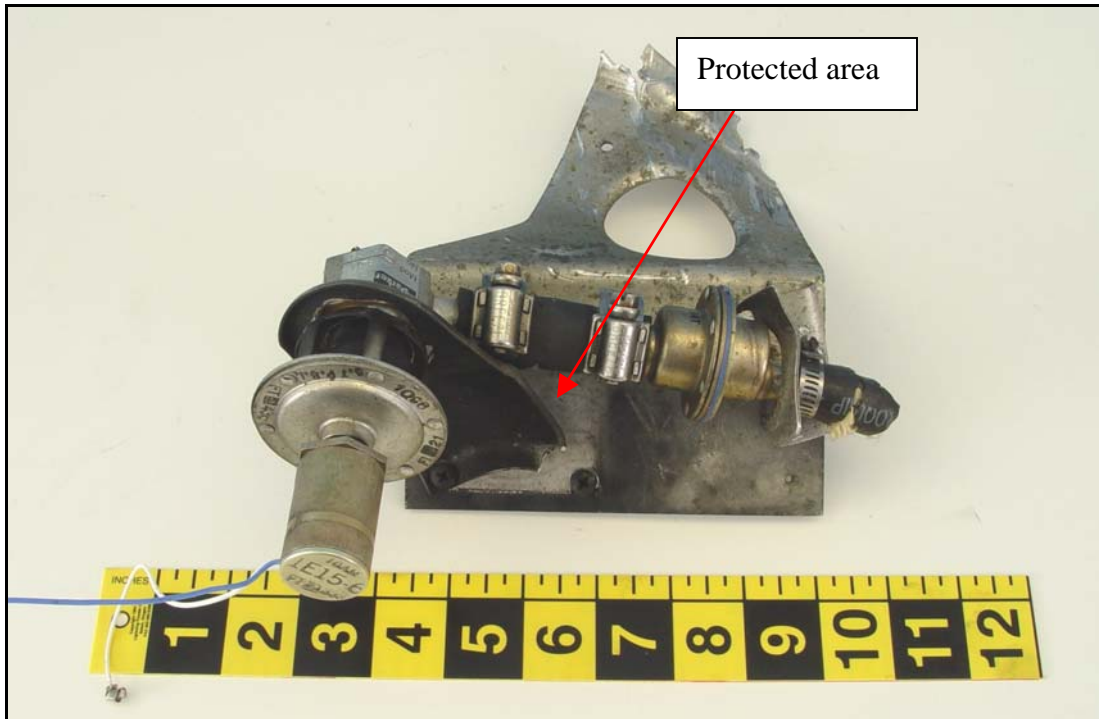
The component shown in Figure 6, identified as part of the DE-ICE system from the right engine nacelle, was found away from the main impact and post crash fire zone. A soot deposit was found on this part surrounding a clean, non-sooted area that was protected prior to fracture and deformation of the part (Figure 6). The soot deposit was heavy, but was limited to a specific area and did not extend over the entire part. Some insulated electrical wires and a rubber hose fitting were located in the vicinity of this soot deposit, but none of these parts showed any signs of thermal degradation or any other effects of exposure to fire. According to Cessna representatives, this soot deposit is consistent with a minor exhaust leak.

Figure 6. Portion of the DE-ICE system.

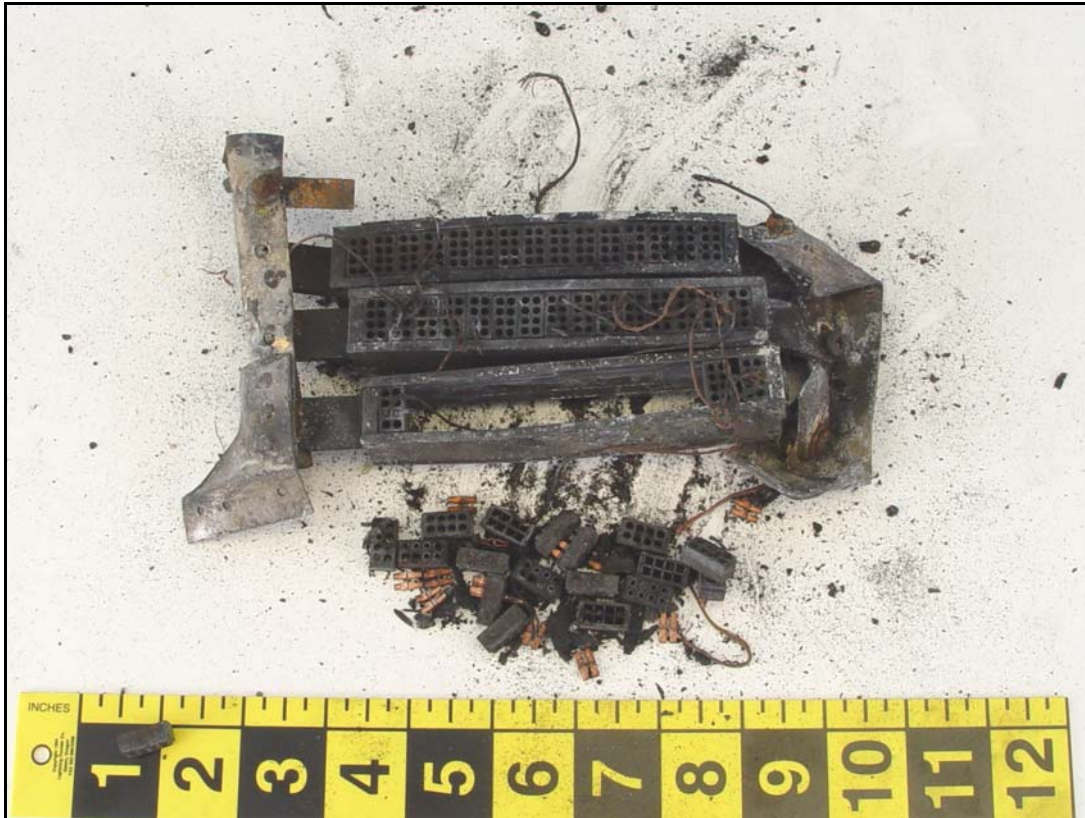
The terminal block was heavily damaged by fire and impact forces (Figure 7). The frame of the terminal block was twisted and bent out of shape. The terminal blocks had become friable from exposure to the fire. The few wires and connector pins remaining attached to the terminal block were examined and no signs of electrical faults were identified.

Figure 7. Terminal block.

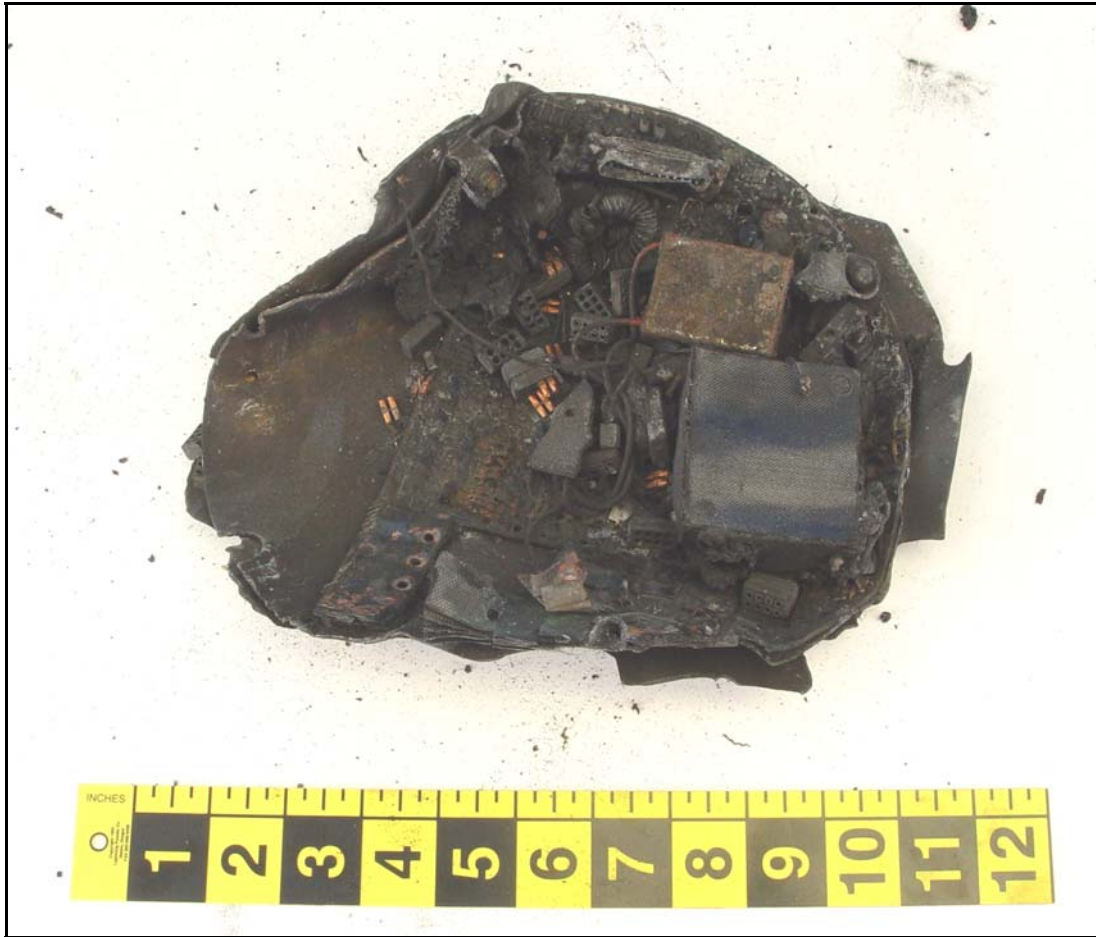
A component belonging to the weather radar antenna assembly was examined (Figure 8). This component was severely damaged by impact forces. Additionally this component had severe thermal damage. Some electronic circuit boards were attached to this component. These circuit boards had become delaminated due to the exposure to fire. No arcing or other signs of electrical faults were observed on this component or the accompanying circuit boards.

Figure 8. Radar system component.
