**NATIONAL TRANSPORTATION SAFETY BOARD**

**Group Chairman's Factual Report - Airworthiness**

Location: Sanford, Florida  
Date: July 10, 2007  
Time: 0835 Eastern Daylight Time (EDT)  
Airplane: Cessna 310R, N501N  
NTSB Number: NYC07MA162

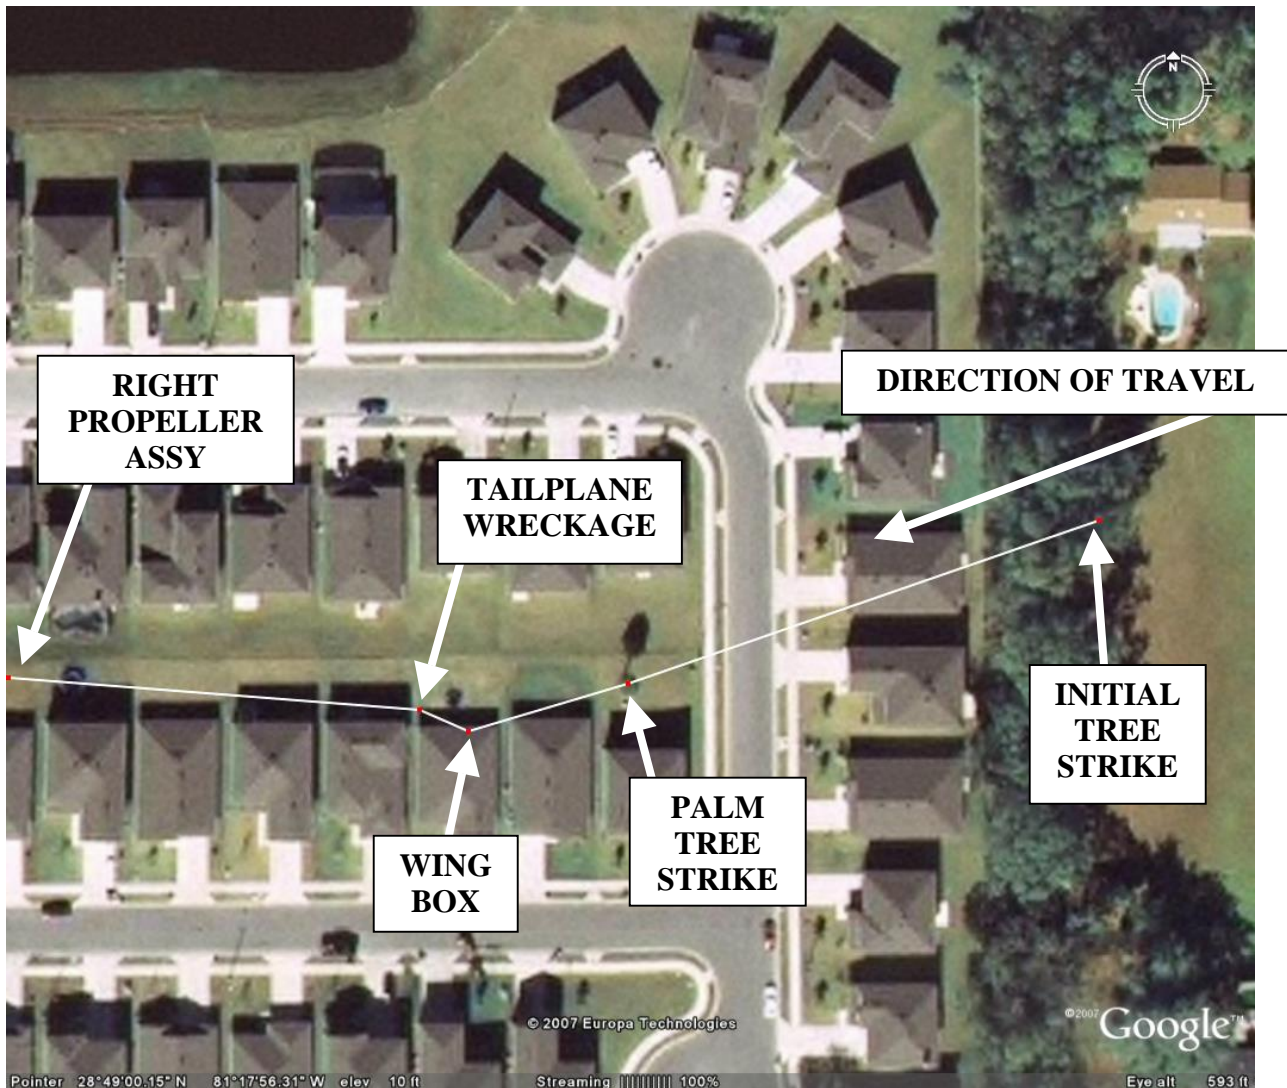
Figure 2 – Airplane Debris Path

The accident site was located approximately 4 nautical miles northwest of SFB. The primary debris path (Fig 2) was approximately 300 feet long, and oriented on a magnetic heading of 255 degrees. The airplane first struck a north-south tree line (Fig 3) at a height of approximately 65 feet above ground level (agl). Multiple tree limb cuts were observed. Debris from the initial tree strikes was scattered along the next 200 feet of the wreckage path. This debris included part of the left aileron, a propeller tip, the right aileron, an outboard section of the right wing, the top left and right engine cowlings, and the rotating beacon lens. The airplane's wings were fragmented, with multiple pieces found along the wreckage path between the initial tree strike and the main wreckage. Numerous document pages from the airplane were also found in this region of the debris field. Approximately a half-dozen document pages from the airplane were found to the east (prior to) of the initial tree strike.

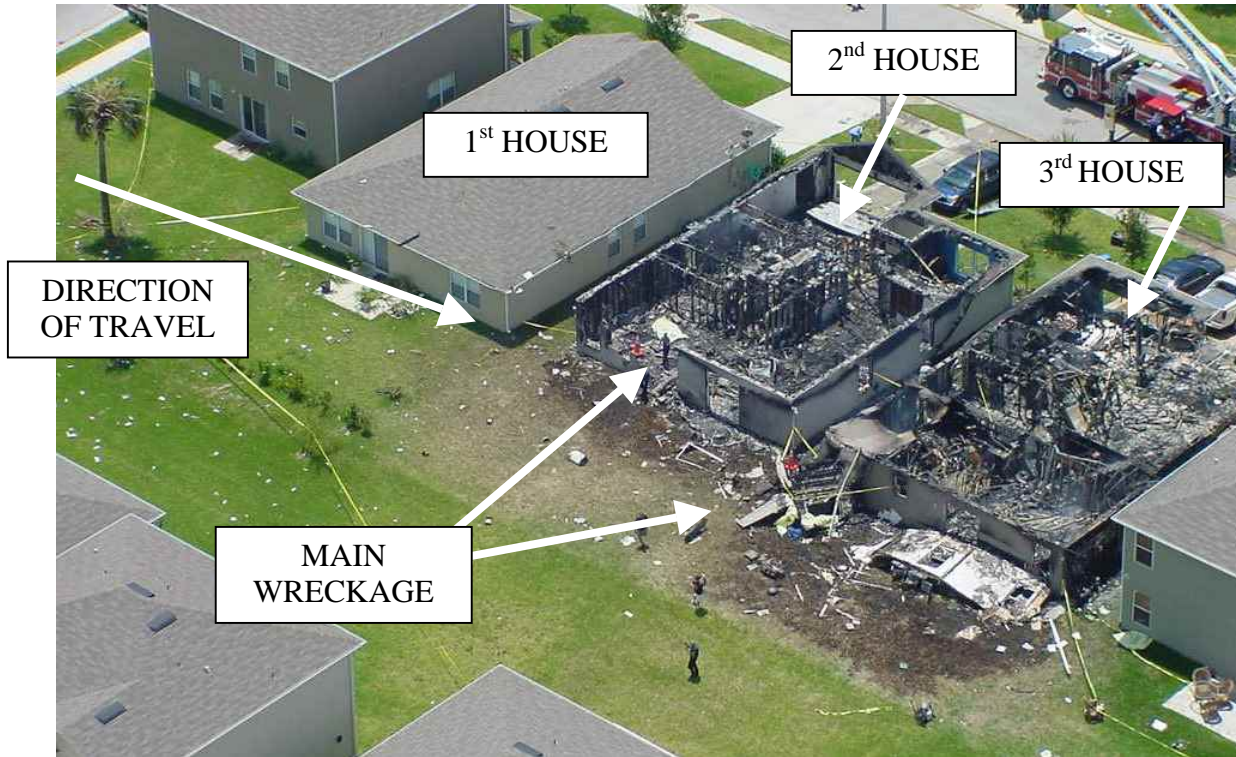
Figure 4 – Overview of Houses and Wreckage

Approximately 270 feet beyond the first tree strikes, the airplane struck a palm tree at a height of approximately 20 feet agl. Beginning approximately 90 feet beyond the palm tree, the airplane contacted the northeast corner of one single story house, resulting in only minor damage. The airplane then directly impacted the single story house next door to the first house, and debris consisting of airplane and house components impacted a third house. (Fig 4)

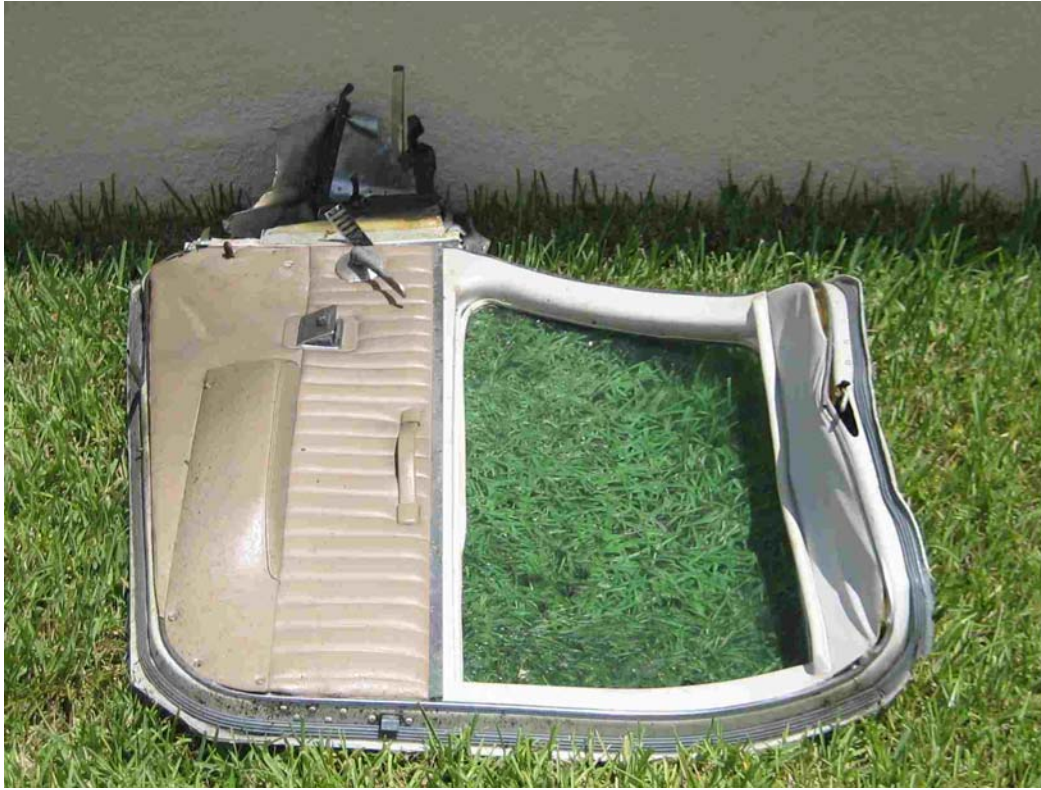
Figure 5 – Separated Cabin Door

The single cabin door, located on the right side of the fuselage, was found unburned (Fig 5) approximately 100 feet north of the main wreckage. Examination of the interior surfaces of this door revealed no thermal damage, but numerous black deposits (Fig 6) of varying sizes were noted. The right propeller assembly was found approximately 400 feet beyond the main wreckage.
