# NATIONAL TRANSPORTATION SAFETY BOARD

MATERIALS LABORATORY FACTUAL REPORT

Report No. 08-049

Place : St. Louis, Missouri  
Date : September 28, 2007  
Vehicle : Boeing MD-83, N454AA  
Operator : American Airlines, Flight 1400  
NTSB No. : DCA07MA310  
Investigator : Harald Reichel, AS-40

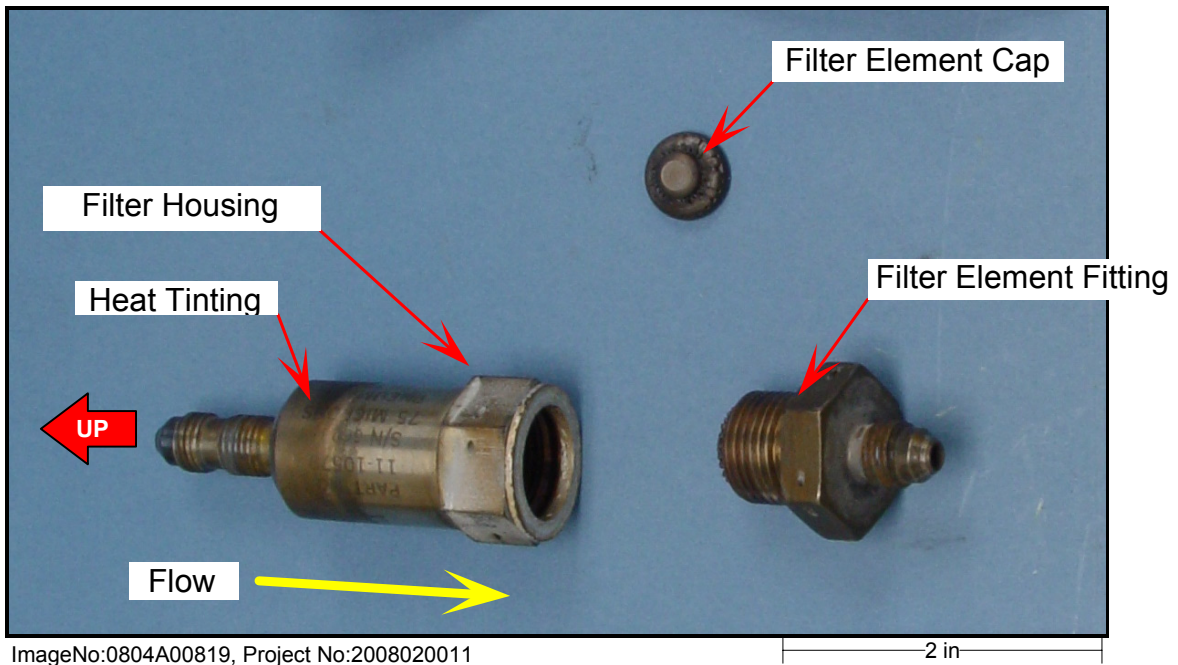
The received pieces of the accident air filter assembly are displayed in figure 1. These consisted of the filter housing, the threaded fitting for the filter element assembly, and the filter element end cap. As shown in figure 2, a portion of the filter cloth was found lodged inside the bore of the housing. The outer surface of the housing was marked with "PTI, Part No. 11-10579, S/N 6628, 75, PN Filter, DAC, 7958540-1, DC-A". The upper end of the filter element end cap was marked "PTI, Lot No. 00??<sup>1</sup> 21-10930".

The exterior of the filter assembly showed darkening of the surface consistent with heat tinting from high temperature exposure. The cadmium plating on the washer between the fitting and the body was bubbled indicating temperatures near the melting point of cadmium, 610 °F.

Figure 1--The as recieved air filter components. Heat tinting is noticable on the upper end of the filter housing.

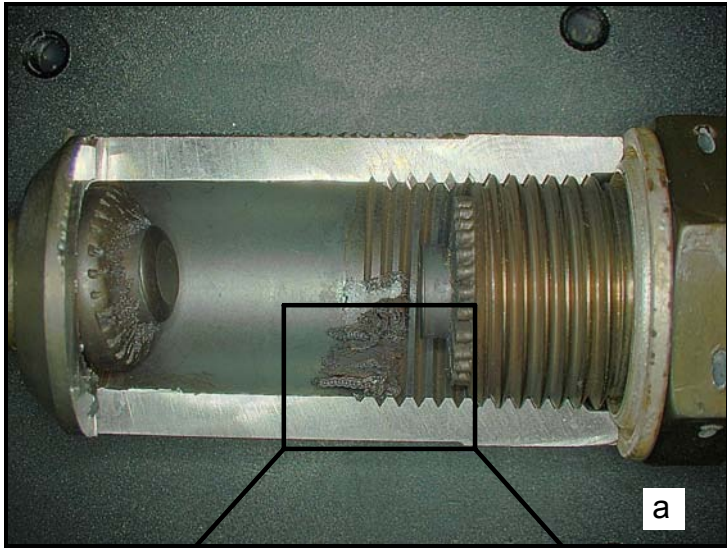
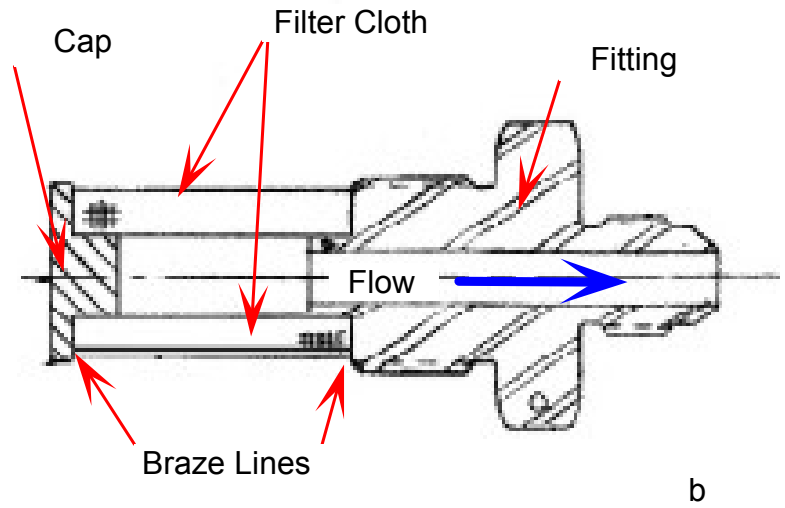
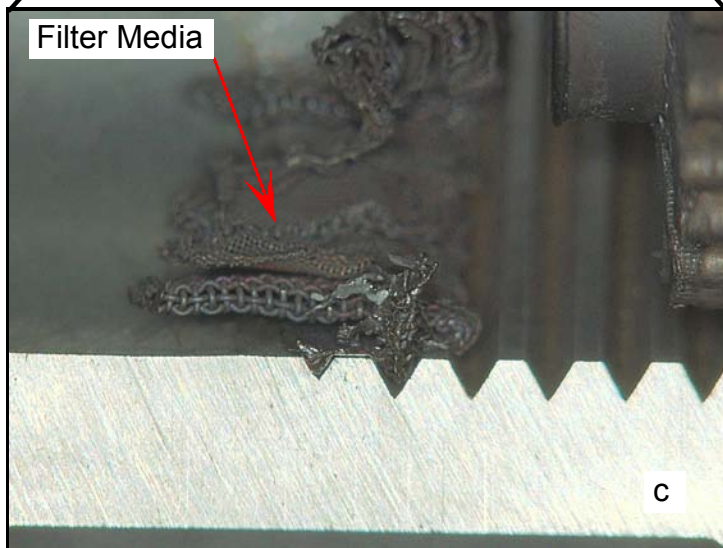
The portion of the filter cloth found inside the housing was folded and tightly compressed and partially imbedded into the internal threads of the housing. Figure 3 (a) and (c) depict the approximate location and condition of the cloth (shown after sectioning of the housing). Figure 3 (d) shows a piece of the removed cloth. The received portion of the filter cloth represented about ¼ to ½ inch of the filter element length. The filter cloth is part of the brazed (inseparable) filter element assembly p/n 21-10930, along with the threaded fitting and filter end cap as illustrated in figure 3 (b).

Figure 3--View of the components installed in the sectioned housing (a) with a closer view of some of the filter material positioned as found in the threads (c). Illustration of the fitting assembly components (b). A closer view of the filter material showing the outline of the housing threads (d).

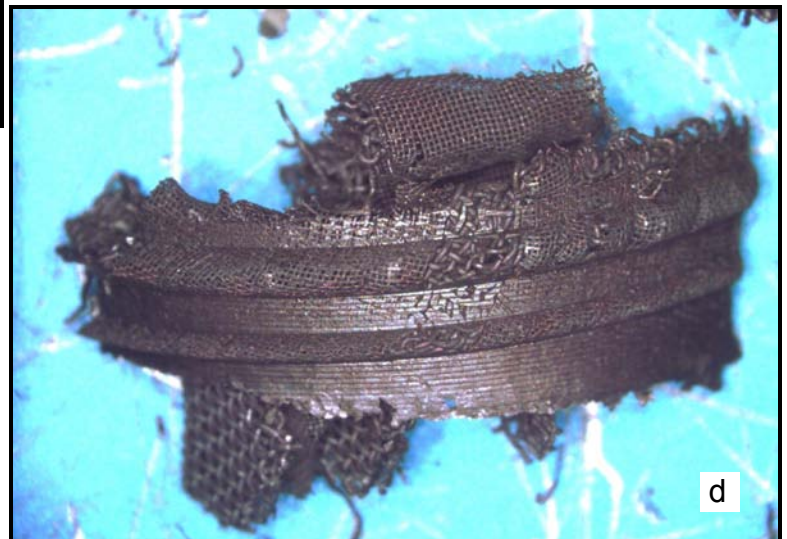
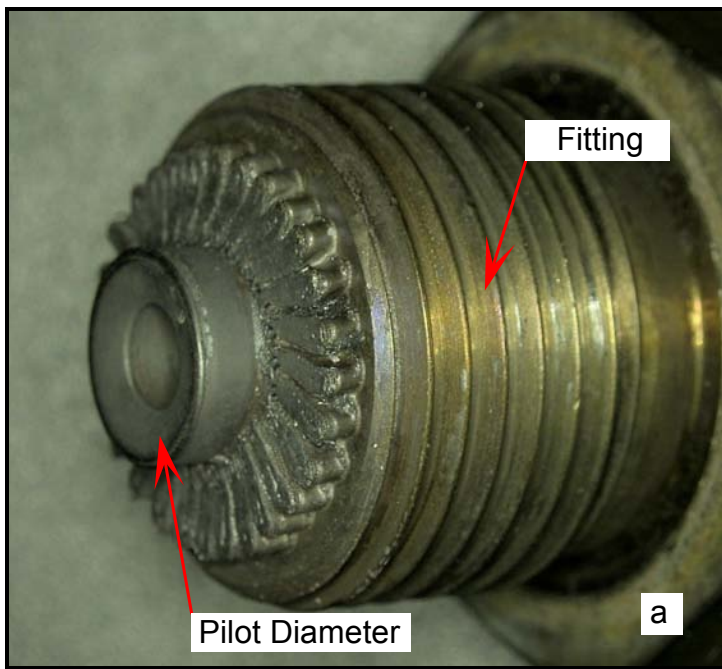
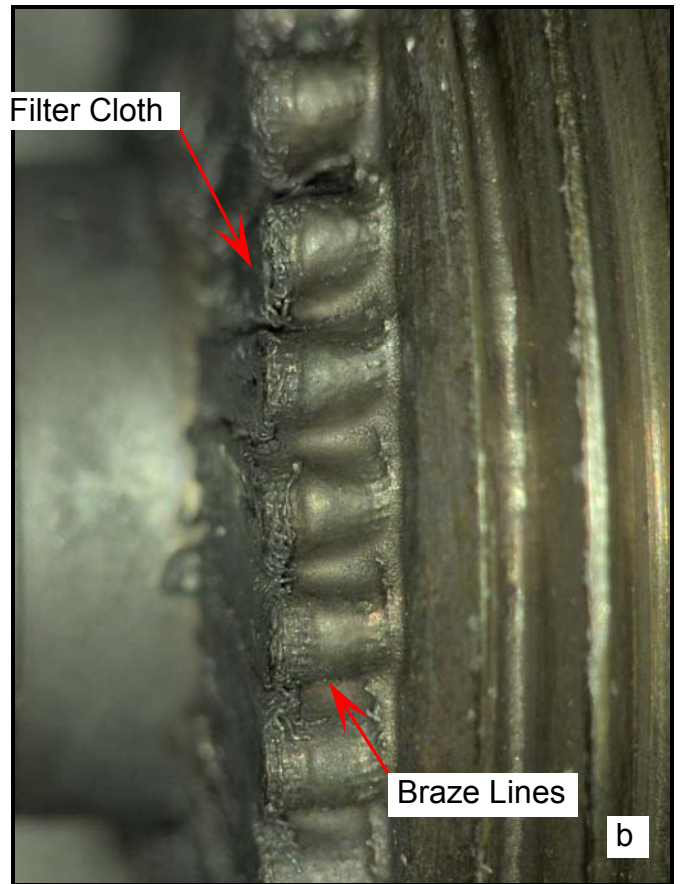
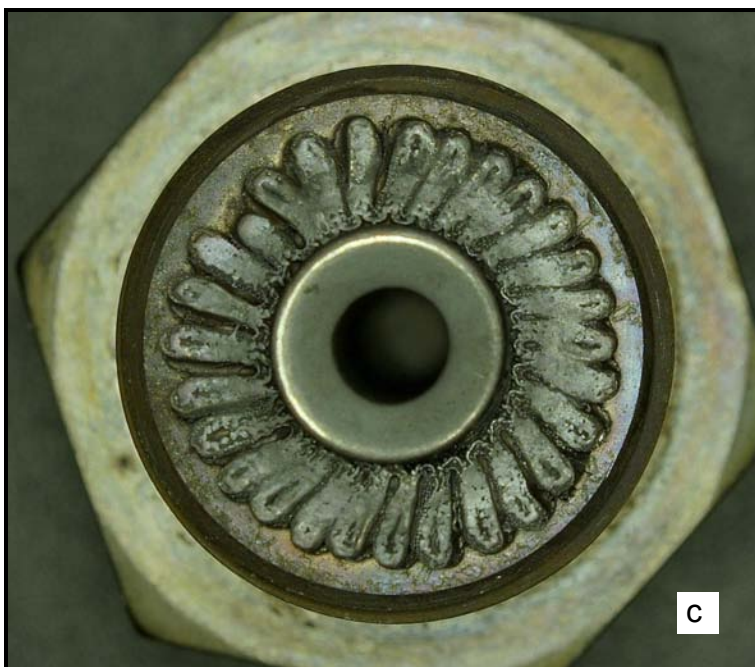
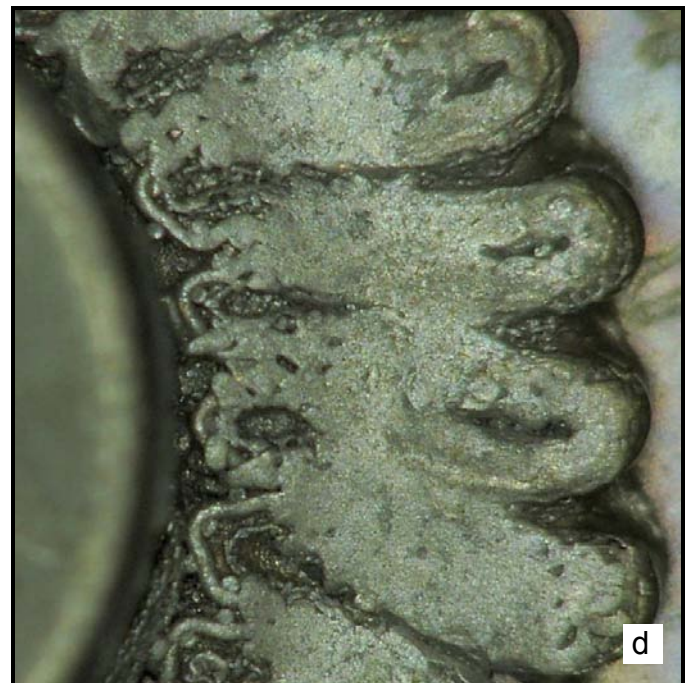
The filter element assembly had major separations through the cloth adjacent to the braze joints at the fitting and the end cap. The braze metal and small portions of the cloth remained attached to the fitting (figure 4) and cap (figure 5). Magnified examinations found severe rubbing damage at the separations, as shown in figure 4 (c) and (d) and figure 5. The damage completely obliterated any fracture features at the separations. Similarly, mechanical damage obliterated separation features on the portion of cloth removed from the housing. The damage was consistent with small amplitude rubbing between opposed side of the separations and not from foreign objects.

Figure 4--The as-received fitting end at the separation of the filter adjacent to the braze joint (a) and (b). Closer views of the face separation showing extensive mechanical damage that obliterated fracture features.

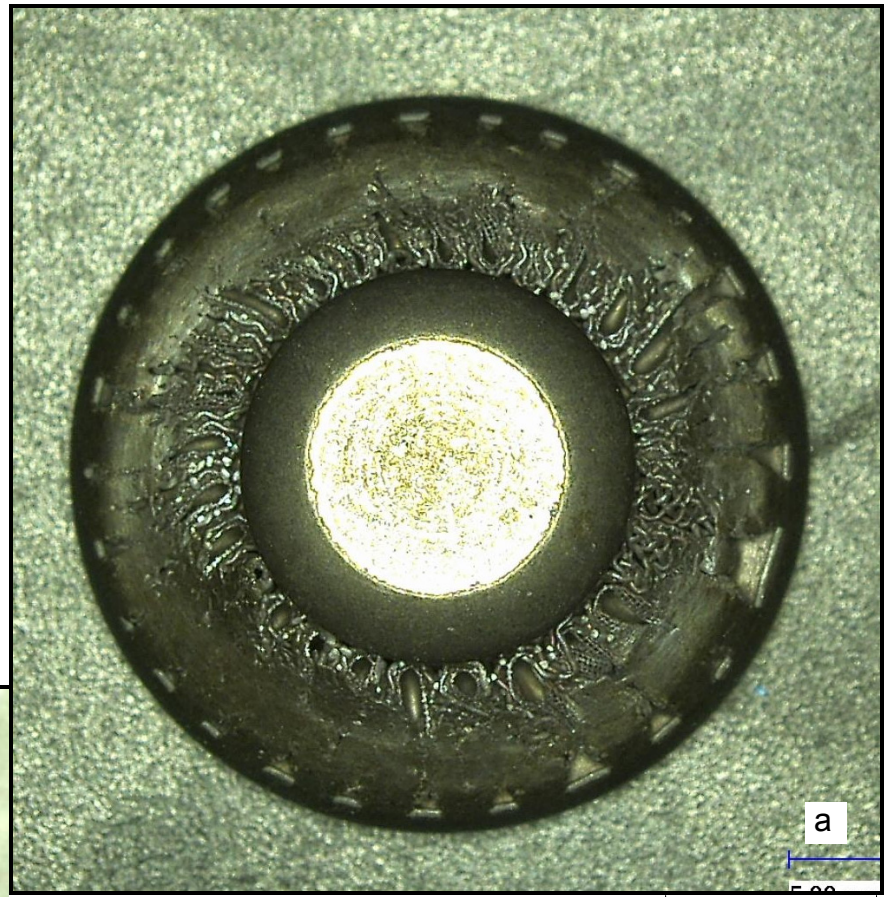
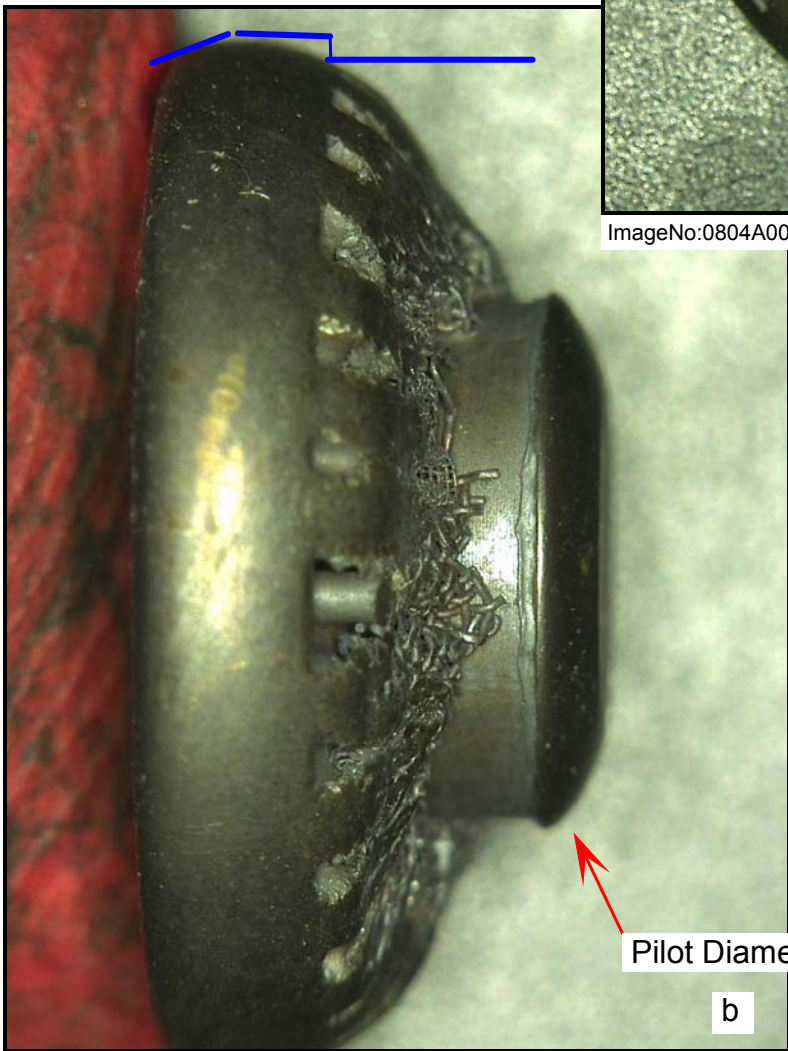
The filter end cap was also mechanically damaged as shown in figure 5. The outer diameter edge of the cap was rubbed and rounded as indicated by blue lines in figure 5 (b). Comparisons to exemplar end caps found the accident cap was reduced in diameter by as much as 0.020 inch. The cap's pilot diameter, see figure 5 (b), was also rubbed and rounded with a similar mating pattern found on the pilot diameter of the fitting, normally at the opposite end of the filter.

Figure 5--The filter element end cap showing the deformation and burnishing damage to the outer diameter and pilot diameter. The approximate original cap profile is indicated by blue lines in (b)

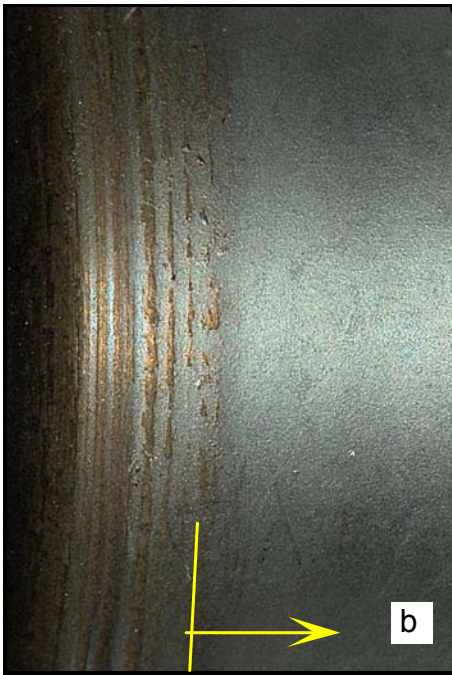
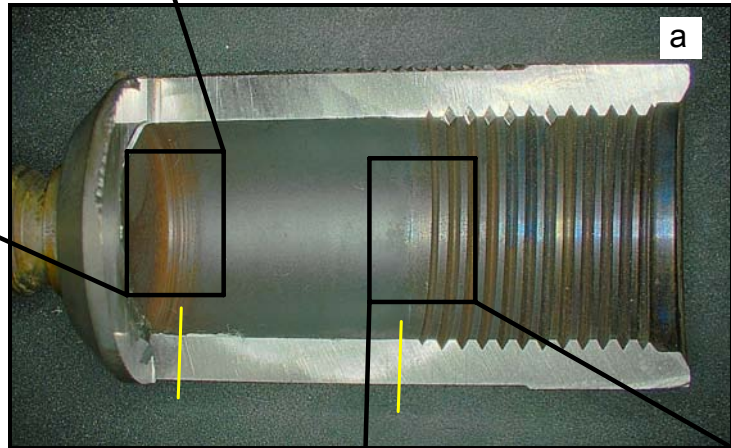
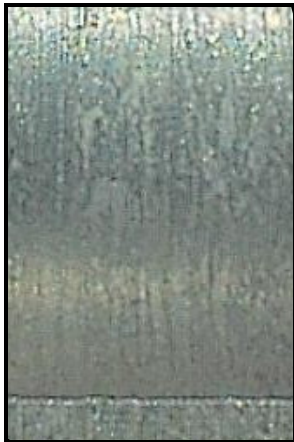
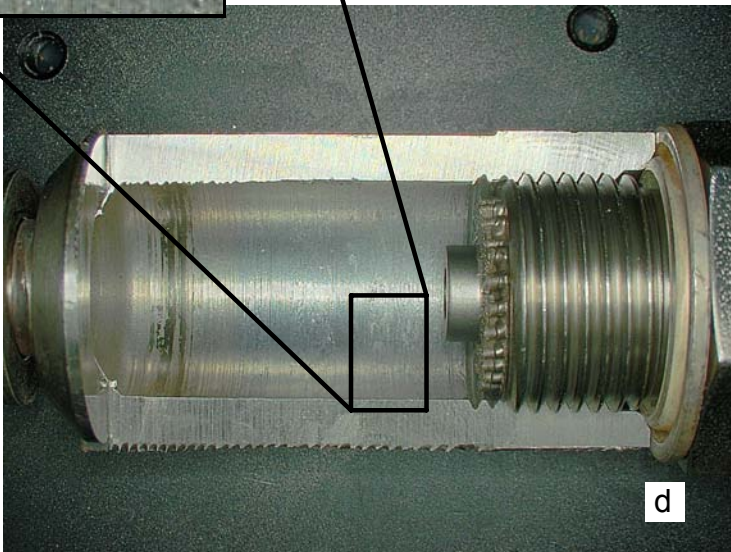
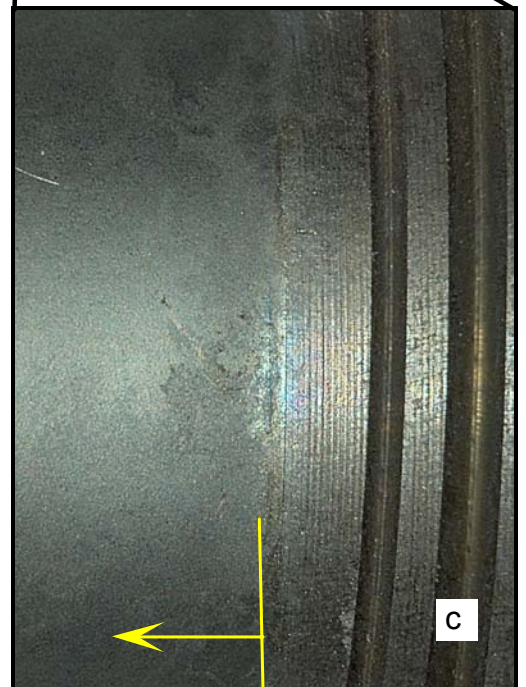
The filter housing was longitudinally sectioned to display the interior surface as shown in figure 6. The central region of the cylindrical interior surface (between yellow lines in (a)) was burnished and polished smooth, obliterating the original turned surface finish. The original machined finish only remained in small bands at the upper (b) and lower (c) end of the section. The interior of an exemplar housing is shown in figure 6 (d) with an enlargement of the surface for comparison.

The damage to the interior of the housing, the end cap and the filter cloth was consistent with vibratory motion of the filter cloth and end cap within the housing. Contact between the end cap and housing mutually burnished the surfaces. The extent of polishing of the housing indicated that the end cap progressed downward in the housing, eventually contacting the fitting end.

Figure 6--The sectioned housing showing burnishing features between yellow lines on the interior (a). The upper and lower extents are shown in (b) and (c). The interior of an exemplar is shown in (d) for comparison.

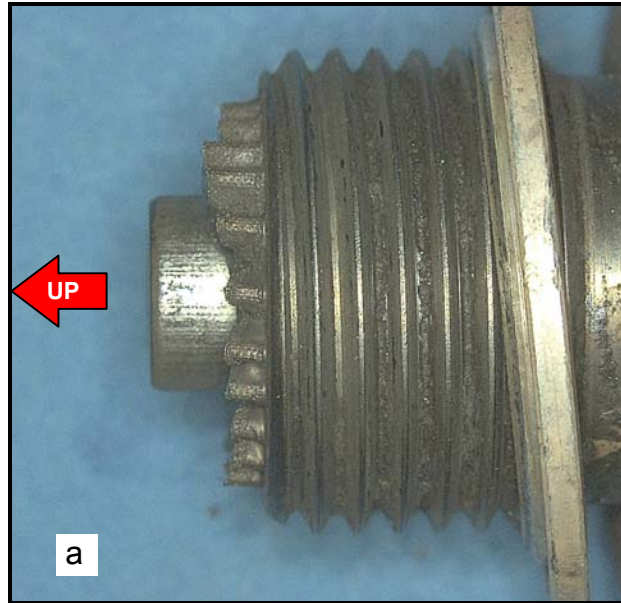
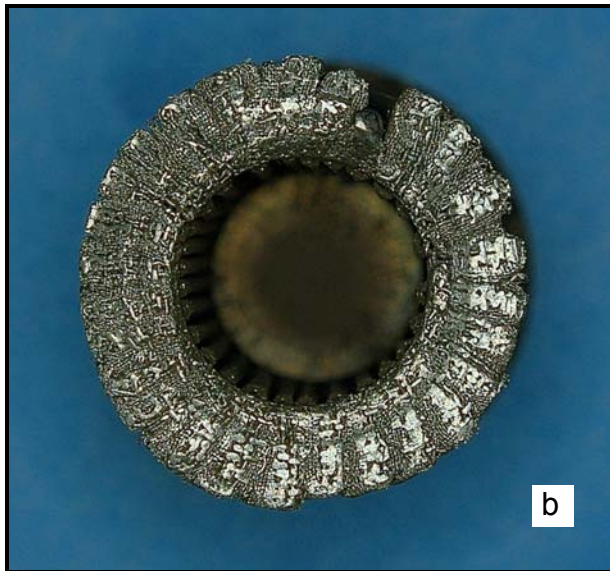
Optical examinations of the separated filter revealed that the longitudinal wires of the cloth screens were fractured near the edge of the braze joint. Close examinations found that the wire fracture surfaces and surrounding areas were rubbed and mechanically damaged to the point that no original fractures remained, see figures 8 (b) and (c).

Figure 8--The separated filter element (a) with extensive mechanical damage of the faces (b) and (c).

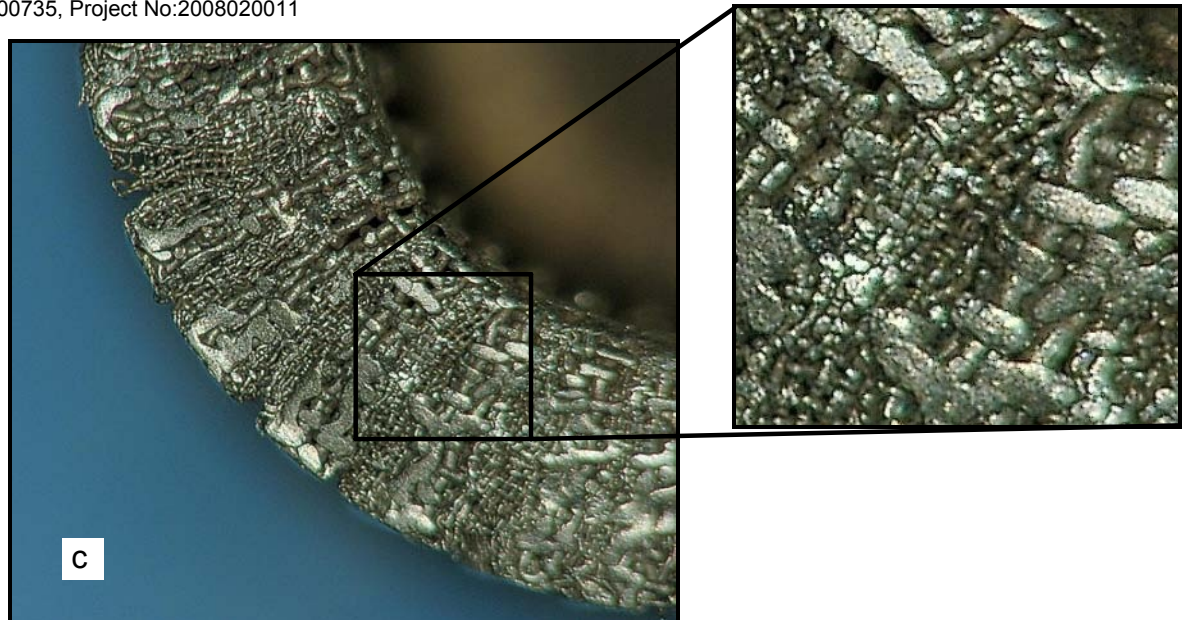
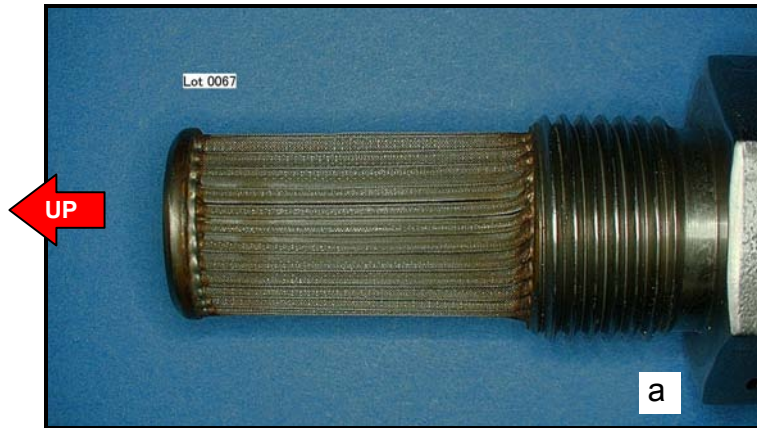
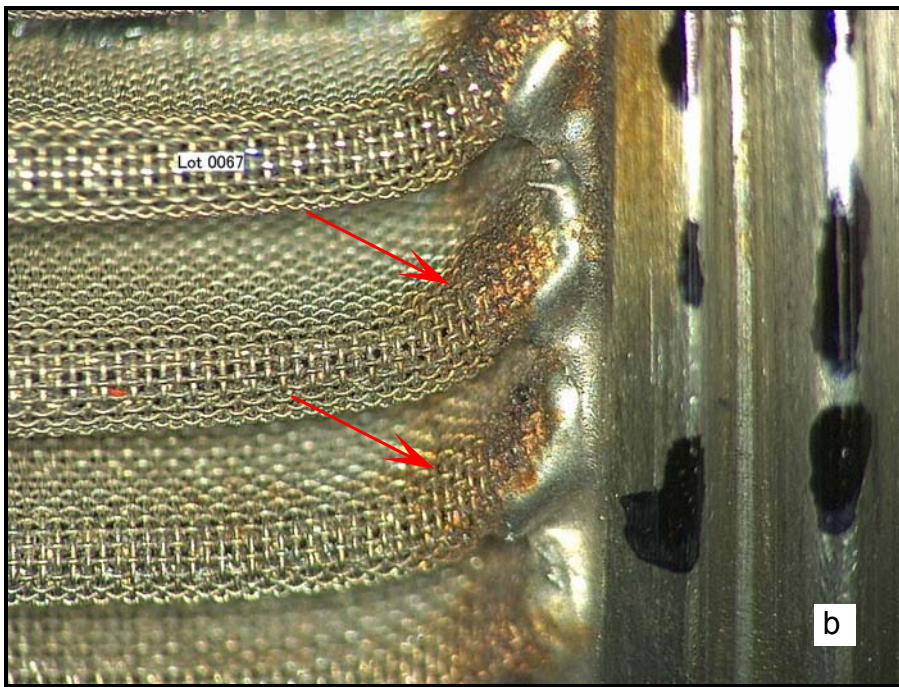
wires were in general only visible at magnifications of 30X and above. Typical areas of the cracked filters are displayed in figures 9, 10 and 11. Filters from lots 0067 and 125 had transverse cracks near the lower braze, as shown in figures 9 and 10. While the filter from lot 012 showed transverse cracks near the upper and lower braze lines and longitudinal cracks along the pleats at the upper braze, as shown in figure 11.

The end cap of the filter from lot 0067 had polishing of the outer diameter. The end caps of the other two filters displayed typical machining marks with no polishing. No housings were received to inspect for comparable burnishing rings.

Figure 9--Exemplar from lot 0067 (a) with arrows denoting locations of cracked fine screen (b). Burnishing of the cap diameter shown in (c) and enlargement.

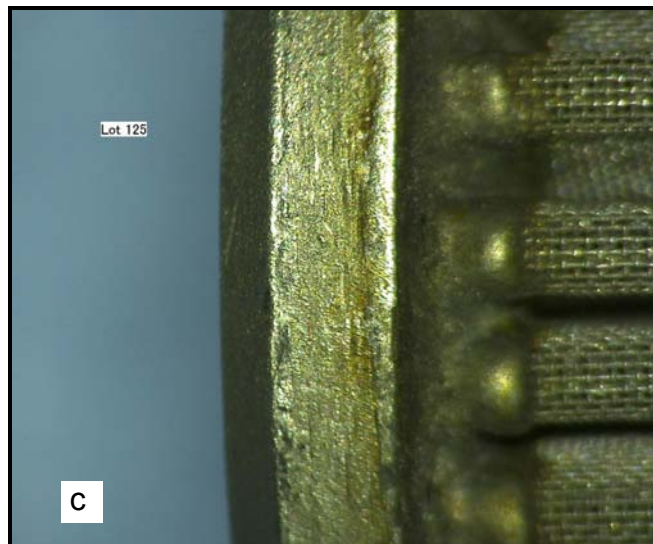
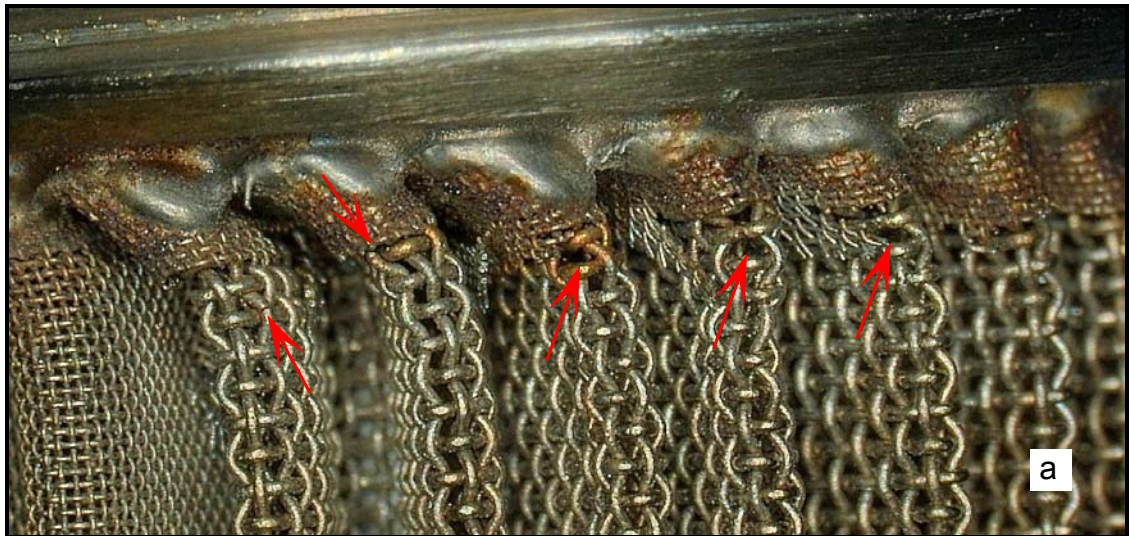
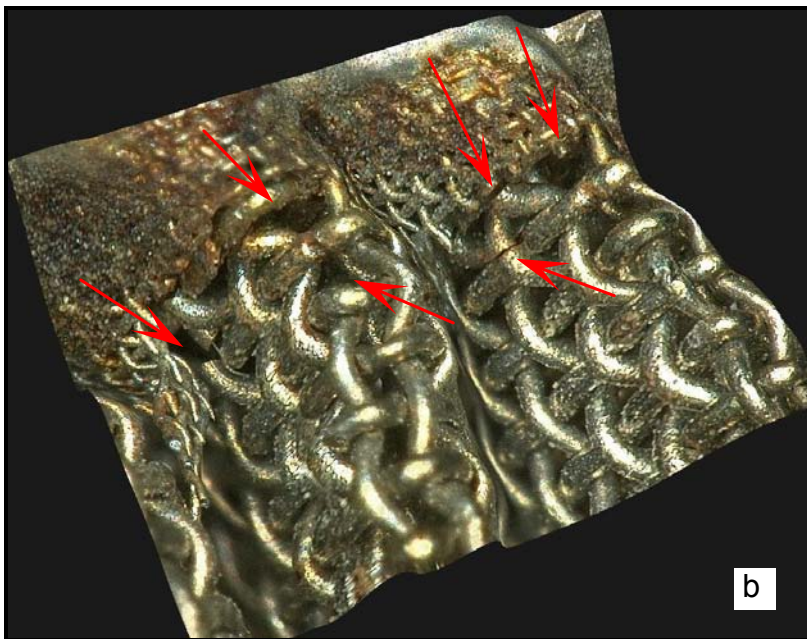
The fine outer screen was partially removed from the filters from lot 012 and 0067 in the area of the cracks. No cracks were found in the underlying coarse screen wires of the lot 012 filter but multiple cracked were visible in the longitudinal wires of the coarse screen of 0067, as shown in figure 12.

Figure 12--Views of typical fractured coarse screen wires (arrows) in the filter from lot 0067.

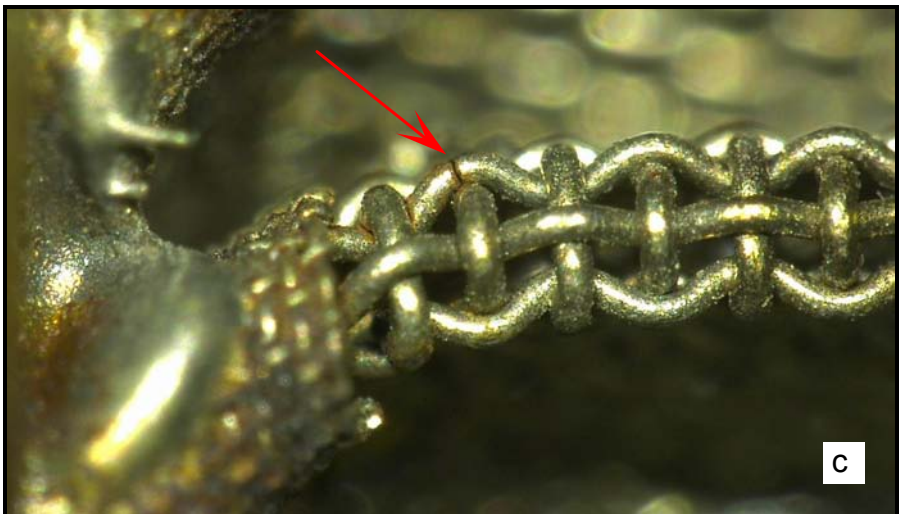
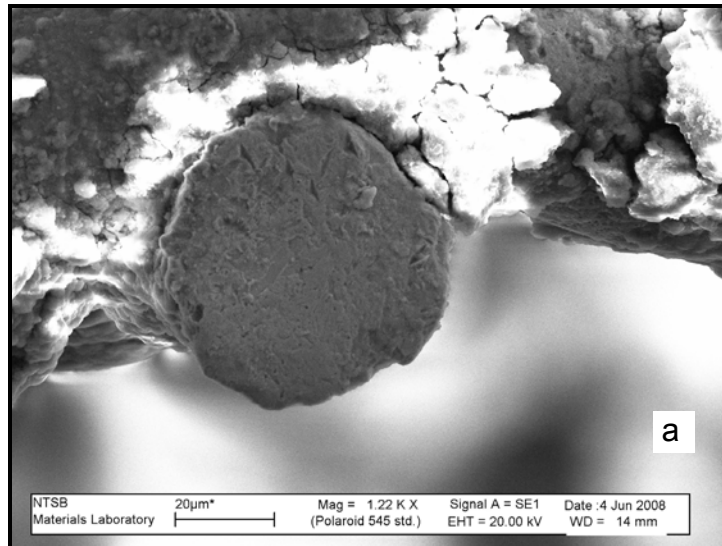
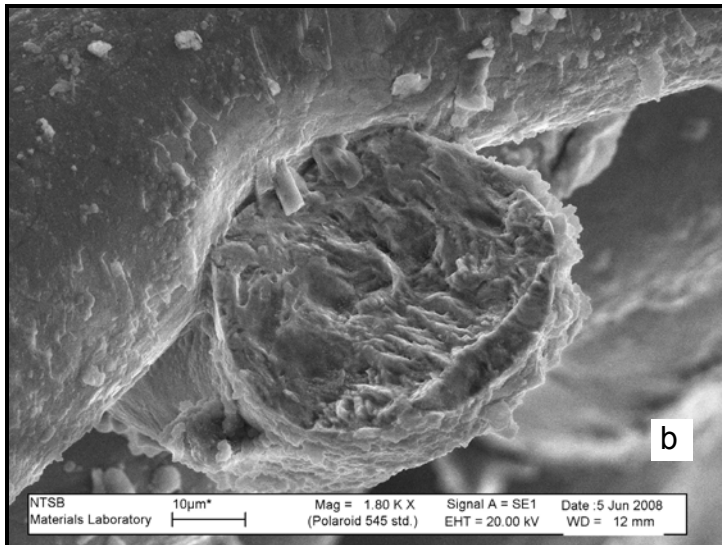
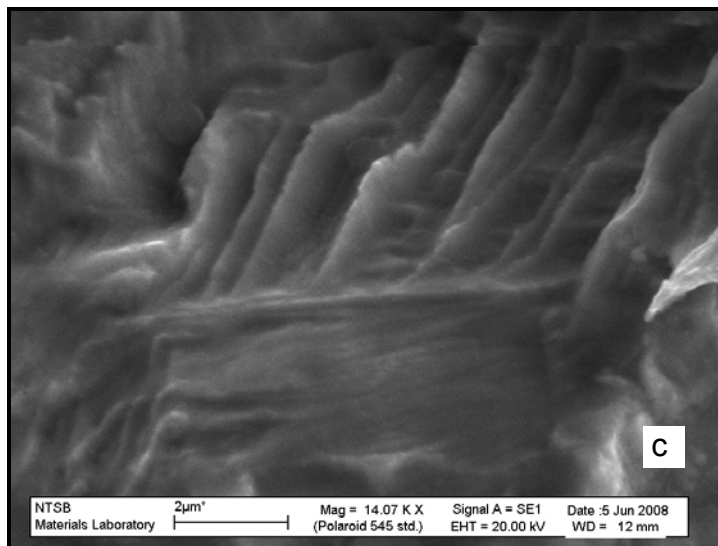
SEM examinations of the fractured fine wires revealed oxidation and mechanical damage to the majority of the wire fracture faces that obliterated most of the separation features. The wire fractures appeared brittle in nature in that there was no apparent yielding or necking adjacent to the breaks. A typical damaged fracture is displayed in figure 13 (a). A few wire fractures were undamaged. These fracture contained micro features indicative of fatigue propagation with initiation at the contact point of the crossing wires. A typical undamaged fracture is displayed in figure 13 (b) with the initiation area and direction of propagation denoted. Intact wires that were fractured during removal of the fine screen displayed significant necking and a dimpled fractured face.

Figure 13-- SEM views of fractured wires from the fine screen of lot 012. Damage wire in (a). Fatigue fractured wire in (b) with a high magnification view of fatigue features in (c).
