NATIONAL TRANSPORTATION SAFETY BOARD

Systems Group Chairman's Factual Report

DCA-07-MA-310

Operator: American Airlines
Location: Lambert – St. Louis International Airport, St. Louis, MO
Date: September 28, 2007
Time: 1:16 PM Central Daylight Time
Airplane: McDonnell Douglas DC-9-82 (MD-82), N454AA

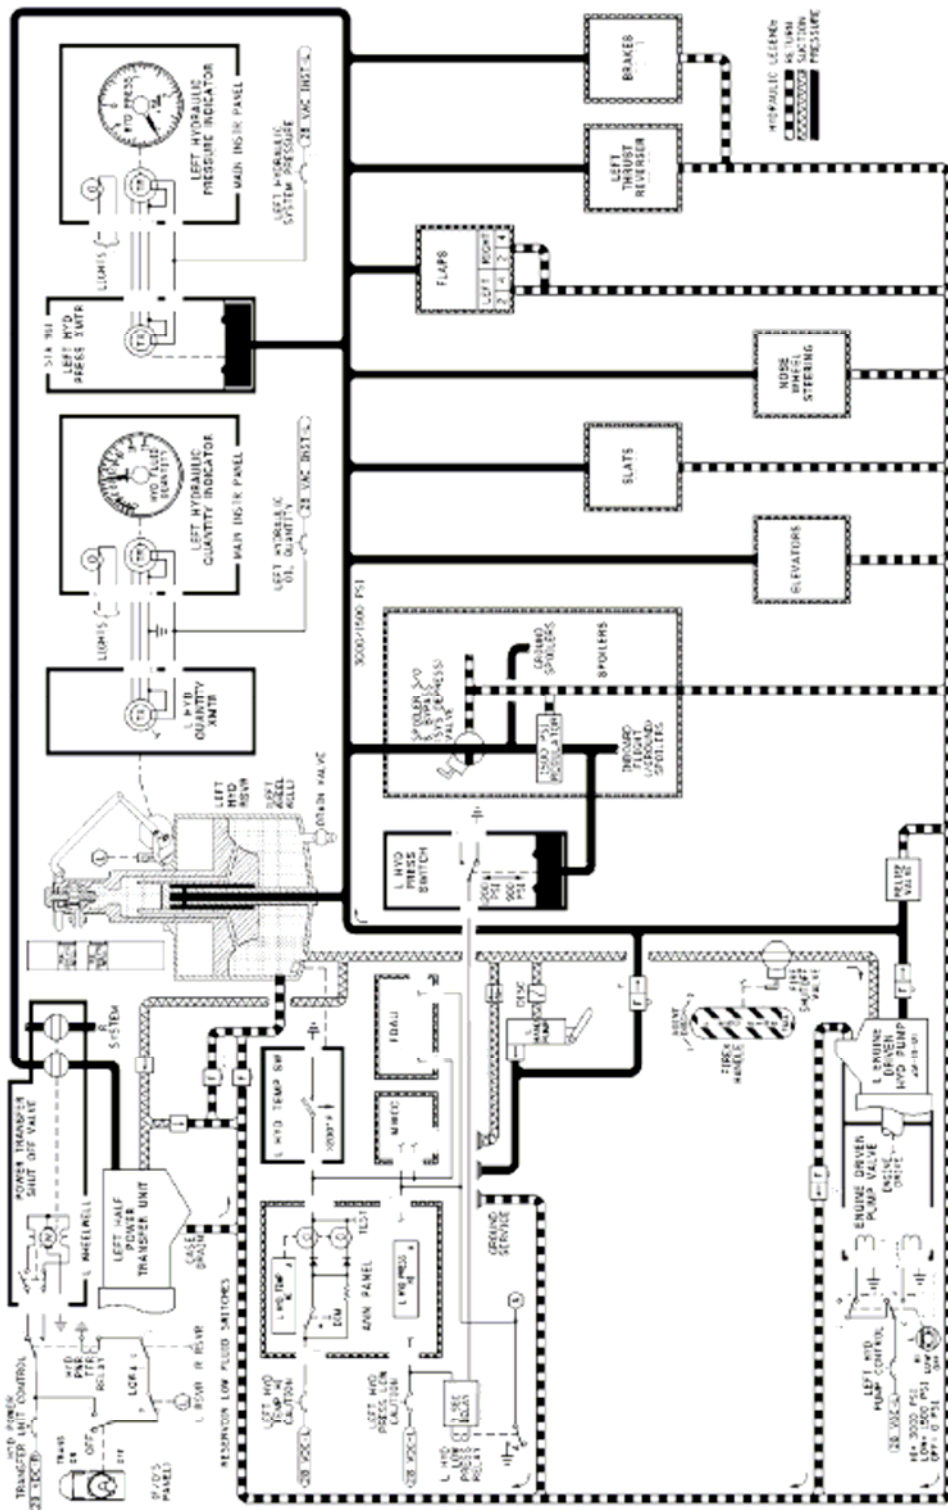
Figure 1 - Left Hydraulic System - Schematic

The hydraulic power system consists of two main systems, an auxiliary system, and an indicating system. The hydraulic main and auxiliary systems provide primary and backup power for operating hydraulically actuated systems and subsystems on the airplane. Main hydraulic power is provided by two, separate, closed circuit hydraulic systems identified as the left and right systems. One engine driven hydraulic pump, on each engine, supplies power to the corresponding system. The hydraulic systems are filled with hydraulic fluid and are normally pressurized by the engine driven pumps to approximately 3000 psi. Hydraulic power is required for the operation of the elevator boost, rudder, flaps, slats, flight spoilers, ground spoilers, ventral stairway, engine thrust reversers, landing gear, brake and nosewheel steering systems. Schematic views of the left and right hydraulic systems are shown in figures 1 and 2.
