NATIONAL TRANSPORTATION SAFETY BOARD

MATERIALS LABORATORY FACTUAL REPORT

Report No. 08-098

Place : St. Louis, Missouri
Date : September 28, 2008
Vehicle : Boeing MD-83, N454AA
Operator : American Airlines, Flight 1400
NTSB No. : DCA07MA310
Investigator : Harald Reichel (AS-40)

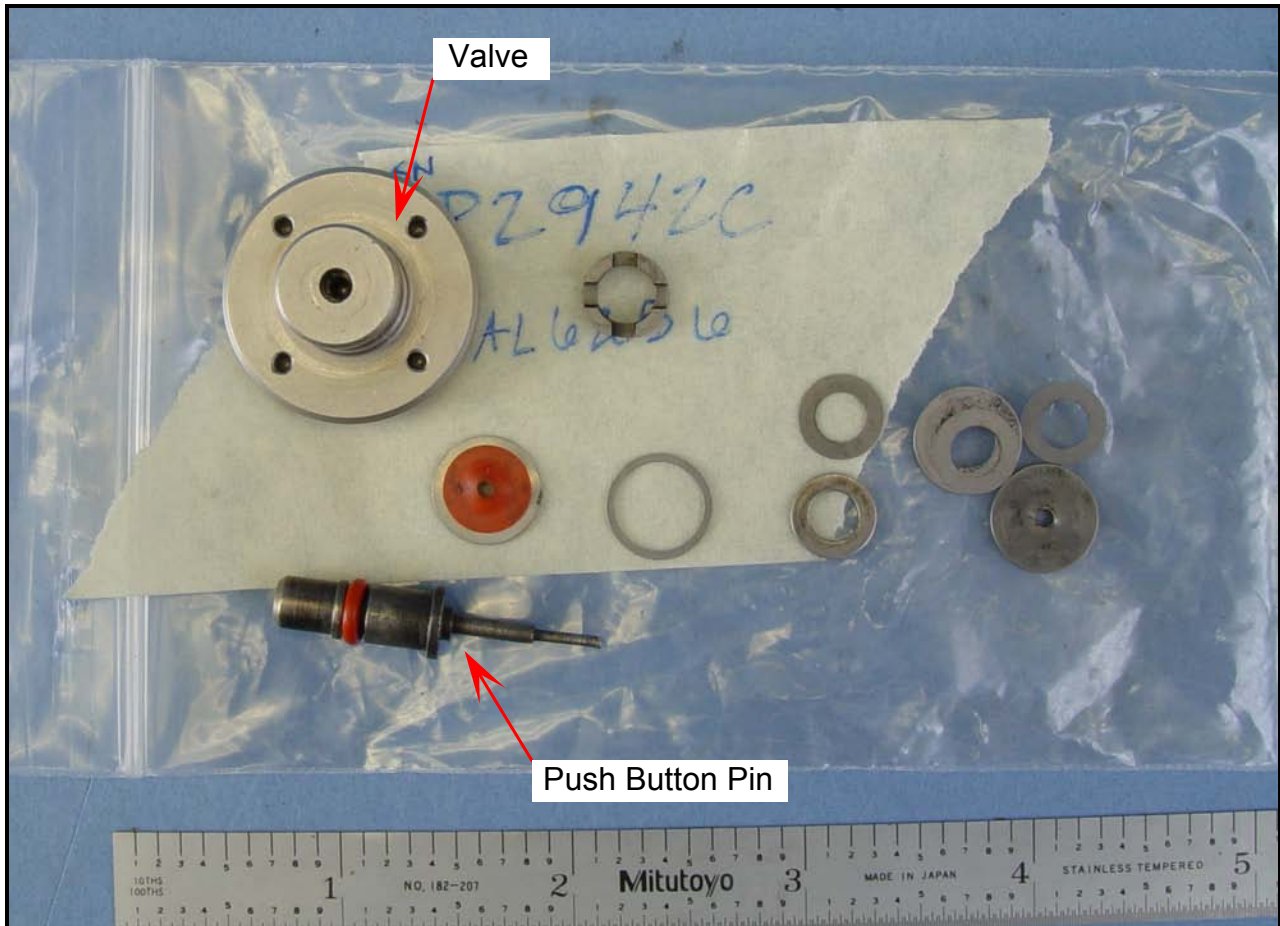
The air interrupt solenoid valve, s/n P2942C, was partially disassembled and is shown along with the push button pin in figure 1. The aborted takeoff solenoid valve, s/n P3052C, was assembled, did not have any ancillary parts, and is shown in figure 4.

Figure 1--An overall view of the as-recieved components from the air interrupt solenoid valve, s/n P2942C. The bent push button pin is noted.

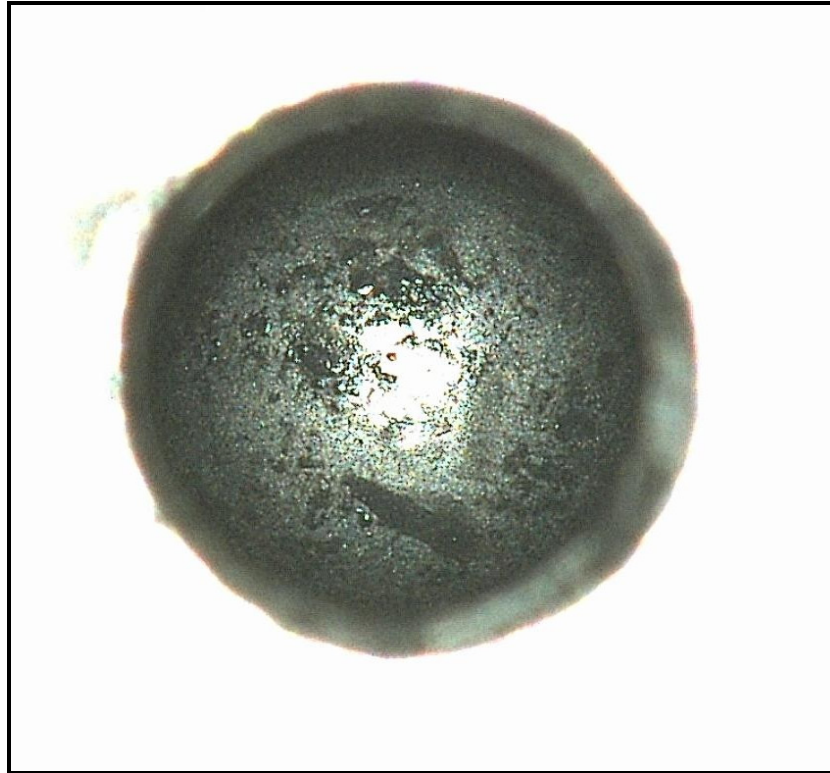
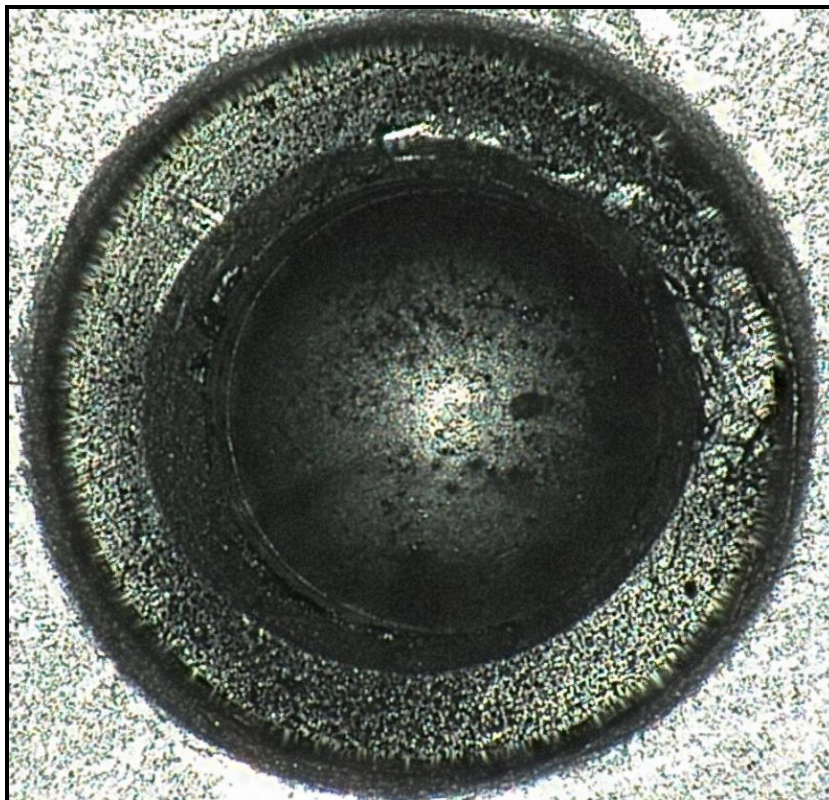
Visual examinations of the valve balls from both solenoids revealed an oily sheen on both balls along with dark particulate material, as shown in figures 2 and 5. When inverted, the balls from both valves would momentarily stick to the valve seats before moving.

Both valves were forwarded to Trace Laboratories Inc. for extraction and FTIR² analysis of the oily material noted on the valve balls. The laboratory report is contained as attachment 1 to this report. The report concludes that the analyzed material was consistent with several aircraft oils.

Figure 2--Views of opposite sides of the valve ball showing the black particulate.

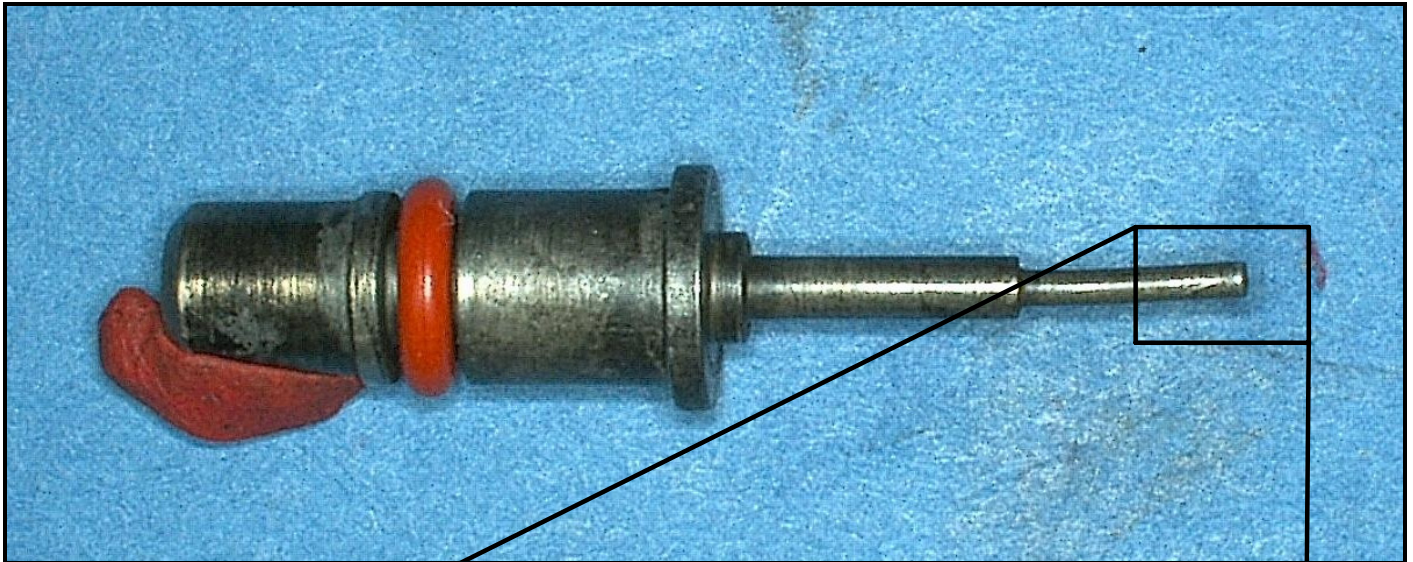
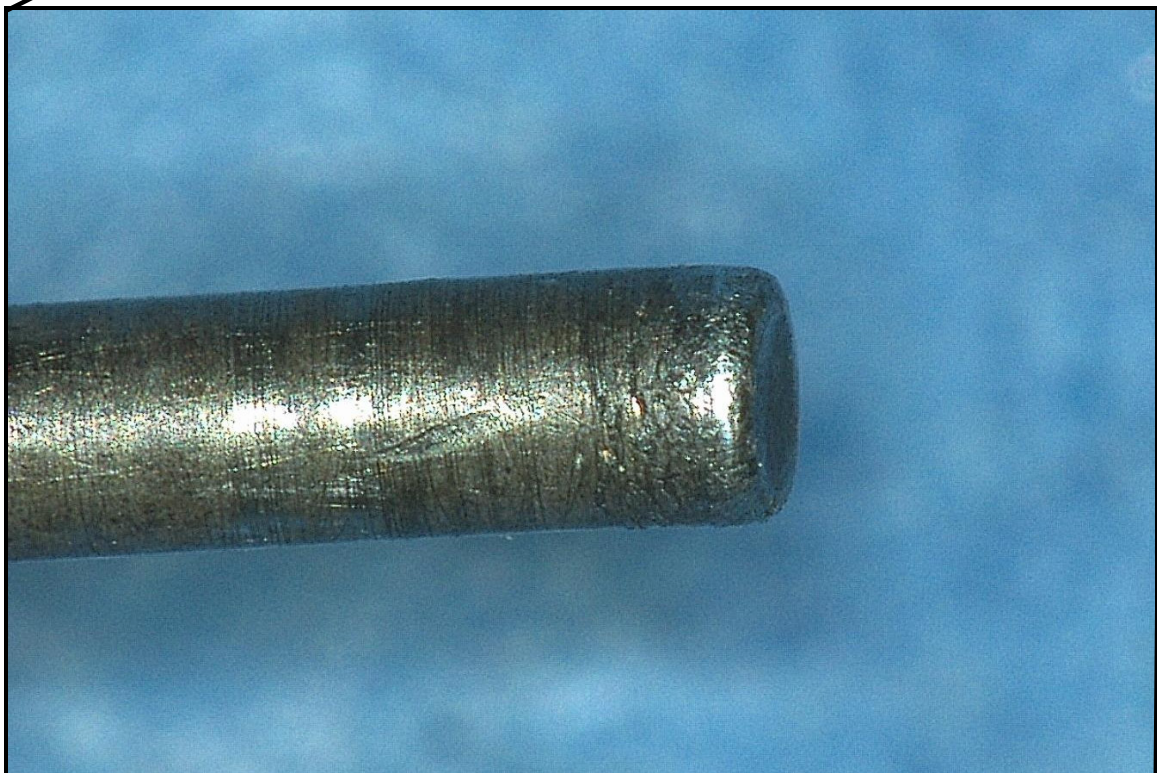
The thin portion of the push button pin on the air interrupt valve was bent as shown in figure 3. In addition, the end of the pin was deformed and spherically dented. The shape and size of the dent was similar to the shape and size of the solenoid valve ball.

Figure 3--The bent push button pin with an enlargement showing the deformed and dented end.

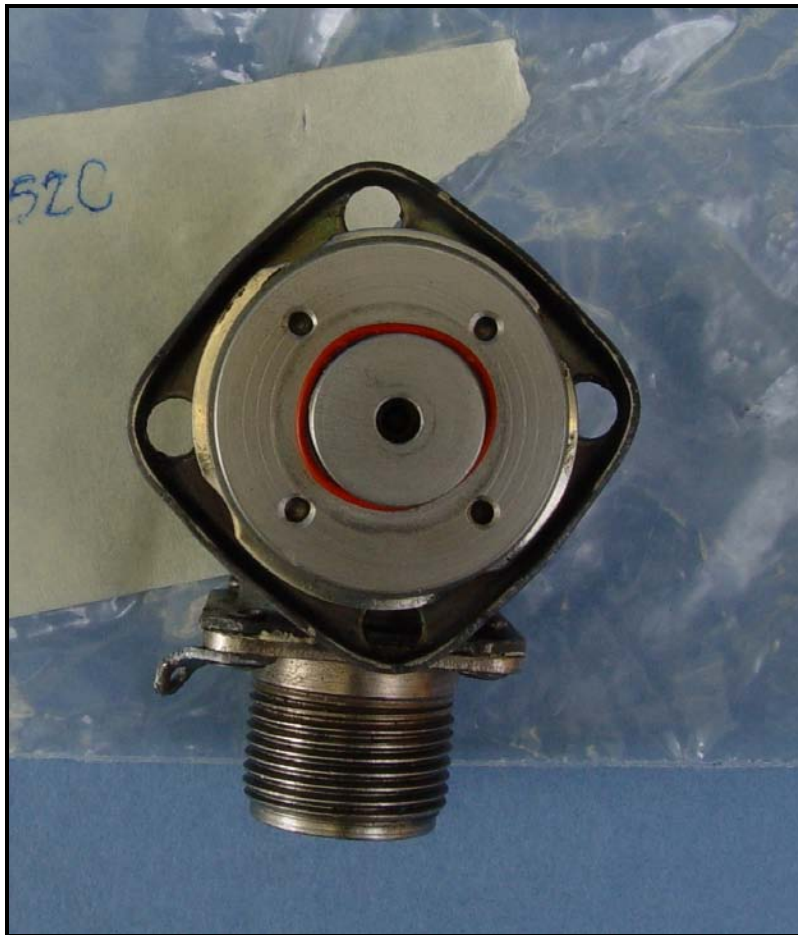
Figure 4--An overall view of the as-recieved aborted takeoff solenoid valve, s/n P3052C.

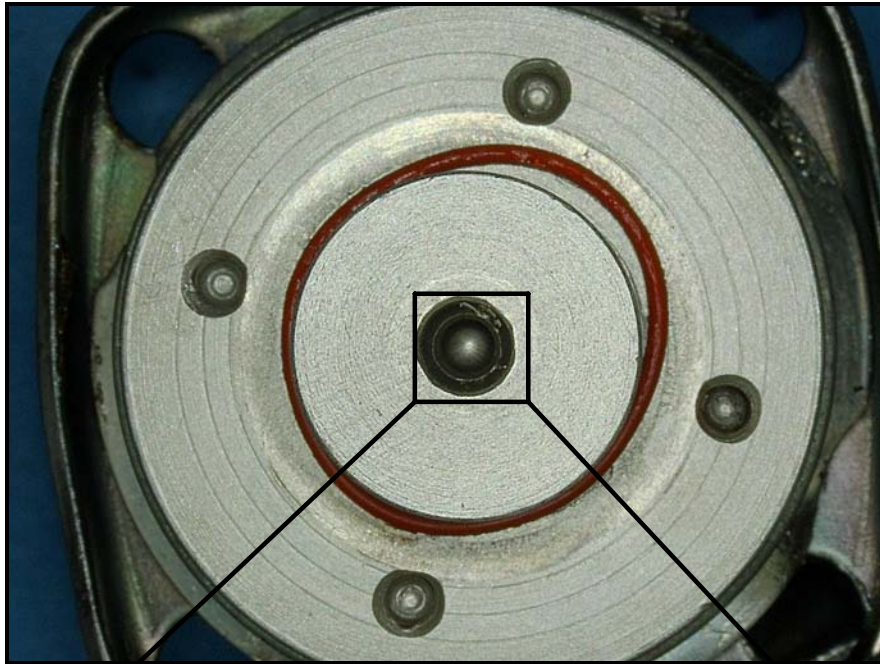
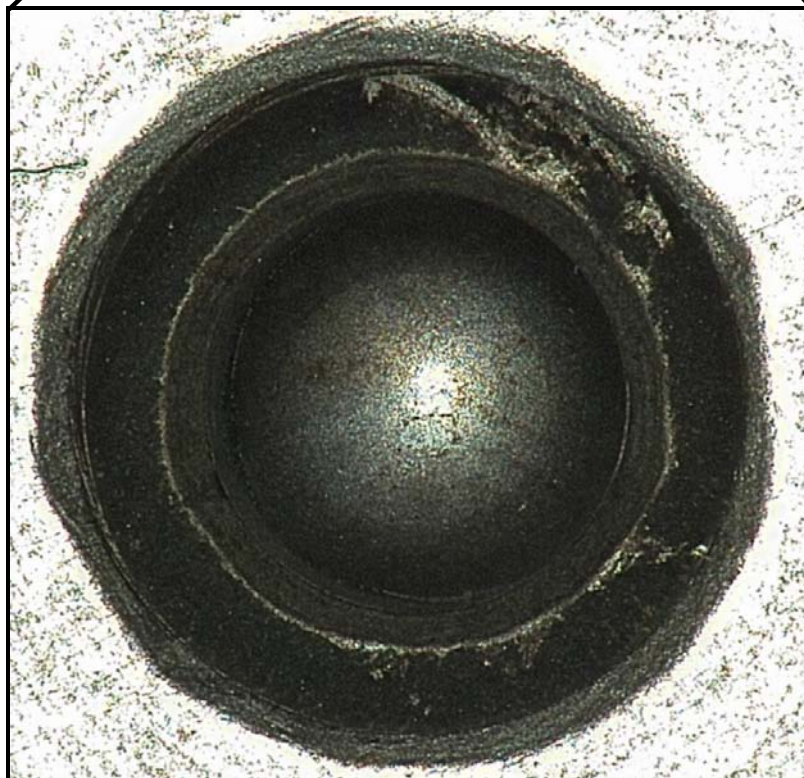
Figure 5--The valve with an enlargement of valve ball showing particulate material.
