**NATIONAL TRANSPORTATION SAFETY BOARD
OFFICE OF AVIATION SAFETY
WASHINGTON, D.C. 20594**

Maintenance Records Factual Report

A. ACCIDENT: DCA-07-MA-310

AIRCRAFT: American Airlines McDonnell Douglas DC-9-82 (MD-82),
N454AA, Flight 1400

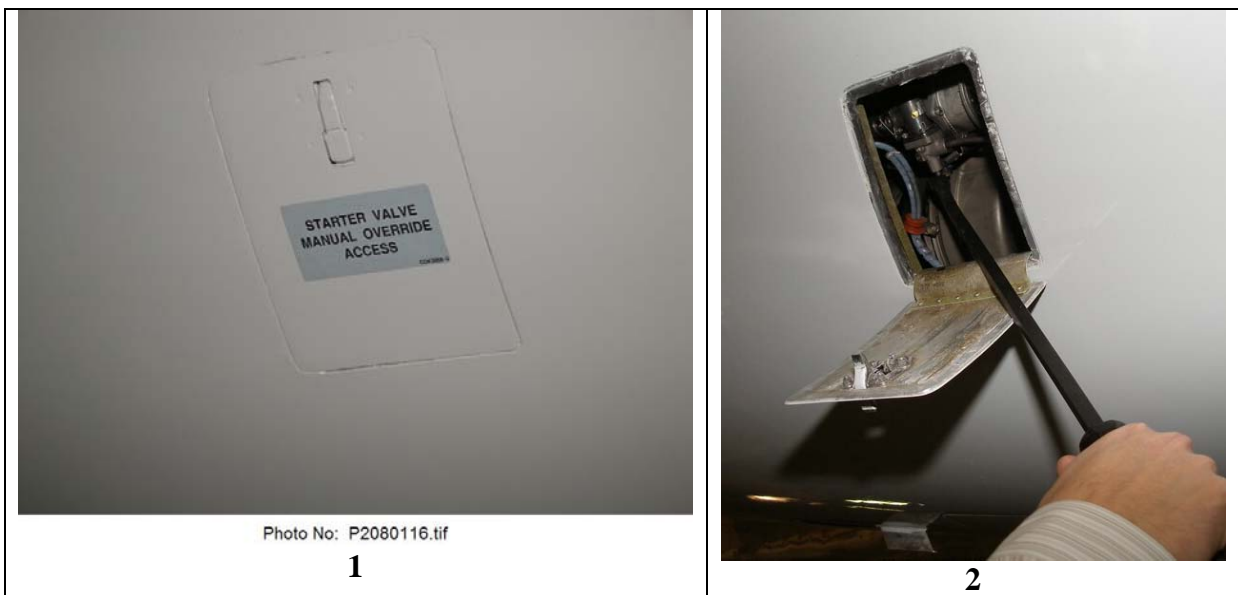
“Use only hand pressure to depress the override button. Use of screwdriver or other type of prying device to depress override button can deform slender pin mechanism inside valve. A deformed override bottom pin can hold solenoid switcher ball off its seat which allows valve to open uncommanded when air pressure is available to engine start valve. If undetected or uncorrected, this condition will result in significant damage to engine starter.”

Although the written procedures to use the specialized tool were well known, according to interviews with line mechanics, it was customary and the most expeditious method to use the manual override button. Typically, a prying device, such as a screwdriver would be used to depress the override button in the event that a start valve failed to open and a manual start was necessary (**Photos 1 and 2**). Furthermore, according to line mechanics statements, AA maintenance supervisors were aware of the use of the override button to manually start the engine and did not take any action to prevent or dissuade its use (**Attachment 6**). Since the use of the override button was not an authorized procedure in the AA maintenance manual, no written CAUTIONS or WARNINGS statements, similar to those in the Boeing procedure, existed to warn the mechanic that prying the override button could result in a bent pin and a stuck override shaft.

Photos 1 and 2: Typical AA Method for Manual Engine Start

Discussions with AA engineering revealed that changes to the maintenance procedures can be requested by any AA employee by submitting a Form E63 “Request for Services” (**Attachment 7**). Guidance and the Form E63 are located in the GPM which is a guide to AA policies and procedures to be followed by all persons performing maintenance and inspection services on company aircraft. A review of the AA change requests did not reveal any requests for changes in the for manual start procedures. The MD-80 engineering section of AA in Tulsa stated that, had a request been submitted, action to review and revise the maintenance procedures would have been accomplished (**Attachment 8**). Review of the maintenance deferral procedures revealed that start valve failures could be deferred by maintenance personnel, the logbook entry completed, the start switch placarded, then the manual start could be attempted. The manual start procedures included coordination with the flightcrew such that the butterfly valve was manually held open, the flightcrew activated the start switch and completed the start normally, after which the maintenance person would close the butterfly valve and verify that the valve index was in the closed position.
