**NATIONAL TRANSPORTATION SAFETY BOARD
OFFICE OF AVIATION SAFETY
WASHINGTON, D.C. 20594**

**Powerplant Group Chairman's Factual Report – Addendum 1
Engine Starting System**

NTSB ID No.: DCA-07-MA-310

Aircraft: American Airlines McDonnell Douglas DC-9-82 (MD-82), N454AA, Flight 1400

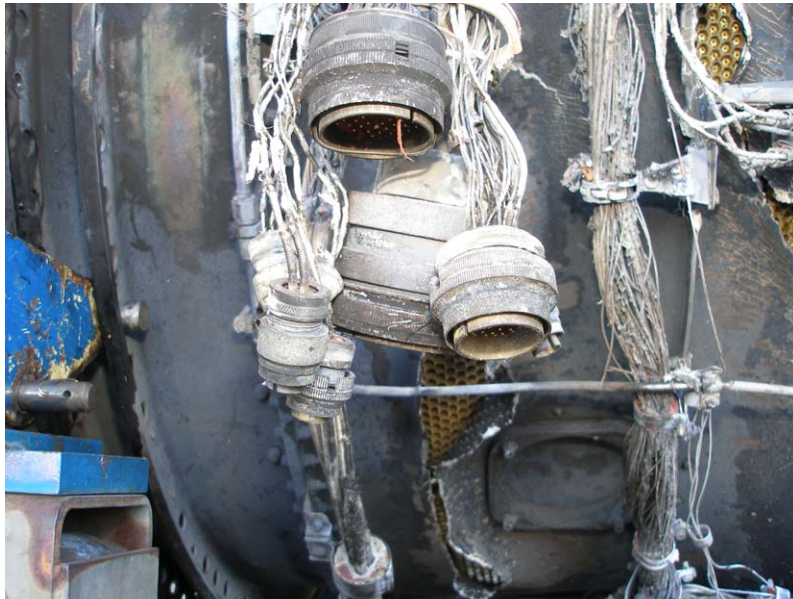
Photo 12 – Wiring harness damage

The left-hand nacelle segment ATSV wiring harness, P/N 5938354-509, from the outboard of the left hand engine pylon firewall connector to the ATSV, was not intact. The pylon Canon plug was present, in its correct secured location, and all the pins within the plug were present but damaged due to heat ([Photo 12](#)).

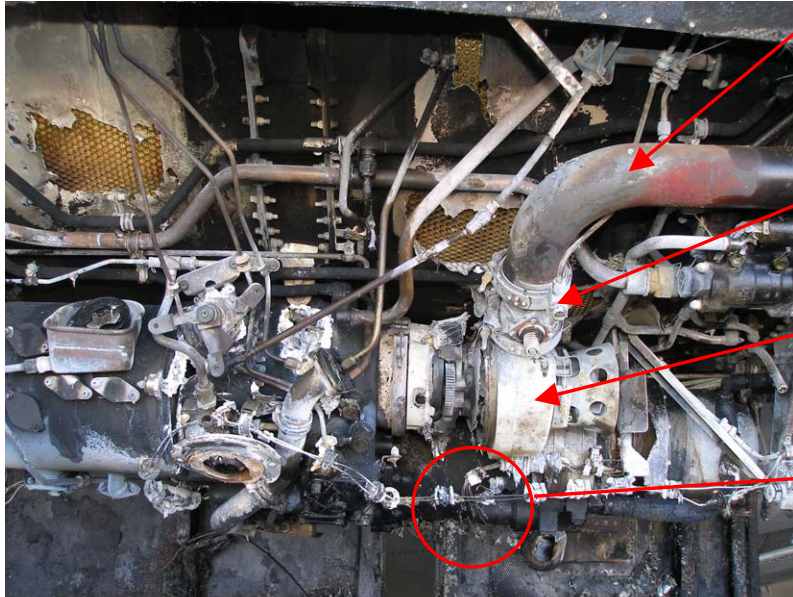
Photo 13 – Engine start system – in situ

The entire nacelle wire harness was damaged due to heat to various extents. Some lengths were only charred while others had the insulation melted, exposing the bare wire. The ATSV wiring harness near the ATSV had separated ([Photo 13](#)). The two ATSV connector plugs, which connect to the solenoid and the micro-switch, were not in their correct location, were separated from the wiring harness and found loose within the debris in the lower cowl door still connected to the melted portion of the ATSV control housing. There were four 1-foot long bare wires still connected to them, two to each Canon plug. There was electrical continuity between the four pylon connector pins and these bare wires near the ATSV but because the insulation material from many of the

Separated
ATSV
wiring
harness

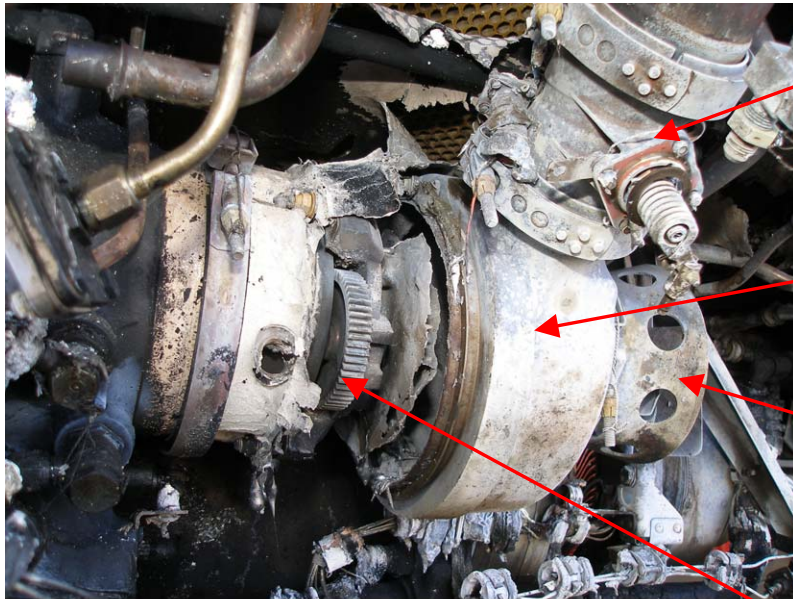
Photo 14 – ATSV and ATS details in-situ

Only the ATSV flow body and butterfly plate were in place between the ATS and the starter pneumatic line (Photo 14 & Photo 15). The piston/diaphragm and its housing were melted and separated from the housing. The actuator housing over the torsional return spring of the butterfly valve was melted allowing the spring to rotate freely. The solenoid and ball valve assembly housing was melted and the solenoid and ball valve assembly as well as the ATSV manual start push button were found at the bottom of the lower cowling door within a melted metallic puddle (Photo 16). When the ATSV was removed, the butterfly valve was observed seized in the CLOSED position.

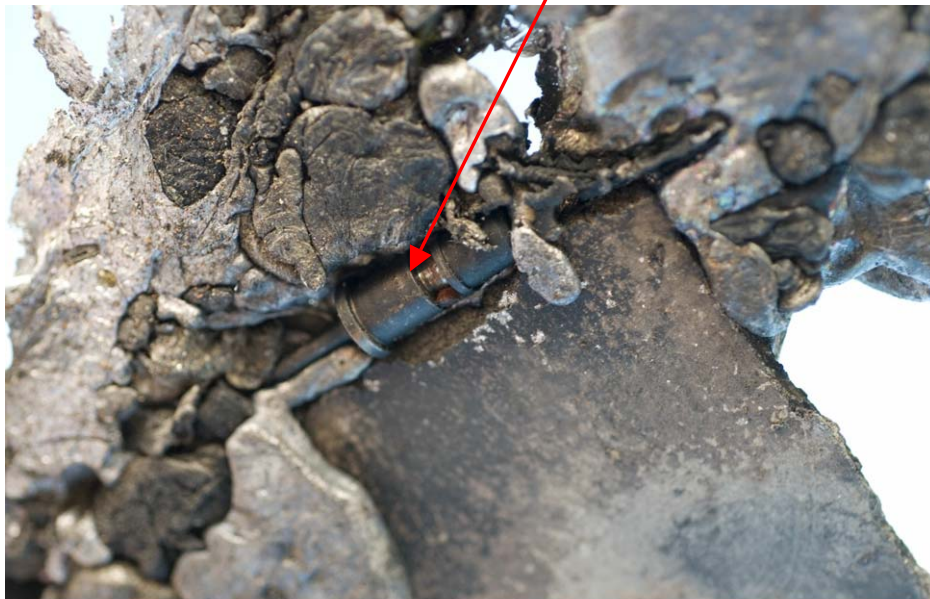
Photo 16 – ATSV manual override button – found in debris

The air turbine starter valve (ATSV) manual override pin was found buckled within the melted debris of the ATSV housing. The manual override button sleeve in the ball valve housing exhibited score marks consistent with contact against the manual override pin.

After the Honeywell examination was complete, all the parts were returned to AA facility in Tulsa, Oklahoma where the manual override button was identified (Photo 16). The manual override button was buckled in a S-shape on the slender end of the rod closest to the ball valve (Photo 26). Additionally, the rod end was deformed with a concave spherical indentation giving the sides a buckled 'mushroomed' pattern (Photo 27). This damage was consistent with a compression type overload. The manual override button sleeve in the ball valve housing was scored (Photo 28) from contact against the ridge of the manual override button, consistent with the application of significant force on the manual override button. An exemplar ball valve housing was sectioned and the event manual override button was placed into position showing that contact and binding of the manual override button ridge against the sleeve within the ball valve housing were possible (Photo 29).

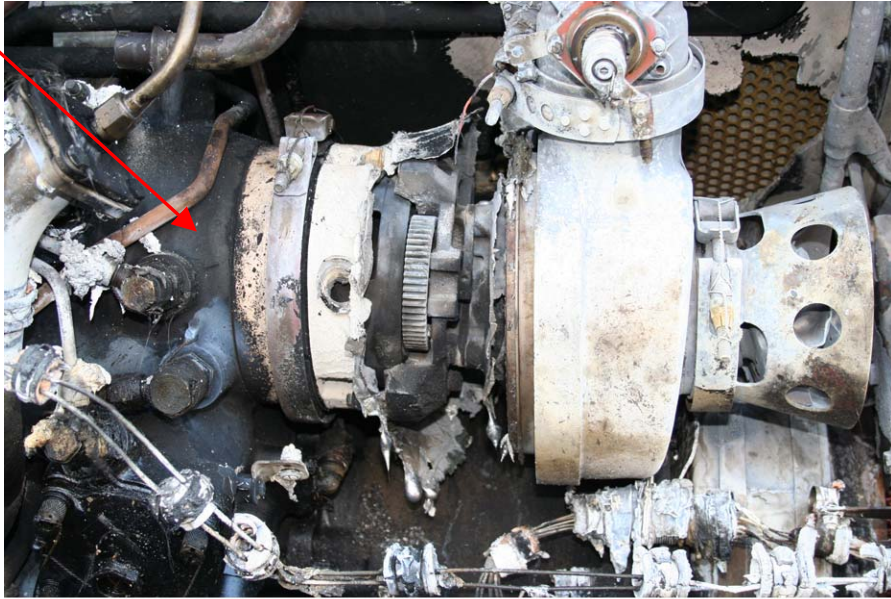
Photo 17 – ATS in-situ - details

The air turbine starter was in-place between the engine gearbox and the ATSV (Photo 17). The aluminum gearbox housing on the front side, forward of the scroll housing, was melted through 360° of its circumference and separated from the scroll housing. The planetary gears of the gearbox were exposed. The turbine rotor, with intact spline shaft, was found lying in the exhaust bell (Photo 18). The blade tips were worn down by approximately ¼ inch and rolled over with material deformation in the direction opposite of rotation. The turbine bearing could be rotated with mild hand effort, and was

very rough. The input spline bearing could be easily rotated by hand effort but the shaft rotation did not cause the planetary gears to rotate along with it.

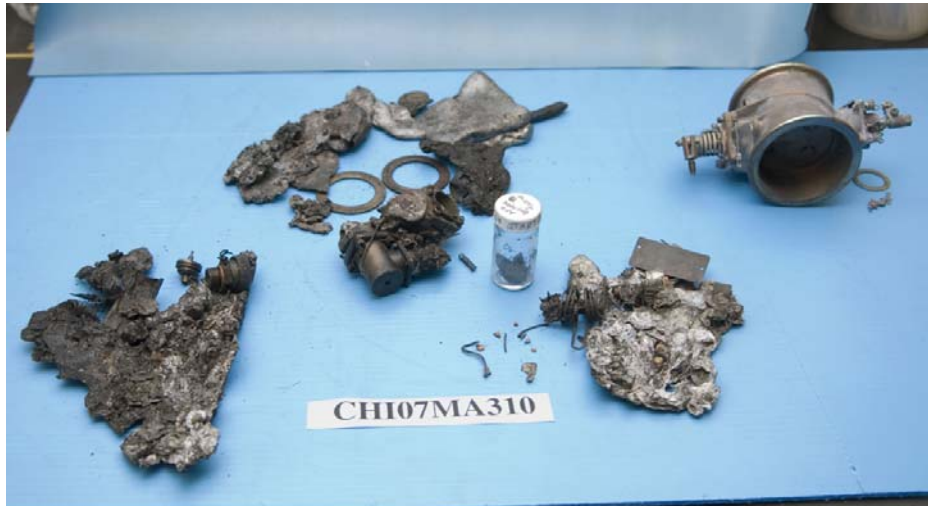
Photo 19 – ATSV parts

A separate container of debris that was collected from the bottom of the cowl door, which was believed to have contained the liberated parts of the ATSV, was also in the shipping container (Photo 19). The aluminum switcher valve housing cap was not present; however, the switcher valve piston and return spring were found separated from its housing and among the debris that was collected from the bottom of the cowl doors. The switcher valve flexible diaphragm was not identified in the materials provided for the examination.

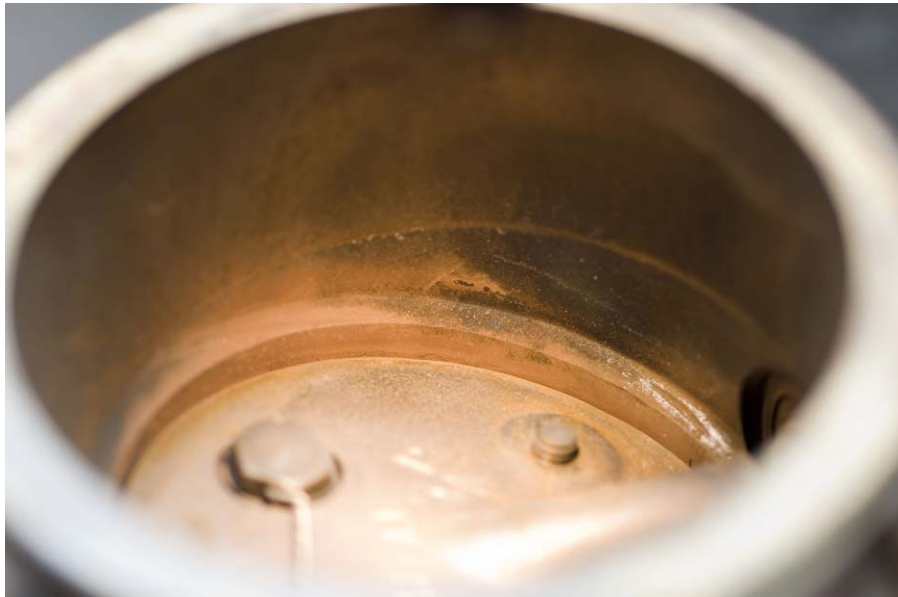
Photo 20 – ATSV butterfly plate

No metallic deposit was noted on the upstream or downstream side of the butterfly plate or inner bore of the flow body housing ([Photo 20](#)). The actuator side bearings were slightly rust-covered. The water flow pattern on the inner bore and butterfly disk appeared to be consistent with normal operation ([Photo 21](#)).

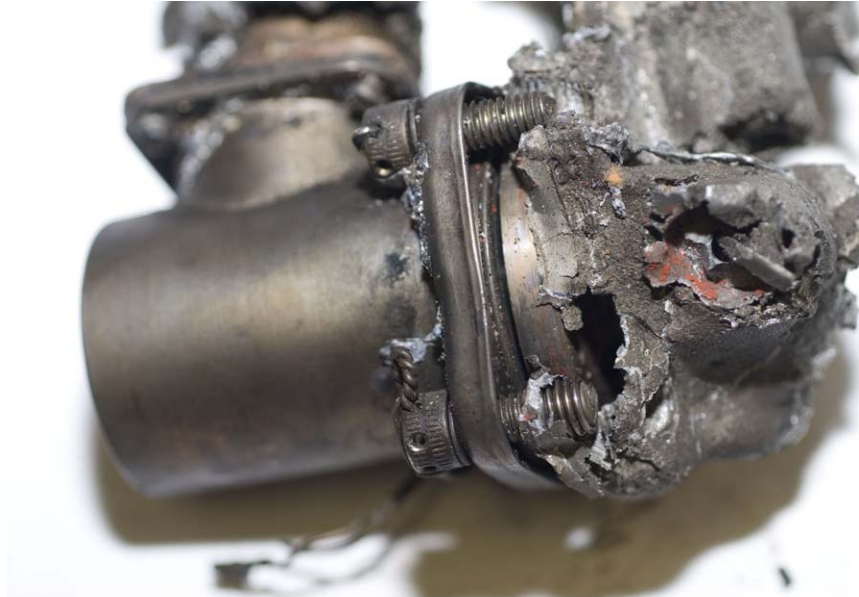
Photo 23 – ATSV Solenoid

The solenoid was found in the debris collected from the bottom of the cowl door (Photo 23). The electrical 'Canon plug' connector was still attached to the solenoid housing. Fractured and exposed electrical harness wires were seen in the 'Canon plug' connector. The solenoid valve assembly was separated from the solenoid housing.

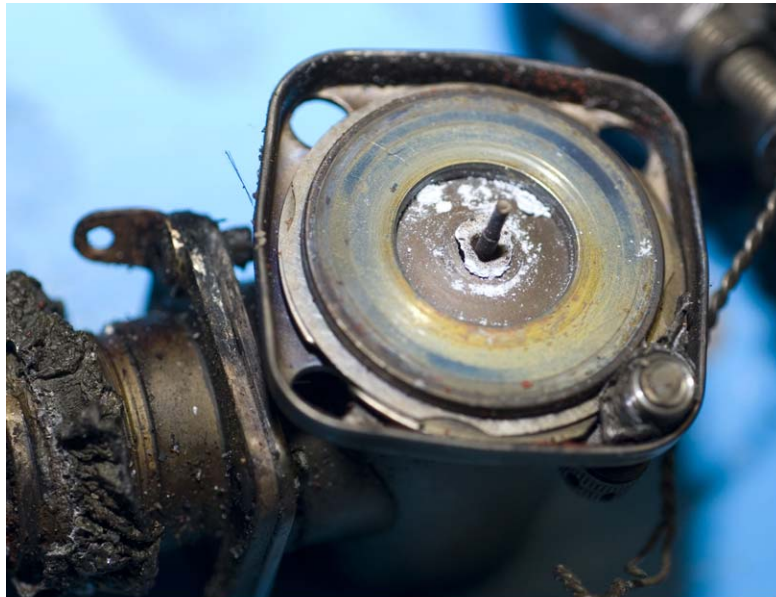
Photo 24 – ATSV solenoid plunger rod

The solenoid housing mounting flange was deformed. The solenoid was disassembled to reveal the armature and the solenoid valve housing (Photo 24). The armature was free to move. There were no witness marks noted on the forward face of the armature. Additionally, there were no axial score marks noted on the plunger rod. The plunger rod face, which is in contact with the ball valve, was slightly worn with a spherical indentation (Photo 25). Based on the measurements of the deformation of the ball valve on the pin surface, the depth of wear was calculated to be 0.002-inches.

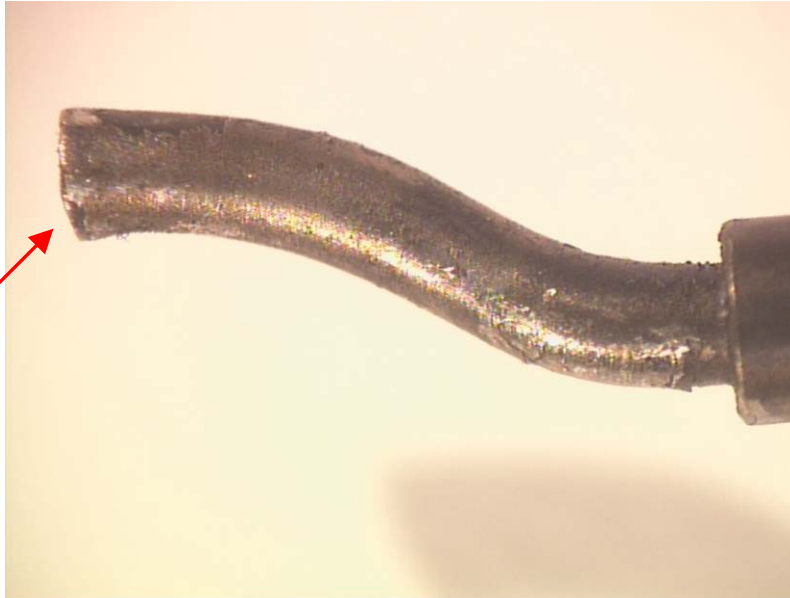
Photo 27 – Detail of buckling and mushroom deformation of rod end

'Mushroom' type deformation of rod end

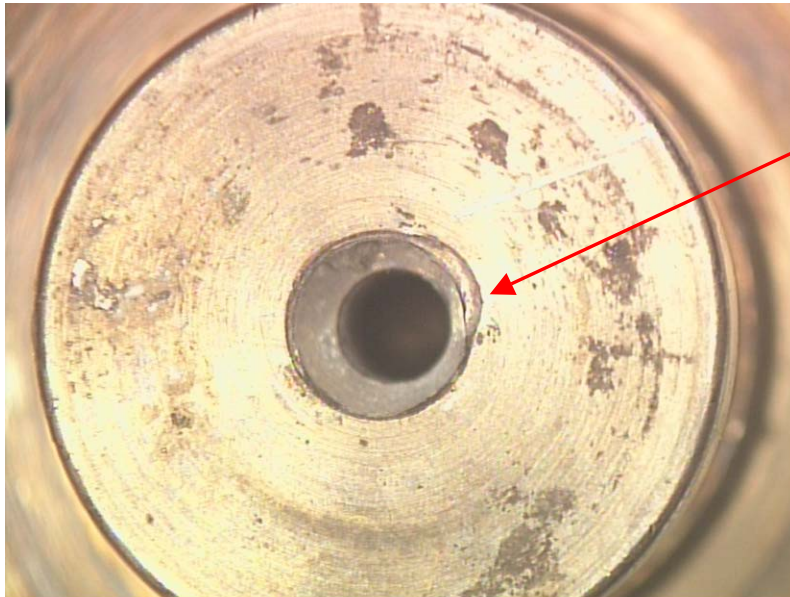
Photo 28 – Ball valve housing manual override button sleeve

Score mark consistent with contact against manual override button ridge

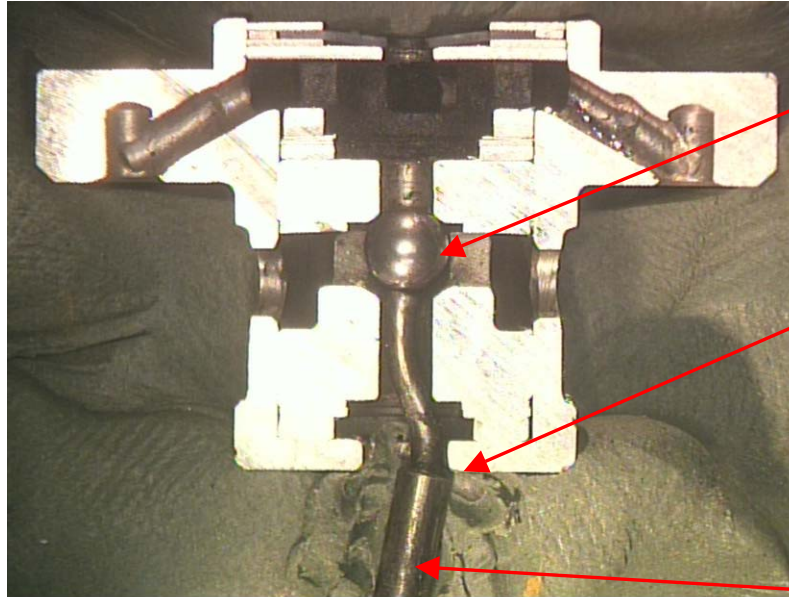
Photo 29 – Manual override button within sectioned ball valve housing

Ridge of manual override button contacts ball valve housing

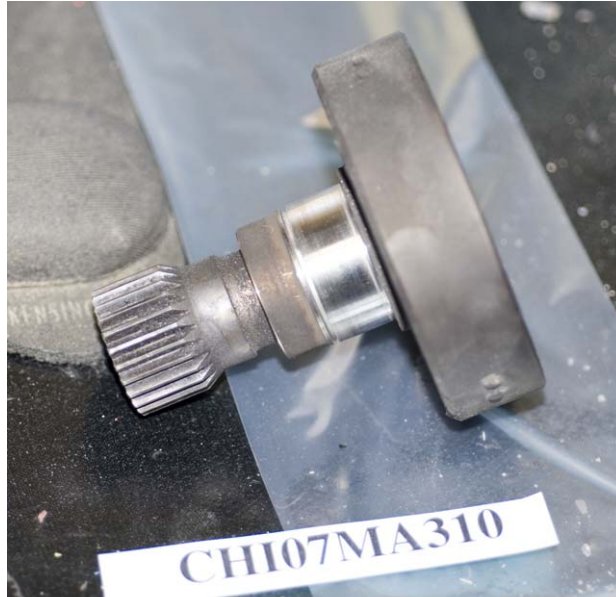
Photo 35 – ATS output shaft with clutch pawl carrier

The clutch output shaft assembly appeared to be undamaged but exhibited a black sooty coating (Photo 35). Before disassembly, the output shaft was free to rotate in both directions; however, there was no corresponding rotation of the planetary assembly or audible ratcheting of the pawls. After removal of the clutch, the pawls were found in the dis-engaged position, undamaged, and were coated with a hard brittle material, which restrained the pawl motion (Photo 36). Once the hard brittle material was removed the pawls were free to move. A spring was removed from one pawl and was compared to a new exemplar spring. The removed spring had a permanent set at an increased radius of curvature. The output shaft bearing could be rotated; however, it was rough and had excessive play.

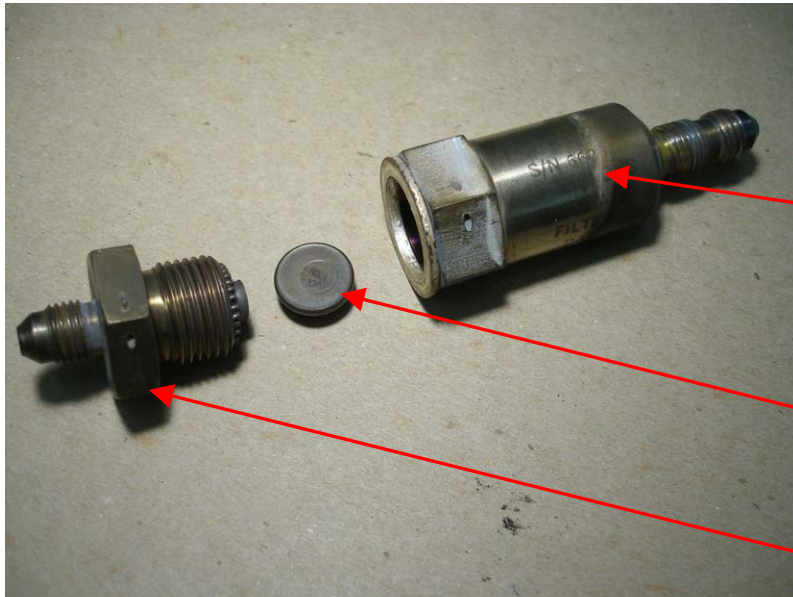
Photo 38 – ATSV-AF dis-assembled – filter element missing

The air turbine starter valve air filter (ATSV-AF) media was deteriorated leaving the internal cap free within the housing. About 30% of the filter media remained but was separated from its fitting and found pressed against the inner wall of the housing. The air filter cap was found covering the air outlet within the ATSV-AF housing.

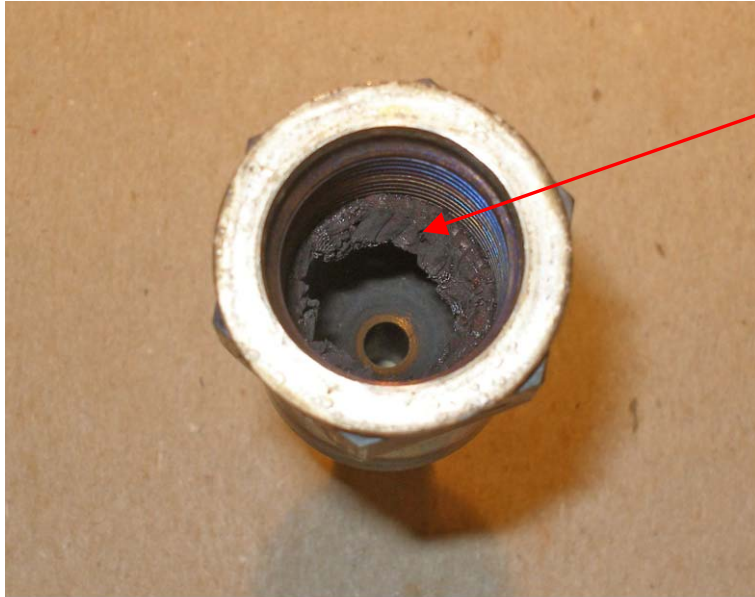
Photo 39 – ATSV-AF housing – internal view

When installed, the orientation of the assembly is vertical with the housing on the top and the fitting towards the bottom. The air flow enters the housing at the top and exits from the lower fitting. The element was found fractured from the fitting along a line just above the fitting braze joint (Photo 38). Most of the fractured surfaces of the filter element remaining on the fitting were smeared. About 70% of the metallic filter element material was missing. The remaining element material adhered to the inner wall of the housing (Photo 39). The remaining filter element material had a red-brown color whereas a new filter is silver in color. The upper cap of the element was still intact but separated from the element (Photo 40 & Photo 41). Some filter element material was still attached to the cap and was worn and rounded-off. The edges of the cap were also worn and was found resting in an inverted condition upon the lower fitting inner nipple and a fretting pattern on the flat surface was present, consistent with contact against the nipple (Photo 42). When the flat surface of the cap is in contact with the fitting nipple, the air flow can be restricted or stopped.

Remains of
filter media

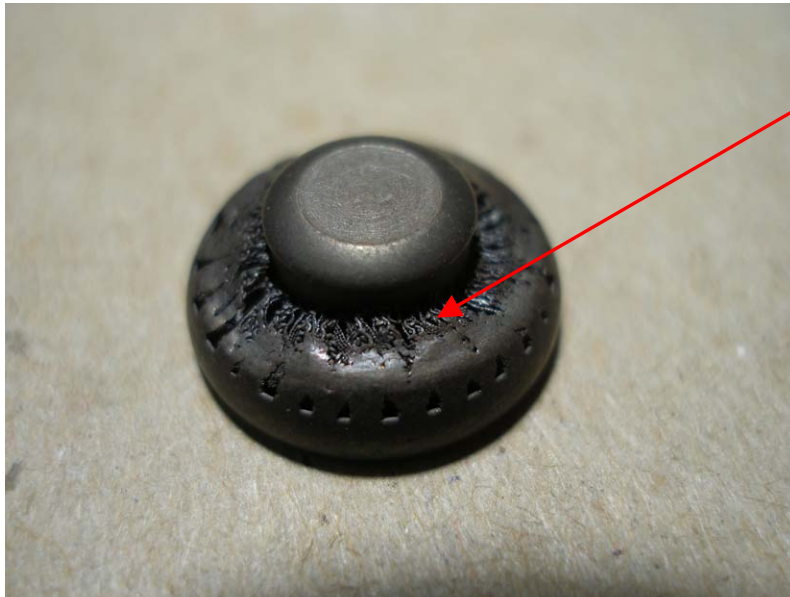
Photo 40 - ATSV-AF end cap – bottom view

Remains of
filter media
and braze
material

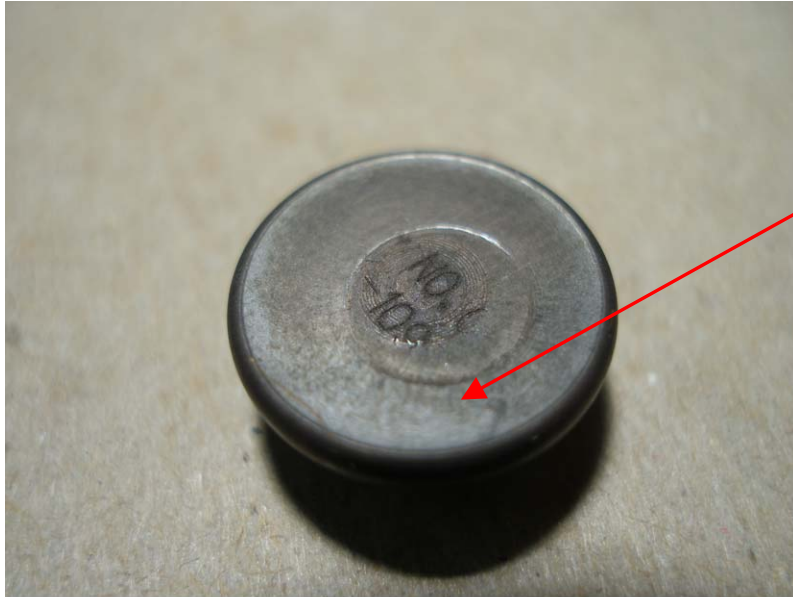
Photo 41 - ATSV-AF end cap – top view

Fretting marks consistent with contact against fitting nipple

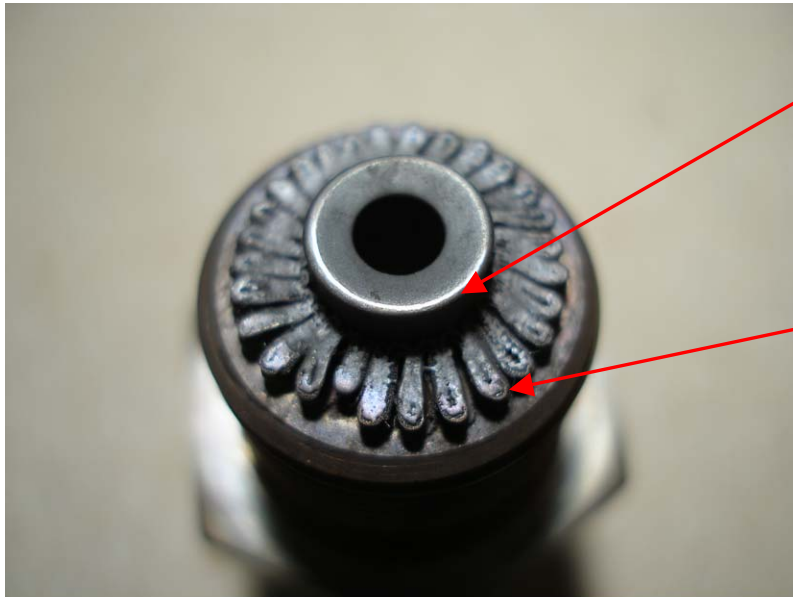
Photo 42 - ATSV-AF top of fitting

Fretting marks consistent with contact against cap top

Remains of filter media and braze material
