SUBMISSION OF THE
ALLIED PILOTS ASSOCIATION
TO THE NATIONAL TRANSPORTATION
SAFETY BOARD

AMERICAN AIRLINES FLIGHT 1400
Lambert- St. Louis International Airport
St. Louis, Missouri, USA
29 SEPTEMBER 2007

NTSB CHI07MA310

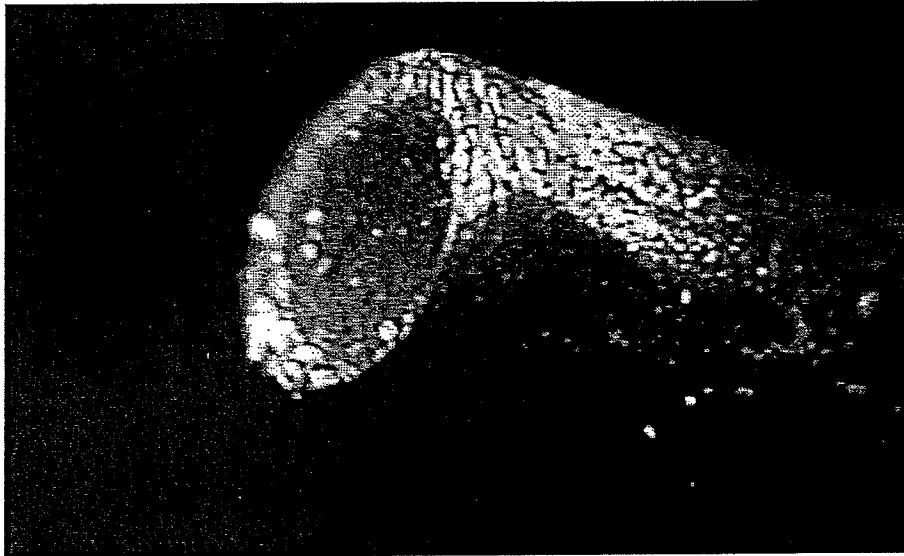
Photo No: DCAO7MA310-8589.tif

- Boeing's DC-9/MD-80 Maintenance Manual recommended maintenance practices, listed in Section 80-10-00, "Cranking-Description and Operation," revealed two methods to manually start an engine. Boeing's instruction provides a CAUTION to only use either hand pressure on the override button or a specialized tool to engage the hex fitting. (See attachment 5)

Photo 26 – ATSV manual override button - bent

13. That the air carrier provide additional training to maintenance technicians, concerning manual start valve operation and valve deactivation.
14. That the air carrier immediately issue a bulletin to all applicable maintenance personnel describing the hazards associated with improper start valve procedures.

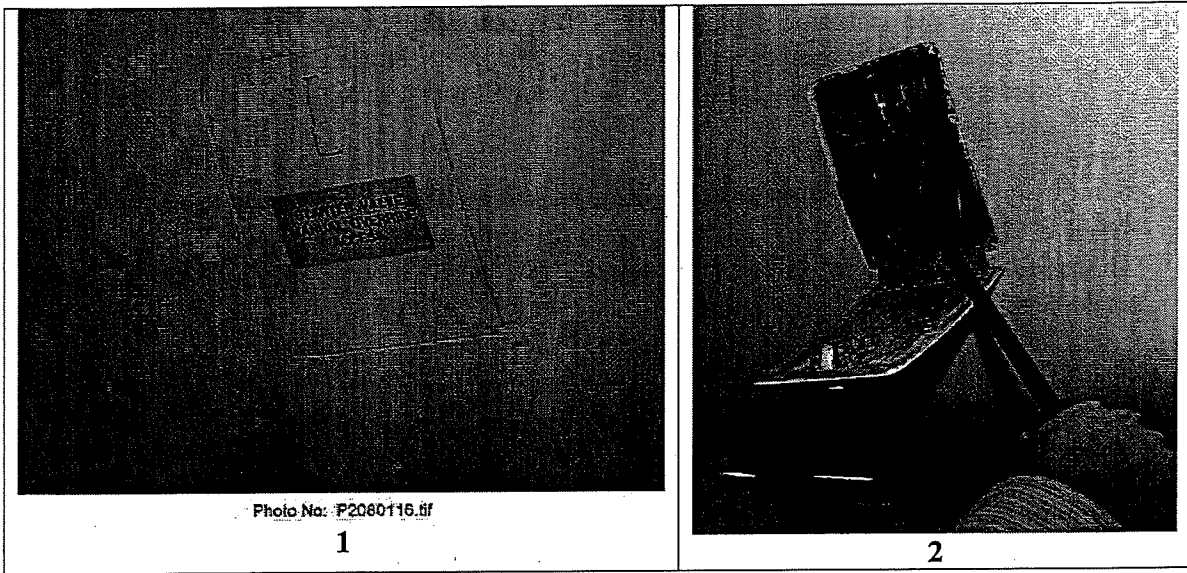
Although the written procedures to use the specialized tool were well known, according to interviews with line mechanics, it was customary and the most expeditious method to use the manual override button. Typically, a prying device, such as a screwdriver would be used to depress the override button in the event that a start valve failed to open and a manual start was necessary (**Photos 1 and 2**). Furthermore, according to line mechanics statements, AA maintenance supervisors were aware of the use of the override button to manually start the engine and did not take any action to prevent or dissuade its use (**Attachment 6**). Since the use of the override button was not an authorized procedure in the AA maintenance manual, no written CAUTIONS or WARNINGS statements, similar to those in the Boeing procedure, existed to warn the mechanic that prying the override button could result in a bent pin and a stuck override shaft.

Photos 1 and 2: Typical AA Method for Manual Engine Start

Discussions with AA engineering revealed that changes to the maintenance procedures can be requested by any AA employee by submitting a Form E63 "Request for Services" (**Attachment 7**). Guidance and the Form E63 are located in the GPM which is a guide to AA policies and procedures to be followed by all persons performing maintenance and inspection services on company aircraft. A review of the AA change requests did not reveal any requests for changes in the for manual start procedures. The MD-80 engineering section of AA in Tulsa stated that, had a request been submitted, action to review and revise the maintenance procedures would have been accomplished (**Attachment 8**). Review of the maintenance deferral procedures revealed that start valve failures could be deferred by maintenance personnel, the logbook entry completed, the start switch placarded, then the manual start could be attempted. The manual start procedures included coordination with the flightcrew such that the butterfly valve was manually held open, the flightcrew activated the start switch and completed the start normally, after which the maintenance person would close the butterfly valve and verify that the valve index was in the closed position.
