NATIONAL TRANSPORTATION SAFETY BOARD
Southwest Regional Office
Gardena, CA

Airworthiness Factual Report

Aircraft: N613TV (Ch 3), Eurocopter AS350B2
N215TV (Ch 15), Eurocopter AS350B2

NTSB Number: LAX07MA231A/B

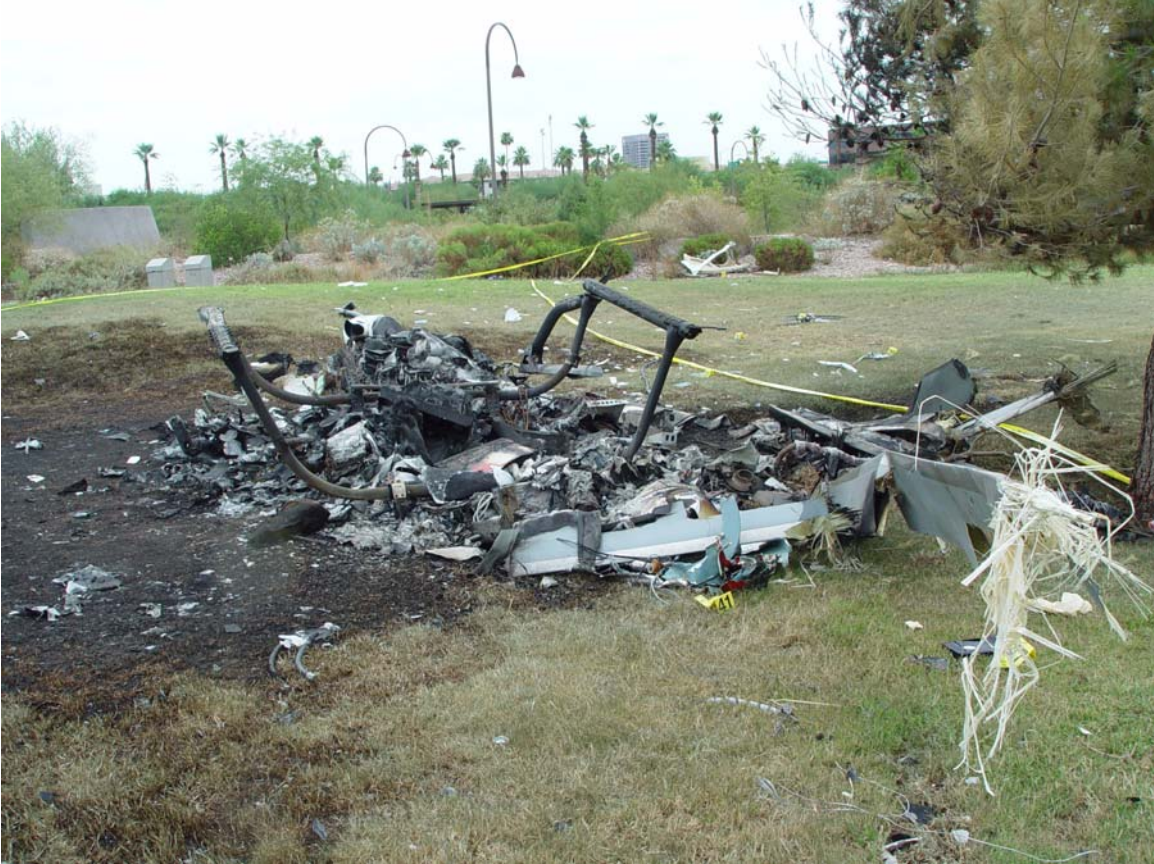
Figure 6. Ch 3 main wreckage

The helicopter was fragmented, and the airframe and engine sustained severe mechanical and thermal damage. The main wreckage consisted of the cabin, engine, mast, and inboard sections of the rotor blades. The cabin was inverted with the mast imbedded several feet into the ground.

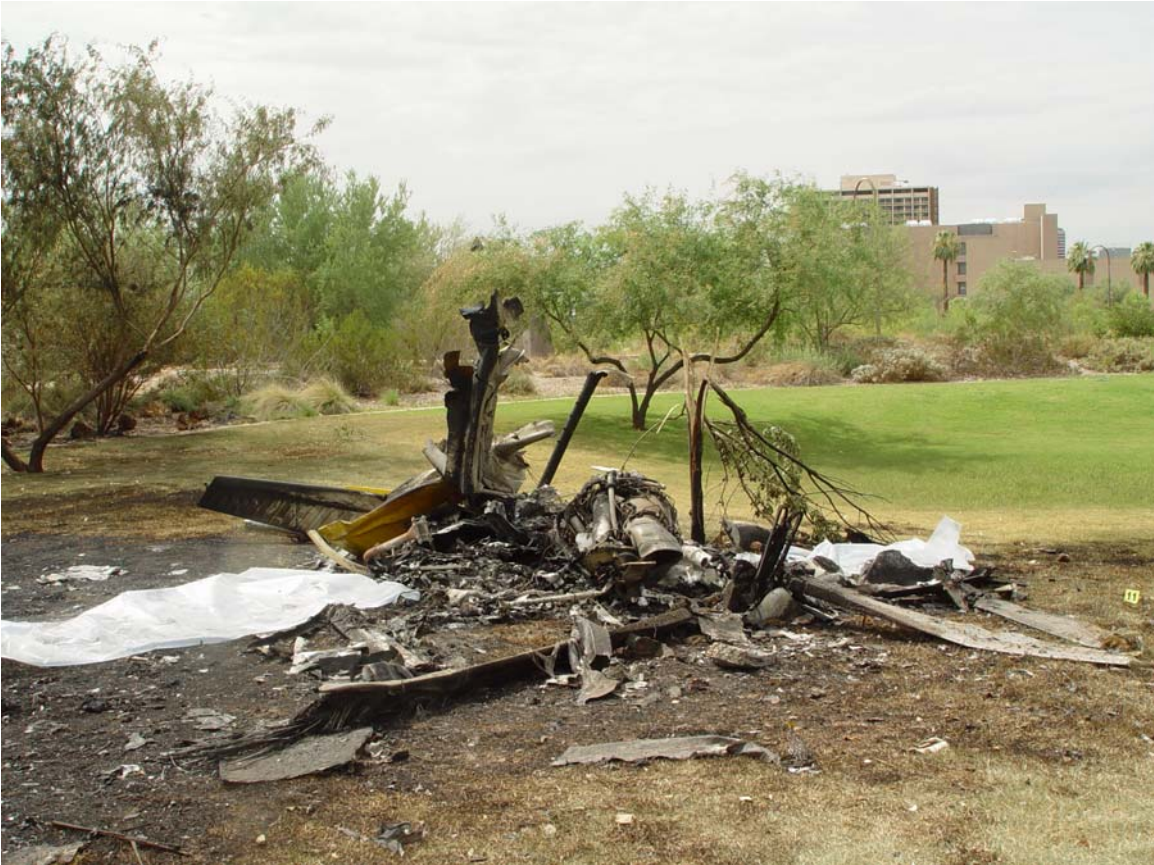
Figure 7. Ch 15 main wreckage

The helicopter sustained severe mechanical and thermal damage. All main airframe components were within the main wreckage debris field. The engine was with the main wreckage. It sustained substantial mechanical and thermal damage.

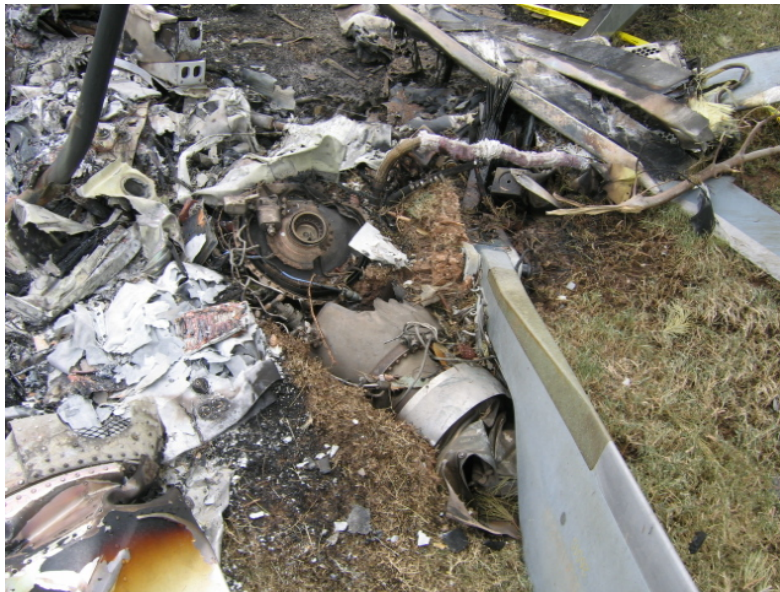
Figure 8. Turbomeca on site picture of engine

Post accident examination of the Ch 3 engine revealed substantial mechanical and post-impact fire damage. The axial compressor separated from the gas generator at the interface of the intermediate casing and the turbine casing assembly of the gas generator. The axial rotor appeared solidly packed with mud and debris. The axial compressor's

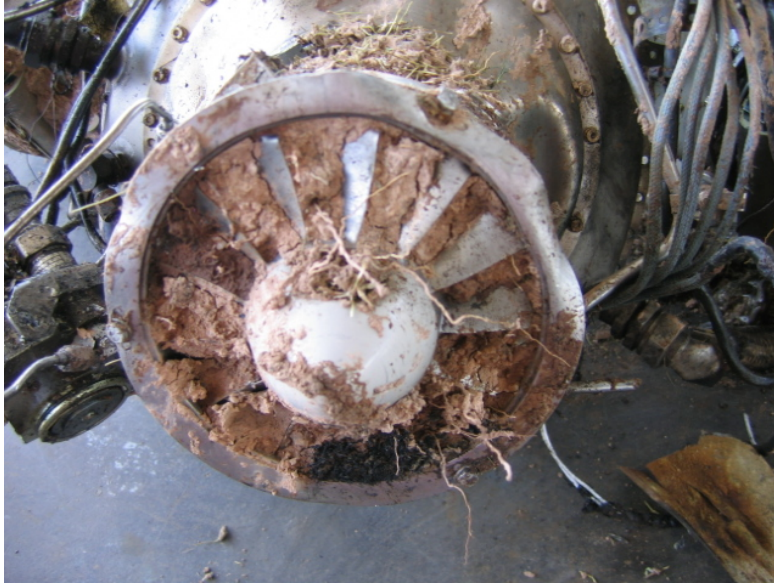
Figure 8. Turbomeca picture of axial compressor - axial rotor and nose bullet

blades exhibited mechanical damage in the form of gouges and scratches. The nose bullet was in place, and appeared undamaged. The linking tube appeared flattened. The short shaft separated from the triangular flange at the rear of the turbine reduction gear flange with the ears of the triangular flange bent backward. The flexible coupling separated with its plates twisted and splayed apart. The coupling's plates exhibited fracture surfaces that were irregularly shaped. The short shaft exhibited rotational scarring aft of the forward attach flange. The free turbine blades were in place, and the tips of the trailing edges appeared chipped and broken.

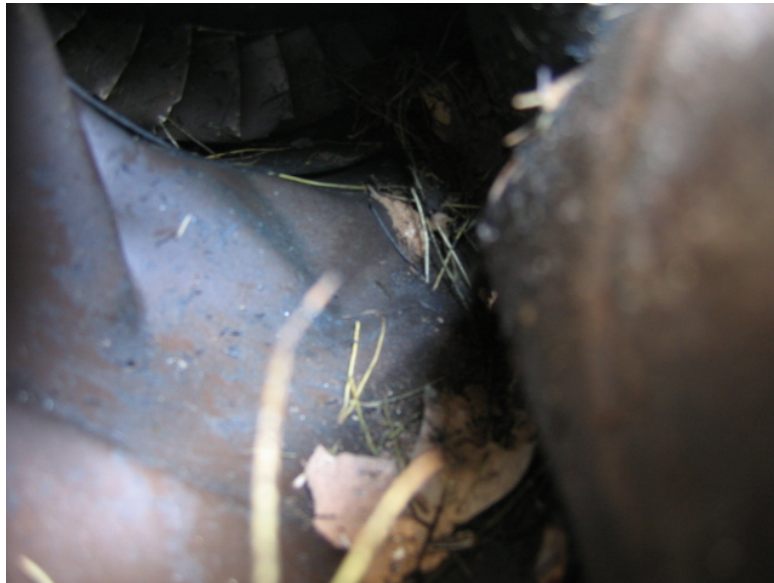
Figure 9. Turbomeca picture of free turbine blades - broken trailing edge tips

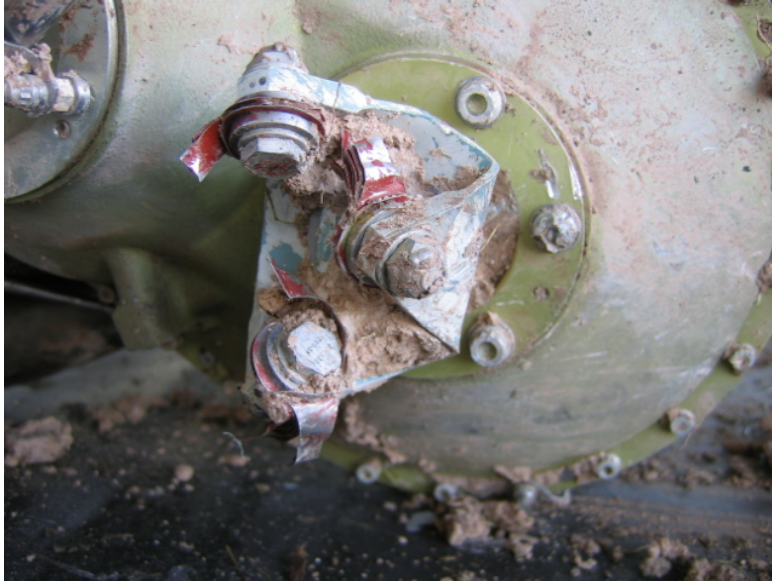
Figure 10. Turbomeca picture of triangular flange at rear of turbine reduction gear

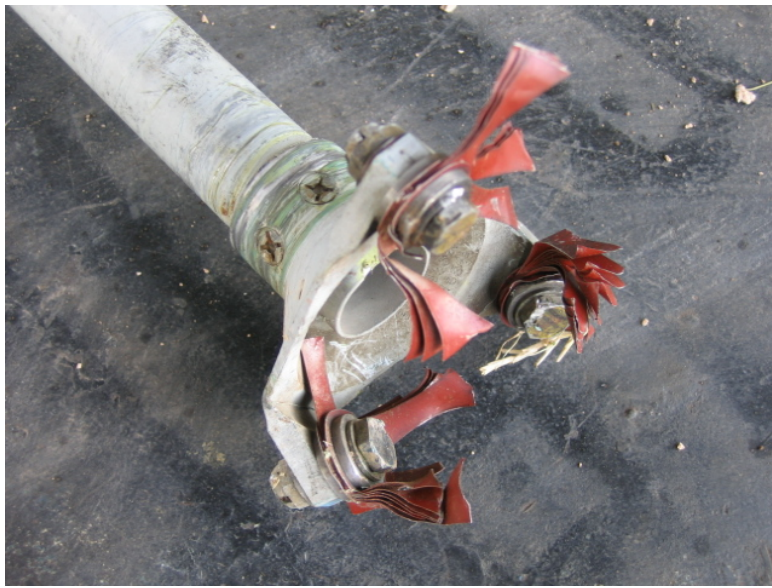
Figure 11. Turbomeca picture of short shaft - rotational scarring

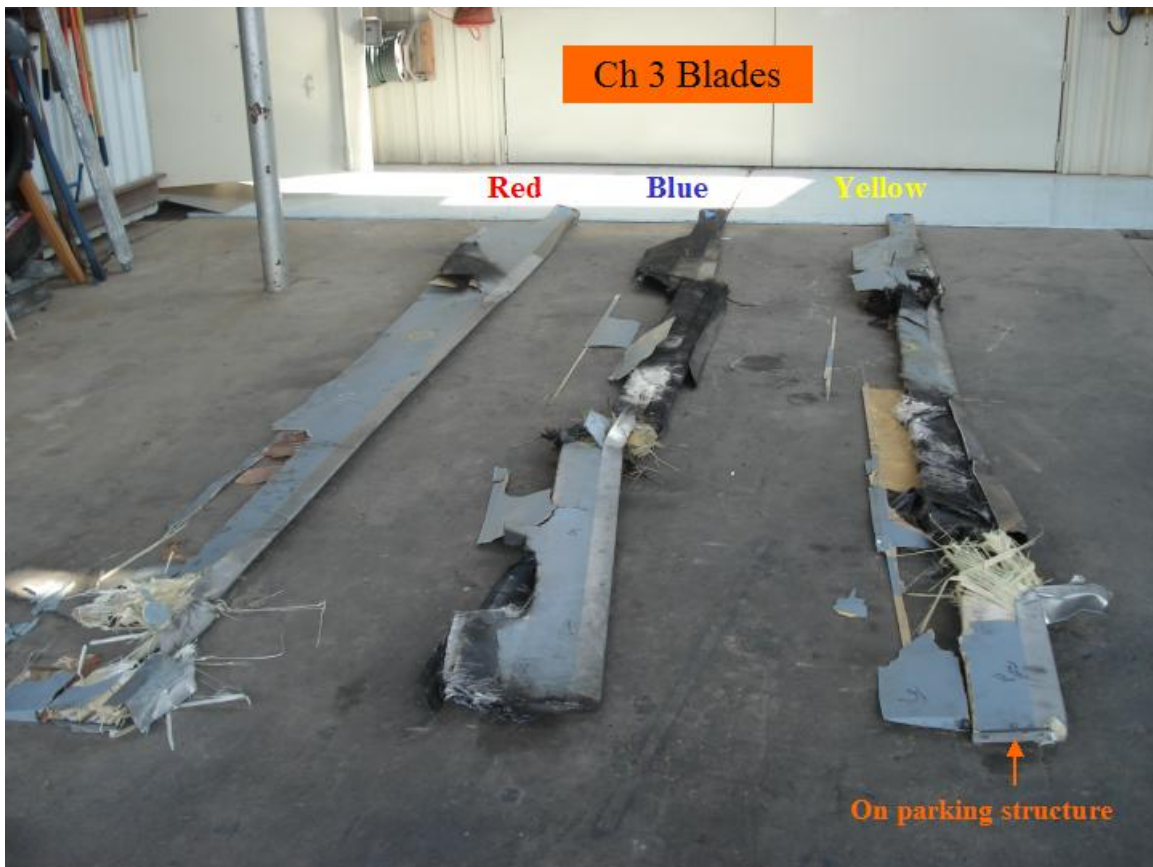
Figure 12. Eurocopter photo of Ch 3 main rotor blades

Charring encompassed the area 4 to 5 feet from the blade root. The blade portion aft of the spar from approximately 11 feet outboard from the root was missing. The blade

sustained mechanical damage to the leading edge about 14 feet from the blade root, and separated into several pieces outboard of this point. Investigators observed blue-gray and orange paint transfer marks on the leading edge from about 12 feet from the root to the separation point. The end plate and weights separated; investigators recovered them several hundred feet north-northwest of the main wreckage.

Investigators observed significant mechanical damage 5 feet and 11 feet from the blade root, and the blade separated at these points. The leading edge stainless steel strip was missing from 9 to 11 feet from the root. The blade sustained thermal damage from the root out to 11 feet. The outboard separated section of the blade contained blue-gray paint. The end plate was in place.

The blade portion aft of the spar was missing from 4 feet 4 inches and outboard from the root. Investigators observed mechanical damage to the leading edge 5 feet from the blade root, and the blade separated at this point. The blade exhibited leading edge mechanical damage 13 to 14 feet from the root. The 9 to 13-foot area sustained thermal damage. The outer 1 1/2 feet of the blade, with the end plate attached, separated; this piece was about 1,050 feet southwest of the Ch 3 main wreckage site. The inboard stainless steel leading edge of this piece exhibited in excess of 90° forward bending mechanical damage. The yellow Starflex blade sleeve exhibited the most severe damage of the three sleeves; it exhibited severe broomstraw damage.

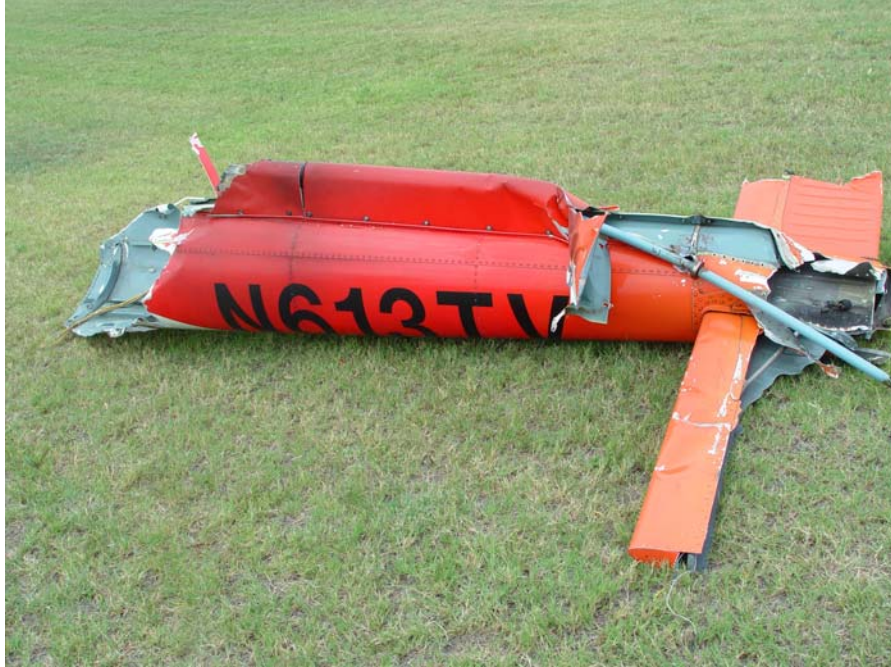
Figure 13. Ch 3-Forward tail boom section

The main rotor blades for the AS350B2 rotate clockwise. The right side of the forward tail boom piece exhibited a

zinc chromate transfer mark and crush damage that was similar to the dimensions of a main rotor blade⁷.

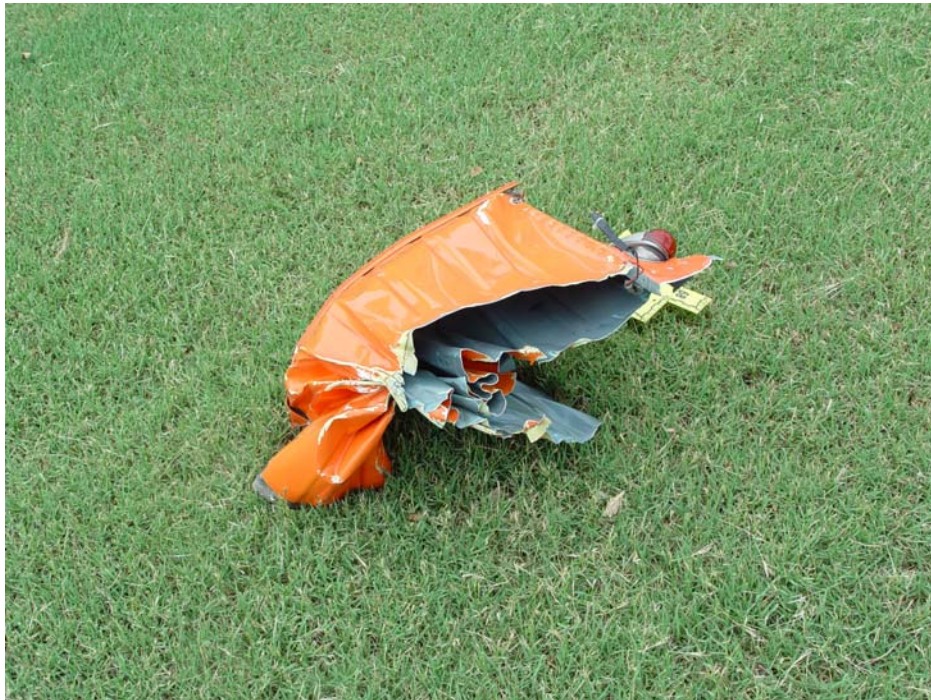
Figure 14. Ch 3-accordion left horizontal stabilizer piece

The outboard section of the right horizontal stabilizer had a camera attached. This piece separated in an outward and aft direction. The aft section of the left horizontal stabilizer separated, and came to rest north of the main wreckage. It exhibited accordion crush damage in the direction of main rotor blade rotation. There was a clockwise zinc chromate primer transfer mark smeared on the upper center section of the tail boom, but over the horizontal stabilizer. The tail rotor drive shaft cover for this area separated, and was north of the main wreckage.

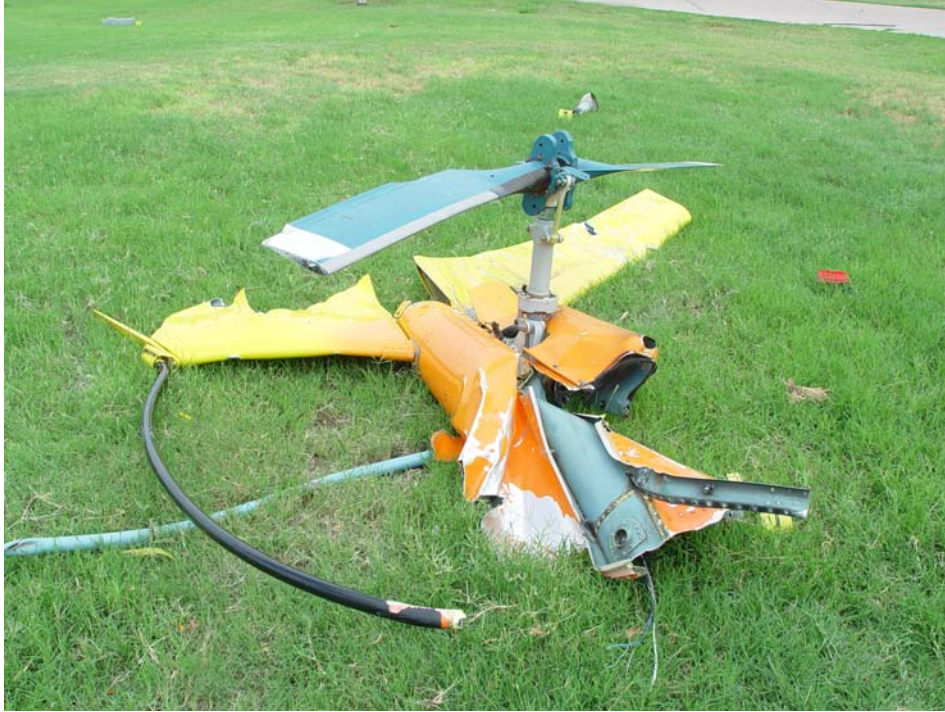
Figure 15. Ch 3-aft tail boom with tail rotor attached

One tail rotor blade exhibited chordwise scoring with orange paint transfer marks on the leading edge, and a flattened strike tab. A twisted skin piece on the right side of the tail boom had a tear mark similar in dimension to the strike tab. The other blade fractured at the cuff, and the strike tab was undamaged. The trailing edge of both blades exhibited witness marks just inboard of the trailing edge tabs. The tail rotor shaft had blue witness marks in the vicinity of the boss weights. The tail rotor drive shaft separated at the front of this section; it exhibited torsional twist in the direction of rotation and an angular fracture surface. The tail rotor pitch change rod separated forward of the tail rotor bell crank input; the rod appeared crushed, and the fracture surface appeared angular and irregular.

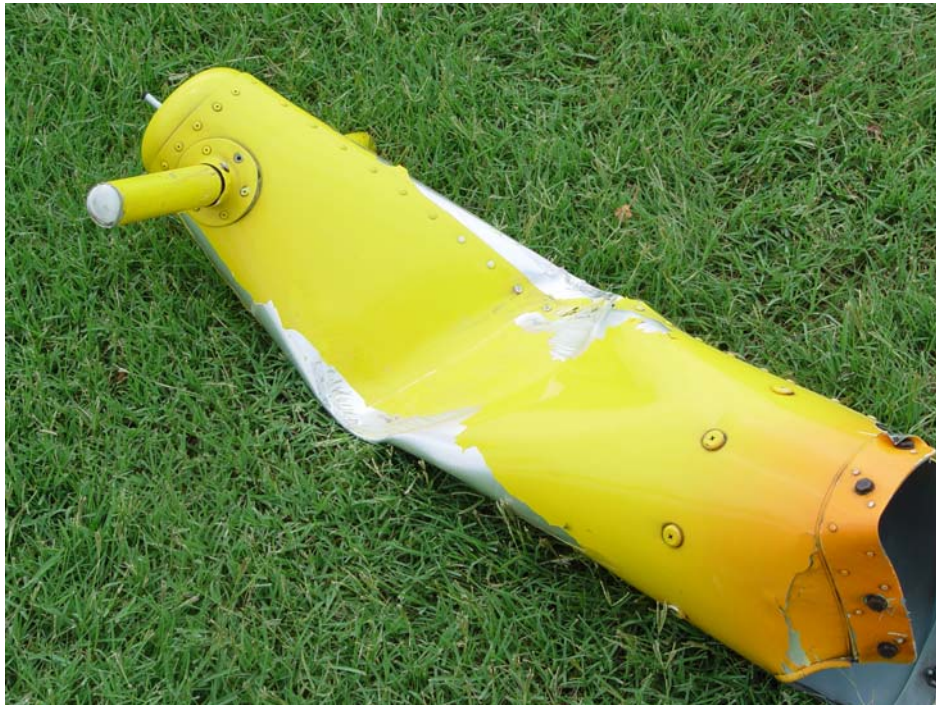
Figure 16. Ch 3-left side of tail cone

The left side of the tail cone exhibited a witness mark and zinc chromate primer transfer mark that was upward and to the right at an approximate 70-degree angle. The right side of the upper vertical stabilizer contained punctures and leftward impact damage about 1 foot from the top. The forward end of this piece exhibited a clockwise twist, and it also had blue-gray paint and zinc chromate primer transfer marks.

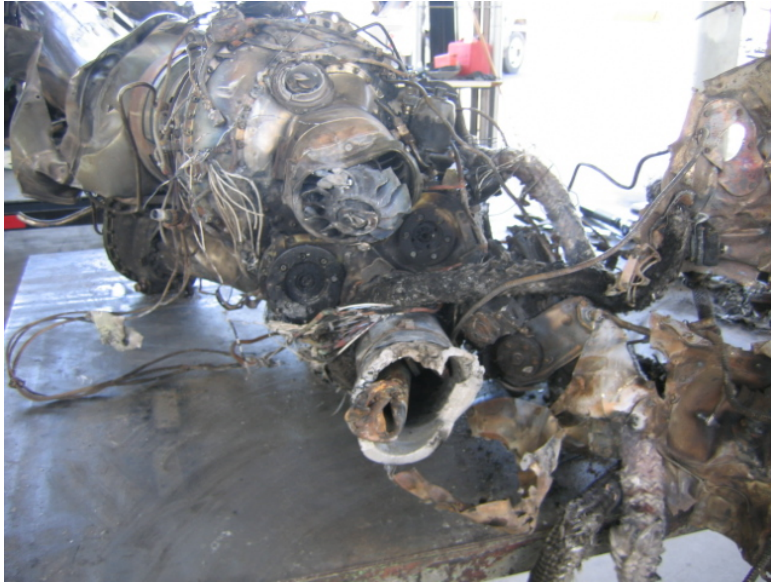
Figure 17. Turbomeca picture of axial compressor, coupling tube, and transmission shaft

Post accident examination of the Ch 15 engine revealed substantial mechanical and post-crash fire damage. The axial rotor blades appeared bent opposite the direction of rotation. The nose bullet appeared flattened and smeared in a direction opposite that of rotation. The coupling tube between the engine and main rotor transmission separated and was twisted and buckled with irregular fracture surfaces. The linking tube exhibited torsional twist and buckling. The transmission shaft was torsionally twisted; it buckled, and had an irregular fracture surface. The short shaft separated from the triangular flange at the rear of the turbine reduction gear, and was twisted and deformed. However, it remained connected to the triangular flange by a portion of the flexible coupling. The free turbine blades were in place, and appeared undamaged.

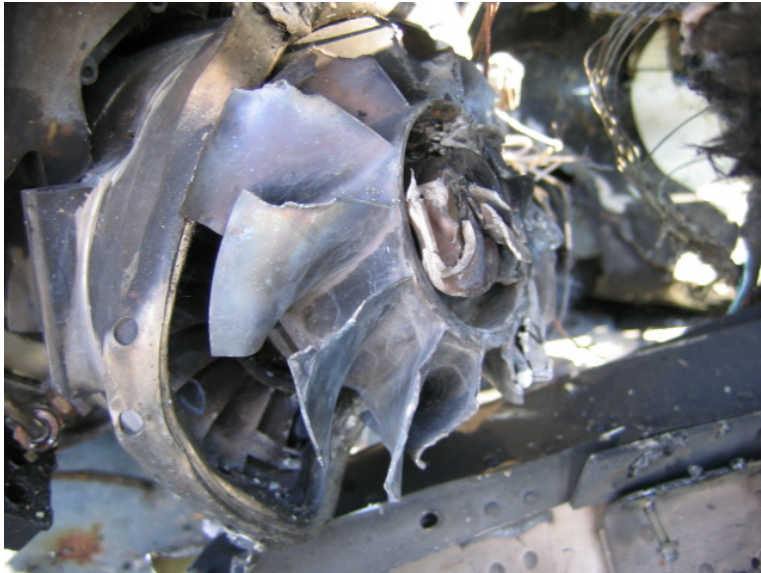
Figure 18. Turbomeca picture of axial rotor and nose bullet detailing bending and smearing opposite to the direction of rotation

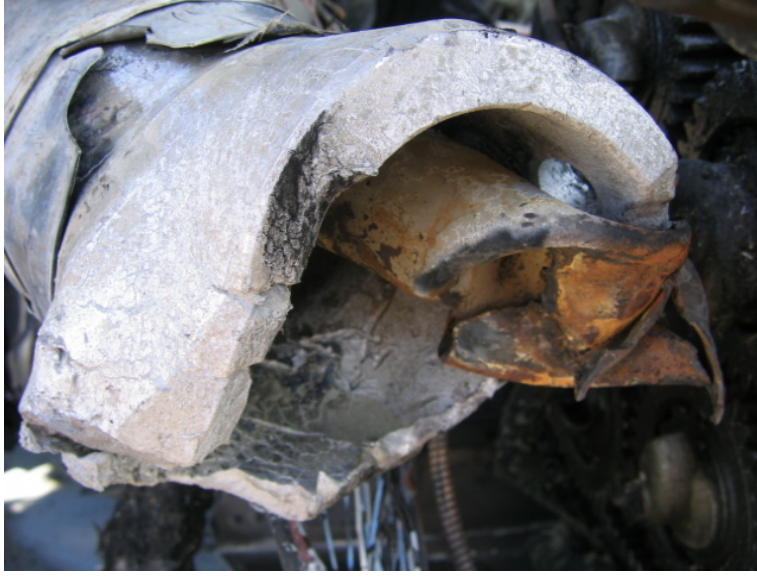
Figure 19. Turbomeca picture of coupling tube and transmission shaft - showing torsional twist

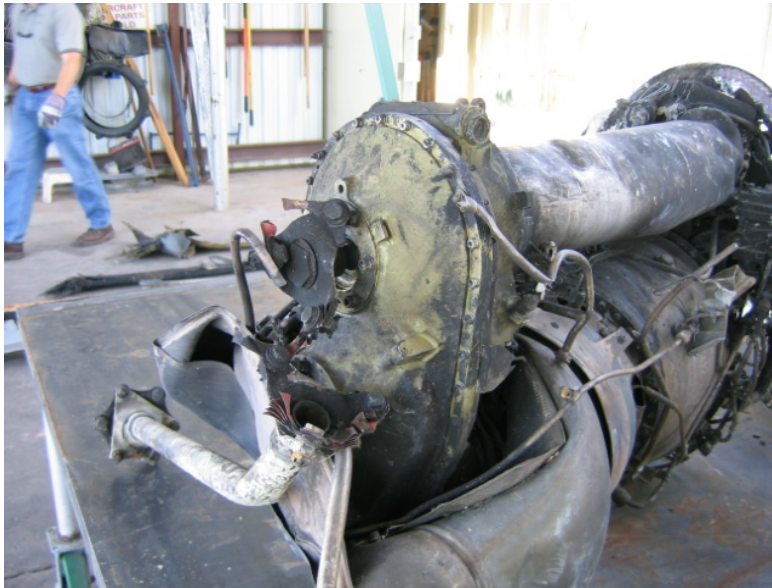
Figure 20. Turbomeca picture of flange at the rear of the turbine reduction gear and short shaft

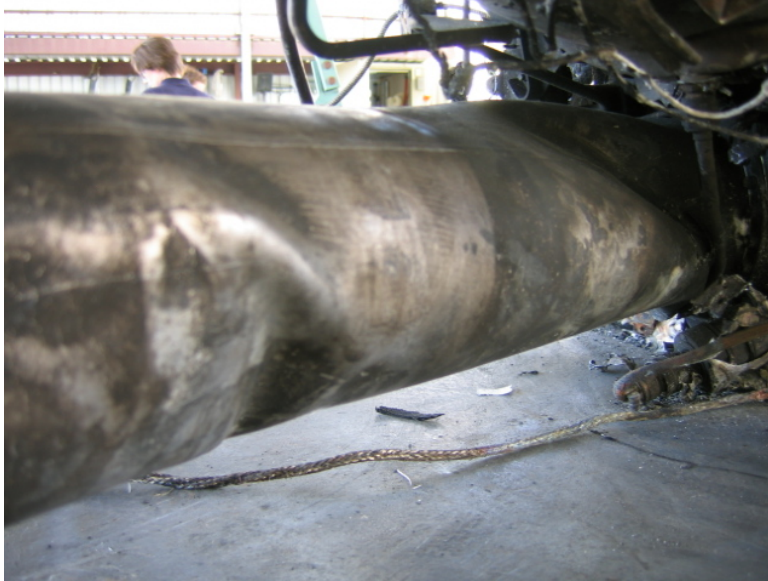
Figure 20. Turbomeca picture of linking tube - torsional twist

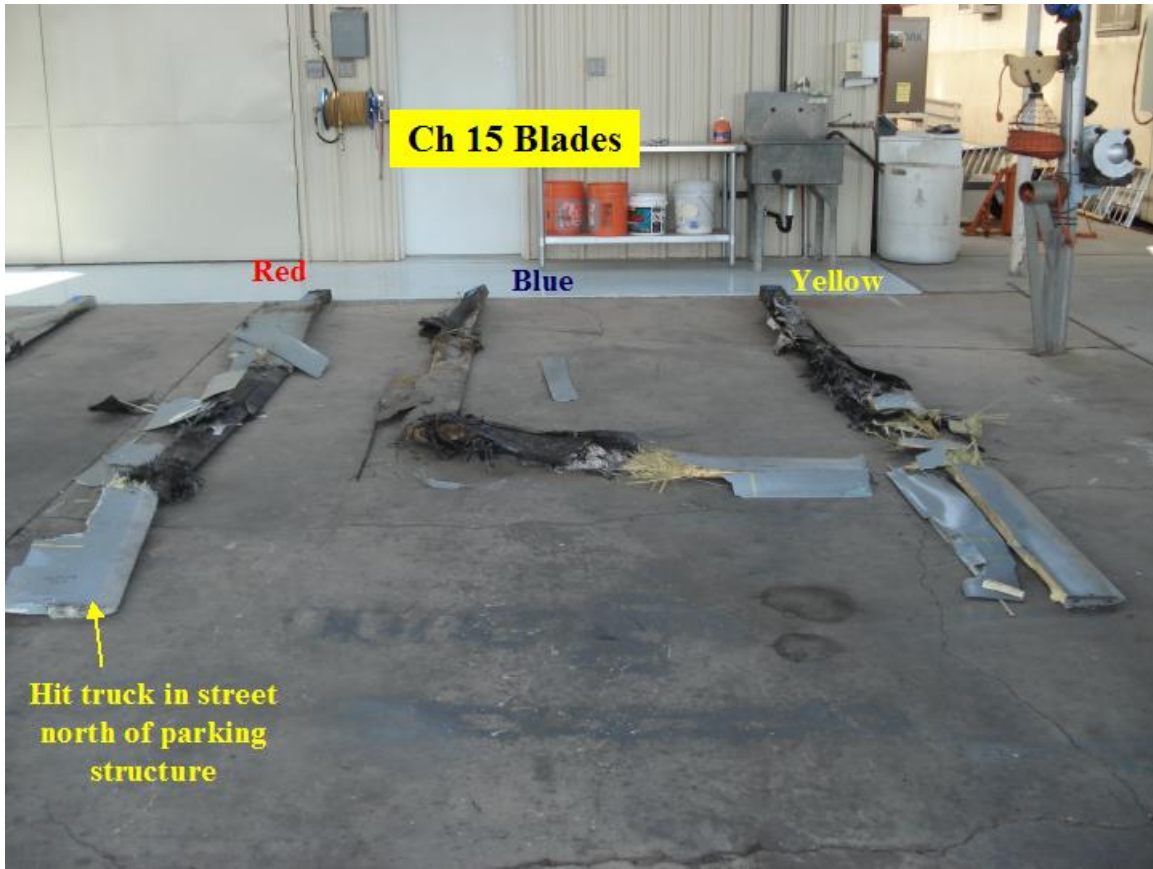
Figure 21. Eurocopter picture of Ch 15 main rotor blades

The leading edge sustained severe mechanical damage 6 1/2 feet from the root, and the blade separated at this point. The blade section aft of the spar was missing from the separation point to 12 feet 8 inches from the root. The leading edge stainless steel strip was also missing from this area. The outboard 2 feet 8 inches of the blade separated, and hit a delivery truck parked at 4041 North Central Avenue. This was 1,040 feet southwest of the Ch 15 main wreckage, and about 180 feet from the separated yellow blade piece from the Ch 3 helicopter. It damaged the hood of the truck, and came to rest about 10 feet away. The end plate was in place.

The leading edge sustained mechanical damage and separated 4 feet 8 inches from the root. The inboard sections of the blade sustained thermal damage. Large sections of blade

skin and foam core were missing. Investigators observed leading edge mechanical damage and forward bending from 9 feet 7 inches to 12 feet 10 inches. The blade piece outboard of this area separated; it was within the park boundaries about 560 feet south of the main wreckage. The end plate separated, and investigators found it in brush several feet away from the blade tip.

The blade sustained thermal damage from the root out to 8 feet 9 inches. Investigators observed severe mechanical damage and separation from 8 feet 9 inches to 11 feet 9 inches. A section of the leading edge stainless steel strip from this area exhibited blue-gray paint transfer marks. The blade section outboard of 11 feet 9 inches separated. This piece was within the park boundaries, and about 520 feet south of the main wreckage. It did not exhibit any thermal damage; the end plate was in place.
