## AIRCRAFT ACCIDENT REPORT

IN-FLIGHT LOSS OF CONTROL AND  
SUBSEQUENT COLLISION WITH TERRAIN  
CESSNA 177B, N35207  
CHEYENNE, WYOMING  
APRIL 11, 1996

**Adopted: March 11, 1997  
Notation 6814**

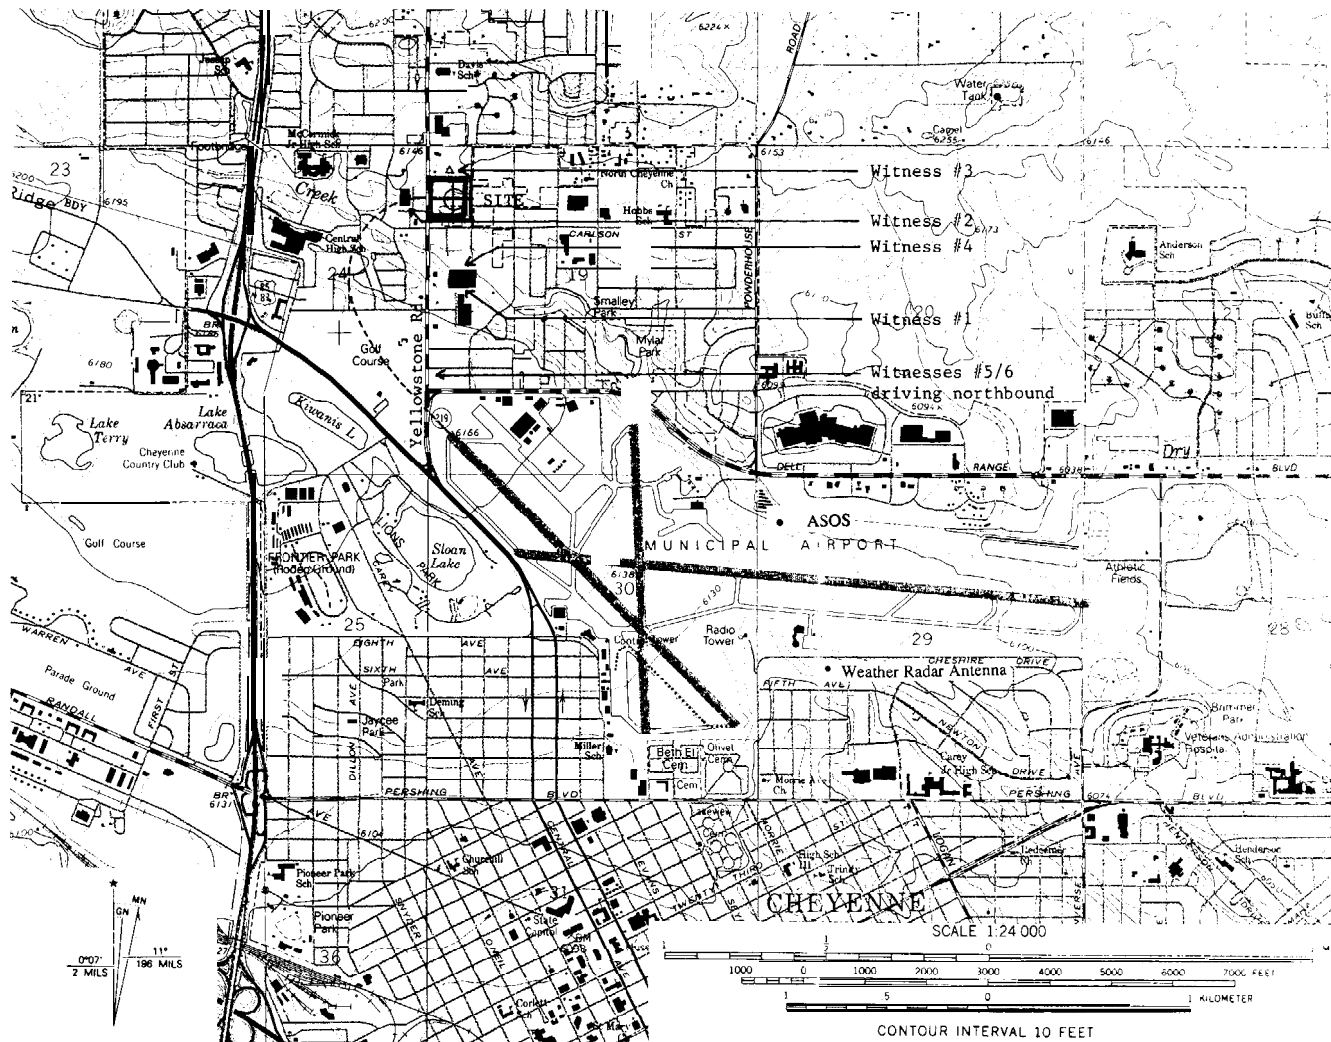
Figure 1.--Map depicting airplane ground track and airport.

Ground witnesses observed the airplane depart the upwind end of runway 30 heading in a northwesterly direction, and then execute a gradual right turn to an easterly heading. The witnesses generally described the airplane as having a low altitude, low airspeed, a high pitch attitude and wobbly wings. As it was rolling out of the right turn, at several hundred feet agl,<sup>10</sup> the airplane was observed to rapidly descend to the ground in a near-vertical flightpath. The impact occurred approximately 4,000 feet north of the departure (upwind) end of runway 30 in a residential neighborhood.

Eyewitnesses who observed all or part of the accident sequence reported that the weather conditions at that time were windy, with moderate to heavy mixed precipitation (rain, snow, and sleet), thunder and lightning. (Locations of eyewitnesses are noted on Figure 1.)

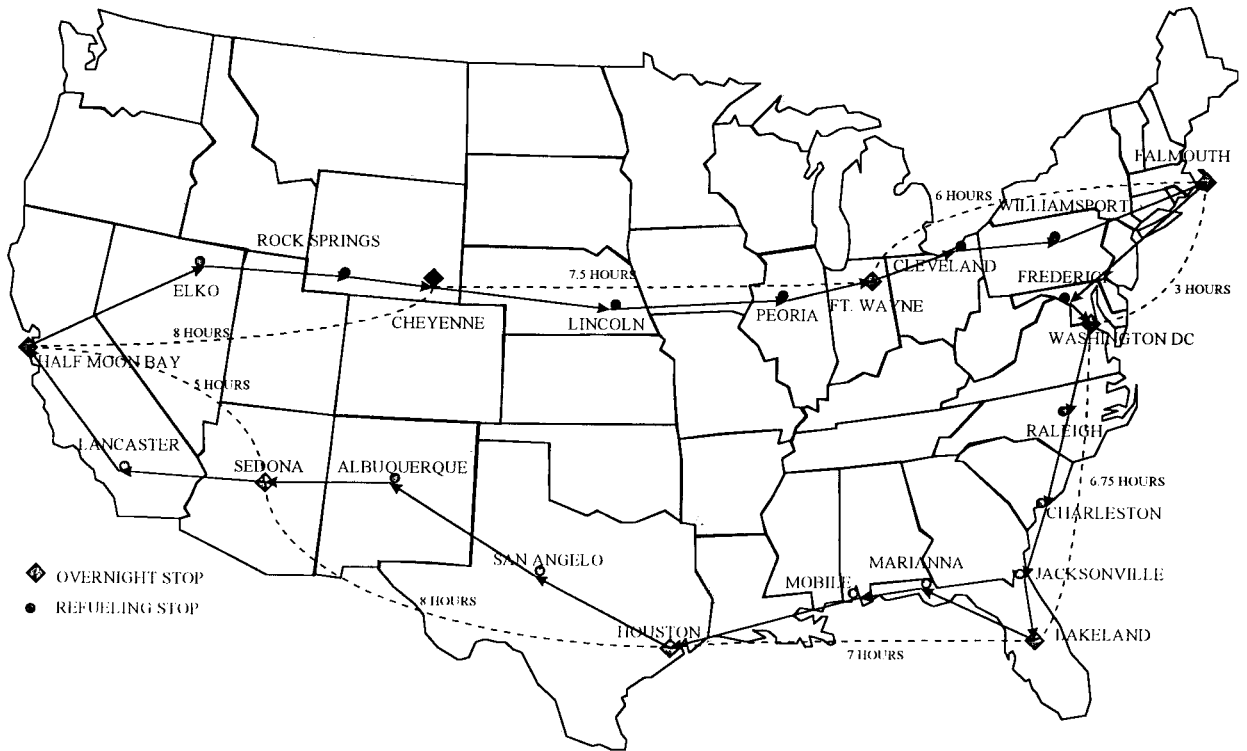
Figure 3.--Proposed route of flight.

The Safety Board concludes that the itinerary was overly ambitious, and that a desire to adhere to it may have contributed to the pilot in command's decision to take off under the questionable conditions at Cheyenne.
