NATIONAL TRANSPORTATION SAFETY BOARD

COLLISION OF TRACTOR/CARGO TANK
SEMITRAILER AND PASSENGER VEHICLE AND
SUBSEQUENT FIRE, YONKERS, NEW YORK,
OCTOBER 9, 1997

NTSB/HAR-98/02/SUM (PB98-916202)

Accident Number: HWY-98-F-H002
Accident Type: Collision and fire
Location: Yonkers, New York
Motor Carrier: Mystic Bulk Carriers, Inc.
Vehicle 1: 1994 Mack tractor and MC-306 cargo tank semitrailer
Vehicle 2: 1990 Eagle Premier sedan
Date: October 9, 1997
Time: 12:10 a.m.
Damage: Vehicles and overpass destroyed
Injuries: One fatality

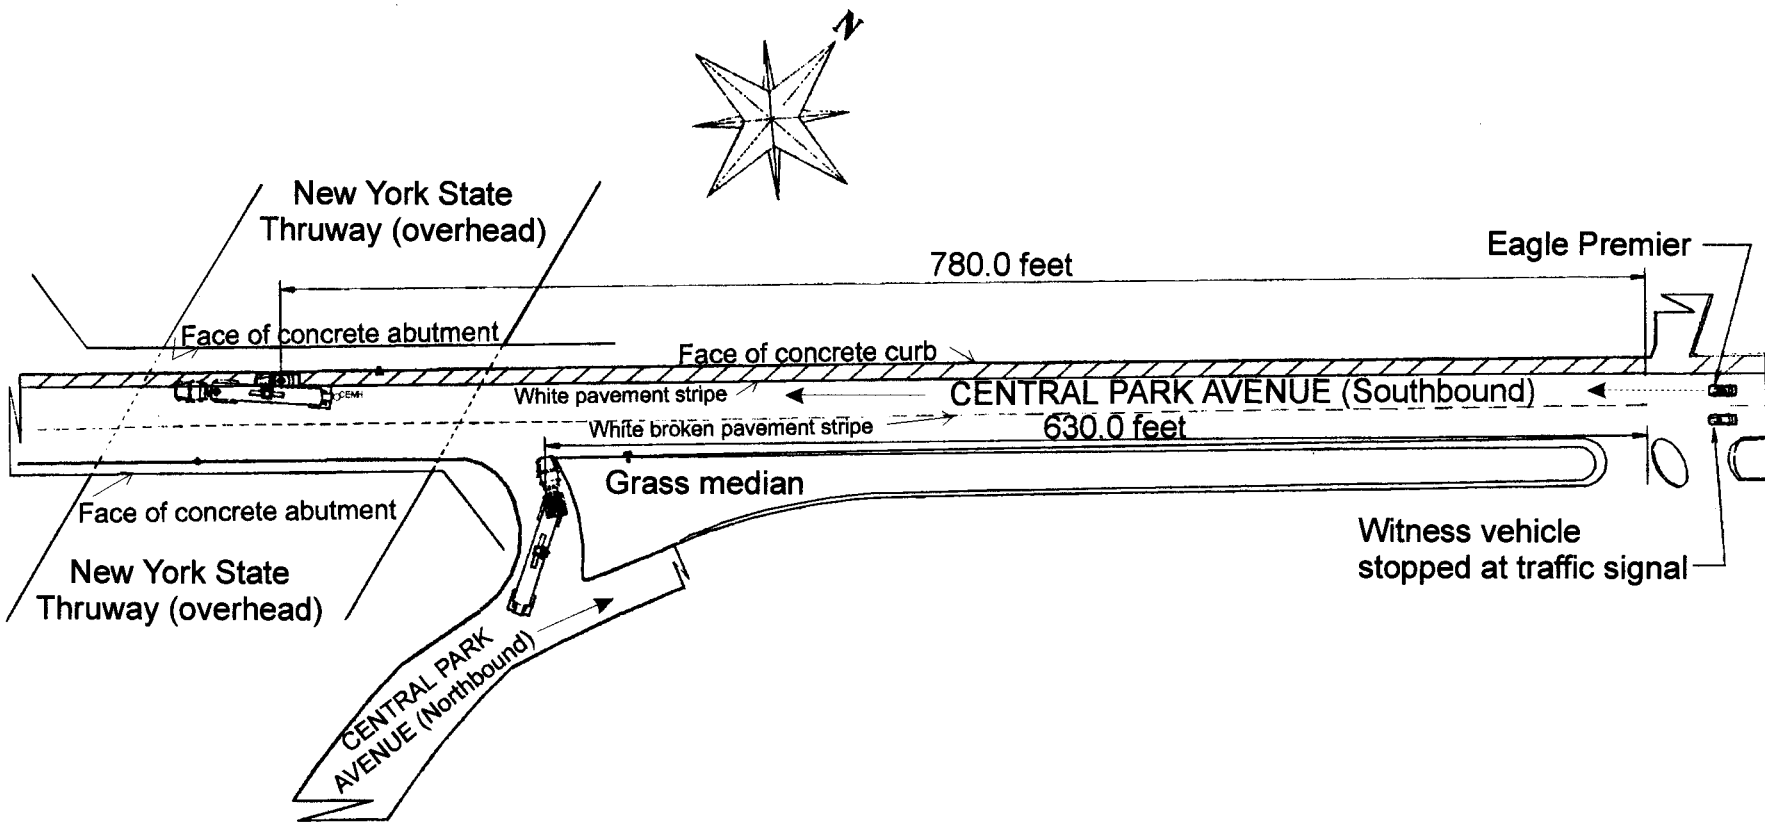
Figure 1.—Schematic of accident scene.

According to the witness, the truckdriver entered the U-turn lane and stopped at the yield sign. After stopping, the truckdriver turned to the left and began to go under the overpass. (See figure 1.)

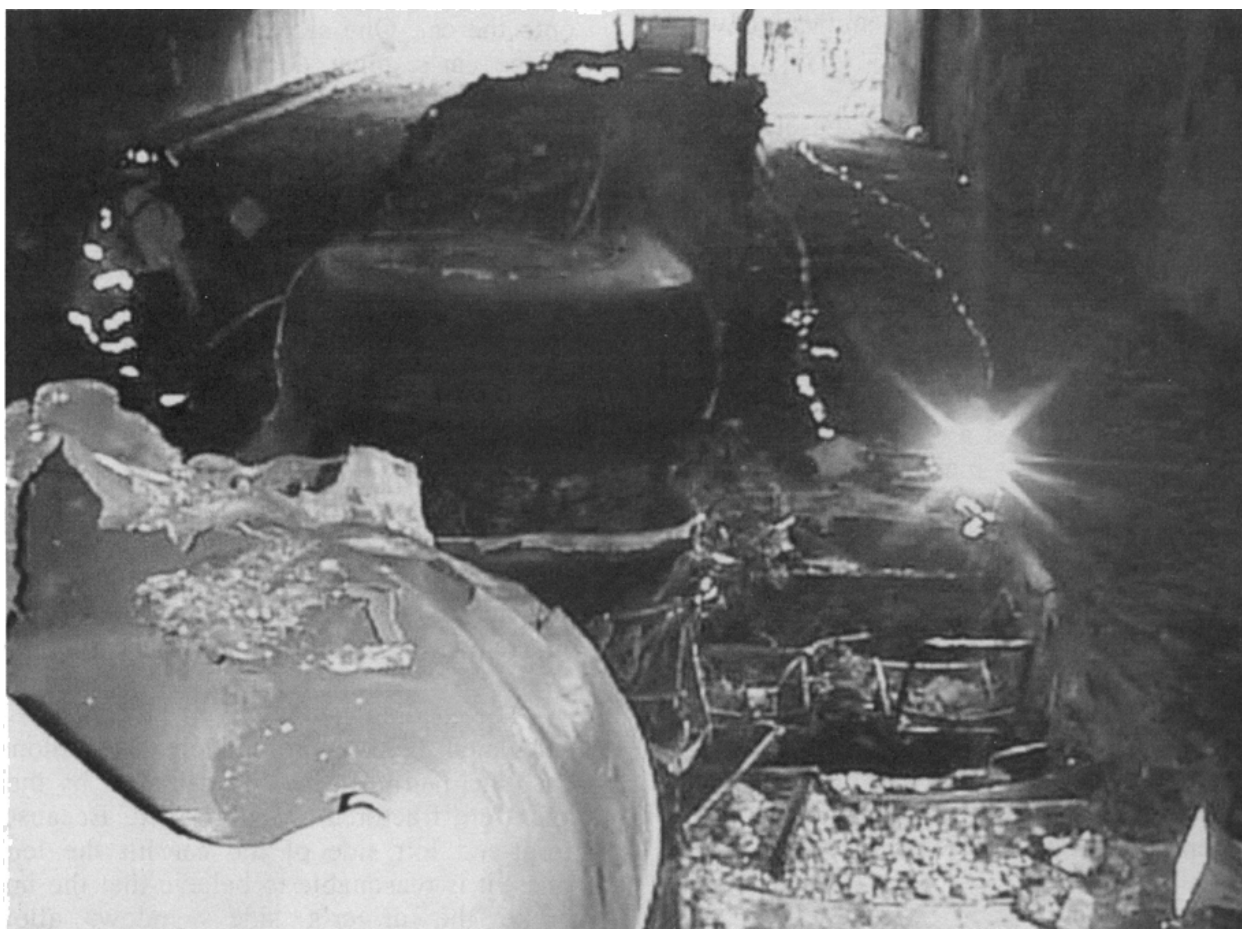
Figure 2.—Vehicles after fire.

Within several minutes both vehicles were fully engulfed in a massive fire, as was the thruway overpass.

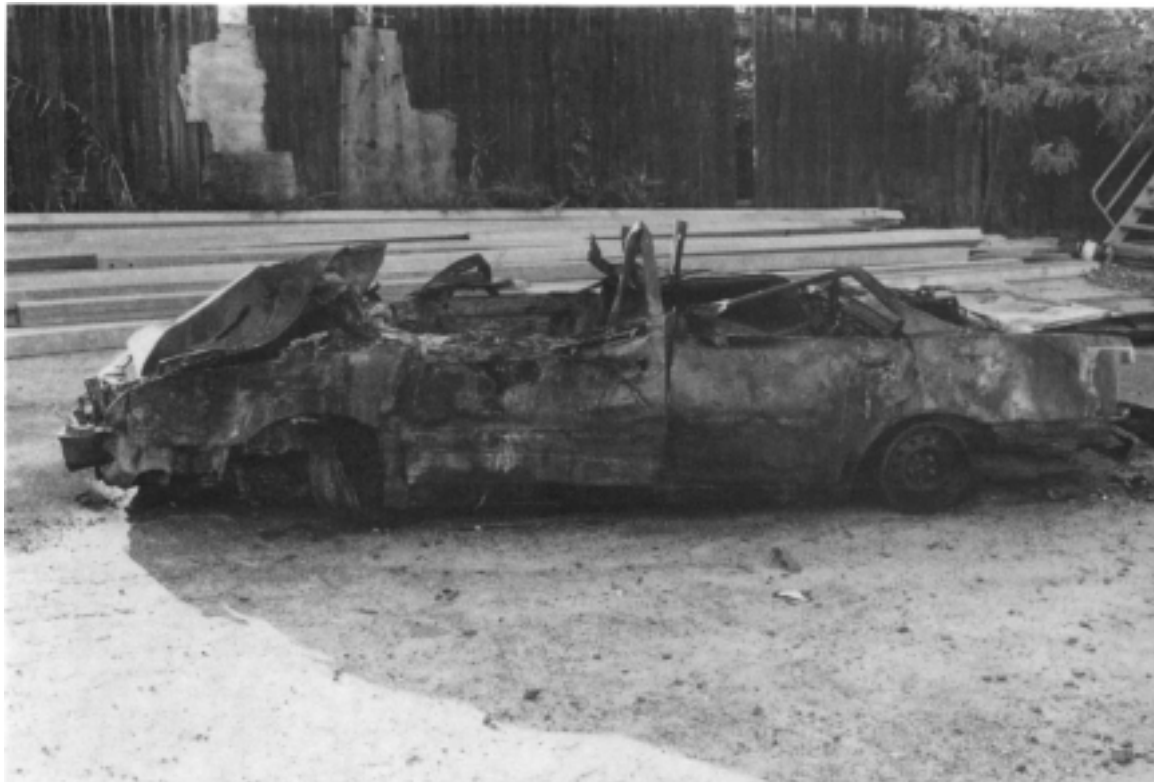
Figure 3.— Car after fire.

The impact pushed the left front quarter panel of the car to the right about 15 inches. A narrow, penetrating gouge ran along the left edge of the hood. The left front wheel assembly was displaced rearward approximately 18 inches, and the outboard edge of the wheel was damaged. The driver's side door was pushed inward and rearward, and the length of the door was gouged horizontally. Because of the intense heat of the fire, the entire roof had buckled inward. The interior and exterior of the car were destroyed by the fire. (See figure 3.)

The accident had not intruded into the passenger's compartment, and there was no evidence that the car driver had suffered from blunt trauma or fractures. According to the autopsy report, he died from burns and smoke inhalation. That he was able to crawl into the rear seat area after the accident, in an apparent attempt to flee the car and the gasoline, also suggests that he was not seriously hurt by the impact. Consequently, the Safety Board concludes that the car driver would have survived the accident had there not been a fire.

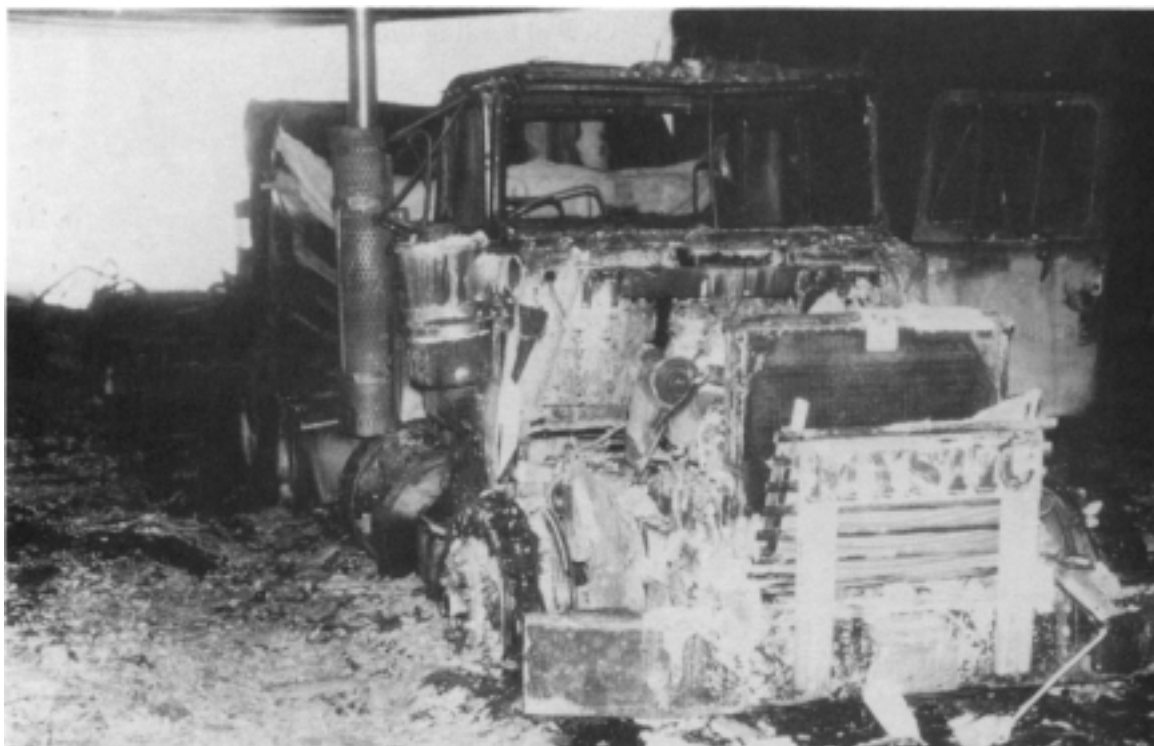
Figure 4.— Truck after fire.

The tractor had an EM7-300 diesel engine and a 7-speed transmission. Because the shifter linkage coupler had been damaged by the fire, it was not possible to determine the gear position. Mystic's records indicated that the tractor had been serviced a month before the accident and was in good mechanical condition. (See figure 4.)

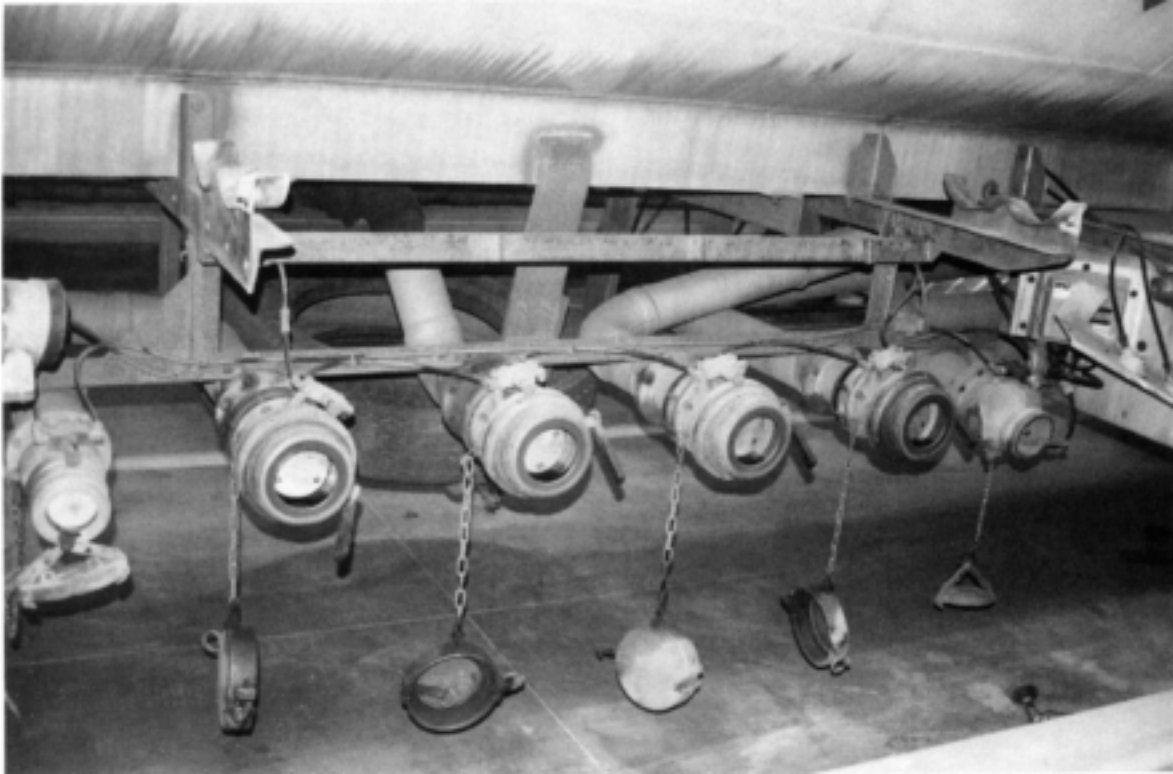
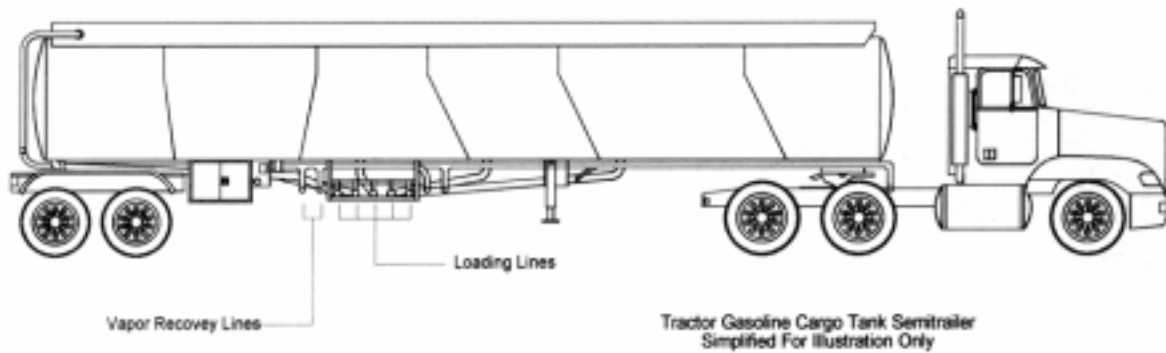
Figure 5a.—View of loading lines.

Each compartment is connected to an outlet valve by a 4-inch-diameter aluminum loading line. Each loading line is attached to a device that is designed to break during an accident to prevent the loading line from tearing a hole in the bottom of the compartment and releasing the contents. (See figures 5a and 5b.)

When the accident car was observed in its final position, it was wedged between the cargo tank and the curb, in the area of the cargo tank's loading lines; the left side of the car was touching the right side of the cargo tank in the area of the loading lines, and the car's right wheels were against the north curb line. A section of aluminum from the cargo tank had melted and become attached to the car. The aluminum was near the firewall at the driver's position and at the base of the "A" pillar (the pillar to which the left side of the windshield is attached). Two sections of chain (typically used to attach end caps to loading lines) had melted onto the car. One section had become attached to the car's upper door trim in the area just behind the spot where the side view mirror had been mounted, and the other section was attached to the upper edge of the left quarter panel at a point near the center of the panel. The investigators also found an end-cap cam-lock arm on the support cross member of the car's radiator; the carrier later identified the cam-lock arm as having secured an end cap to a loading line.

Based on the way in which the vehicle was damaged and on the statement of the witness, the Safety Board believes that the car probably struck the cargo tank near the loading lines. The positions of the sections of the aluminum and the chains that had melted onto the car were adjacent to the loading lines of the cargo tank.

The loading lines, which the Safety Board calculated held approximately 28 gallons of gasoline, had been heavily damaged by the fire and were fractured and deformed. Because the front-end left side of the car hit the loading lines, it is reasonable to believe that the impact broke the driver's side window, allowing gasoline from the loading lines to enter the car's passenger compartment. Therefore, the Safety Board concludes that the car struck and fractured one or more of the loading lines of the cargo tank, thus releasing up to 28 gallons of

gasoline. The Safety Board believes that the immediate result was a fire inside and below the car.

Prohibit the carrying of hazardous materials in external piping of cargo tanks, such as loading lines, that may be vulnerable to failure in an accident.
(H-98-27)

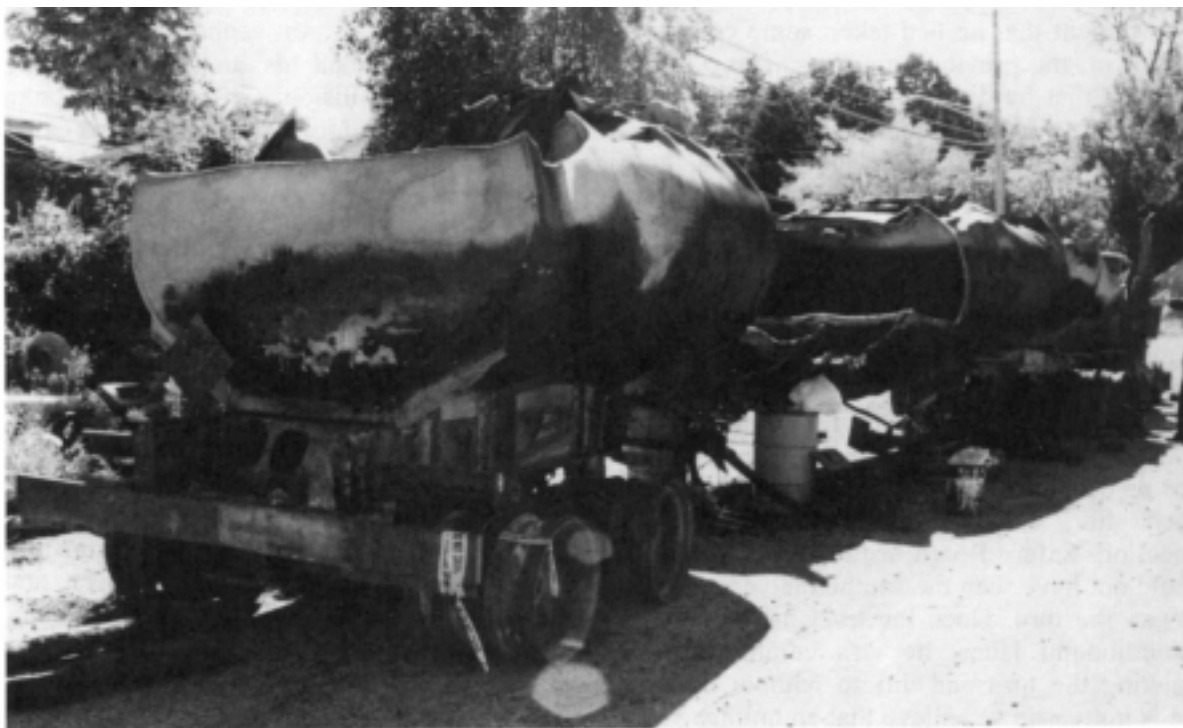
Figure 6.—Melted tanker truck.

The heat of the fire had partially consumed the cargo tank, melting much of the shell in the upper half of the tank. (See figure 6.) Consequently, the fuel for the initial fire was the gasoline that was released from the cargo tank's loading lines during impact. The fire was then fed with gasoline from the cargo tank's compartments. The Safety Board concludes that had the loading lines been empty, the fire would likely not have occurred.

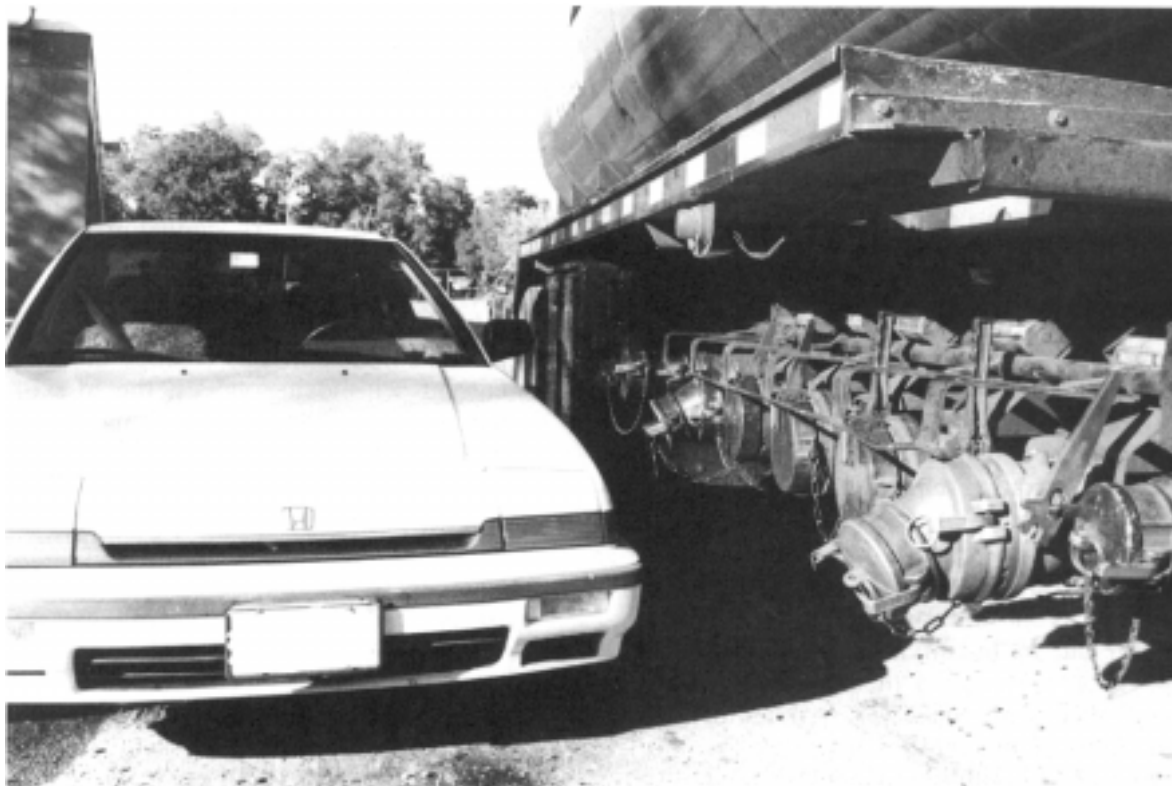
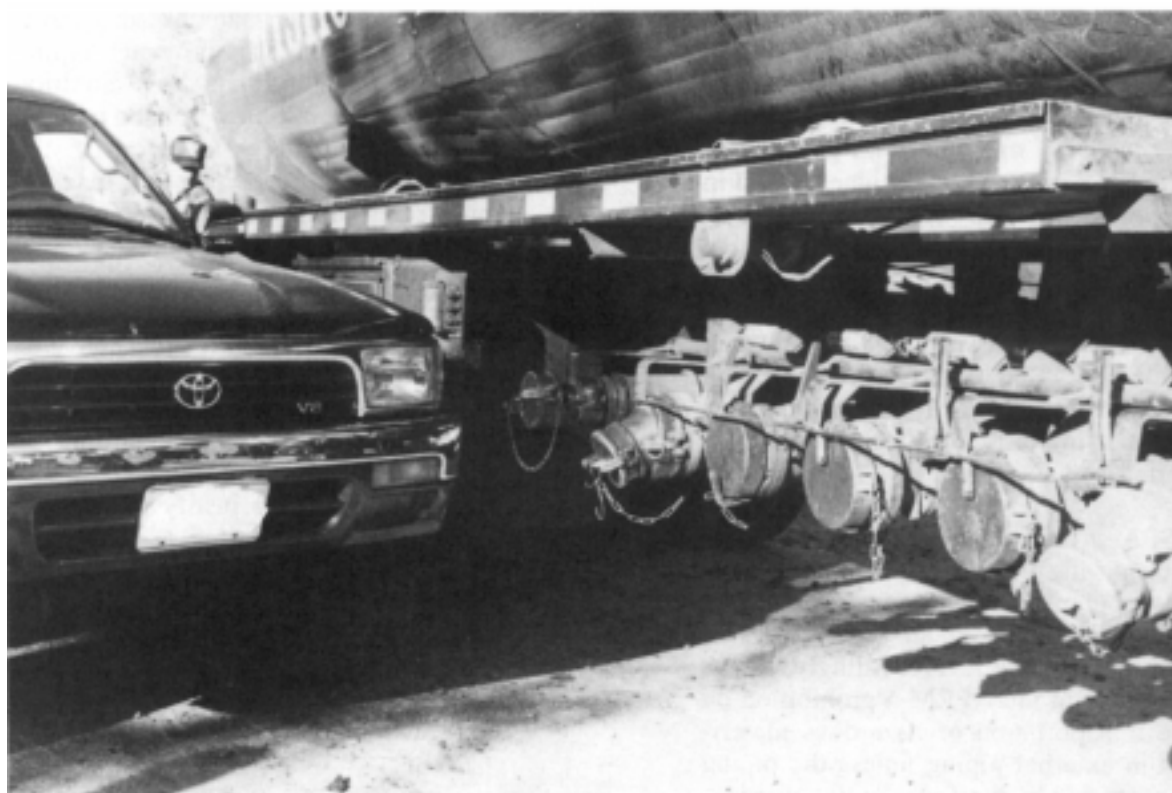
Figure 7.—Two views of cars next to loading lines.

Safety Board investigators demonstrated the vulnerability of loading lines by placing 12 passenger vehicles (varying in type and size) near the loading lines of a cargo tank that was similar to the accident cargo tank. Each vehicle was placed so that the angle between it and the truck was approximately the same as the angle between the accident car and the accident truck. The investigators found that each of the 12 vehicles would have struck the loading lines of the truck had the vehicle moved forward. (See figure 7.) Therefore, the Safety Board believes that most vehicles currently in use are capable of striking the loading lines of cargo tanks.

The Safety Board concludes that transporting hazardous materials in loading lines creates a hazardous condition. Therefore, the Safety Board believes that the DOT should prohibit the carrying of hazardous materials in external piping of cargo tanks, such as loading lines, that may be vulnerable to failure in an accident.
