## RAILROAD ACCIDENT REPORT

COLLISION BETWEEN UNION PACIFIC  
FREIGHT TRAINS MKSNP-01 AND ZSEME-29  
NEAR DELIA, KANSAS  
JULY 2, 1997

NTSB/RAR-99/04  
PB99-916304  
Notation 6899B  
Adopted: August 31, 1999

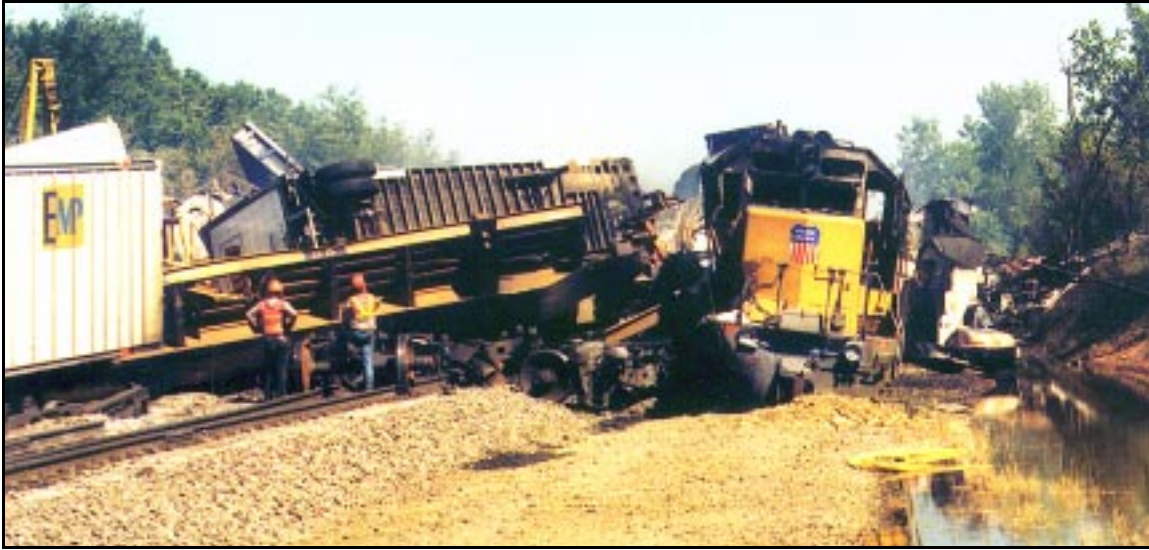
**Figure 3.** Accident site (looking east). Unit facing camera is the lead locomotive of westbound train NP-01.

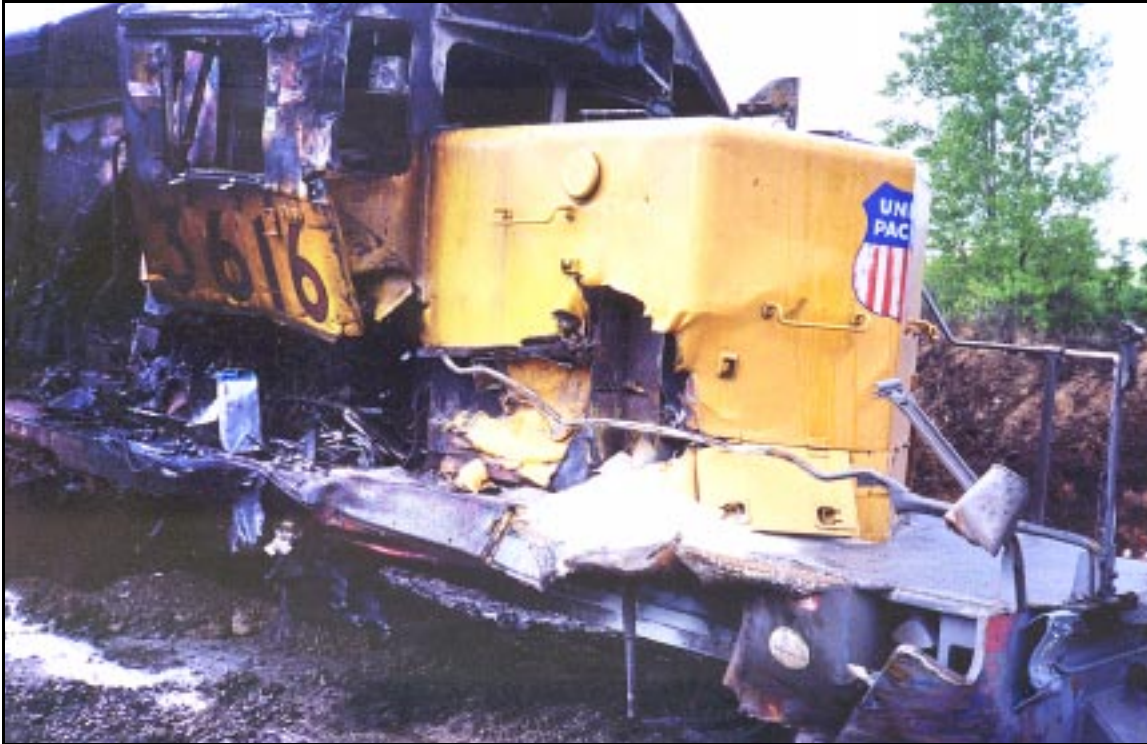
The control stand was displaced rearward 3 feet (figure 4). The right side wall at sill level showed extensive intrusion damage and was separated from the sill. The upper half of the right rear control compartment door was displaced inward and jammed in the door frame. The left front door was open. All window glazing was broken out of the

**Figure 4.** Unit UP 3616, the lead locomotive of train NP-01

window frames in the control compartment. The fuel tank was still attached to the underside of the sill; however, the tank's front wall was crushed rearward and was distorted, gouged, and holed on its left side and its underside.

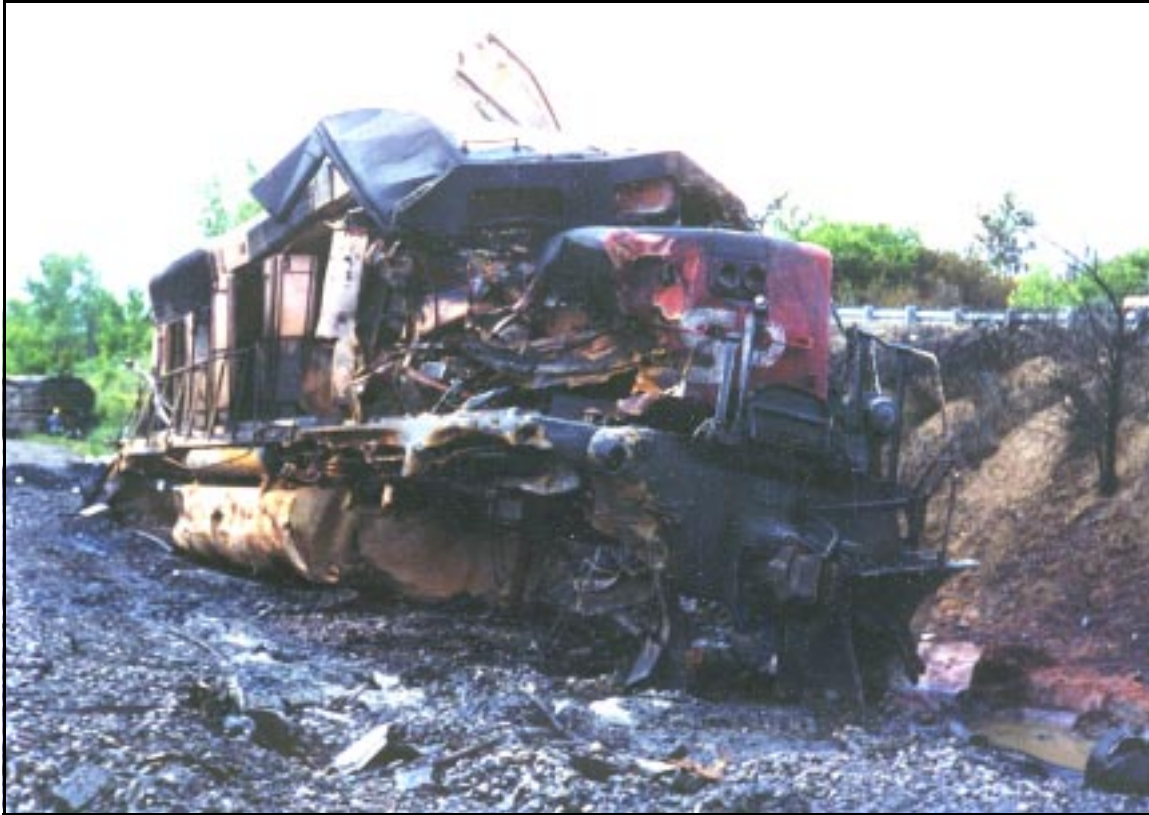
**Figure 5.** Unit SP 7519, the second locomotive of train NP-01

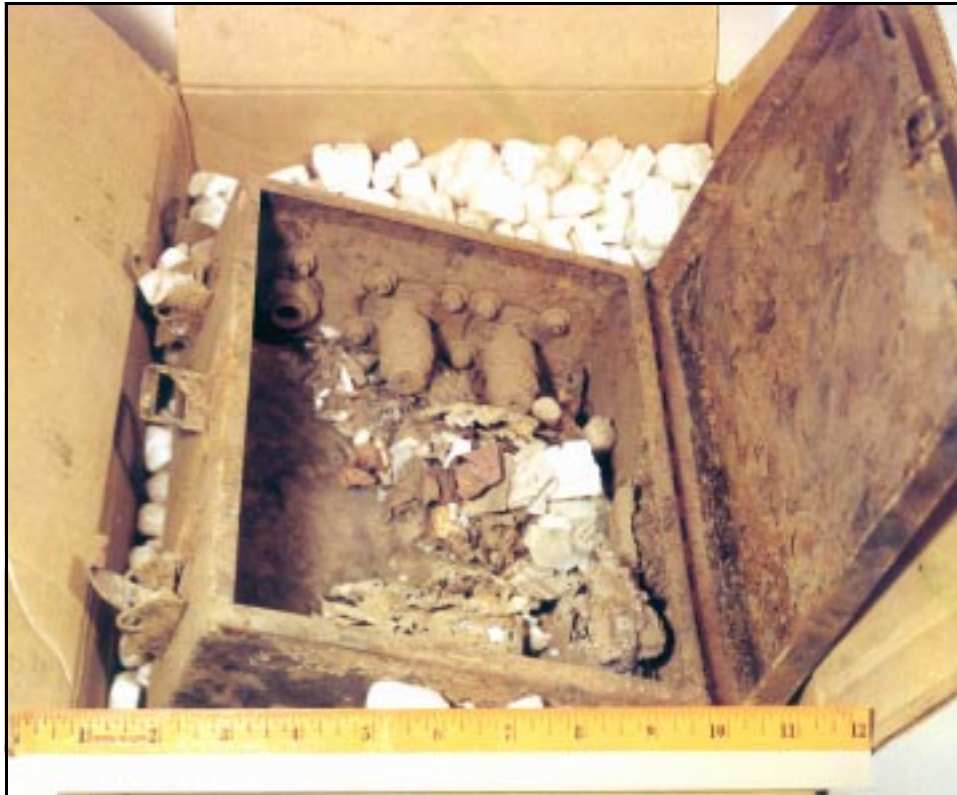
The event recorder of NP-01's lead unit, UP 3616, was destroyed by the collision and fire (see figure 9). The second unit was not required to be and was not equipped with an event recorder. UP officials printed out the recorded data from train ME-29's event recorders under the supervision of Safety Board investigators.

**Figure 9.** The event recorder from UP 3616, train NP-01's lead locomotive

To identify measures for improving railroad safety, it is essential that event recorder data be preserved after a catastrophic event. In this accident, fire destroyed the event recorder on train NP-01's lead locomotive unit. Inspection of the fire-damaged units showed that the location of the recording equipment provided satisfactory protection from crash forces. However, the type of encasement designed by the manufacturer did not protect the event recorder from the effects of the fire. The Safety Board therefore was not able to determine what actions the engineer did or did not perform after the train left Kansas City. Consequently, vital information about such functions as braking, throttle manipulation, and the chronological relationship of precollision events, was not available.
