National Transportation Safety Board

Hazardous Materials Accident Brief

Accident No: DCA99MZ003
Location: Louisville, Kentucky
Date of Accident: November 19, 1998
Time: 8:15 a.m. eastern standard time
Carrier: Matlack, Inc.
Vehicles: MC-307 Cargo Tank
Injured: 7 minor
Evacuated: About 2,400 people were evacuated from the plant and surrounding business. About 600 local residents were told by authorities to remain inside their homes.
Property Damage: In excess of \$192,000
Materials Involved: Nickel nitrate and phosphoric acid solution reacting with sodium nitrite solution
Type of Accident: Chemical reaction during cargo transfer

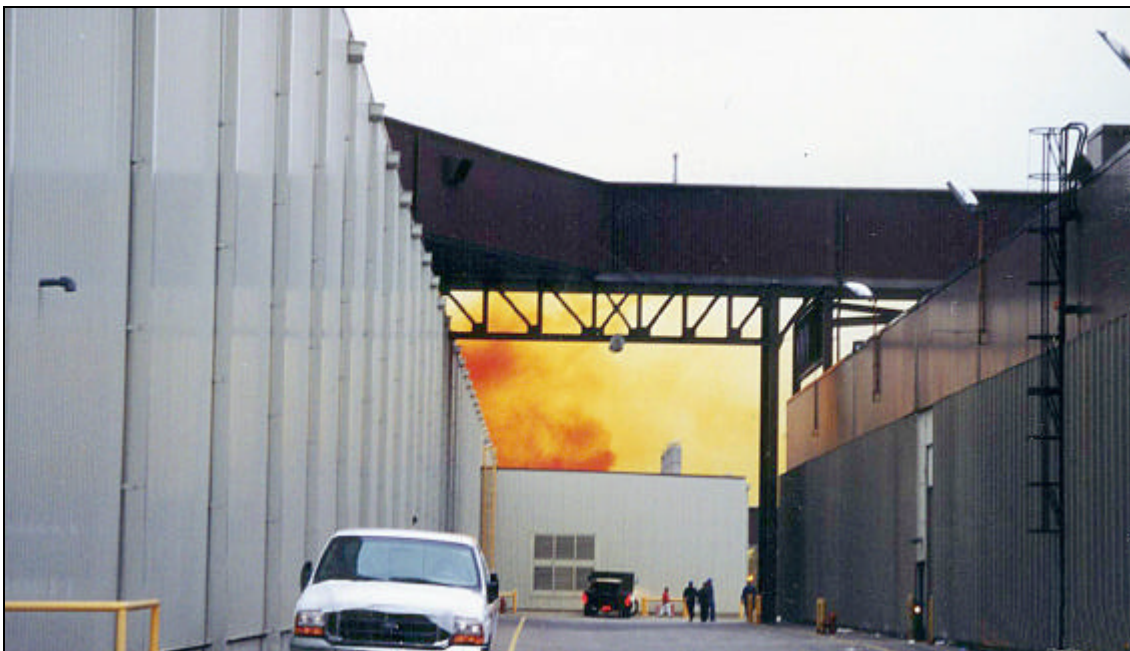
About 8:15 a.m., after the air pressure was built up in the cargo tank, the truckdriver started the transfer. When the nickel nitrate and phosphoric acid solution from the truck mixed with the sodium nitrite solution in the storage tank, a chemical reaction occurred that produced toxic gases of nitric oxide¹ and nitrogen dioxide.² The driver stated that about 10 minutes after he started the transfer, he saw an orange cloud coming from the bulk storage building. (See figure 1.) He said he closed the internal valve of the cargo tank to stop the transfer of cargo and waited for someone to come out of the building. After several minutes, the pipefitter ran out of the building and gestured for the driver to stop the unloading process.

Figure 1. Postaccident view of the bulk storage building (center) with vapor cloud visible

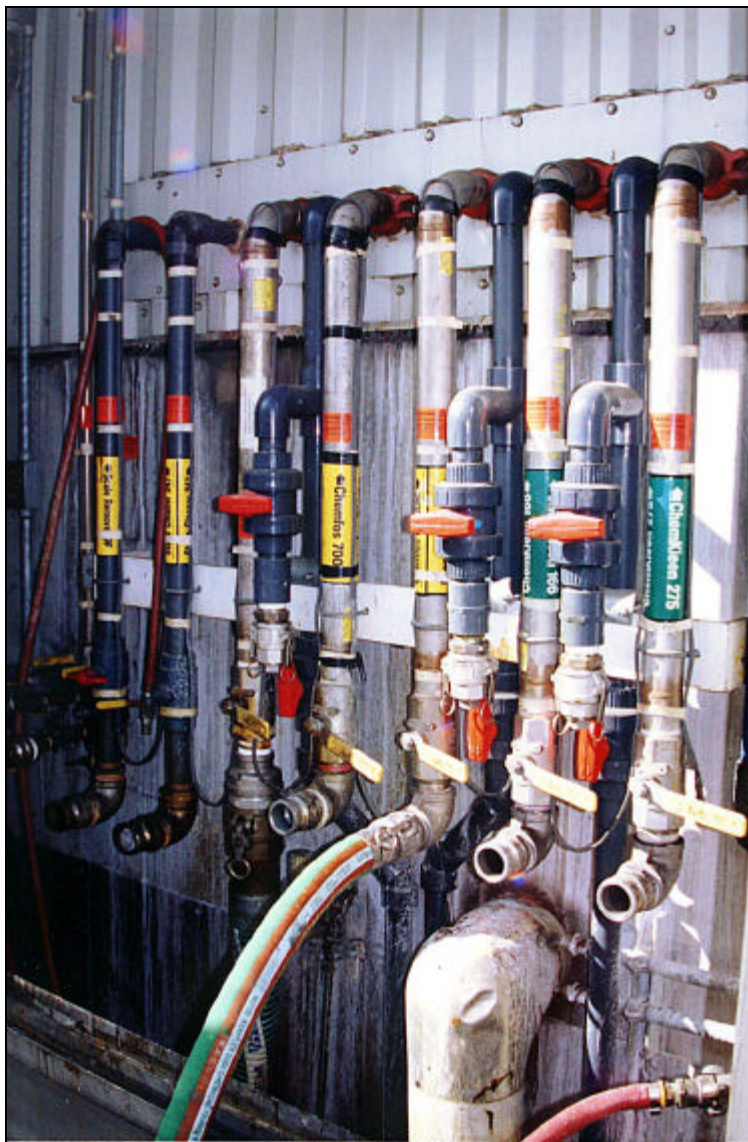
The chemical transfer station for unloading cargo tanks was on the outside of the bulk storage building. The system consisted of six 2-inch pipe connections enclosed in an access panel. (See figure 2.) The connections were identical stainless steel quick-connect couplers, and each had a shutoff valve. Each connection led to a different chemical storage tank. The couplings were not equipped with caps or locks, nor could the access panel be secured when the system was not in use.

Figure 2. Transfer coupler access panel with transfer hose attached

According to Ford officials, the company now requires that before a cargo tank can be unloaded, the proper connection of the transfer hose must be verified by specially trained company personnel, the truckdriver, and an on-site chemical supplier employee (if available). The company has also upgraded the signs at transfer stations, installed color-coded key locks on pipe end caps, installed locks on the access panel, and posted unloading instructions at the transfer station.

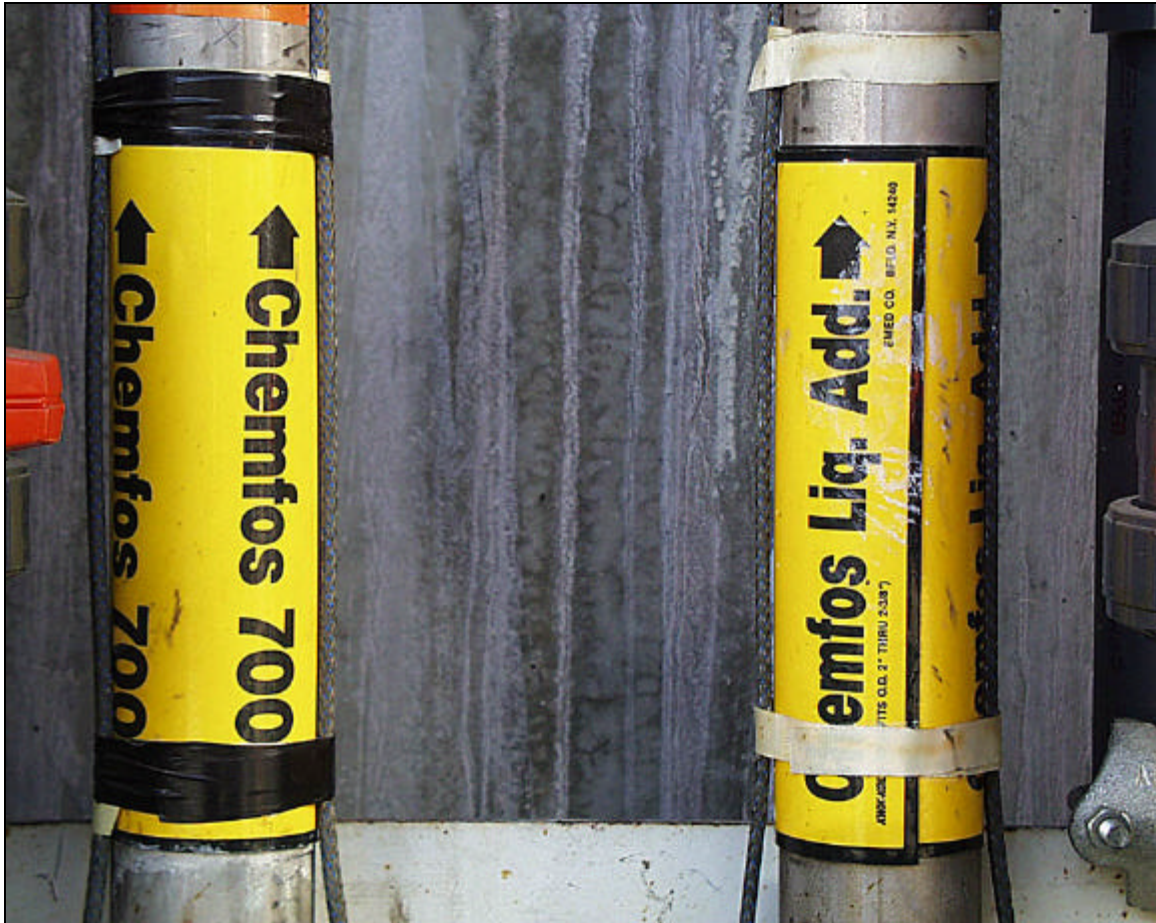
The connection for the nickel nitrate and phosphoric acid solution was labeled “CHEMFOS 700” in black print on a yellow background. An identical adjacent pipe had similar labeling, but the wording on the label was “CHEMFOS LIQ. ADD,” which was partially obscured by tape. (See figure 3.)

Figure 3. Close-up view of the correct transfer coupler (left) and the coupler to which the transfer hose was inadvertently attached (right)

The National Transportation Safety Board determines that the probable cause of this accident was inadequate training of Ford Motor Company's employees on the company's procedures for unloading bulk hazardous materials. Contributing to the accident was the similar labeling of adjacent pipe connections, which made it possible for the pipefitter to confuse the two connections. Further contributing to the accident was the failure of the U.S. Department of Transportation to establish, and oversee compliance with, adequate safety requirements for unloading hazardous materials from highway cargo tanks.
