Hazardous Materials Accident Report

Release and Ignition of Hydrogen Following Collision of a Tractor-Semitrailer with Horizontally Mounted Cylinders and a Pickup Truck near Ramona, Oklahoma May 1, 2001

**NTSB/HZM-02/02
PB2002-917003
Notation 7371A
Adopted September 17, 2002**

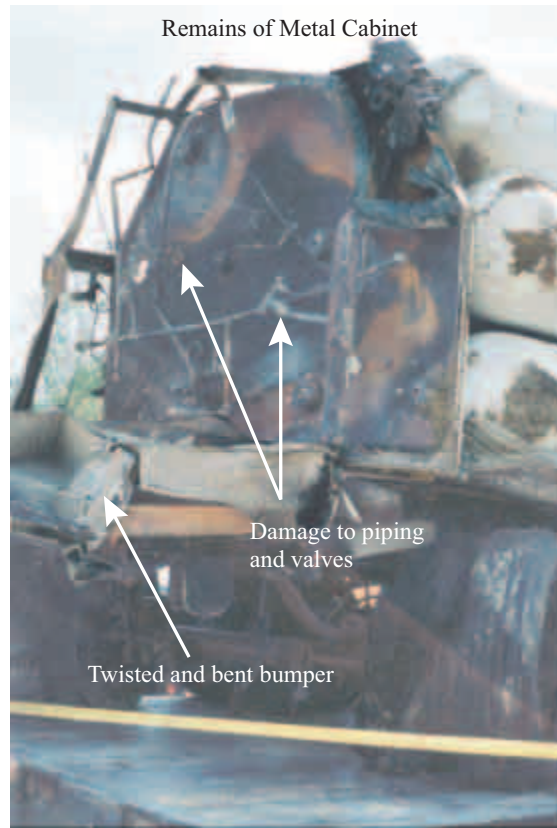
The cabinet, which enclosed the valves, piping, and fittings for the cylinders, had separated from the rear bulkhead and was crushed inward from the passenger side of the semitrailer toward the driver's side. (See figure 4a. Figure 4b shows the rear view of a similar vehicle configuration without damage.) The master valve and the shutoff valves, piping, and fittings for eight of the cylinders had been sheared off. The valves for the other two cylinders were intact but broken away from their piping. Both valves were bent in a direction consistent with the application of a force applied from the right side of the trailer.

Figure 4a. Cabinet after accident; 8 of the 10 valves have been sheared off.

During the accident and rollover, nearly all of the shutoff valves, piping, and fittings for the 10 cylinders were destroyed by the impact with the roadway and/or terrain. Eight of the 10 shutoff valves were sheared off, resulting in the release and ignition of the hydrogen. The master valve was also destroyed by impact damage. The metal cabinet

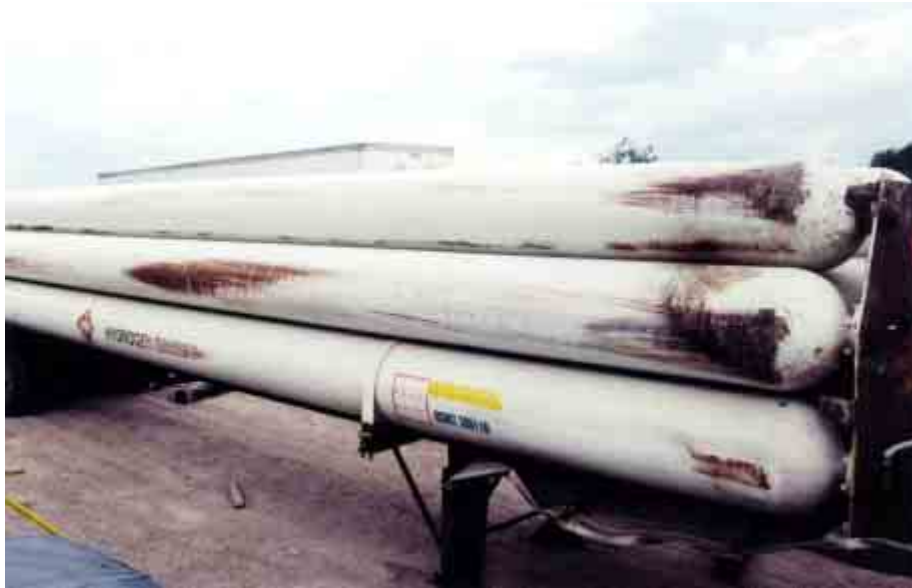
Cylinders. The paint on the rear end of most of the cylinders (cylinders 1, 2, 4, 7, 8, and 9) was sooted and discolored. The sooted area was directly over the rear tires, which were shredded and burned. The paint on the outboard side of each outside cylinder (cylinders 1, 2, 3, 6, 7, and 10) was, to varying degrees, scraped along the length of each cylinder. (See figure 5.) These cylinders extended beyond the envelope formed by the bulkheads. (Refer to figure 1.) Cylinder 1 also had scraped paint that extended around its circumference in a 2- to 3-foot-wide strip near the middle of the cylinder. The unpainted threads at each end of cylinder 1 were also visible. (The unpainted threads cannot be seen when a cylinder is fully screwed into flanges bolted to the front and rear bulkheads. The flanges secure the front and rear of the cylinder to the front and rear bulkheads of the semitrailer.) (See figure 6.)

Figure 5. Scrapes on the outboard sides of cylinders on the accident semitrailer.

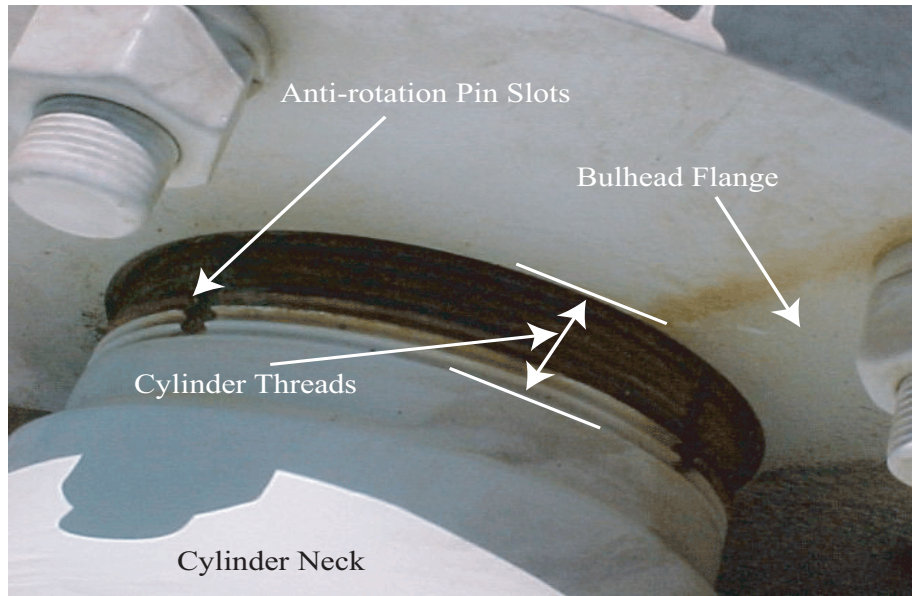
Figure 6. Unpainted threads of cylinder 1 next to the bulkhead flange.

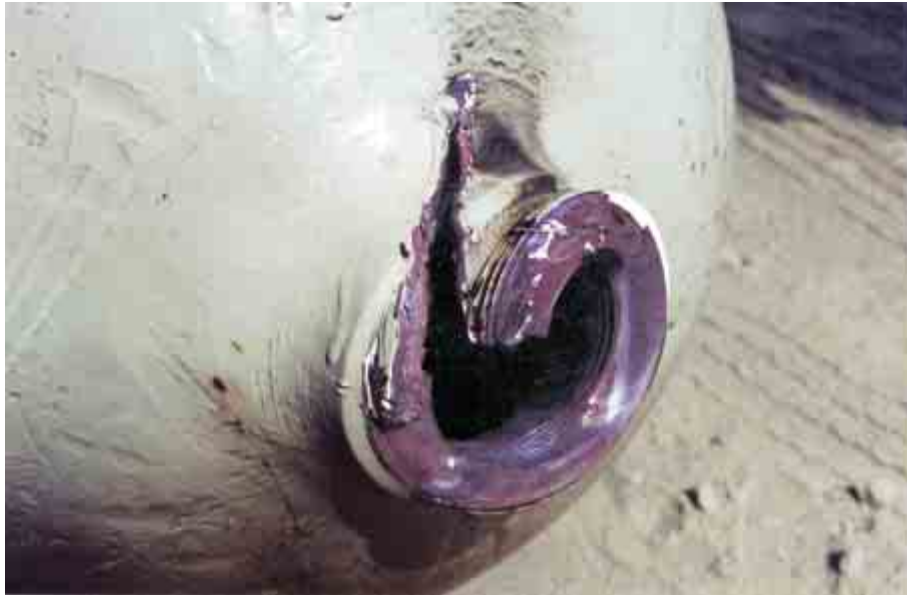
Cylinder 3, which had been ejected from the vehicle, also had circumferential abrasions. The front neck/shoulder of the cylinder was fractured (see figure 7). The fracture features and deformation were consistent with an overstress fracture. The threads on the rear neck of the cylinder and the threads on the rear flange were also damaged, with off-axis rotational scoring.

Figure 7. Cylinder 3's forward end, which has an overstress fracture on its shoulder and a spiral crack from the fracture surface into the head of cylinder.
