**Nurse Tank Failure With Release of Hazardous Materials
Near Calamus, Iowa
April 15, 2003**

**Hazardous Materials
Accident Report**

NTSB/HZM-04/01

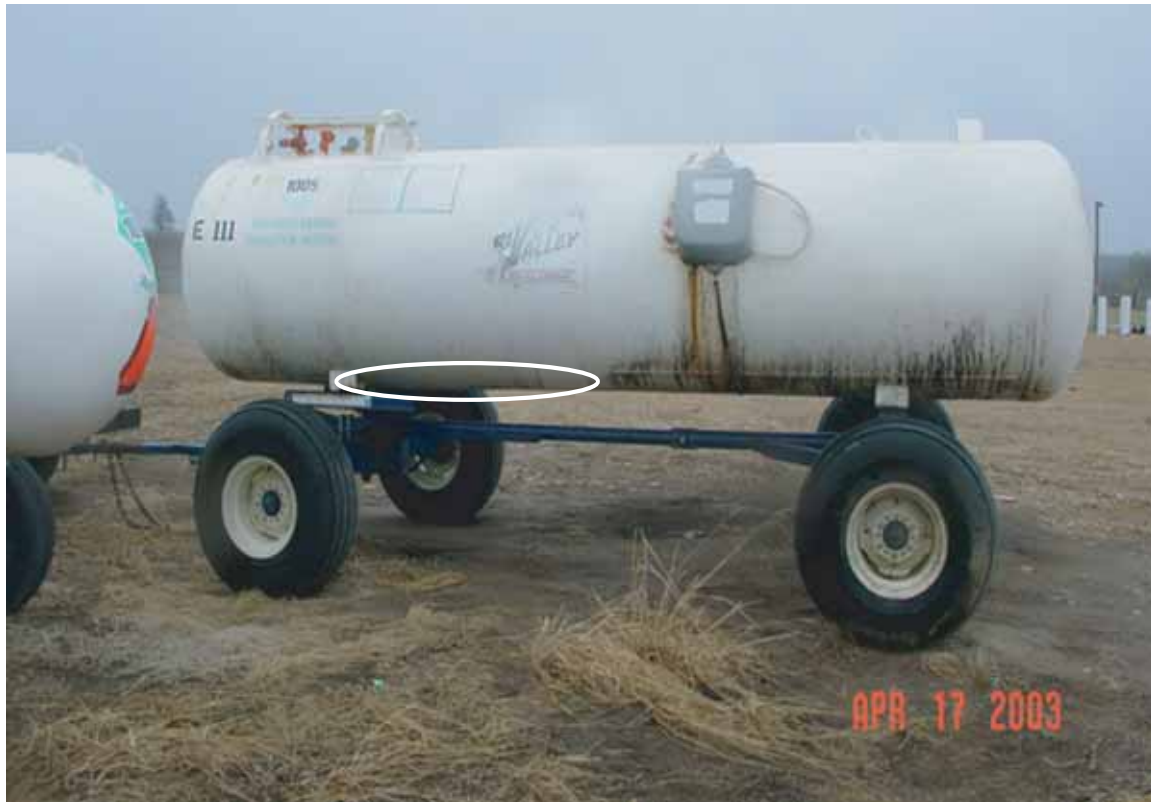
Figure 1. Accident nurse tank with shell fracture area circled.

As a result of the accident, the front half of the bottom of the nurse tank shell split open. The 53.5-inch-long split was located about 6 inches to the right of center at the tank bottom (viewed from the back). The split was along one side of a longitudinal weld in the shell on the tank bottom. (See figure 4.) Equipment repair and replacement costs associated with the accident totaled about \$3,100.

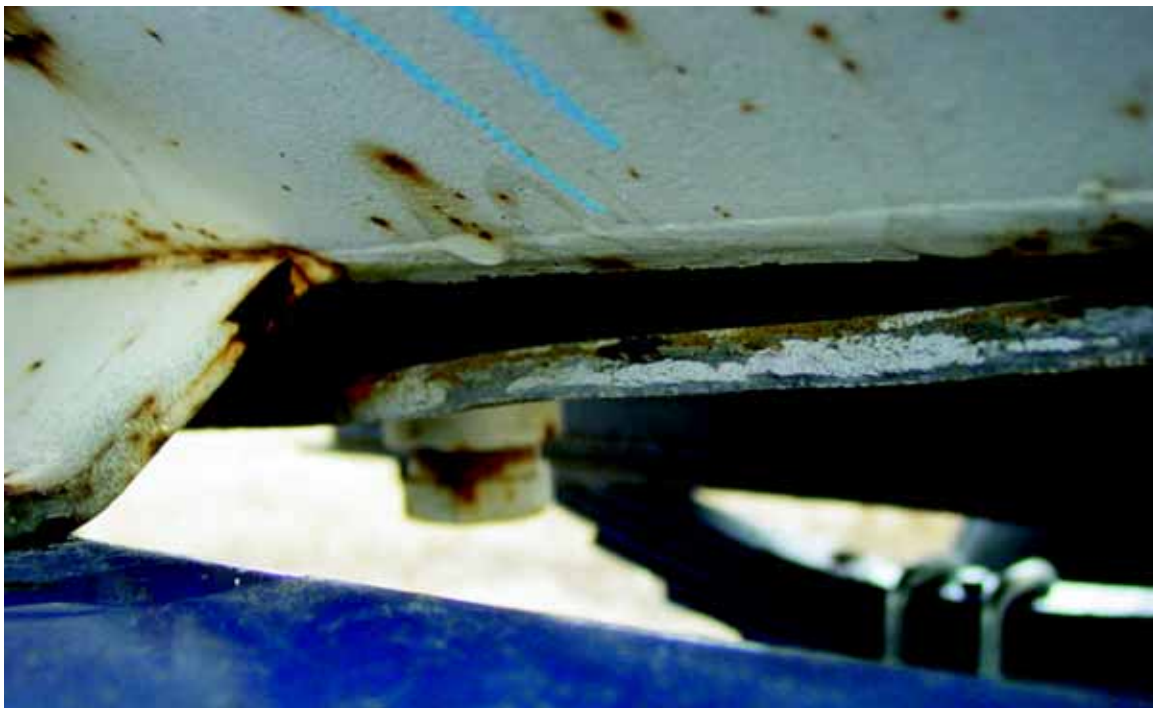
Figure 2. Close-up view of accident nurse tank shell fracture area.

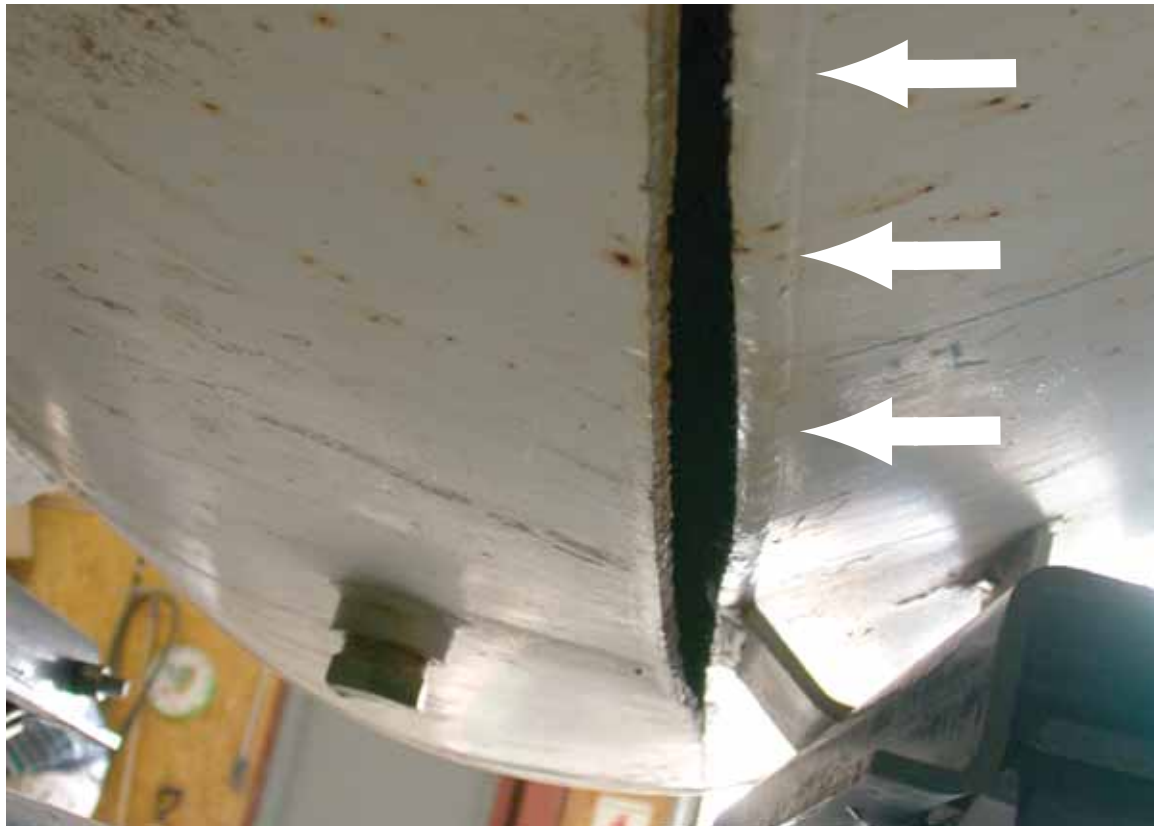
Figure 4. Fracture running beside, to the left of, longitudinal weld (line of weld is marked with arrows).

Postaccident examination and matching of the characteristics on each side of the longitudinal fracture in the shell of the accident nurse tank revealed that the two sides of the shell could not be aligned to form a circular arc. Where they had been welded together, the two sides were at about a 30-degree angle relative to each other.

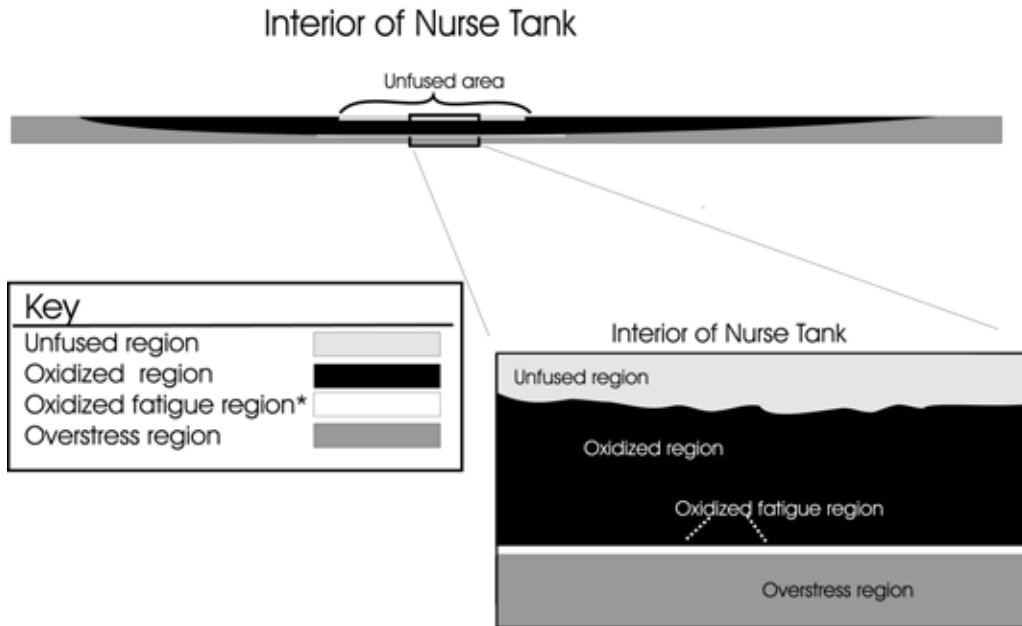
The metallurgical examination of the tank indicated that, when manufactured, a portion of the nurse tank's interior longitudinal weld was not centered on the shell seam. Examination of the nurse tank's 53.5-inch-long fracture, which was along the longitudinal weld, revealed four significant regions. (See figure 5.) They are described below:

- *Unfused region* - Where the inner weld bead¹¹ was offset to one side of the shell seam, an unfused region 3.25 inches long and up to 0.102 inch deep was found. (See figure 6.)

- *Oxidized region* - Beneath and encompassing the unfused region, the fracture surface contained a 12.75-inch-long region covered with black oxides, consistent with oxidation in a low-oxygen environment over a considerable period. This oxidized region had a smoothly curving boundary, consistent with the fracture's initiating from the vicinity of the unfused region. The oxidized region's maximum depth was 0.317 inch (including the 0.007-inch-wide "oxidized fatigue region" described below), and it came to within 0.063 inch of the tank's exterior surface. Cleaning with a deoxidizer revealed that this region (except the outer edge "oxidized fatigue region" described below) had relatively rough fracture features consistent with overstress or low-cycle fatigue fracture.¹²

- *Oxidized fatigue region* - Cleaning also revealed a 0.007-inch-wide region at the outer edge (in the direction of the tank exterior) of the oxidized region that had features consistent with high-cycle fatigue cracking, which is caused by repeated low-load events over time.

- *Overstress region* - The remainder of the fracture surface (to the breach in the exterior tank wall) had features consistent with overstress failure, such as failure caused by a single load event exceeding the load-bearing capacity of the cracked tank wall.

Figure 5. Diagram showing the four regions of the fracture surface. This diagram is not to scale and is intended only for use as a visual aid to the reader. [*Note: The oxidized fatigue region indicated above was actually part of the total oxidized region found during the postaccident examination. Because the fatigue region was metallurgically different from the rest of the oxidized region, it is indicated on this graphic by a different shade from the rest of the oxidized region.]

Examination of the area of black oxidation below the unfused area of the weld showed that a crack initiated from the unfused area, moving from the interior surface of the tank toward the outside surface, as indicated by its curved shape encompassing the unfused area. This 12.75-inch-long oxidized area, in combination with the unfused area, penetrated 83 percent of the tank shell, leaving only about 0.063 inch of steel to maintain the tank's integrity. Because the process of oxidation in a low-oxygen environment takes place over time, the black oxidation covering the fracture surface of this part of the crack indicates that the crack was present for some time before the final fracture occurred on April 15, 2003. Also, the relatively rough surface of the bulk of the oxidized area³⁰ means this part of the crack likely formed as a result either of a single overstress event or of low-cycle fatigue.

The crack continued to grow by fatigue as the tank continued in service over 27 years, being repeatedly loaded to about 140 psig³¹ and unloaded. This process is evidenced by the relatively smooth fracture features with curving boundaries typical of high-cycle fatigue in the 0.007-inch-wide region on the outer edge of the oxidized area of the crack.

Then, on April 15, 2003, the nurse tank failed when the crack became unstable and propagated through the remaining thickness of the shell under the pressure from the routine loading of the tank with anhydrous ammonia on that day. This is evidenced by the fact that the final region in the fracture shows indications of overstress failure.

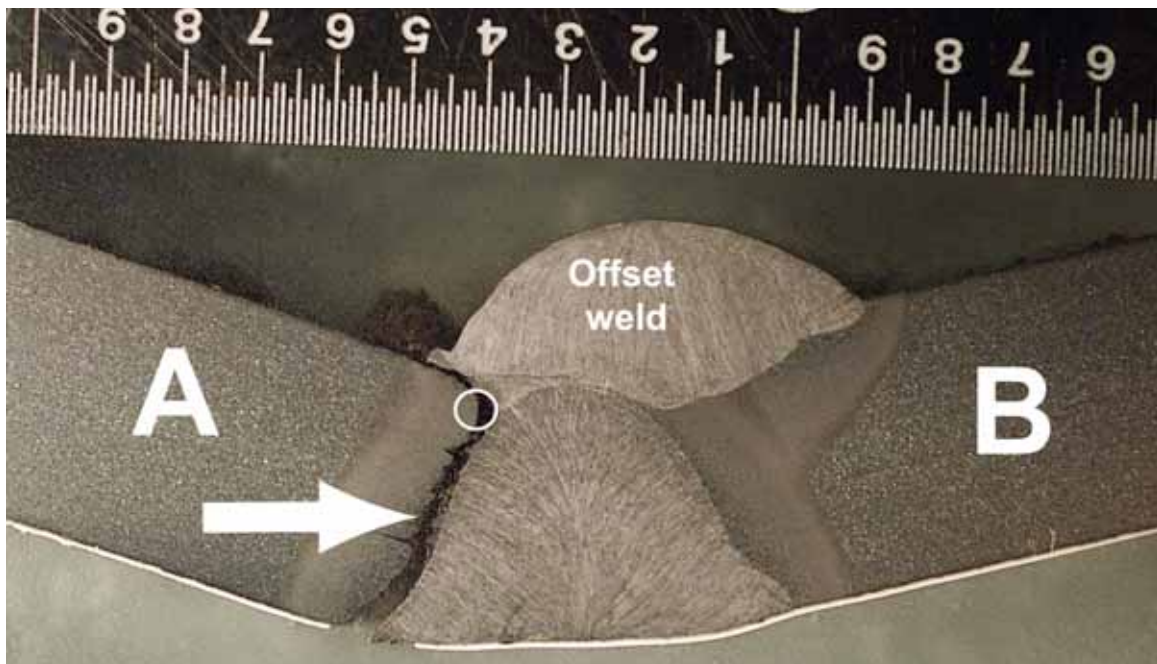
¹¹ The weld bead in the area of the unfused region was observed to make a large angle with the shell wall (as shown in figure 6). Such a feature is known to significantly increase the local operating stresses in a structure. See John F. Harvey, *Theory and Design of Modern Pressure Vessels*, Second Edition (New York, NY: Van Nostrand Reinhold Company, 1974) 348–349.

Figure 6. Cross section view of nurse tank longitudinal weld, showing left steel shell plate A and right steel shell plate B welded together. Fracture through tank shell is indicated by arrow. Circle marks area of lack of fusion.

In addition, the failed section of the nurse tank had some indications of an out-of-roundness condition. Postaccident examination indicated that, during the nurse tank's manufacture, the two sides of its shell that formed the longitudinal seam may have been improperly aligned. When examined after the accident, the two sides could not be aligned to form a circular arc and appeared to be aligned at about a 30-degree angle relative to each other at the weld. This indicates that there was some misalignment of the shell surfaces when the tank was manufactured. A misalignment would have produced an area of localized stress concentration and increased tensile stress on the inner surface of the shell when the tank was pressurized. The Safety Board concludes that the unfused area and offset portion of the longitudinal weld significantly weakened the nurse tank shell; misalignment of the shell surfaces and the large angle weld bead increased the operating stresses in the weakened area.

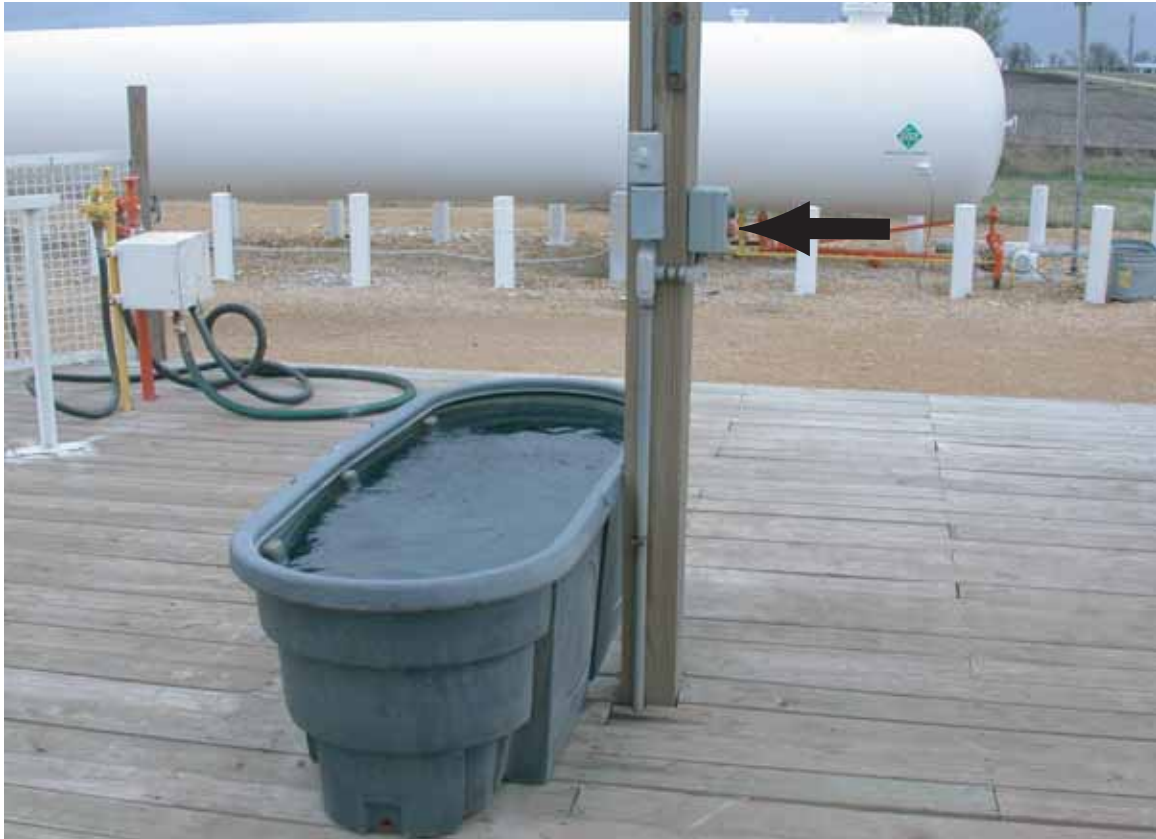
anhydrous ammonia pump) and get into the water immersion tub. (See figure 8.) Loaders were to remain in the tub until emergency responders arrived and told them it was safe to get out. Water immersion tubs are designed to provide on-site emergency first aid for injuries caused by exposure to corrosive materials by enabling a person whose skin or soft tissues are exposed to the material to flush the area with water. They are not intended to provide protection from, or first aid for, inhalation injuries.

Figure 8. Immersion tub in the center of loading platform. Arrow indicates emergency shutoff button location.

The tub held 200 gallons of water and was large enough for two individuals to sit in it, but it would have been difficult for two occupants to fully immerse themselves. A second immersion tub was located at one end of the facility's storage tank, about 40 feet from the loading platform.
