**National Transportation Safety Board
Office of Research and Engineering
Washington, D.C. 20594**

**Fire Factual Report
February 23, 2006**

Accident No: DCA05MM002

Vessel: Shuttle Express II

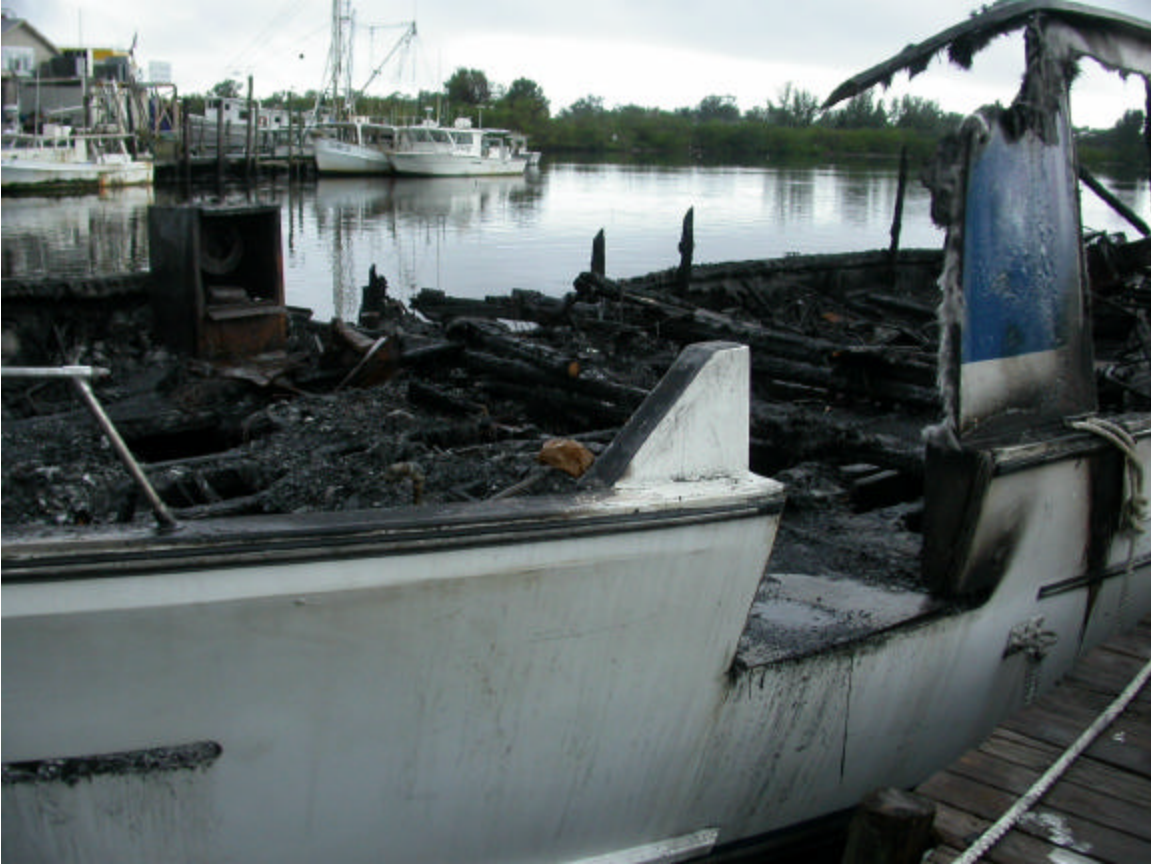
The damage to the Express Shuttle II resulted in the vessel being declared a total constructive loss. The fire destroyed the entire vessel from the top deck through the main deck⁵. A section of the port outboard cabin bulkhead had been charred by the fire but was still intact. The destroyed sections of the upper decks collapsed on to the main deck and into the bilge and engine compartments.

Wooden components were heavily charred and partial consumed. Fiberglass components were brittle with most of the resin burned out of the structure. A large portion of the main deck had been burned through especially in the area of the engine compartment. All items located on the main and upper decks (chairs, tables and other miscellaneous items) were also completely destroyed.

Figure 1: Portside view of the Shuttle Express II after the fire.

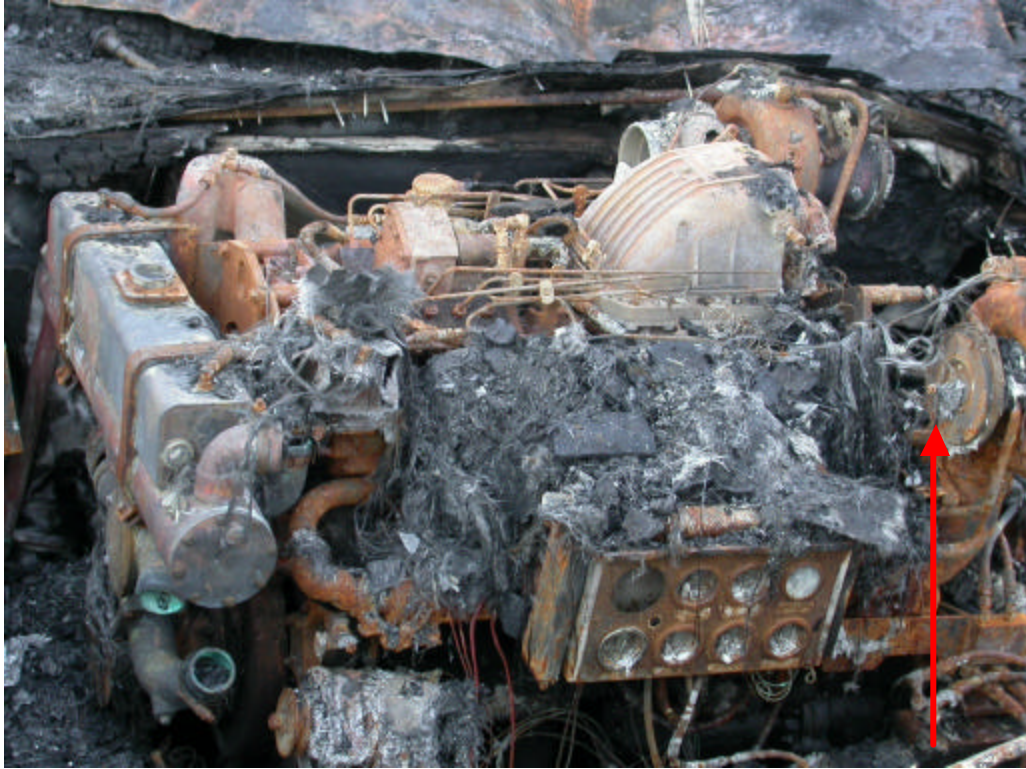
Remaining Turbocharger Impeller

⁹ Most of the engine surfaces, including the turbocharger housing, are water-cooled and are not to exceed 400°F. The average temperature of water-cooled surfaces is 180°F according to the engine manual.

Figure 2: Starboard engine.

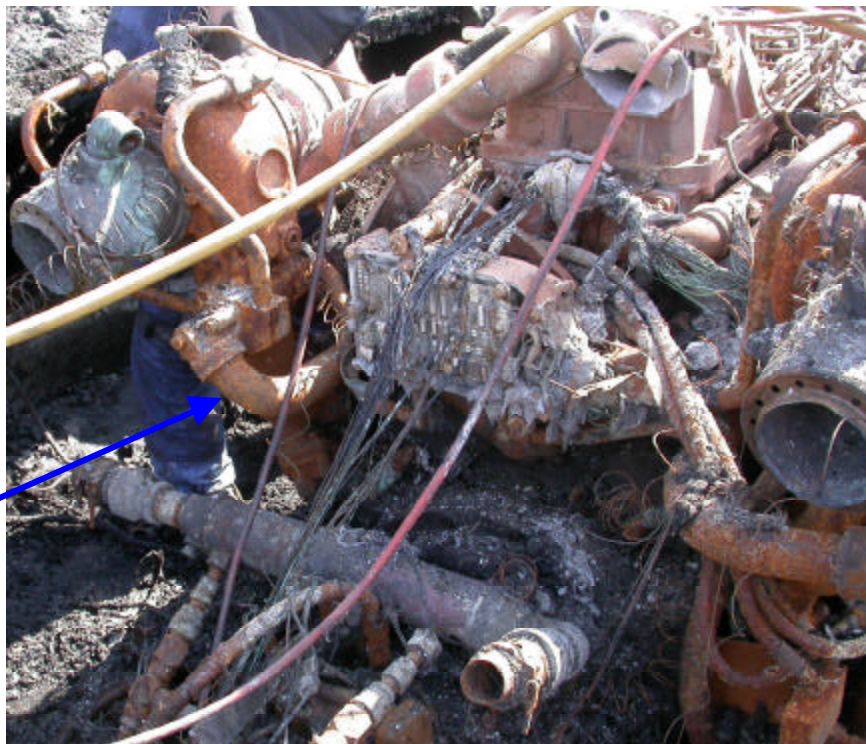
Exhaust
Manifold

¹¹ The average internal operating temperature of the exhaust gas manifold is 1065°F according to the manufacturer. This manifold is not water-cooled. See Figure 3 for location of manifold.

Figure 3: Starboard engine aft section.

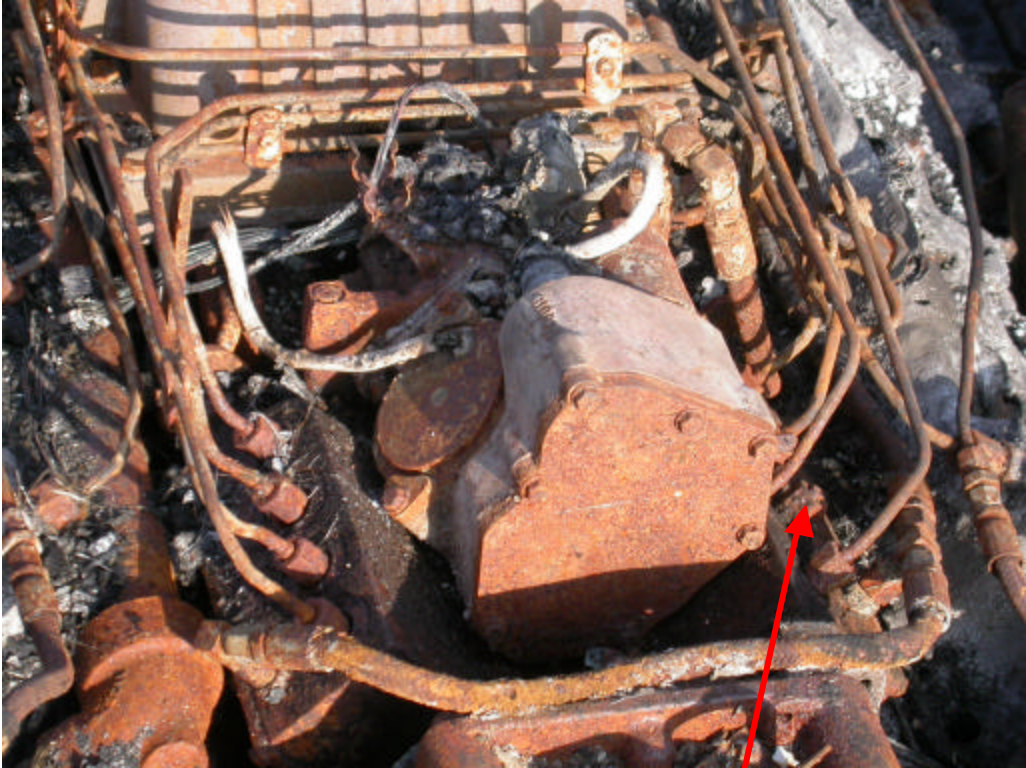
#5 Fuel Line

On the inboard manifold, the fuel delivery line (as shown in Figure 4) to the #5 injector from the front was broken at the fuel delivery pumped end⁶. The fracture occurred at the ferrule for attaching the fuel injection line to the fuel pump manifold⁷. The #5 fuel injection line was not clamped to the engine block or to another fuel line. The Caterpillar Service Manual for 3408 and 3412 High Performance marine engines stated that the clamps for the fuel injection lines should be installed in the correct location. Incorrectly installed clamps may allow the fuel lines to vibrate and the damaged lines may leak and cause a fire.

One loose unattached clamp was found in the vicinity of the broken fuel line on the engine block. The clamp was found in the unscrewed (open) position. None of the other fuel injector lines were clamped to the engine block, although, some were clamped to each other⁸. On the inboard turbocharger⁹, the compressor side housing and impeller were destroyed with only a small amount of melted impeller remaining¹⁰. The impeller for exhaust side of the inboard turbocharger was intact. The aluminum housing for the outboard turbo charger had melted but the compressor side impeller and the exhaust side impeller were both intact. The exhaust gas manifold, which provides exhaust gas pressure to propel the turbocharger, was also intact¹¹. The air intake shutoff arm was in the “on” position. The fine fuel filters, located on the inboard side of the engine, were destroyed. The inboard valve covers were melted. The outboard fuel lines were intact but not clamped to the engine block. The starboard engine had a pulley pump drive for the bilge pump.

⁸ During the laboratory examination, two other fuel injector lines, Lines #1 and #3, were worn through a portion of their diameter.

Figure 4: High-pressure fuel lines for starboard engine.

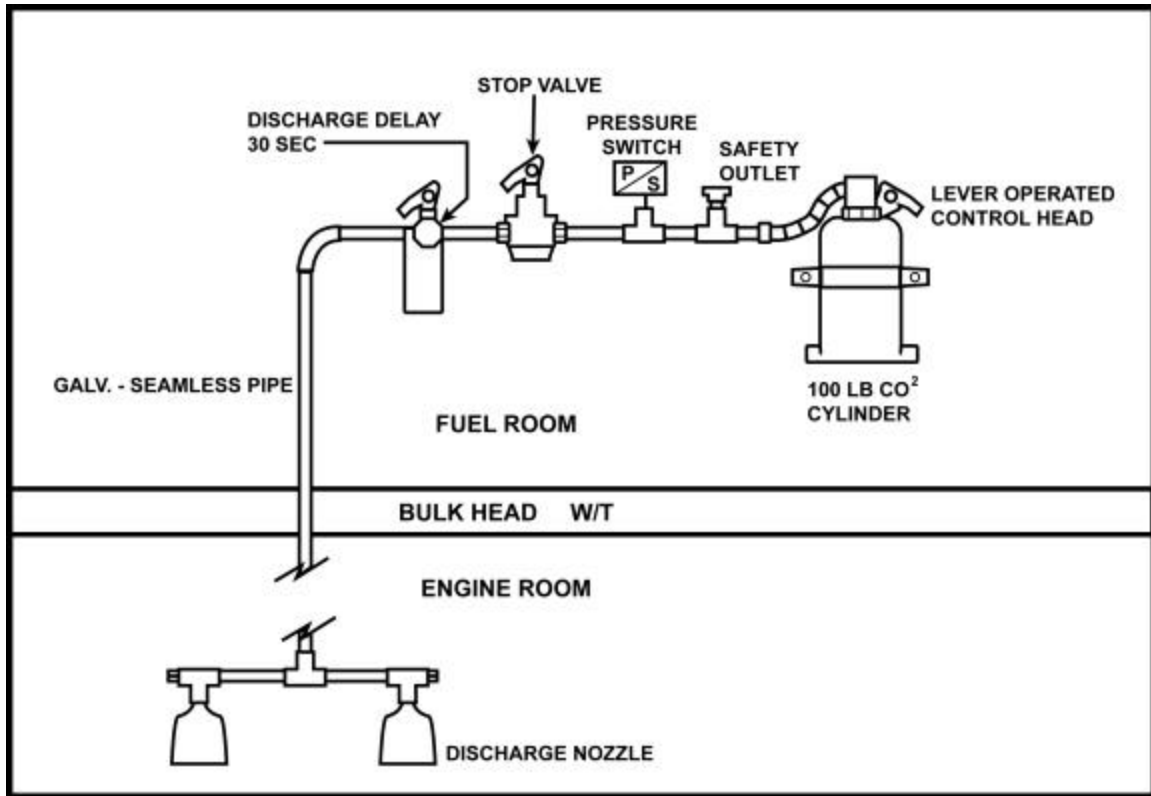
The system consisted of a 100 pound cylinder of carbon dioxide (CO₂) located in a compartment forward of the fuel tanks¹³. According to the information in the vessel file, the system had an operating pressure of 2,500 pounds per square inch (psi). Calculations in the system information indicated that to flood the 1,460 square foot engine room, 91.4 pounds of carbon dioxide were required¹⁴.

Figure 1A: Fire suppression system diagram.

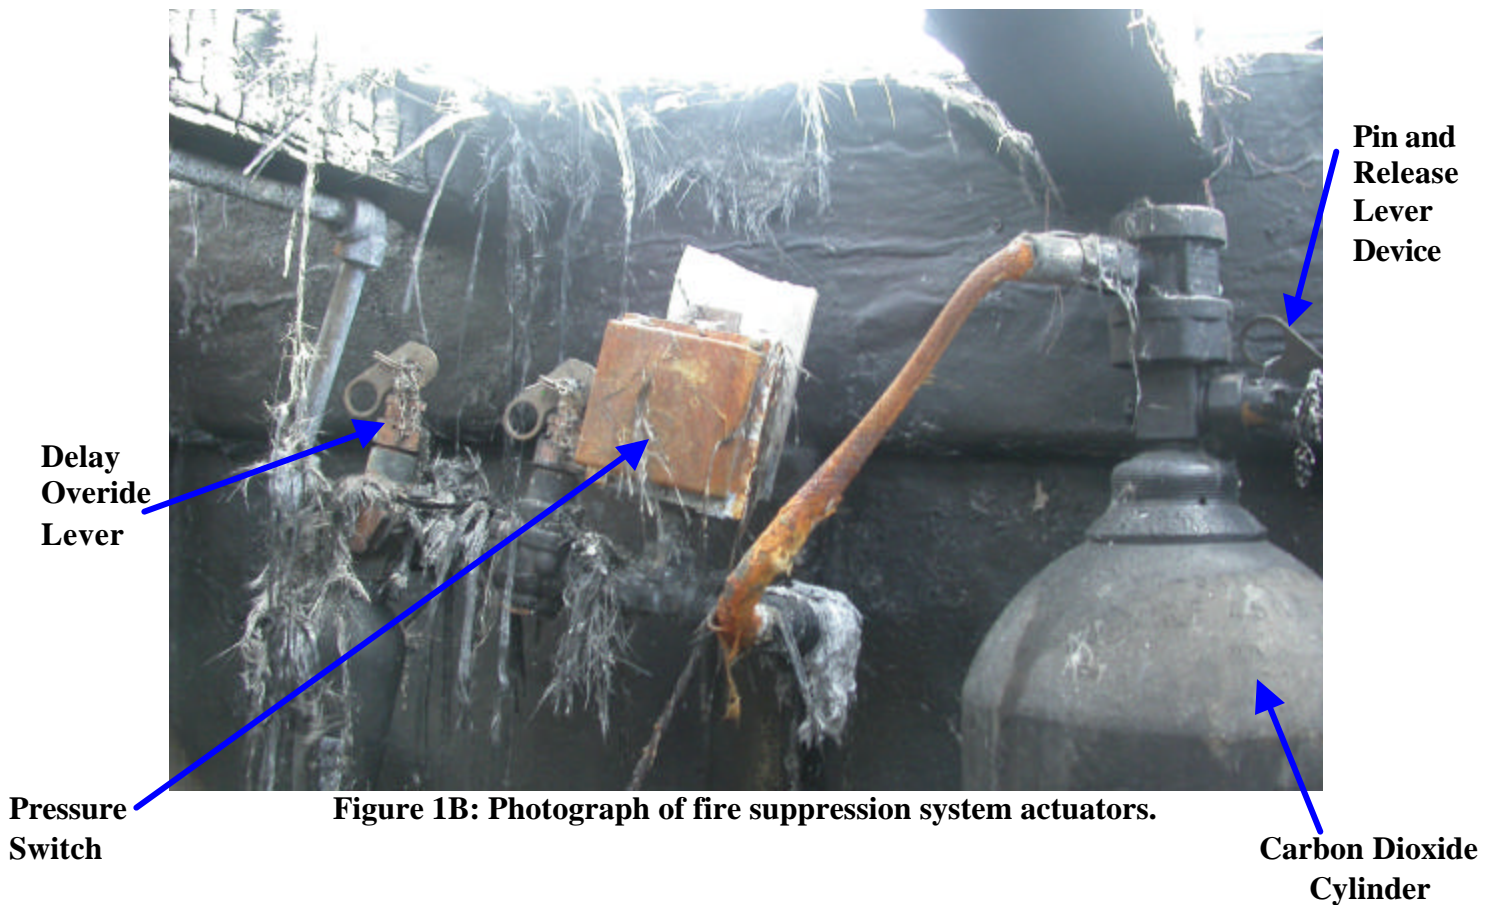
Three actuation devices were located near the cylinder below the main deck level. A hatch covered the system actuation devices and gas cylinder. In order to access the actuation devices, a person would have to enter the space through the hatch. To begin the discharge of the system, the pin and lever, located on the top of the cylinder, would have to be pulled to open the cylinder. There is also another pin and lever device located on the stop valve next to the pressure switch that will also open the cylinder. The two levers, the one on the cylinder and the one of the stop valve are mechanically interconnected. Once the gas was flowing, a pressure switch would activate, shutting down the engines and ventilation into the engine space. A thirty-second time delay, controlled by a delay valve, takes place before the CO₂ would be released into the engine space. No discharge will pass through the elbow to the 30- second delay valve until the engines and ventilation switch is actuated. A third device

was installed in the system that, if pulled, would by-pass the time delay and immediately discharge the CO₂ into the engine space. Galvanized steel piping extended from the cylinder aft to the engine compartment and terminated in two bell shaped discharge nozzles. One discharge nozzle serviced each engine, however both nozzles would discharge simultaneously once the system was activated. Suncoast Fire Safety Inc, a third party, inspected and provided any needed maintenance on the system annually. Suncoast would submit an inspection report to the owner upon completion of the yearly inspection and this report would then be submitted to the Coast Guard as part of the annual Coast Guard inspection.

Figure 1B: Photograph of fire suppression system actuators.

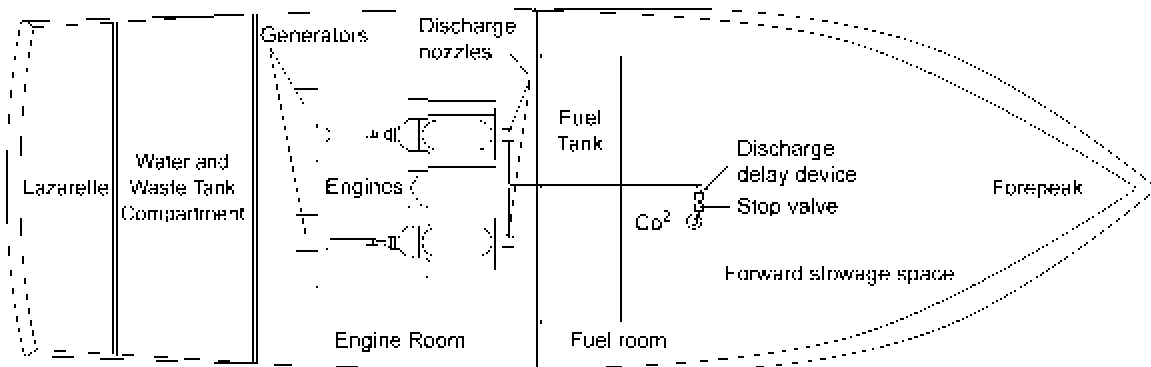
Figure 2A: Fire suppression layout diagram.

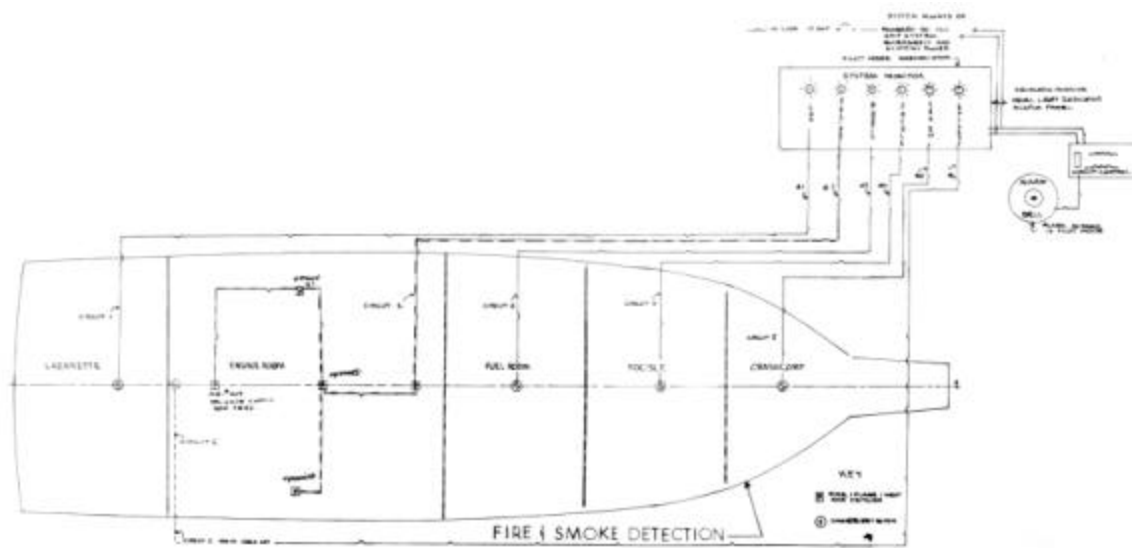
In accordance with 46CFR181.400, a space containing propulsion machinery is required to be equipped with a fire detection system of approved type. The fire detection system onboard the *Express Shuttle II* was a custom designed and built system comprised of a control panel manufactured by Aqualarm with detectors (both smoke/heat and heat) wired directly to the panel. Diagrams of the panel and control board layout were found in the vessel file. A detector layout schematic was found on the original blueprints¹⁵. However, no wiring diagrams were found. The system was installed during original construction of the vessel in 1997. At the time this system was installed, the system was approved under a “Type Approval.” Under “Type Approval”, as long as the components were approved, a system made entirely from approved components was also approved. To be an approved component under the regulations, a component must be Underwriter Laboratory (UL) approved for that specific use in this case, for use in a fire detection system. However, while the Aqualarm panel had a UL approval for use as an electronic component, it was not UL approved for use in a fire detection system. As of November 2004, Aqualarm is no longer type approved by the Coast Guard.

These lights indicated the status of the individual detector in that zone. Each zone was equipped with a smoke/heat detector²⁰ with the exception of the engine room, which had heat detectors²¹. According to the original design, the engine room was to have multiple detectors wired in parallel. The Port Captain for SunCruz could only recall one detector located in the back of the engine room, between the starboard engine and the starboard generator. The alarm was 110 decibel (db), 12V horn siren²². The siren is triggered by the energized monitor panel in the event of a smoke or heat detector activation. The detectors installed were Underwriter Laboratories (UL) approved, 2 wire, 12V smoke detectors with auxiliary relays²³. The detectors were locally sounding. The control panel provided the power for the detectors²⁴. According to Aqualarm, the initiating devices were wired to have a single connection to

the panel, leaving the circuit “open” or unsupervised²⁵. The repair technician verified this was the design on-board. There was no indication in the original documentation that end of line devices were installed.

Figure 3A: Fire detection system layout diagram (as designed).
