**Controlled Flight Into Terrain  
Beech King Air 200, N501RH  
Stuart, Virginia  
October 24, 2004**

**NTSB/AAB-06/01**

**Accident Number:** IAD05MA006  
**Aircraft and Registration:** Beech King Air 200, N501RH  
**Location:** Stuart, Virginia  
**Date:** October 24, 2004  
**Adopted on:** February 7, 2006

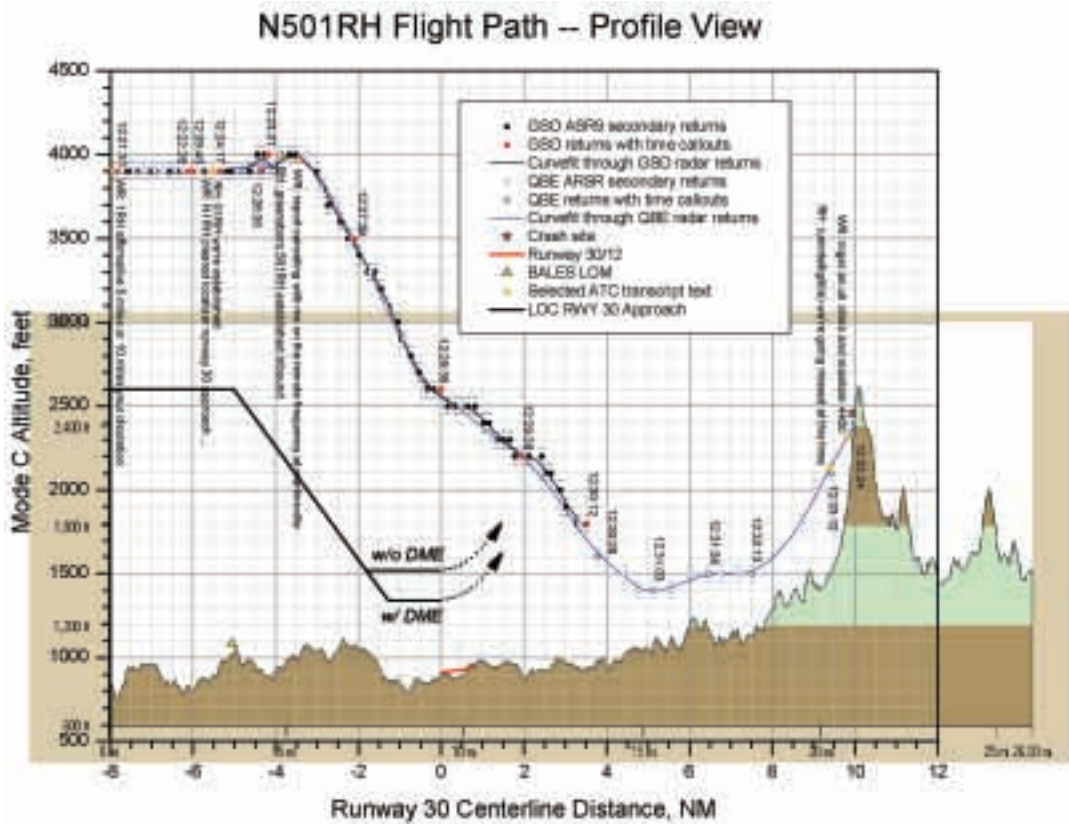
**Figure 3.** Accident airplane's altitude profile.

The airplane leveled at 1,400 feet, about 4 nm beyond MTV and 5 nm beyond the MAP. The airplane maintained level flight between 1,400 and 1,500 feet for the next 1 minute 13 seconds. At 1232:13, about 8 nm beyond MTV, the airplane initiated a straight-ahead climb.

At 1233:21, the controller advised the flight crew to climb and maintain 4,400 feet. At 1233:24, the radar target was lost. The accident occurred on Bull Mountain in Stuart, Virginia, at an elevation of about 2,400 feet and near the extended centerline of the runway.
