Sweeney, Christopher J (ISI), 07:39 AM 2/3/2003, Thoughts and Prayers

**Howard M. Adelman, 01:13 PM 2/3/2003, Response to questions about Columbia**

Date: Wed, 12 Feb 2003 13:48:15 -0500  
To: r.h.daugherty@larc.nasa.gov  
From: "Katherine A. Barnstorff" <k.a.barnstorff@larc.nasa.gov>  
Subject: Associated Press article

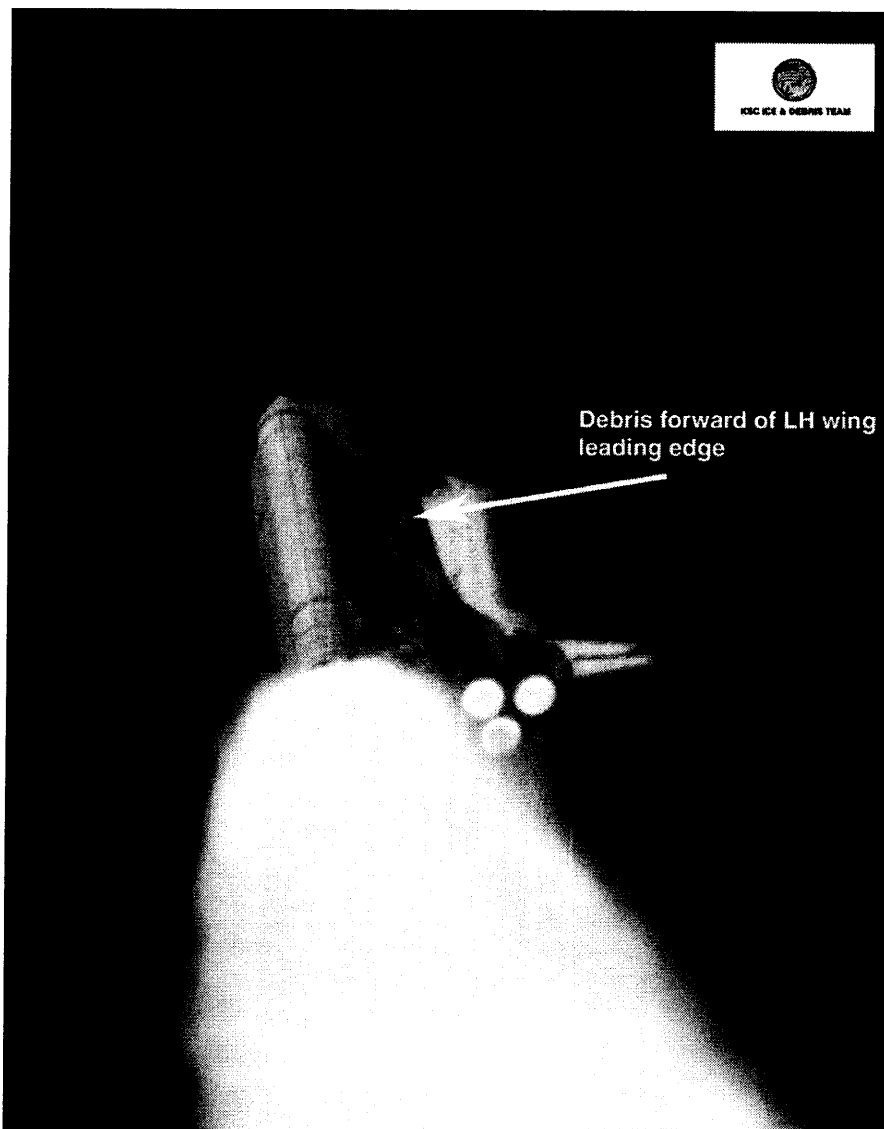
Photo 1.

1. At approximately 80-84 seconds (accurate timing off of film will be done tomorrow) after T-0 a large piece of debris is observed striking the underside (-Z) of the LH wing of the orbiter. The debris appears to originate from the area of the -Y bipod attach point on the external tank. (E-208, E-212) No damage to orbiter TPS is apparent. Further analysis will continue.

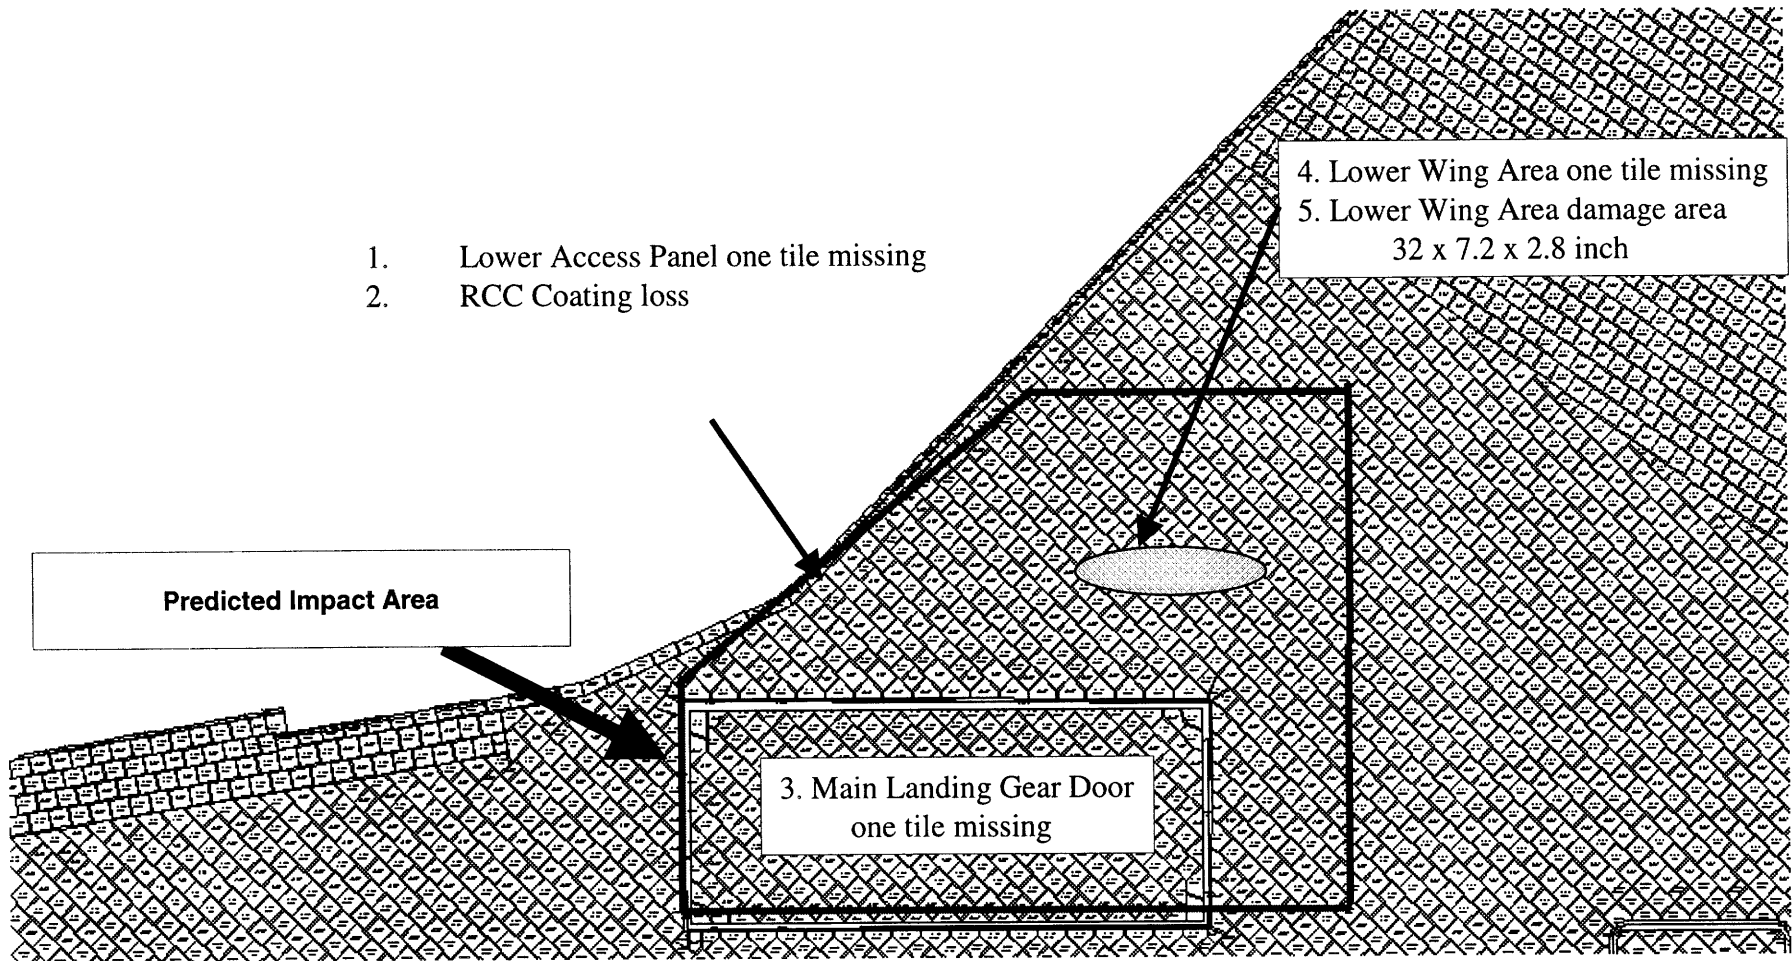
# Impacted Lower Surface Location Thermal Predictions

Case	Location	Assumptions	Results
1	Access Panel (one tile missing)	Loss to last layer of TMM Densified layer ~ .2 inches	Temperature of Al Tube Carrier 790 °F No issue
2	RCC Panel 9 Lower Flange OML (Coating Missing)	Coating loss and Carbon substrate exposed	Substrate thickness: 0.193 inches Loss .09 inches No issue
3	Main Landing Gear Door (one tile missing)	Loss to last 2 layers of TMM Densified layer ~ .4 inches	Temperature of Structure 540 °F No issue
4	Lower Wing Area (one tile missing)	Loss to last 2 layers of TMM Densified layer ~ .4 inches	Temperature below 350 °F design req. No issue
5	Lower Wing Area (32 x 7.2 x 2.8 inch) Damage	Loss to last layers of TMM Densified layer ~ .2 inches	
6	Main Landing Gear Door (several tiles Lost)	Loss to last layers of TMM Densified layer ~ .2 inches

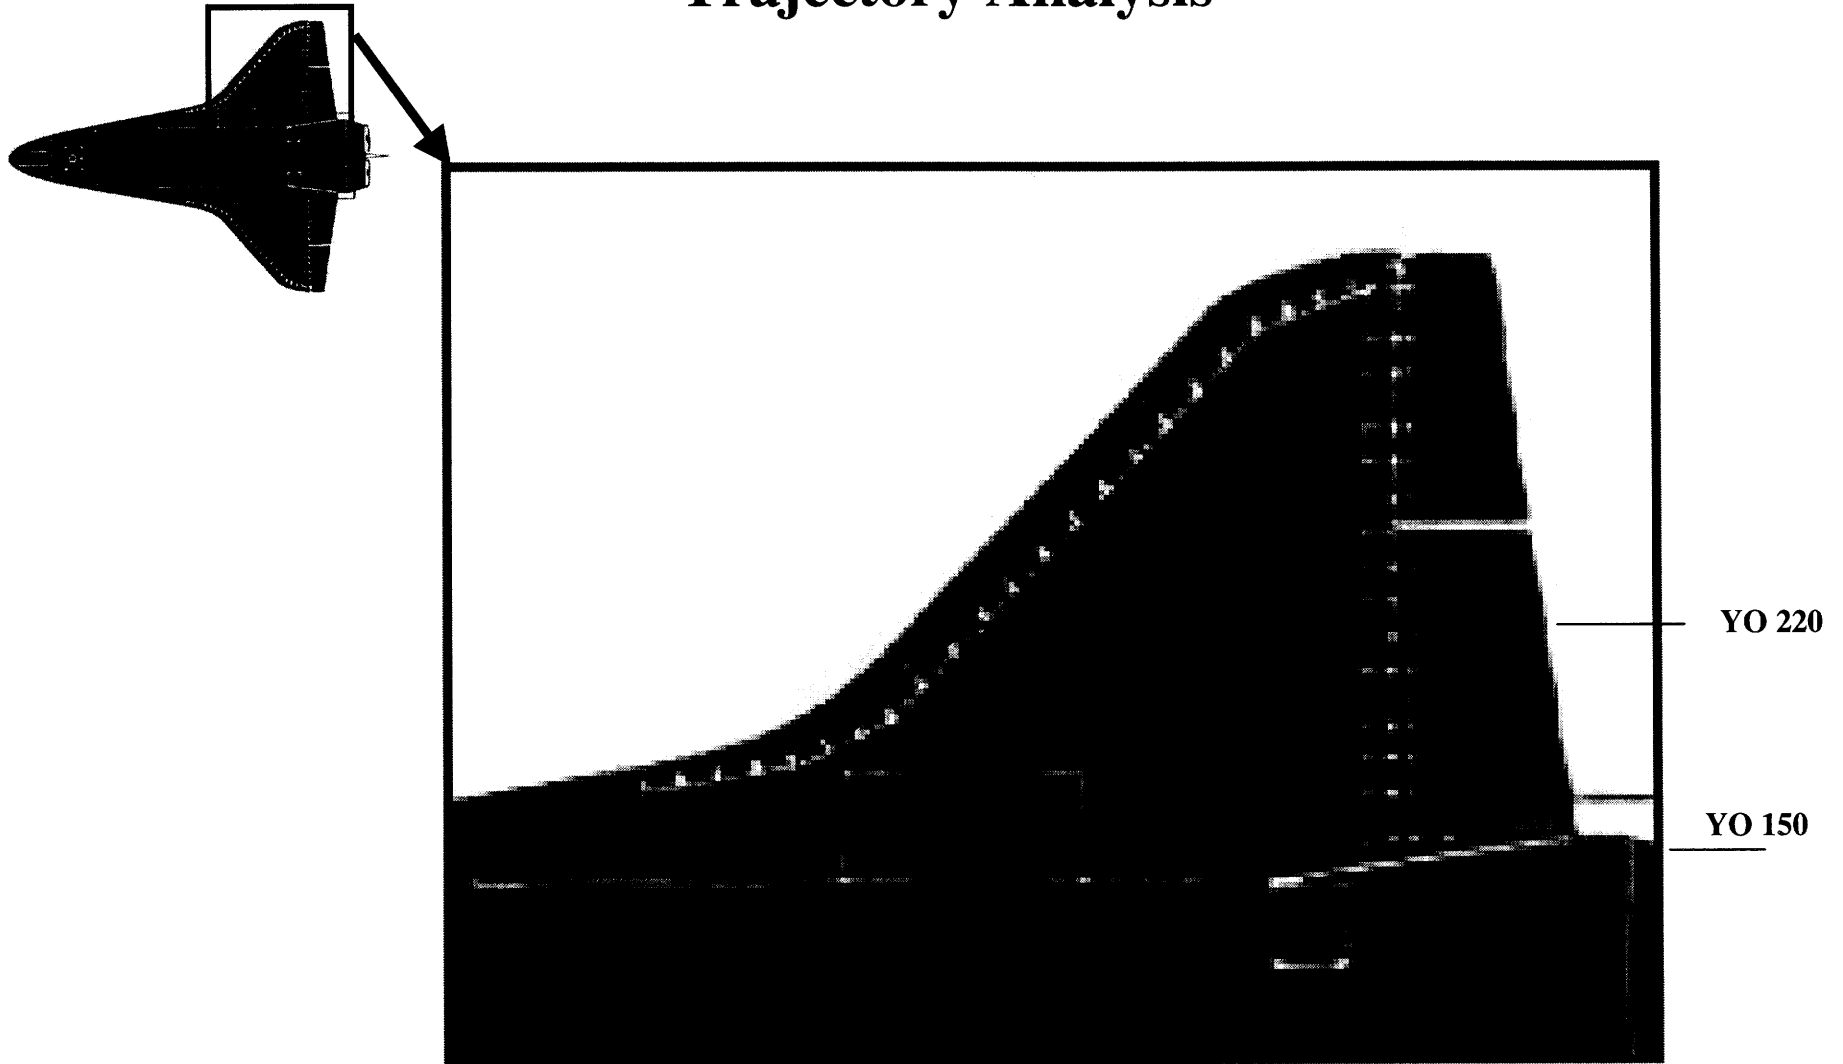
# Predicted Impact Area Derived from Film Observations and Trajectory Analysis

STS-107 Debris Impacting Orbiter Wing

(Debris Size = 20'' x 10'' x 6'', Density = 2.4 lb/ft<sup>3</sup>)

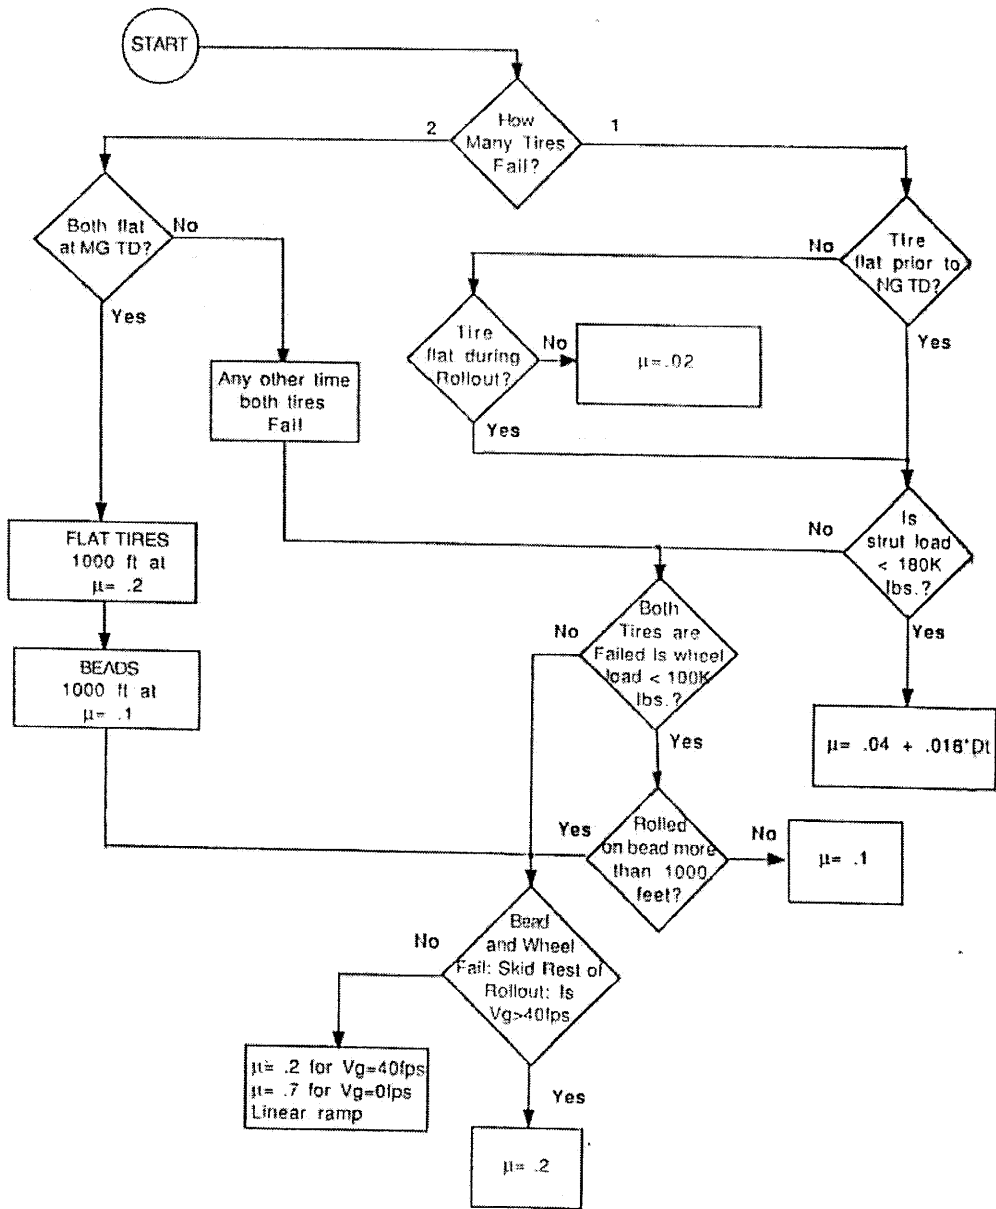
1. Flat tires can survive 1000' if loaded 70K or less.
2. Good tires loaded above 180K fail immediately.
3. \*Failed tires roll on beads for 1000' if wheel loads are < 100K.
4. \*If rolling on beads and wheel loads exceed 100K, then bead fails and rim flange breaks in 50'.
5. Center section may survive any length (flowchart assumes 0 length).
6. \*For 1 good tire and 1 flat tire and strut load < 180K then strut drag  $\mu = .04 + .016 \times$  deflection of good tire.

Note: DI = Deflection of good tire : should range from 0 to 10 in.

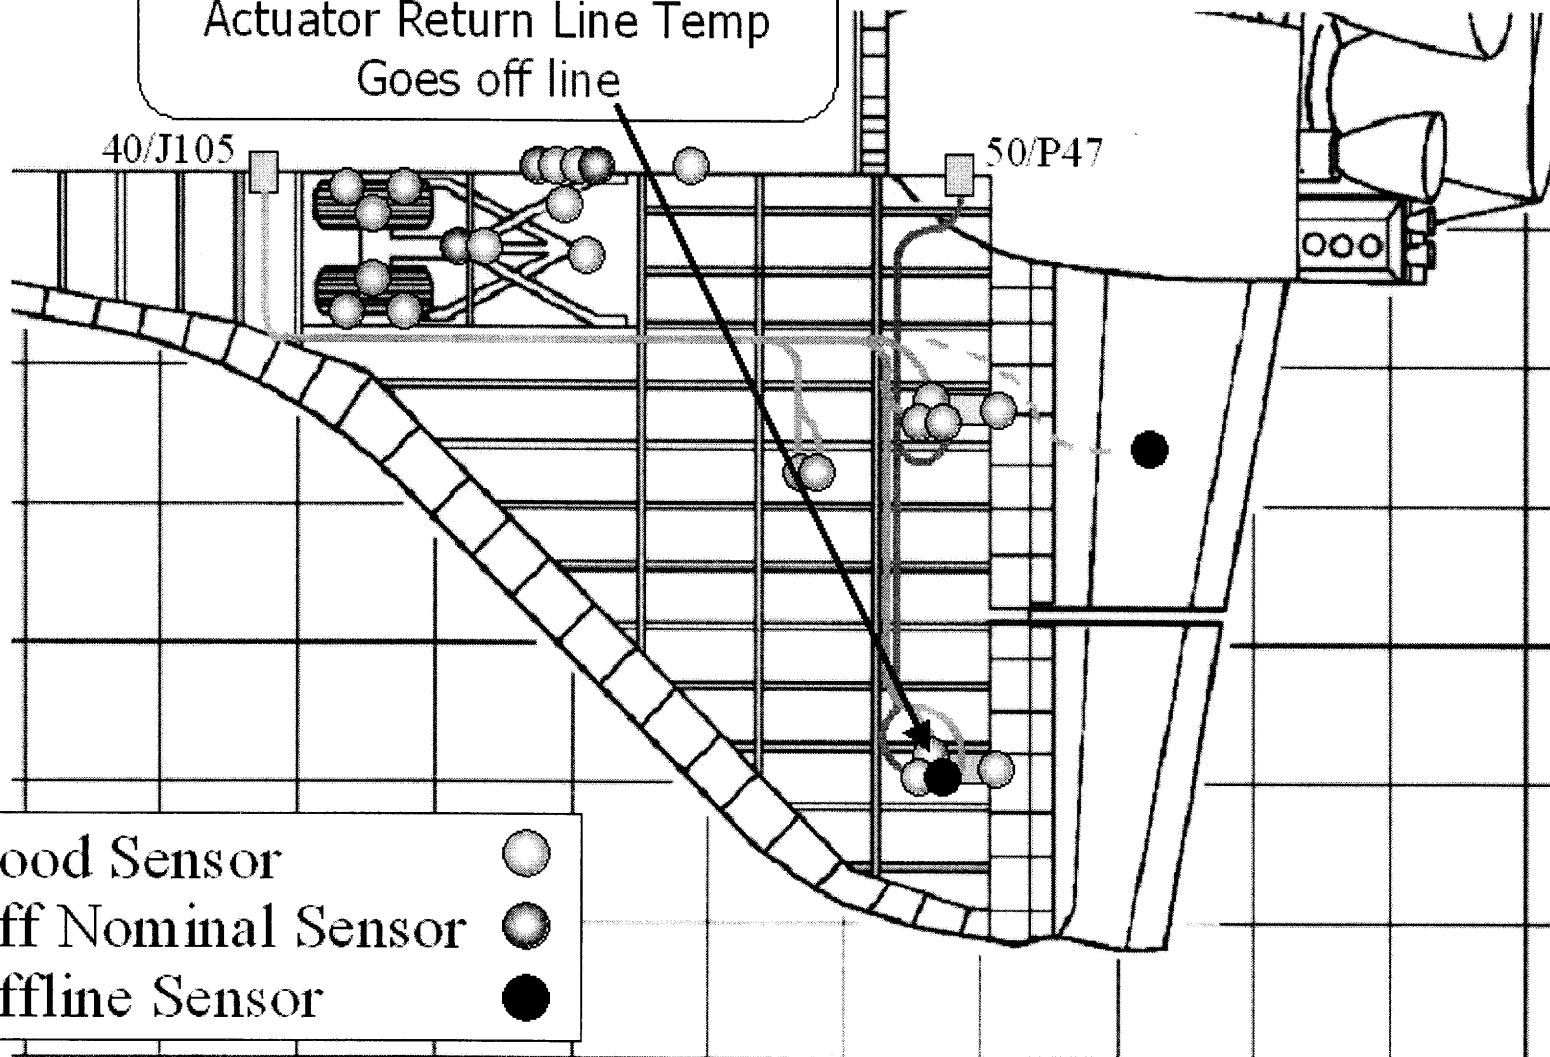
V58T0394  
Hyd Sys 3 Left Outboard Elevon  
Actuator Return Line Temp  
Goes off line

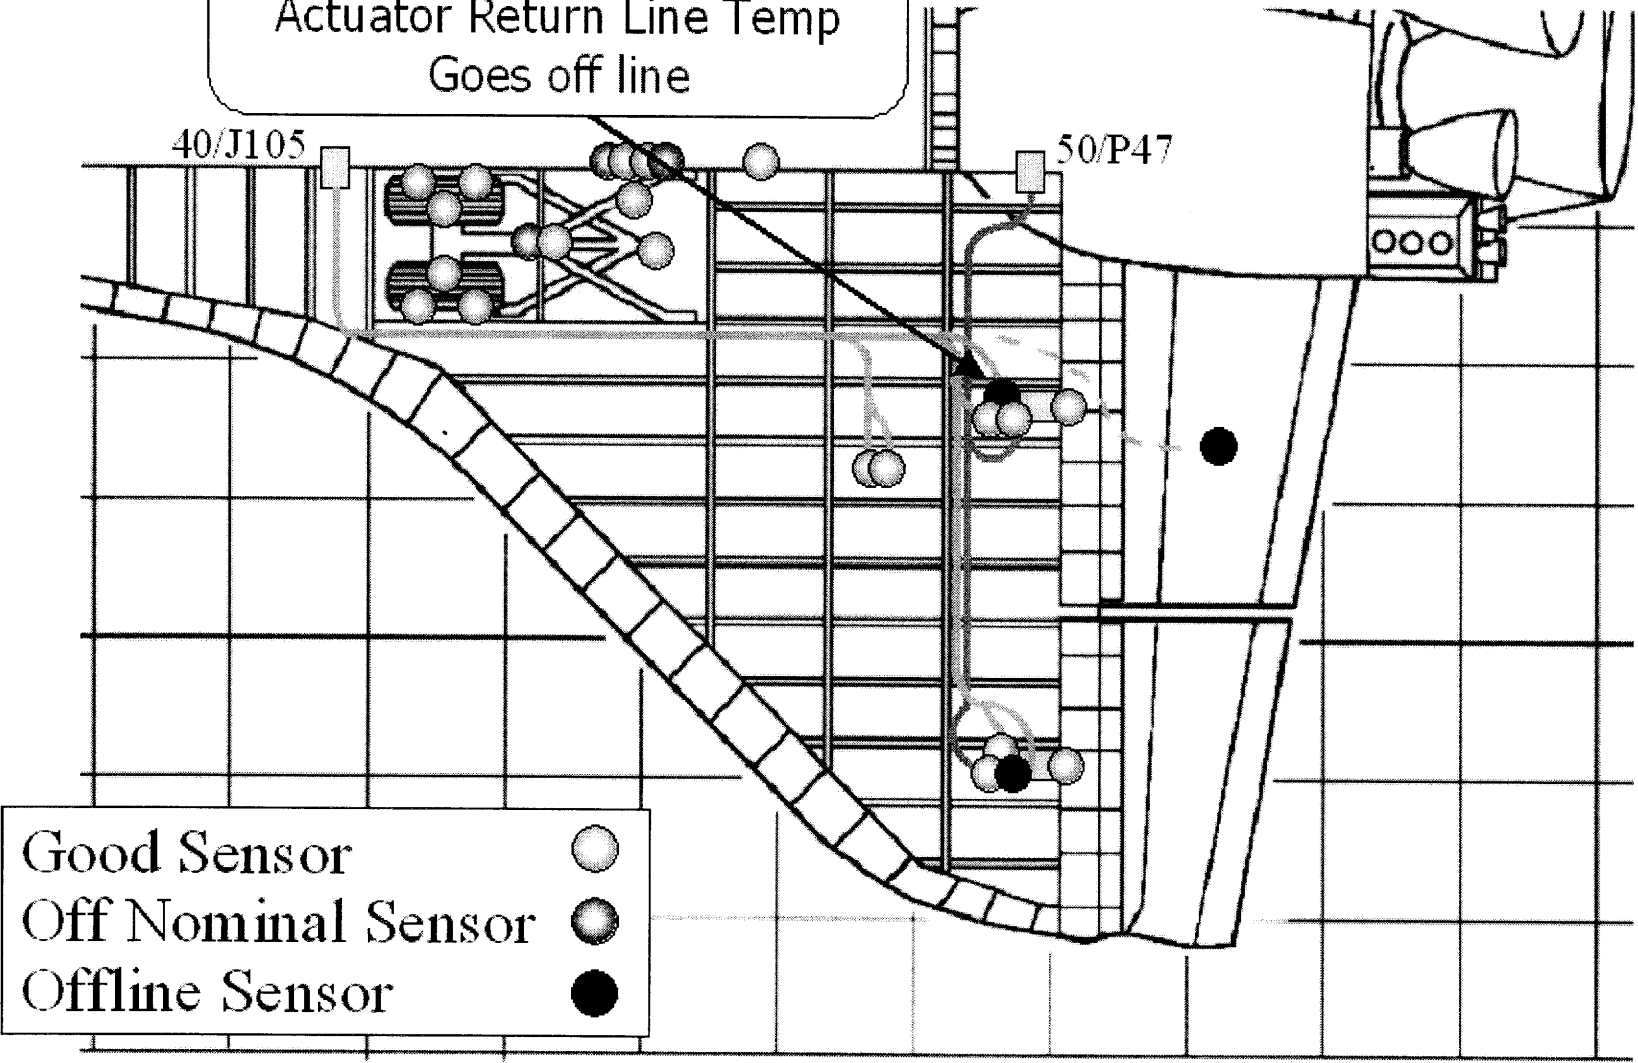
V58T0157  
Hyd Sys 1 Left Inboard Elevon  
Actuator Return Line Temp  
Goes off line

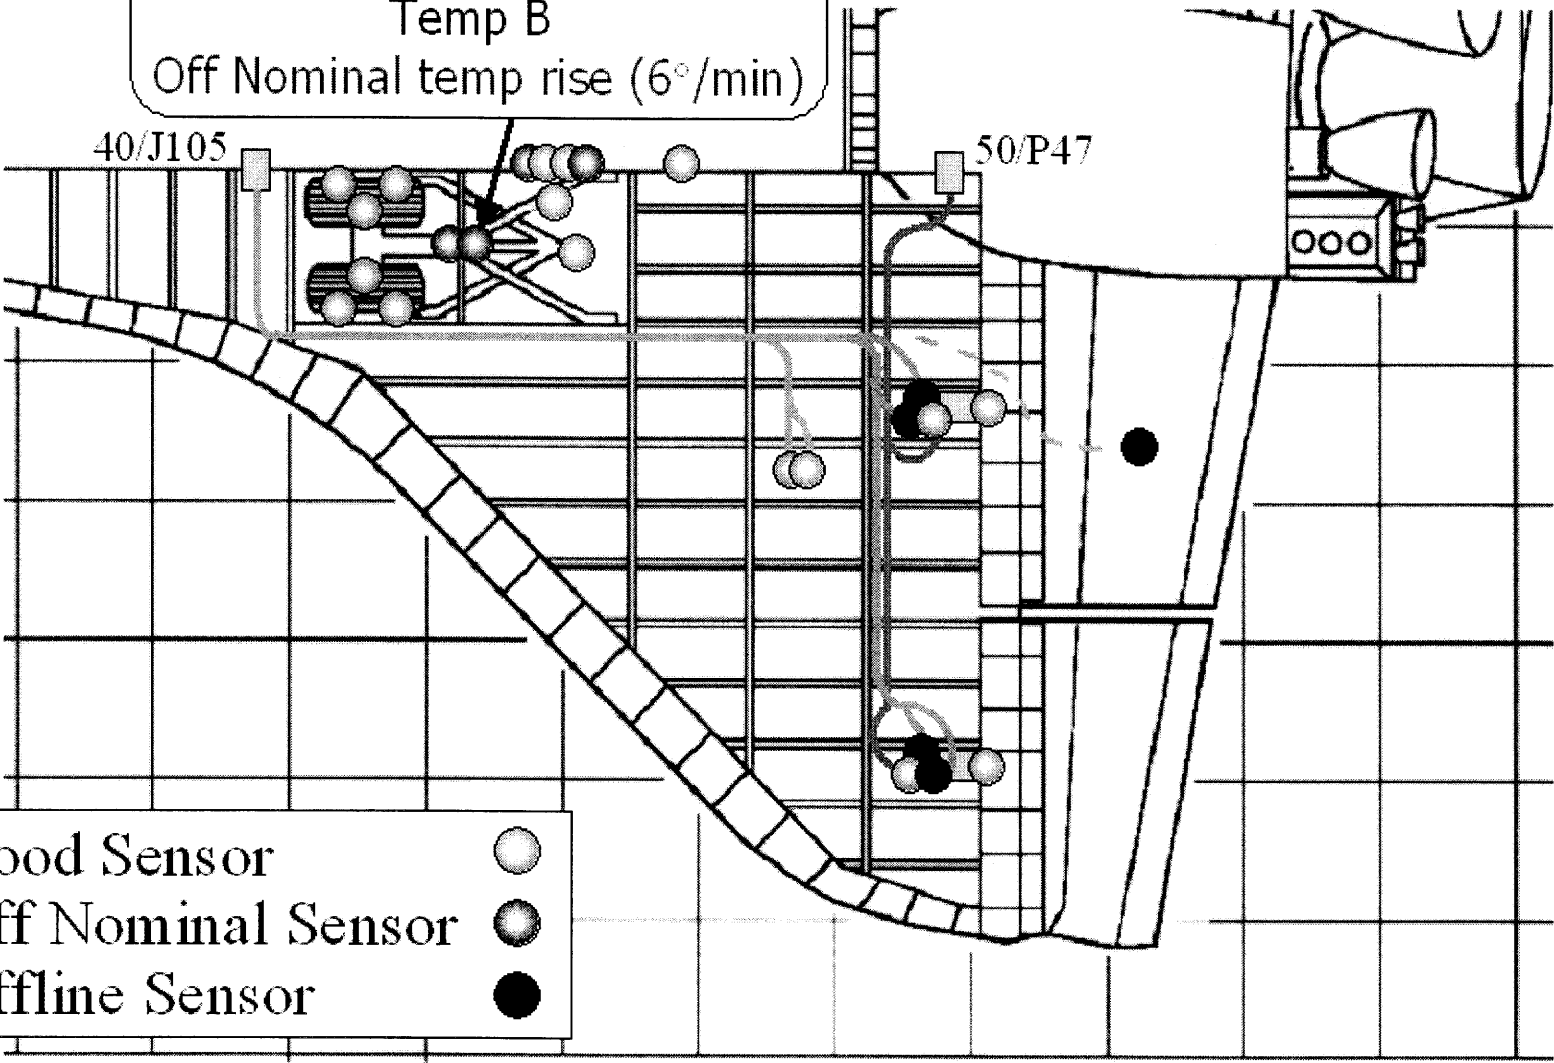
V58T1701  
Left Main Gear Brake Line  
Temp B  
Off Nominal temp rise (6°/min)

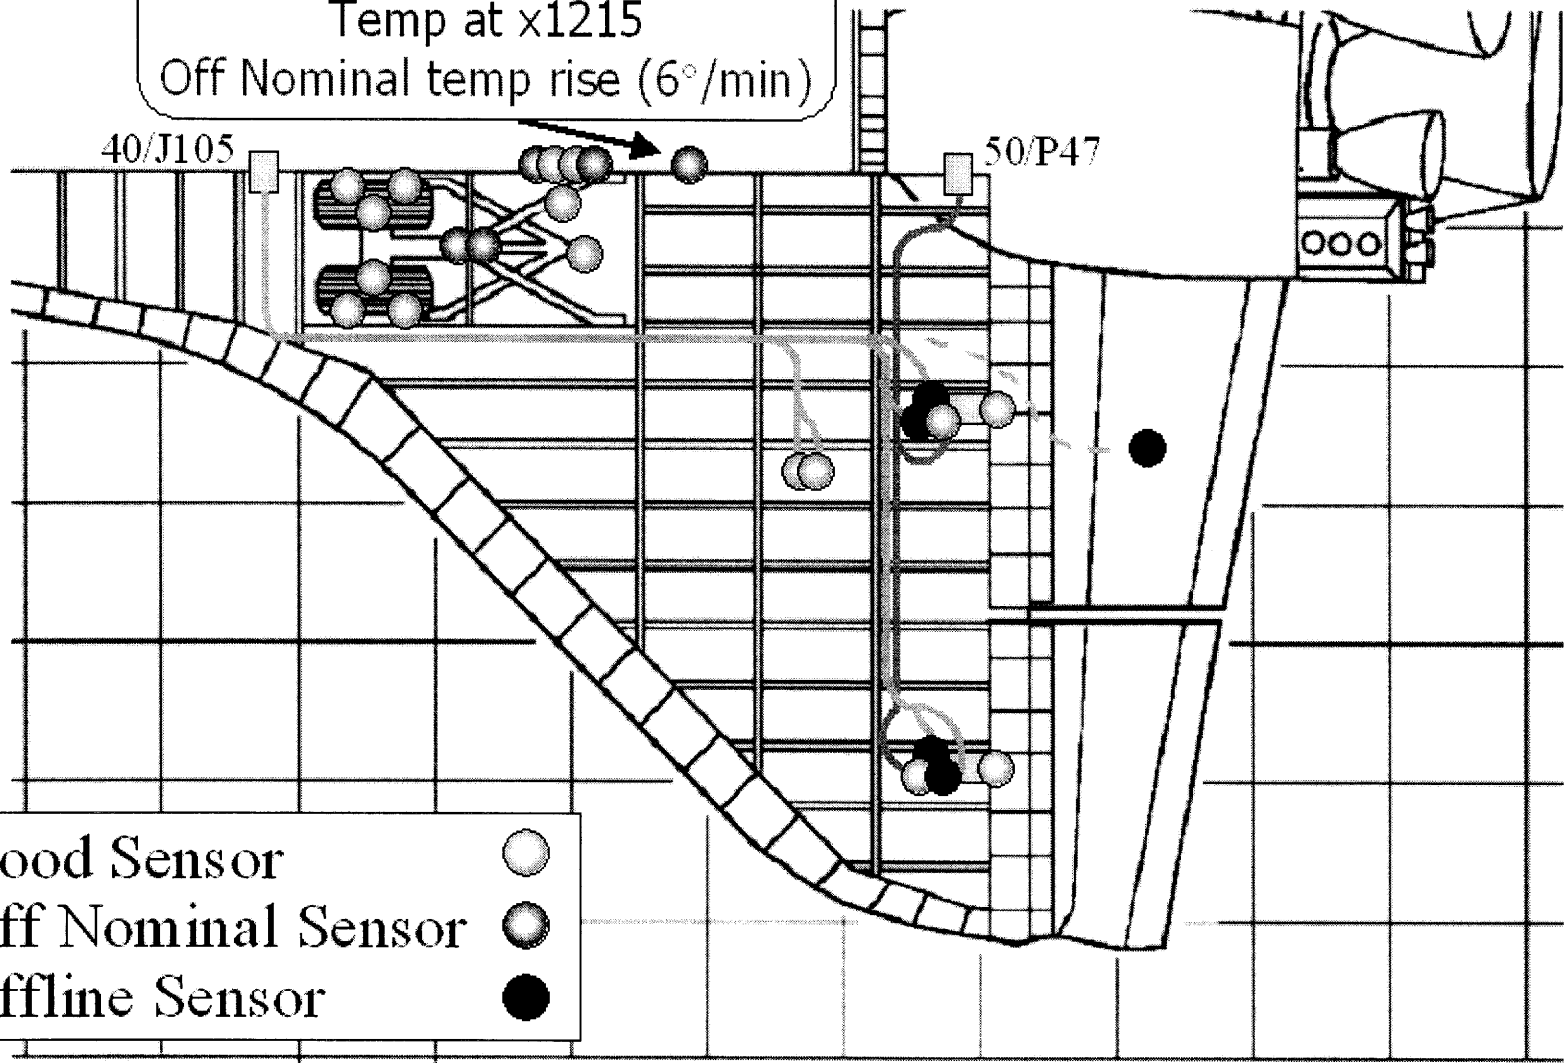
V34T1106  
Mid Fuselage Left Body Line  
Temp at x1215  
Off Nominal temp rise (6°/min)

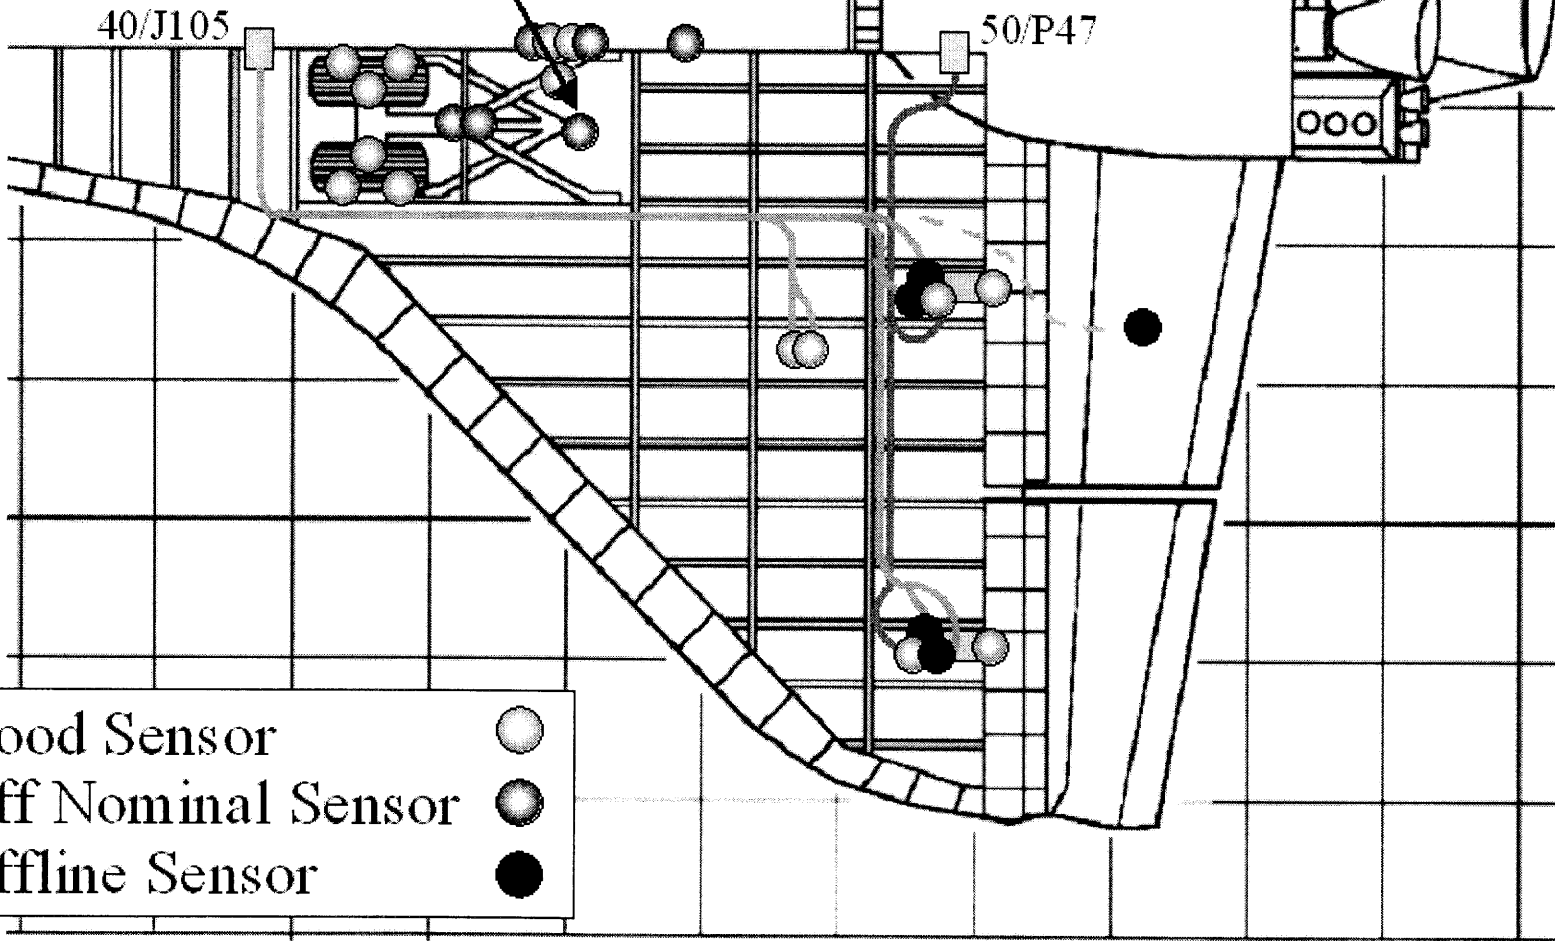
V58T0405  
Left Main Gear Strut  
Actuator Temp  
Off Nominal temp rise (7°/min)

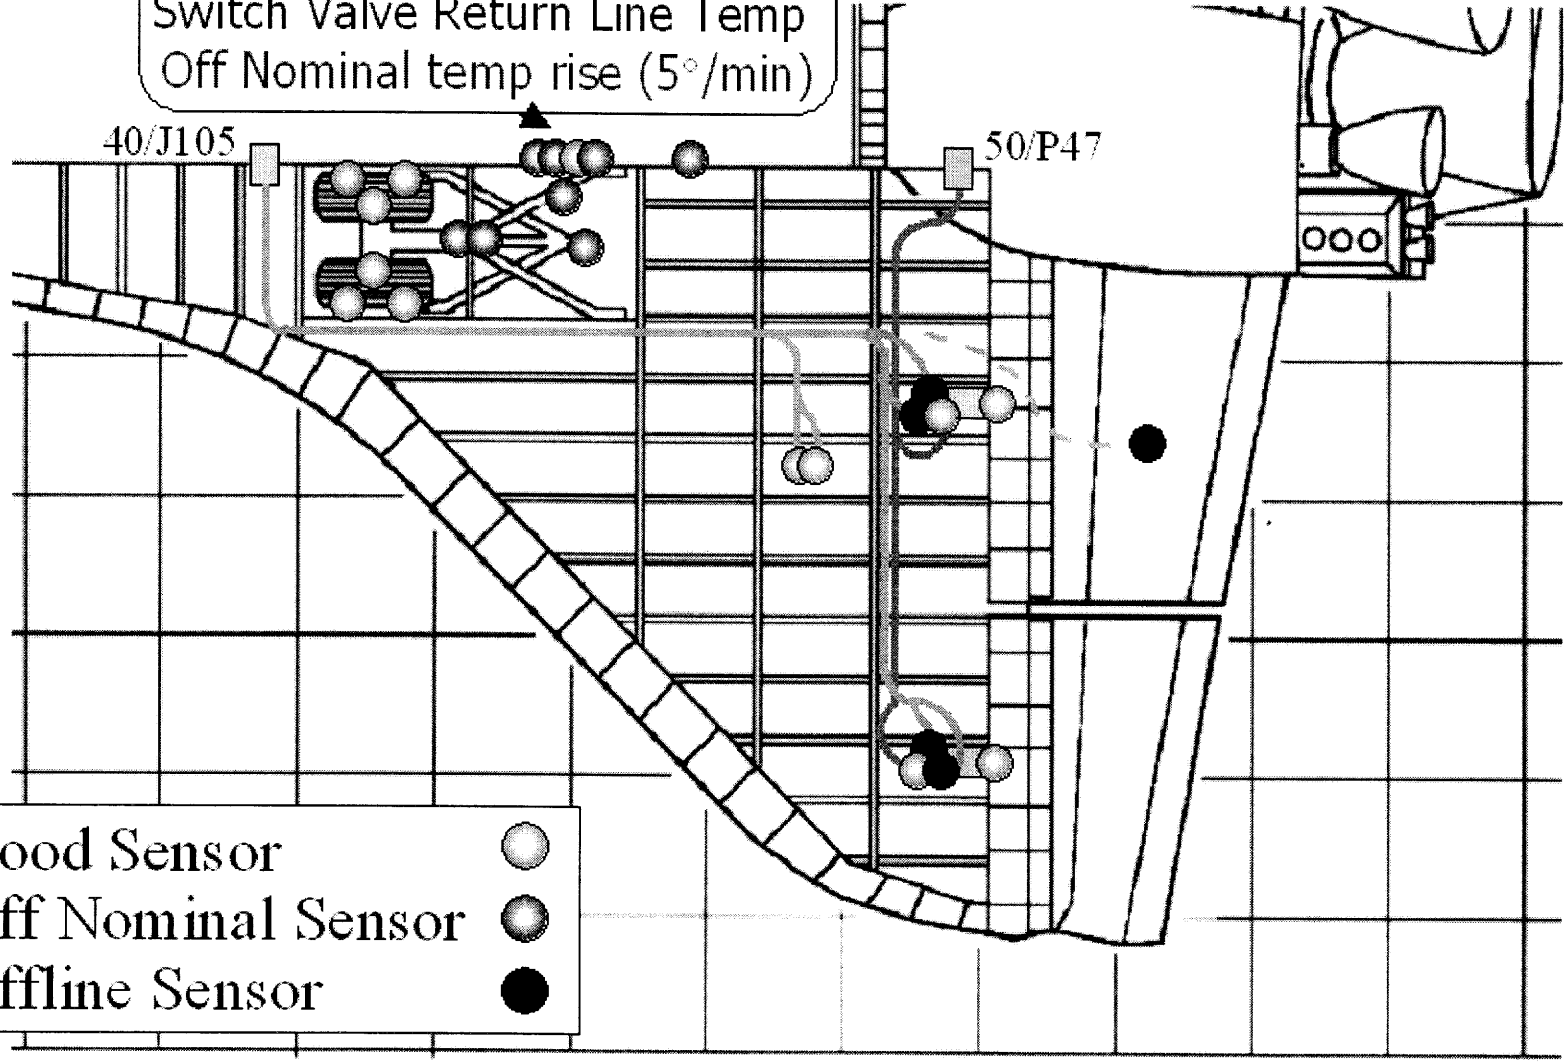
V58T0842  
System 3 LH Forward Brake  
Switch Valve Return Line Temp  
Off Nominal temp rise (5°/min)

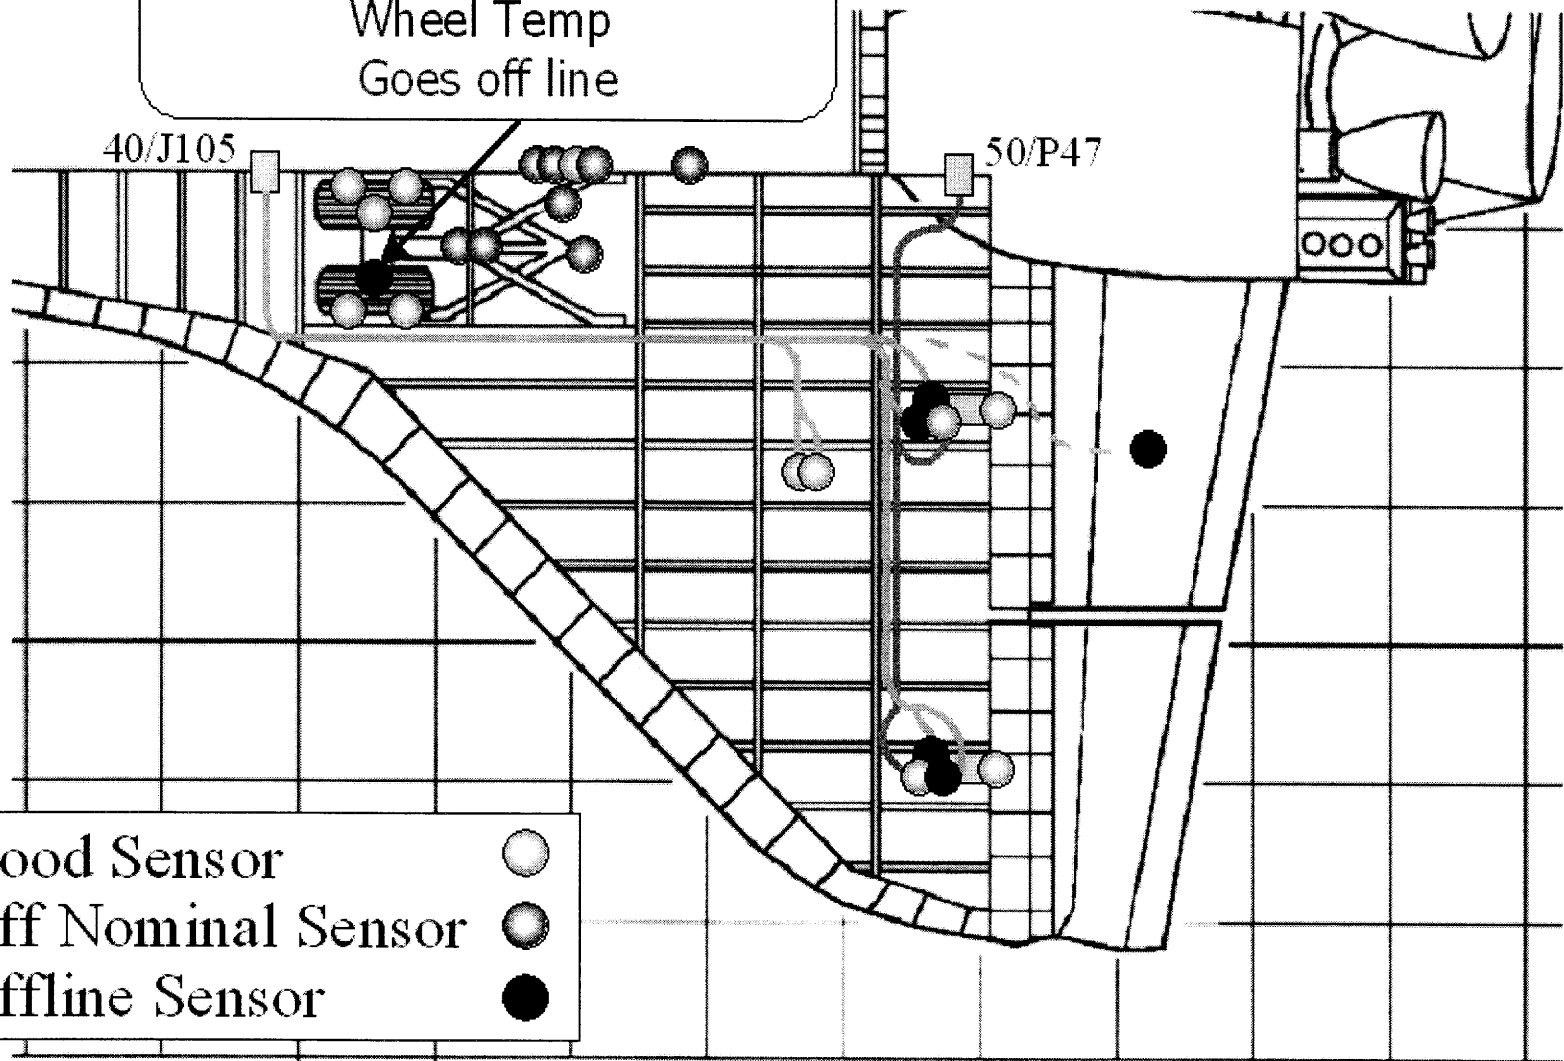
V51T0574  
MLG Left Outboard  
Wheel Temp  
Goes off line

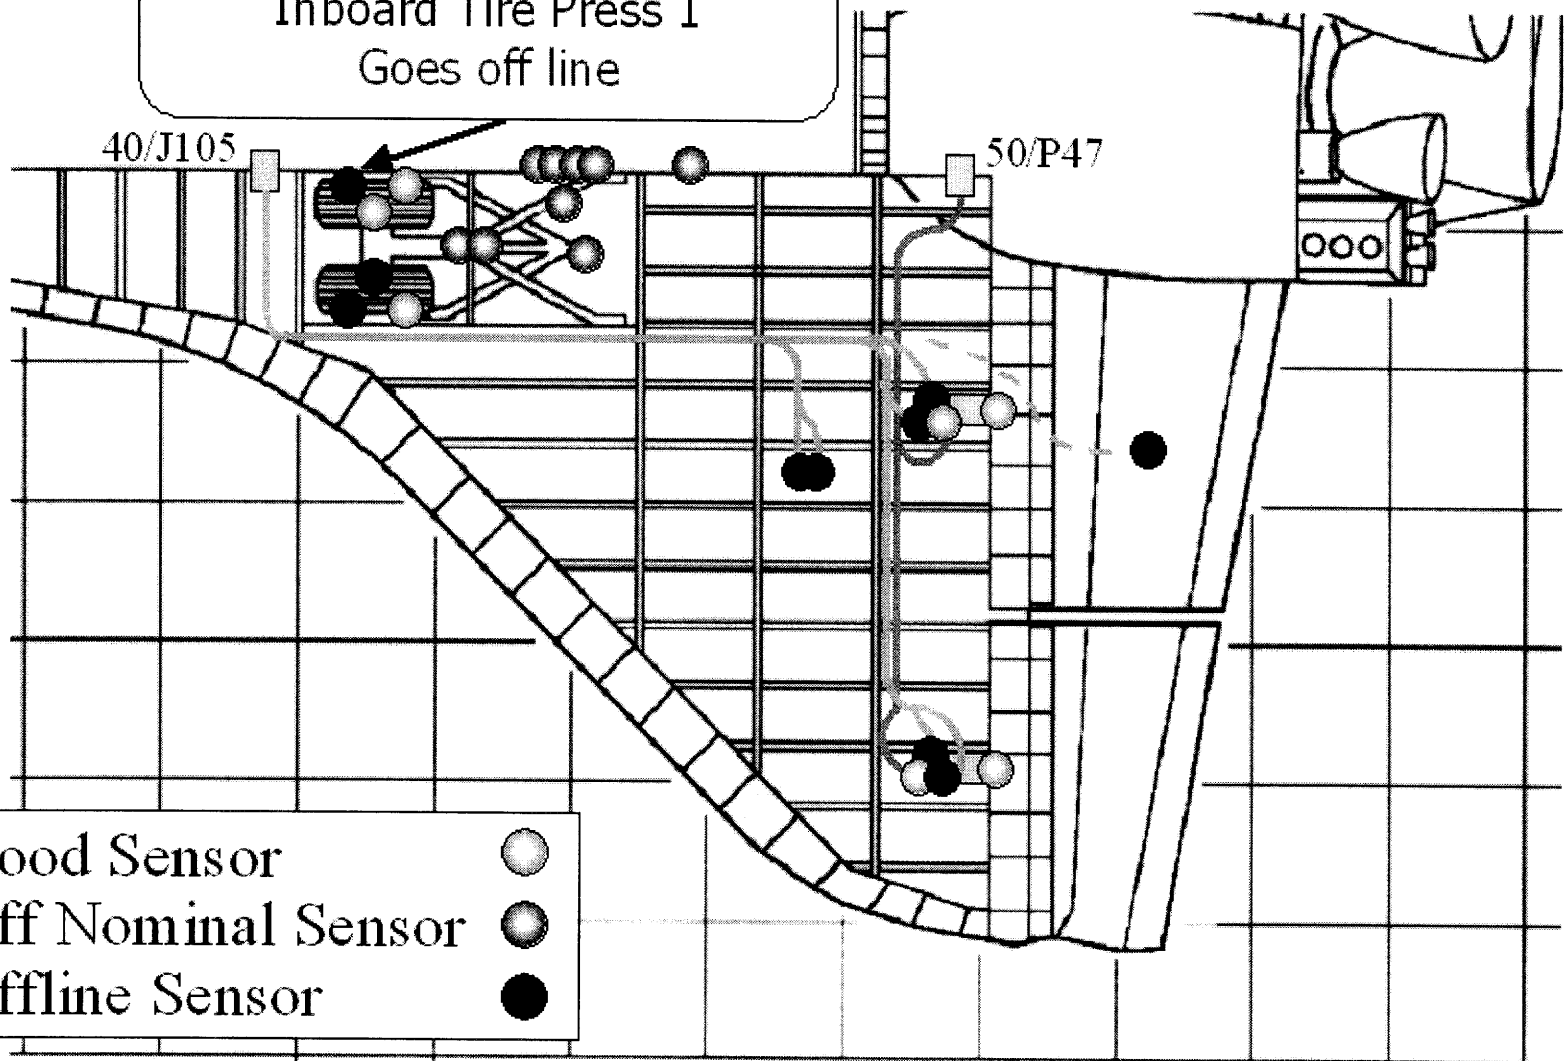
V51P0571A  
Main Landing Gear Left Hand  
Inboard Tire Press 1  
Goes off line

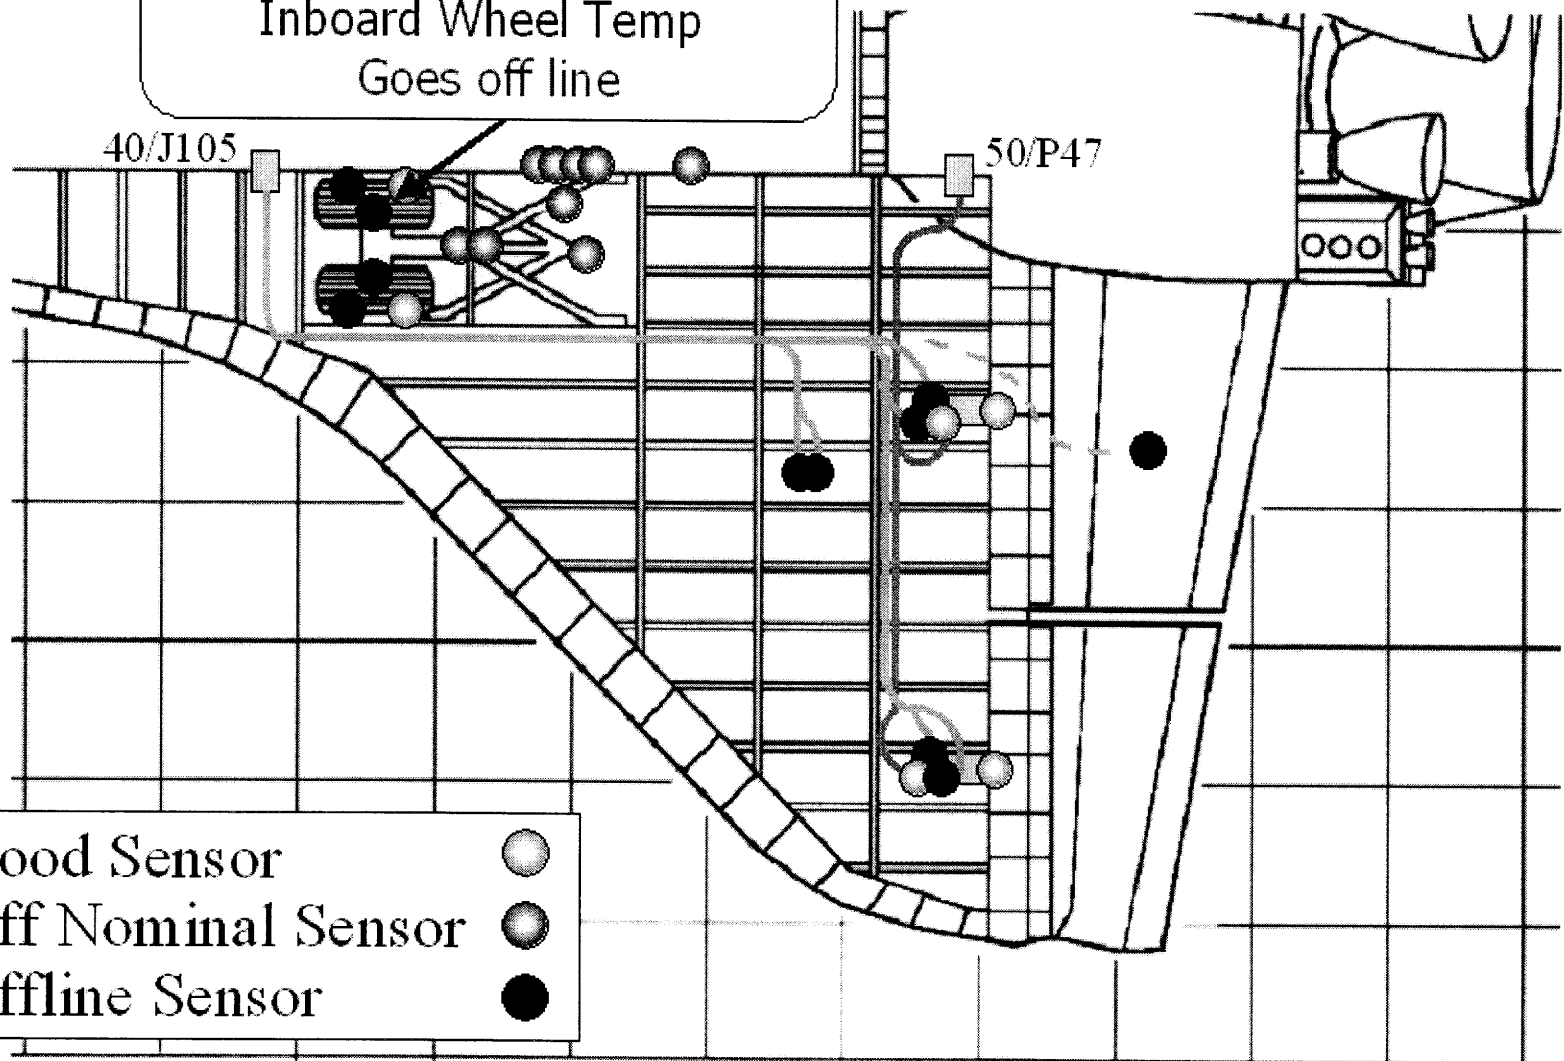
V51T0575  
Main Landing Gear Left Hand  
Inboard Wheel Temp  
Goes off line

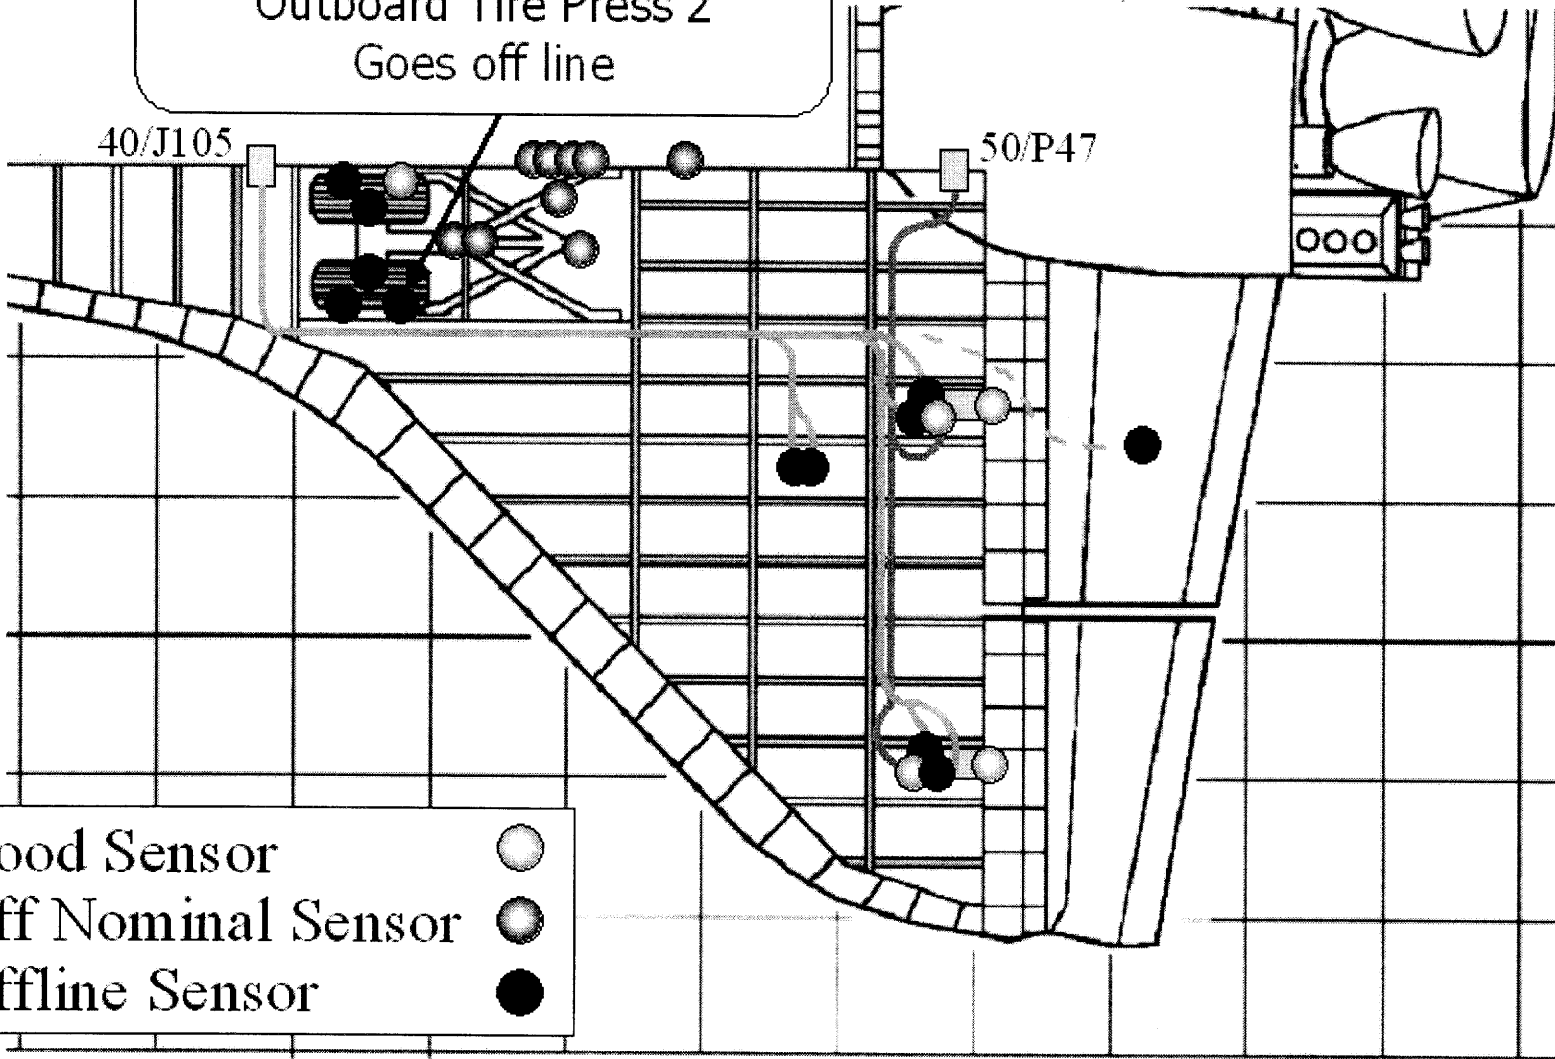
V51P0572A  
Main Landing Gear Left Hand  
Outboard Tire Press 2  
Goes off line
