Sweeney, Christopher J (ISI), 07:39 AM 2/3/2003, Thoughts and Prayers

**Howard M. Adelman, 01:13 PM 2/3/2003, Response to questions about Columbia**

Date: Wed, 12 Feb 2003 13:48:15 -0500  
To: r.h.daugherty@larc.nasa.gov  
From: "Katherine A. Barnstorff" <k.a.barnstorff@larc.nasa.gov>  
Subject: Associated Press article

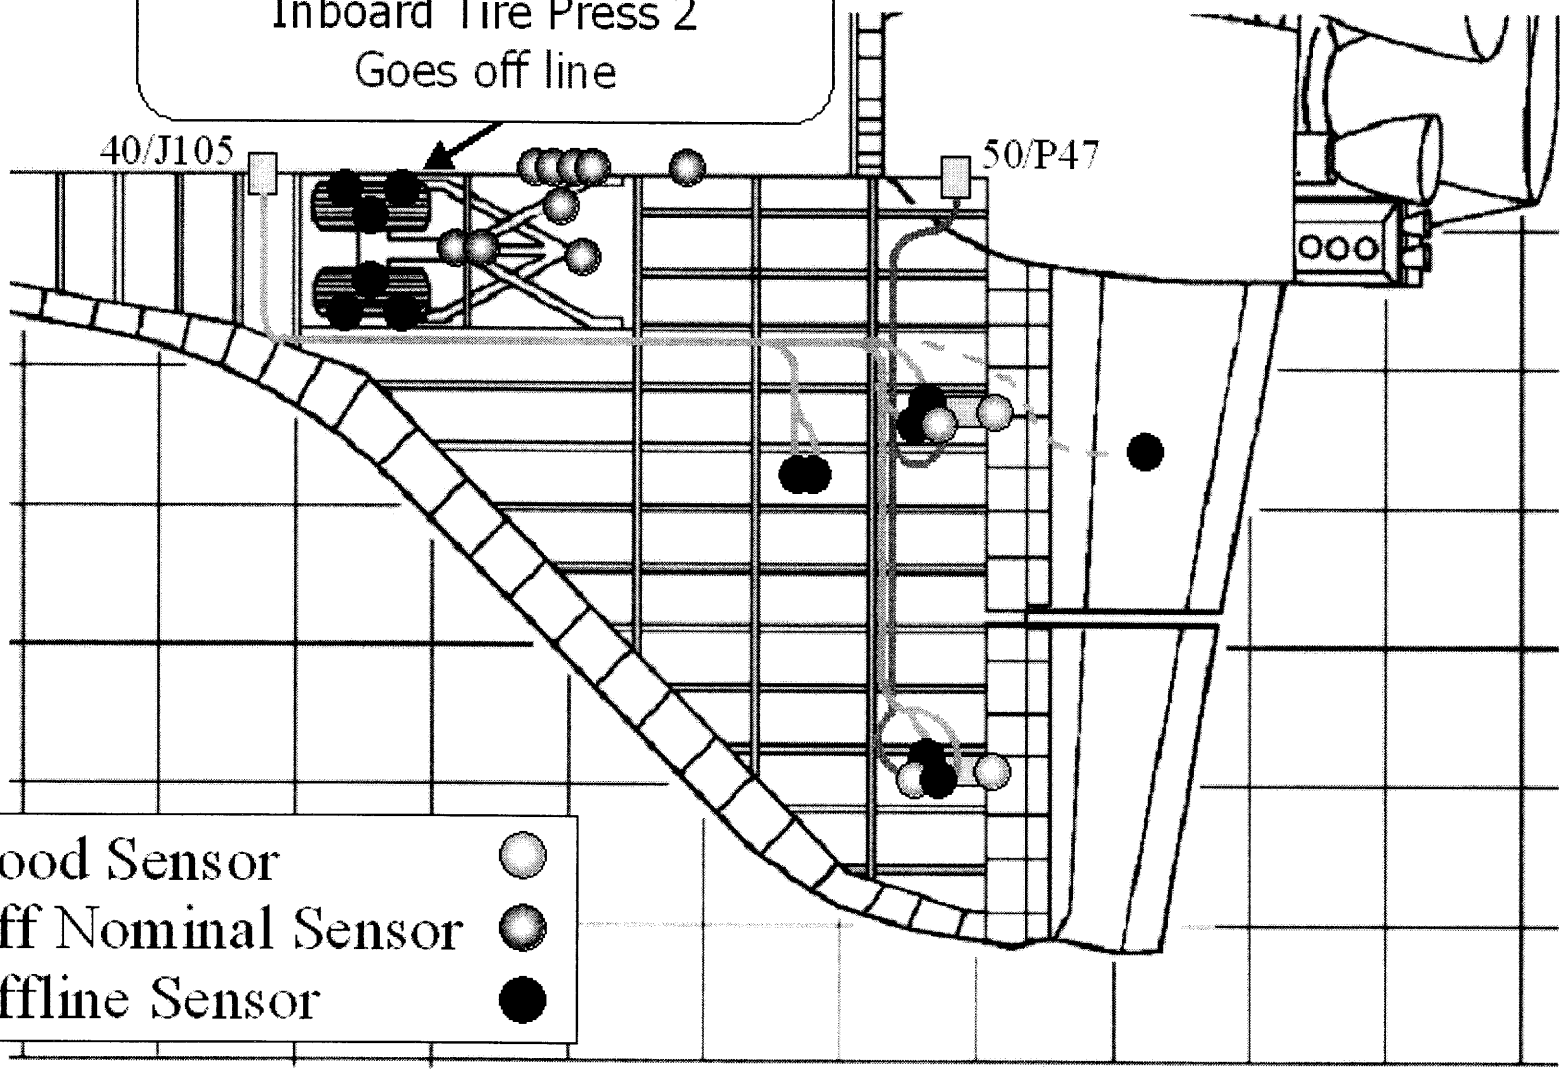
V51P0573A  
Main Landing Gear Left Hand  
Inboard Tire Press 2  
Goes off line

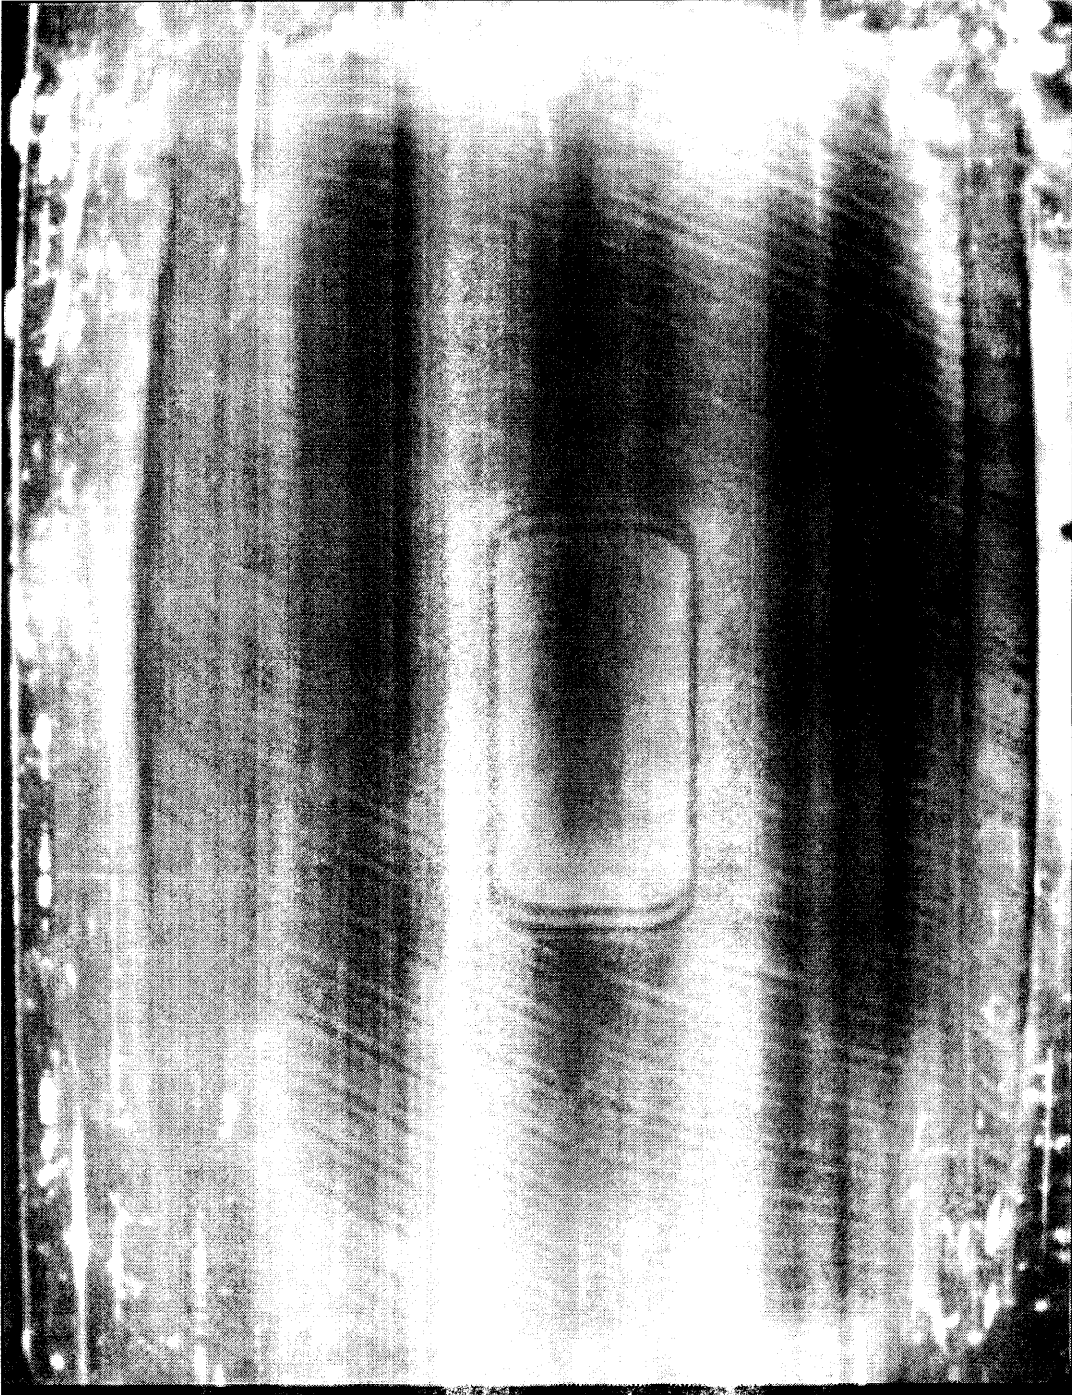
Orbiter Main Tire 44.5x16.0-21/34 Part No. MC194-0007-0007

Tire Serial No. 0169U02008 LGTF Tire Code No. 500-N

Balance Pad: 6 ounce pad located approximately 270 degrees from the serial number.

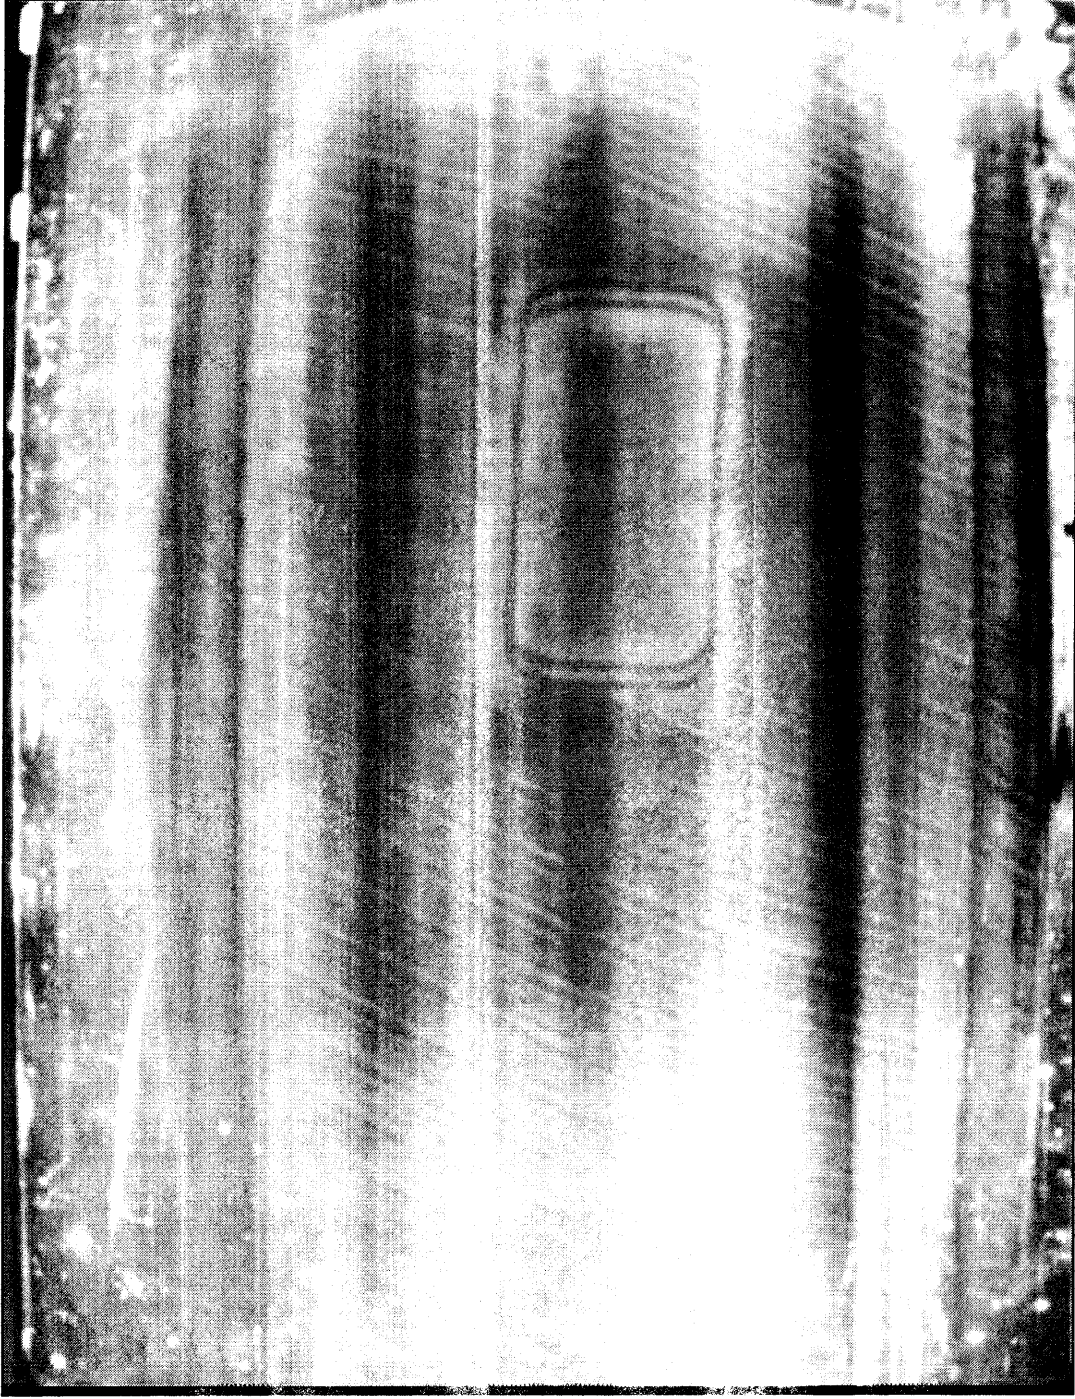
Orbiter Main Tire 44.5x16.0-21/34 Part No. MC194-0007-0007

Tire Serial No. 0170U02002 LGTF Tire Code No. 501-N

Balance Pad: 6 ounce pad located approximately 270+ degrees from the serial number.

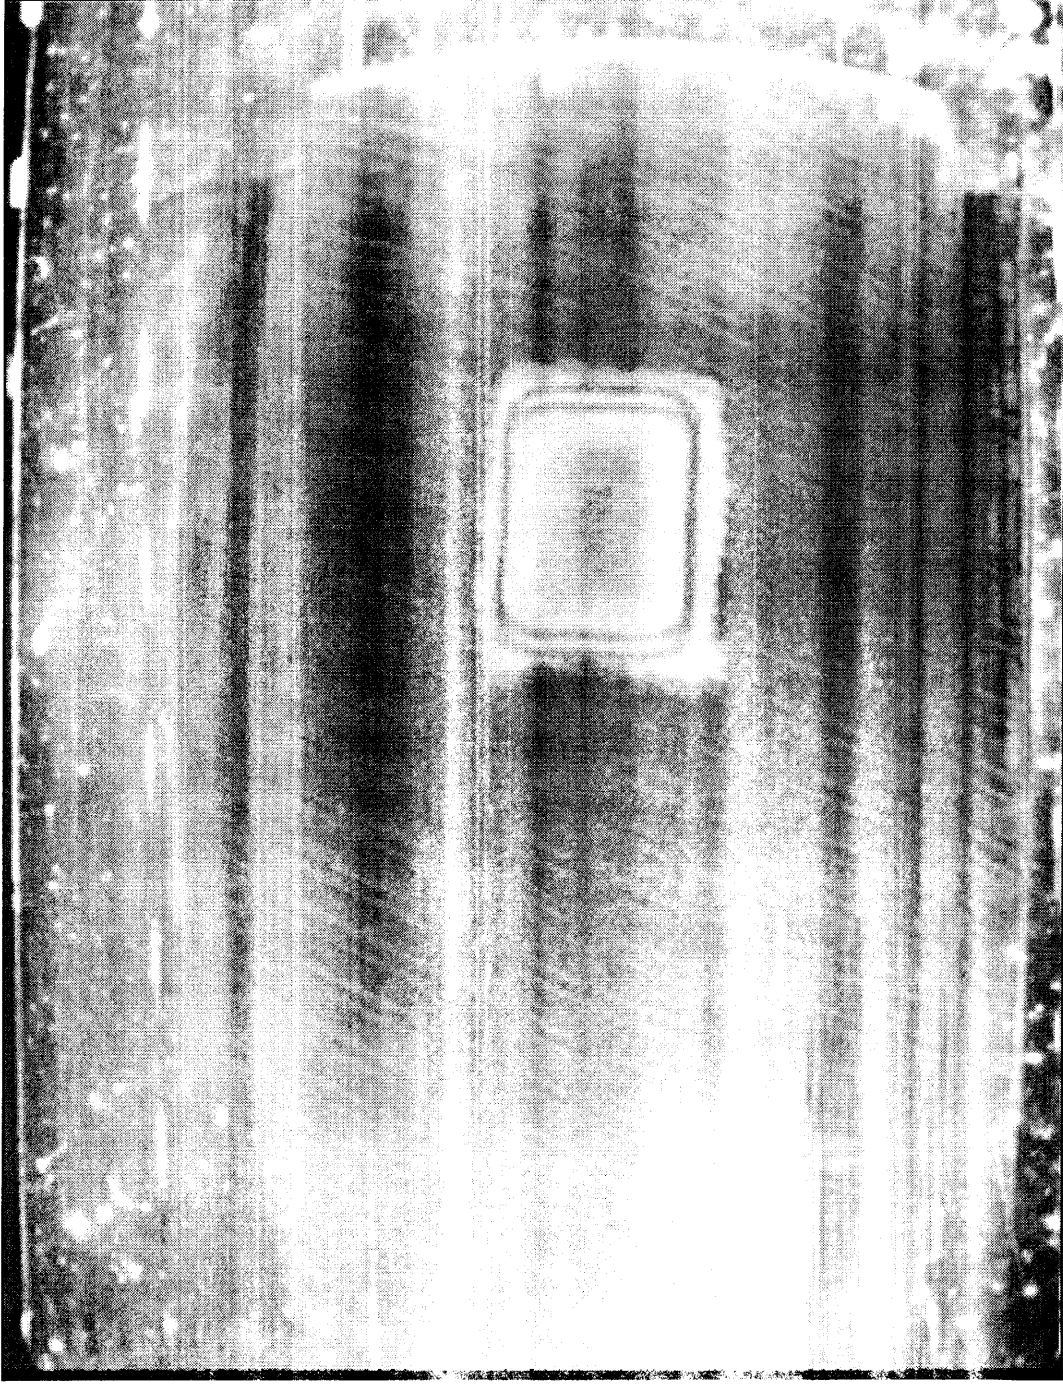
Orbiter Main Tire 44.5x16.0-21/34 Part No. MC194-0007-0007

Tire Serial No. 0171U02004 LGTF Tire Code No. 503-N

Balance Pad: 3.5 ounce pad located approximately 180+ degrees from the serial number.

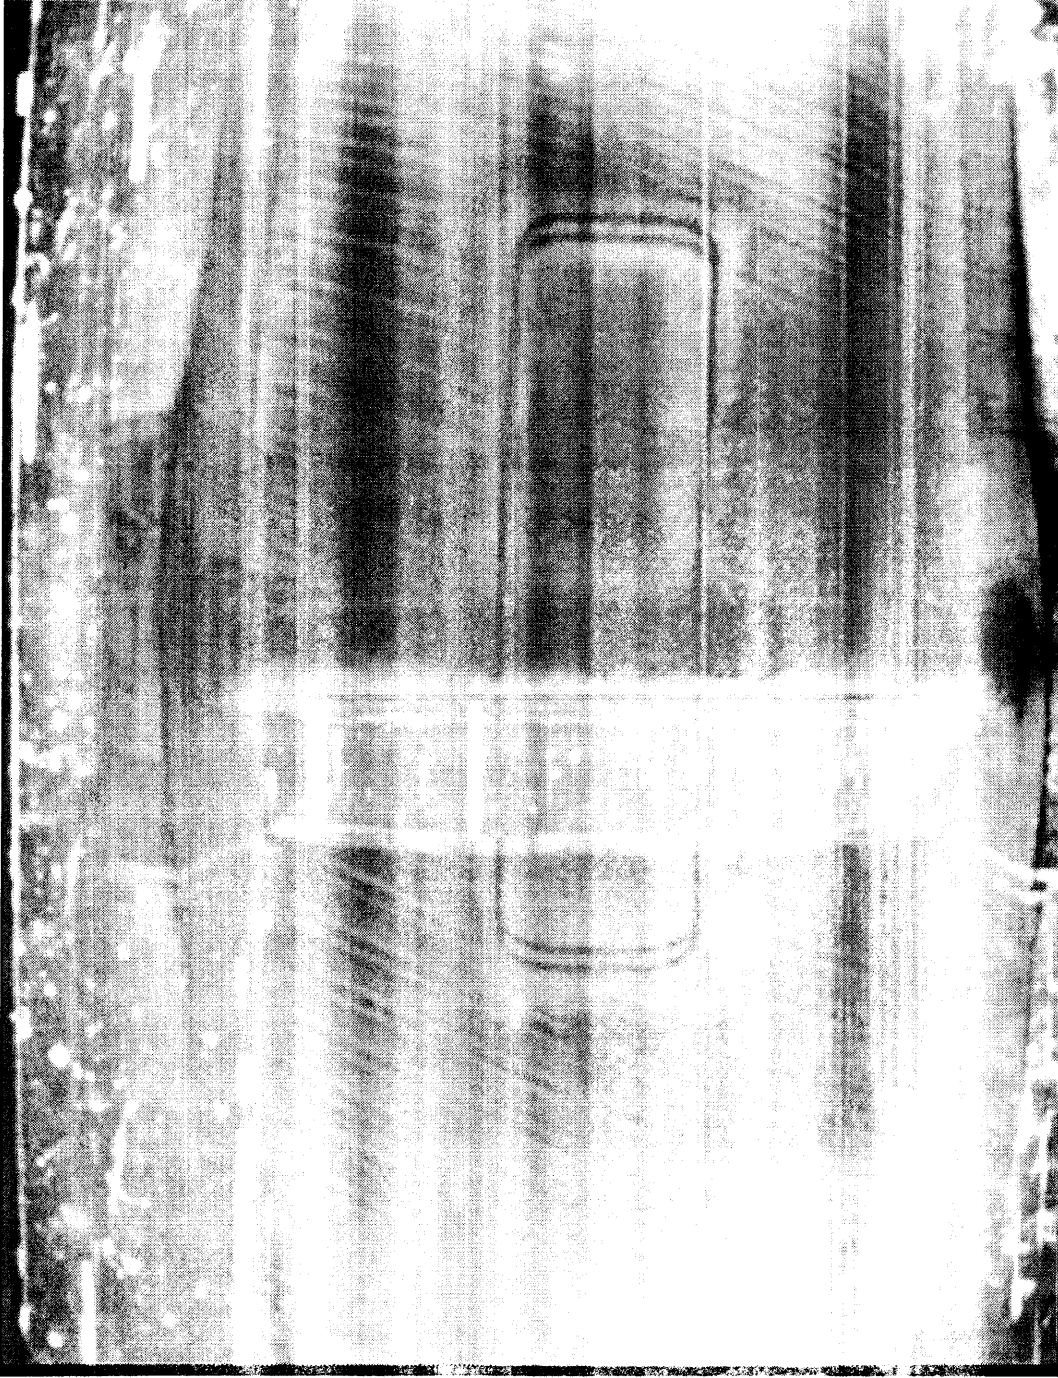
Orbiter Main Tire 44.5x16.0-21/34 Part No. MC194-0007-0007

Tire Serial No. 0171U02005 LGTF Tire Code No. 504-N
