**Hard Landing, Gear Collapse
Federal Express Flight 647
Boeing MD-10-10F, N364FE
Memphis, Tennessee
December 18, 2003**

NTSB/AAR-05/01

**NTSB/AAR-05/01
PB2005-910401
Notation 7632A
Adopted May 17, 2005**

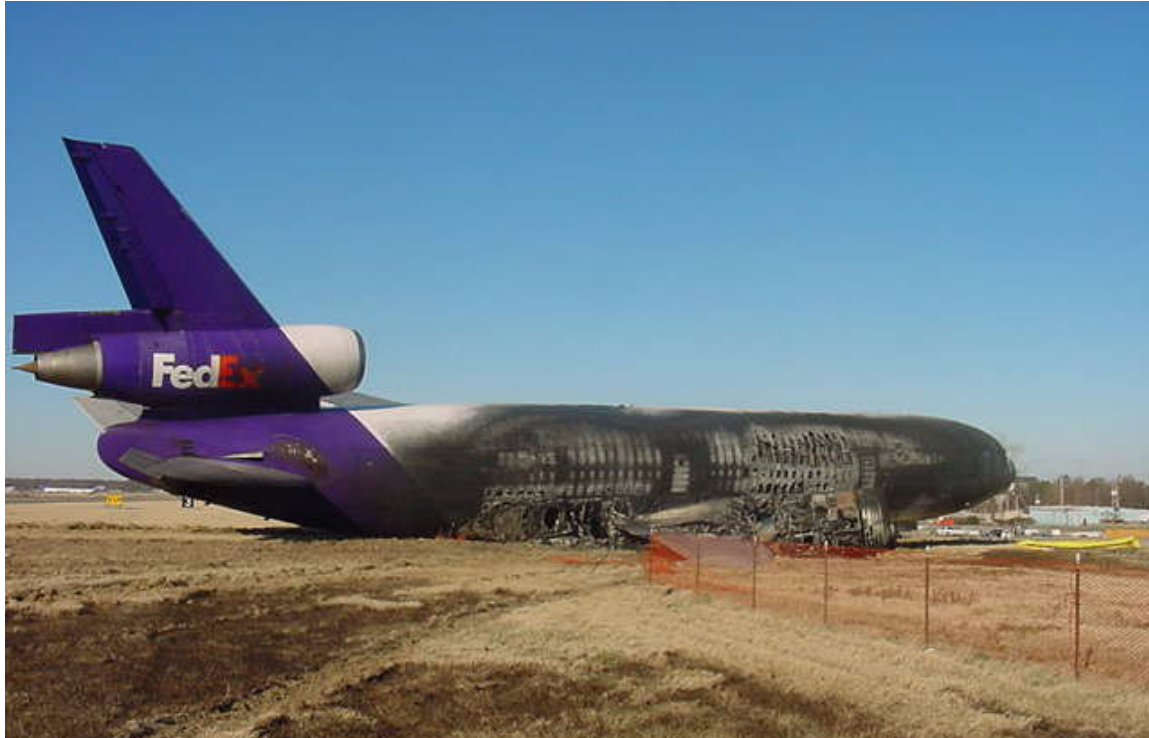
Figure 2. Photograph of the damage to the right side of the airplane.

The airplane came to rest in the grass about 155 feet right of the runway 36R centerline and 5,979 feet from the approach end of the runway. The airplane was aligned on a magnetic heading of about 070° and in a slight (about 20°) right-wing-down attitude. The right main landing gear assembly collapsed, and the airplane was supported by its nose landing gear, left main landing gear, and the lower surface of the right wing. The fuselage remained largely intact, but the right wing and the fuselage immediately adjacent to it exhibited substantial impact and fire damage. The right side of the fuselage also exhibited impact damage (including punctures and metal buckling) and extensive fire and heat damage (including paint blistering and some areas of burn-through). The right wing, slats, flaps, and ailerons showed evidence of substantial impact, fire and heat damage, and the right engine was separated from the wing at its wing-to-pylon attachments. Soot deposits were observed on portions of the lower fuselage and most of the right side of the fuselage. (Figure 2 is a photograph of the damage to the right side of the airplane.) The left

side of the fuselage, left wing, and the nose and tail sections exhibited minimal impact or fire damage.
