Crash During Approach to Landing
Business Jet Services, Ltd.
Gulfstream G-1159A (G-III), N85VT
Houston, Texas
November 22, 2004

NTSB/AAB-06/06
PB2007-100699

Accident Number:	DCA05MA011
Aircraft and Registration:	Gulfstream III, N85VT
Location:	Houston, Texas
Date:	November 22, 2004
Adopted On:	November 2, 2006

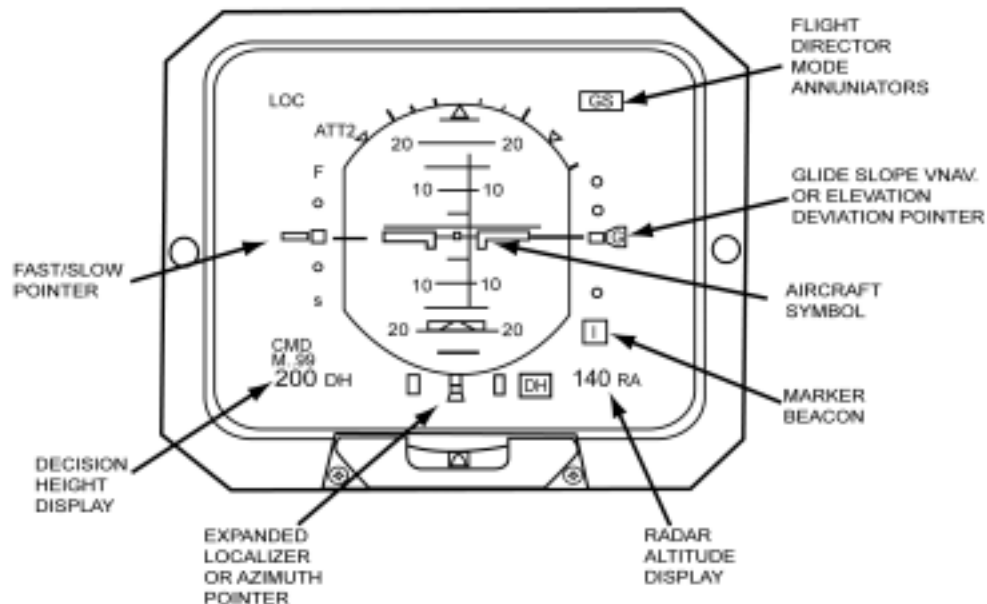
Figure 4. A diagram of the EADI.

The glideslope and fast/slow indicators are the same color and about the same size. Each indicator consists of a moving pointer on a rectangular display, and each display has markers above and below the rectangle to indicate the degree of deviation. The glideslope pointer resembles a blunt-point arrow, and the fast/slow pointer resembles a rectangle (see figure 4). The accident airplane’s EADI was configured with the glideslope indicator on the left side and the fast/slow indicator on the right side.¹² A review of the Safety Board’s accident database revealed

Note: The diagram shows the glideslope and the fast/slow indicators on the right and left side of the EADI, respectively, which is opposite of the accident airplane's configuration.

The first officer’s failure to activate and identify the ILS frequency earlier in the approach prevented the flight crew from recognizing that the airplane was off course and below the glideslope. The fast/slow indicator on the EADI resembles the glideslope indicator and is visible on the EADI at all times, whereas the glideslope indicator only appears on the screen once an ILS frequency has been activated. Postaccident flight simulations revealed that the fast/slow indicator would have been centered within one dot during the approach sequence and that the indications would have been consistent with the first officer’s comments about the glideslope if he had mistaken the fast/slow indicator for the glideslope indicator.
