NATIONAL TRANSPORTATION SAFETY BOARD

AIRCRAFT ACCIDENT REPORT

UNCONTROLLED DESCENT AND COLLISION WITH TERRAIN
USAIR FLIGHT 427
BOEING 737-300, N513AU
NEAR ALIQUIPPA, PENNSYLVANIA
SEPTEMBER 8, 1994

AIRCRAFT ACCIDENT REPORT
NTSB/AAR-99/01 (PB99-910401)

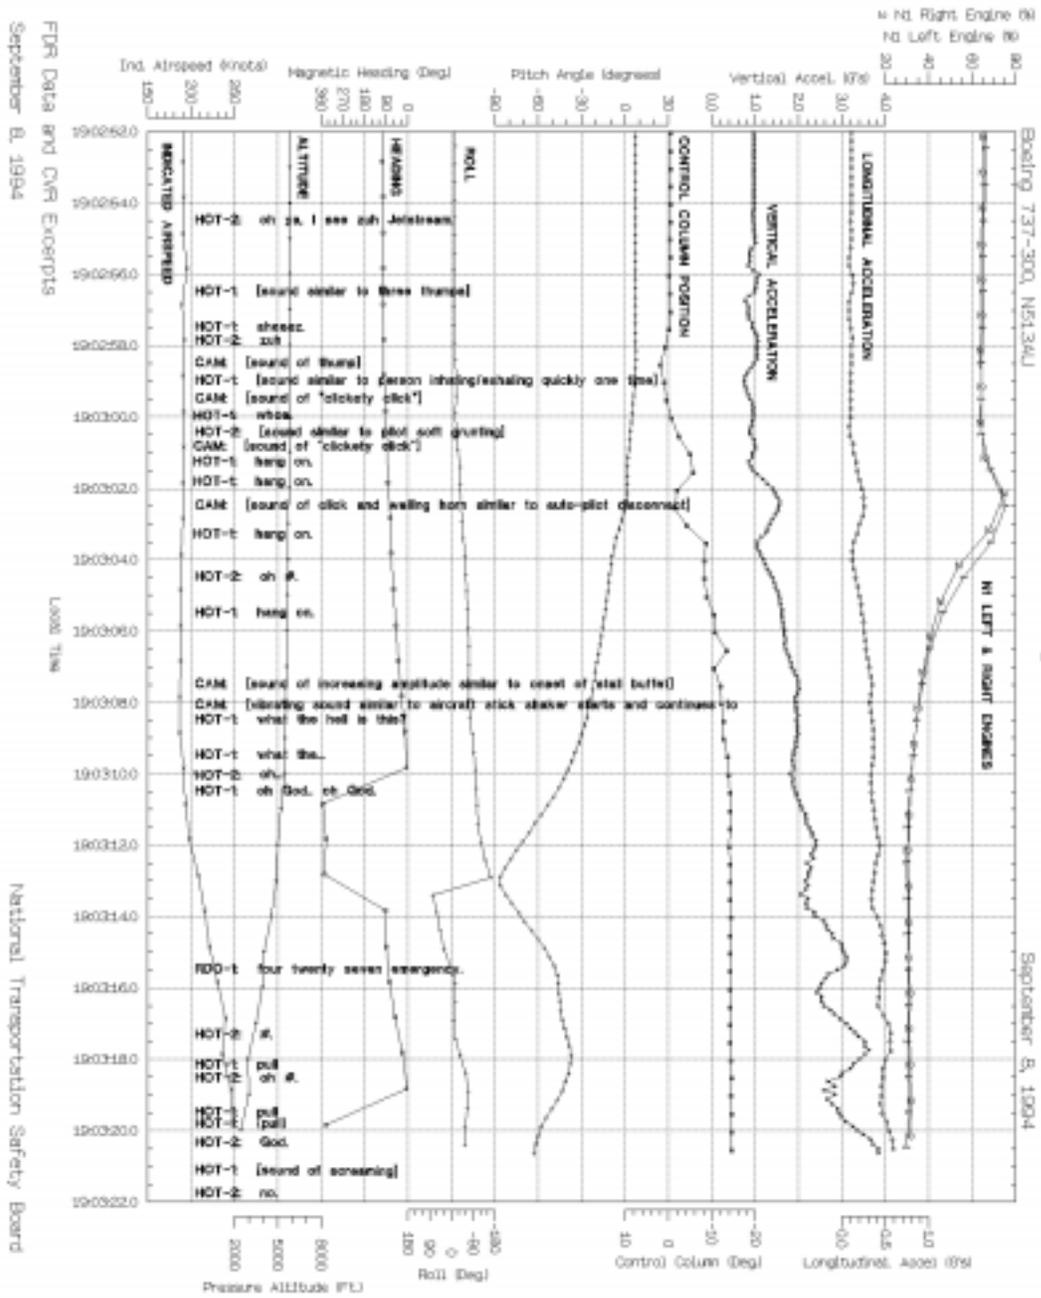
Figure 1. FDR data during the final 30 seconds of USAir flight 427.

FDR information revealed that, just before 1903:03, the airplane's left bank angle had increased to about 43°, the airplane had begun to descend from its assigned altitude of 6,000 feet msl, the control column had started to move aft, and the airspeed started to decrease below 190 knots. Less than 1 second later, the CVR recorded the sound of the autopilot disconnect horn. During the next 5 seconds, the FDR recorded increasing left roll, aft control column, decreasing altitude, and a decreasing airspeed to about 186 knots.

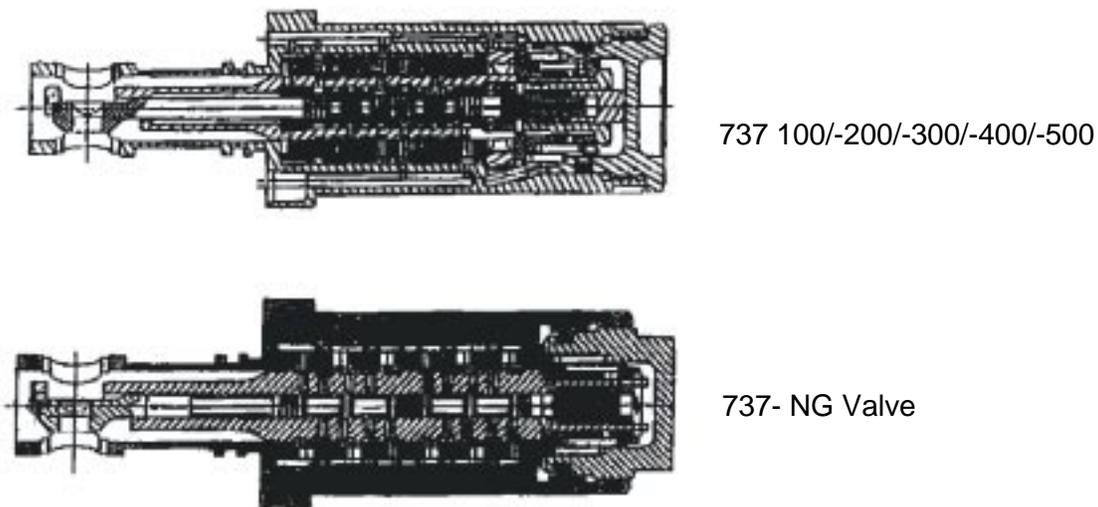
single piece rather than built up by a group of smaller parts. Figure 31 shows the 1998 redesigned servo valve for both the earlier 737 series airplanes and the 737-NG airplanes.

Figure 31. Parker's 1998 redesigned servo valve for 737 airplanes.
