Factual Lines About Submarine Hazards

FLASH

Submarines

April - June 2009

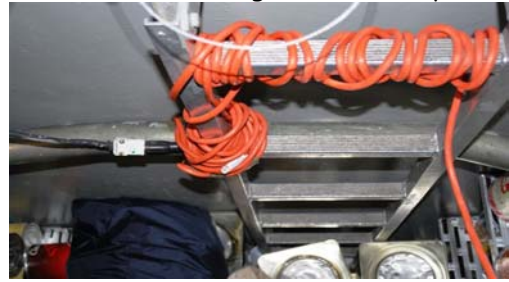
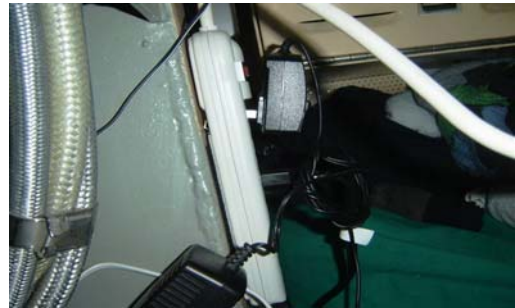
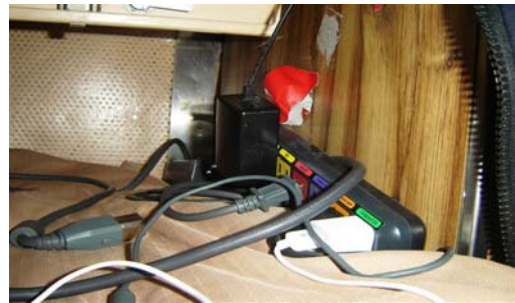
3. Electrical ratings are making two common mistakes. First: Tagging equipment that is unauthorized for submarine use. Second: Not following the MRC. This is not uncommon, we repeatedly find *unauthorized* multi-outlet power strips, power cables, and damage power cables with safety checks/tags (often recently checked). This is unacceptable!

Photo's taken during recent surveys.

1. Stop being a lemming! Call away the casualty and secure the brow!
2. The electricians should have noted the damage during the electrical safety check. The divers should have discovered the damage while rigging the cable. Ship's force personnel (at a minimum; Sentry, POOD, BDW, Duty Chief, or Duty Officer) should have found this damaged cable using basic submarine watchstanding principles.

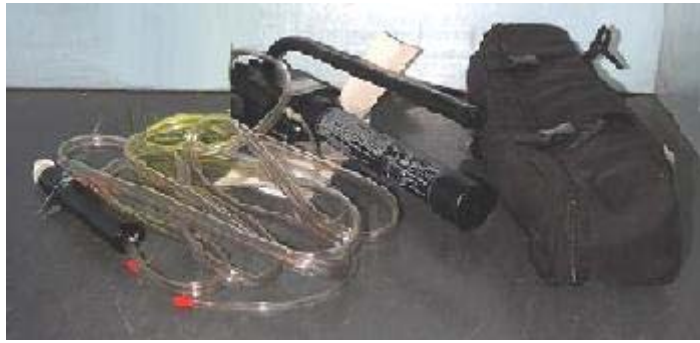
Manual Reverse Osmosis Desalinator:

During the past few surveys, I noticed personnel are not aware of the Planned Maintenance System (PMS) MIP: 5940/001 (Q-1R) for the Manual Reverse Osmosis Desalinator (MROD), step 1h., requires the sailor to "Place the unit in a plastic bag." Previous Force Revisions (FR) listed a plastic bag which did not fit the device. Device dimensions are called out as 3.70 inches wide by 5.70 inches in height by 22.4 inches in length. The SPMIG number has been updated for an 18 inch by 24 inch bag. This bag is not a Ziplock-type bag and does not have to be heat sealed. PMS card for MROD MIP: 5940/001 (48M-1), SPMIG number 11699 for Test Kit, is missing (NSN 4610-01-548-9743) required data and 11697 for Tool Kit (NSN 5180-01-549-6746). PMS TFBR has been submitted to correct the missing material items needed to complete the PMS. The 48M-1 maintenance requirement may require assistance from the Engineering Laboratory Technician (ELT) division for completion.
