July-September 2009

Submarine Division of the Naval Safety Center

FLASH

Factual Lines About Submarine Hazards

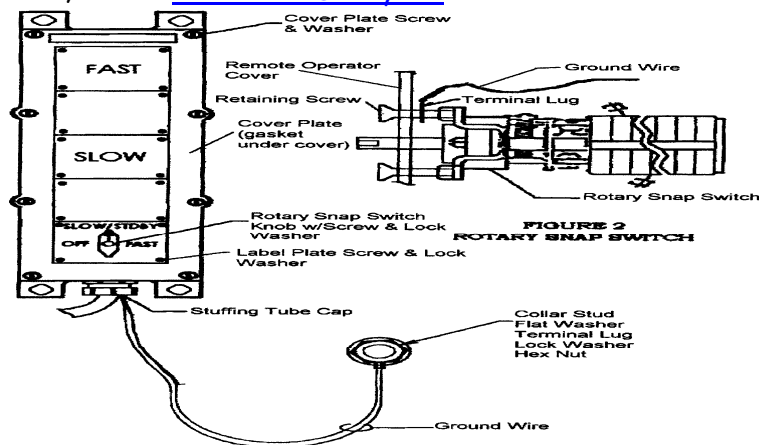
688 Class Ventilation Fans 6 and 7 Shock Hazard

A number of 688 class boats have discovered voltage present on the shaft of the operating switches for ventilation fans 6 and 7. These controllers are of a different design than other fan controllers on board. The voltage may vary with switch position, but values of greater than 30 volts have been measured. A&I N3470 has been issued to eliminate this shock hazard.

A&I N3470, Install Ground Wires on Vent Fan 6 & 7 Remote Operators. This A&I is applicable to SSNs 688,690, 691, 698-701, 705, 706, 711, 713-715, 717, 719-725 and 750. Also, SSNs 751-773 that do not use rotary snap switches for ventilation fans 6 and 7. Ready for issue (RFI) material to accomplish the A&I became available in Feb 2009. This is a category B A&I which indicates that the fleet has two years from the time the material is made RFI to complete the alteration (Feb 2011). The A&I can be downloaded at the following SIRP website: <http://www.fleetforces.navy.smil.mil/comsubfor/N4/default.aspx> Direct questions or comments regarding the technical content of this A&I to the SSN 688 class planning yard: Earl Koepcke, phone (757) 688-2224. NAVSEA point of contact is: MR. Rick Kurek, (202) 781-1274, e-mail rick.kurek@navy.mil.
