# Biennial Report<sup>1</sup> on Occupational Safety and Health Inspections

Conducted in the legislative branch during the 109<sup>th</sup> Congress pursuant to the Congressional Accountability Act of 1995

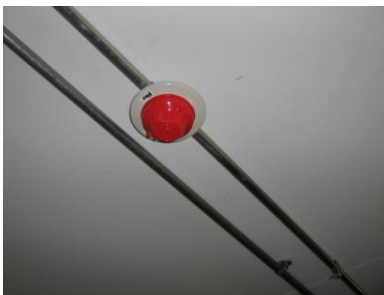
While some progress has been made in complying with the OSHA and NFPA standards, the inspection team found 86 instances of obstruction and failure to maintain the required eighteen inches of separation between the sprinkler heads and obstructions during the 108<sup>th</sup> Inspections; and, over 300 instances during the 109<sup>th</sup> Inspections.

**Picture 1 Capped fire sprinkler**

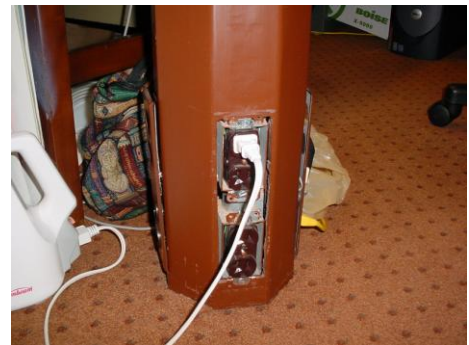
employee reach. A majority of these hazards qualified as RAC 2 in severity requiring prompt correction. Several qualified for RAC 1 in severity requiring immediate attention. Hazards of this type were specifically noted in the 1998 and 2002 Reports. 1998 Report, p. 21; 2002 Report, pp. 39-40. Many remain unabated.

**Picture 2 Faceplate missing from outlets**

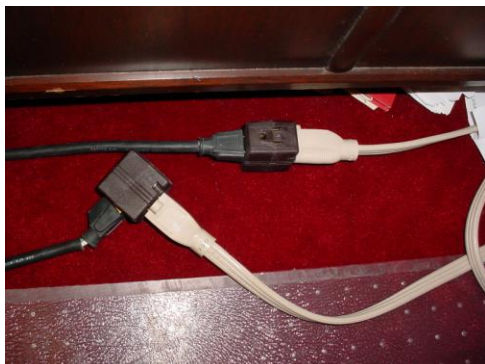
**Picture 3 Extension Cords and Cube Tabs in Use**

The 109<sup>th</sup> inspection continued to reveal numerous locations using non-permanent wiring in lieu of available outlets. Over 2,300 locations were found with extension cords used as permanent wiring. An additional 2,400 locations had “daisy chains” wherein power strips or surge protectors were linked to extend their reach or increase capacity. Both of these conditions violate the National Electrical Code and OSHA requirements. These standards establish that extension cords may not be used as permanent wiring and their use may not

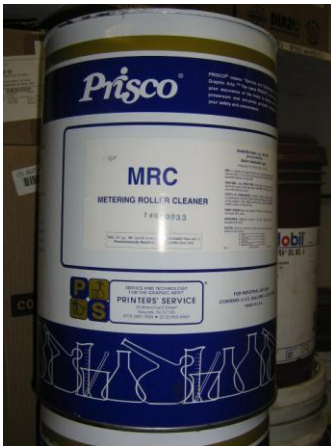
**Picture 4 Product containing Methylene Chloride**

Methylene chloride is a volatile chemical that has been used as a stripping agent and industrial lubricant. Since 1998, its use has been strictly regulated by OSHA because of its carcinogenic nature. Methylene chloride is known to cause respiratory distress, depress the nervous and cardiovascular systems, damage the liver and kidneys, and cause eye irritation. For this reason, the use of and exposure to methylene chloride are subject to strict monitoring and exposure control requirements. The OOC inspection team discovered methylene chloride in use, or stored in legislative branch facilities, without the proper hazard communication and chemical use program, and monitoring in place despite prior reports warning against this hazard.

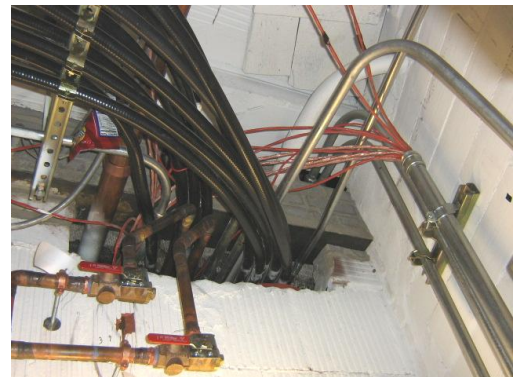
**Picture 5 Penetration in a fire wall**

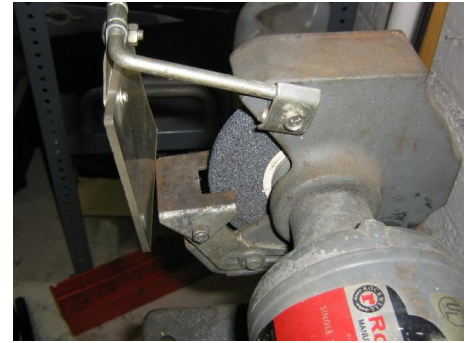
been removed or have fallen off without being replaced. Carelessly used paper cutters can amputate fingers unless properly guarded. OSHA regulations require the maintenance of the manufacturer's installed guards; however, there were a total of 150 machine guarding hazard findings during this inspection.

**Picture 7 Bench Grinder with inadequate guarding**
