MARINE ACCIDENT REPORT

SS EDMUND FITZGERALD

SINKING IN LAKE SUPERIOR

REPORT NUMBER: NTSB-MAR-78-3

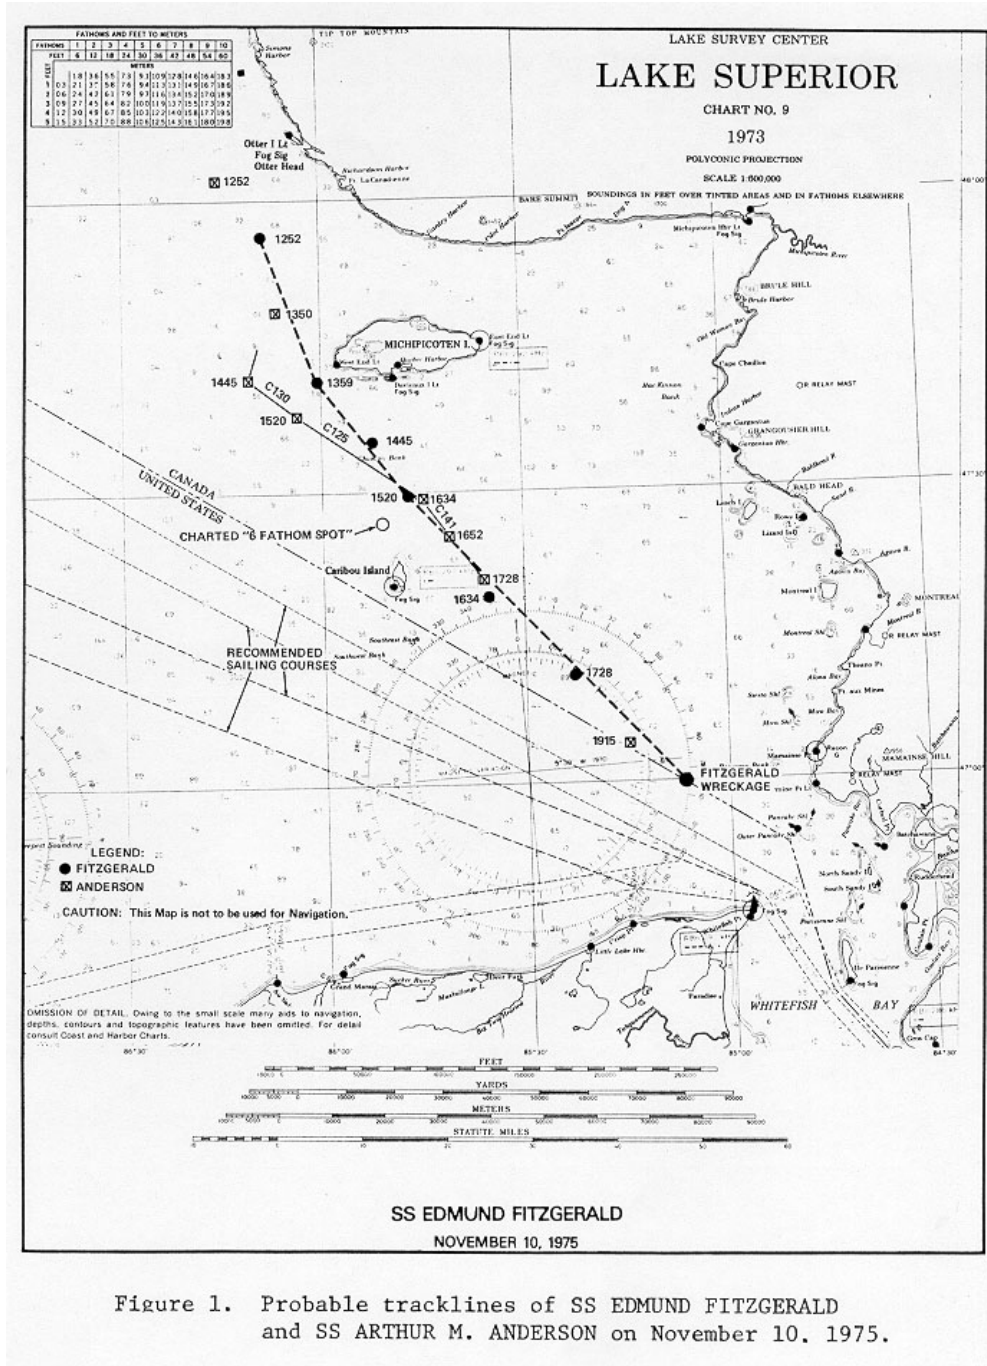
Figure 1: Trackline/Course of the SS EDMUND FITZGERALD

Based on radar data observed by the ANDERSON, the FITZGERALD's position at 1350 (1359), 1445, 1520, 1652 (1634), 1701 (1728), and 1915 correlate with the 141T course reported by the FITZGERALD and the Safety Board's calculated speeds. (See figure 1.)

The trackline of the FITZGERALD lies 2.75 miles east of Chummy Bank and 2.5 miles east of the 10-fathom curve outlining the shoal area north of Caribou Island known as North Bank. Some testimony placed the FITZGERALD closer to North Bank; however, the course of 141 T from West End Light to Whitefish Bay is well known to Great Lakes navigators and this was the intended track of both the ANDERSON and the Fitzgerald. The ANDERSON was navigated to return to this trackline at 1634 for the final leg of her voyage. At this time the FITZGERALD was observed to be almost dead ahead of the ANDERSON when her heading was 142 T.

10. The most probable trackline of the FITZGERALD, from west of Michipicoten Island to the position of her wreckage, lies east of the shoal areas north and east of Caribou Island; therefore, damage from grounding would have been unlikely.

Figure 1. Probable tracklines of SS EDMUND FITZGERALD and SS ARTHUR M. ANDERSON on November 10, 1975.

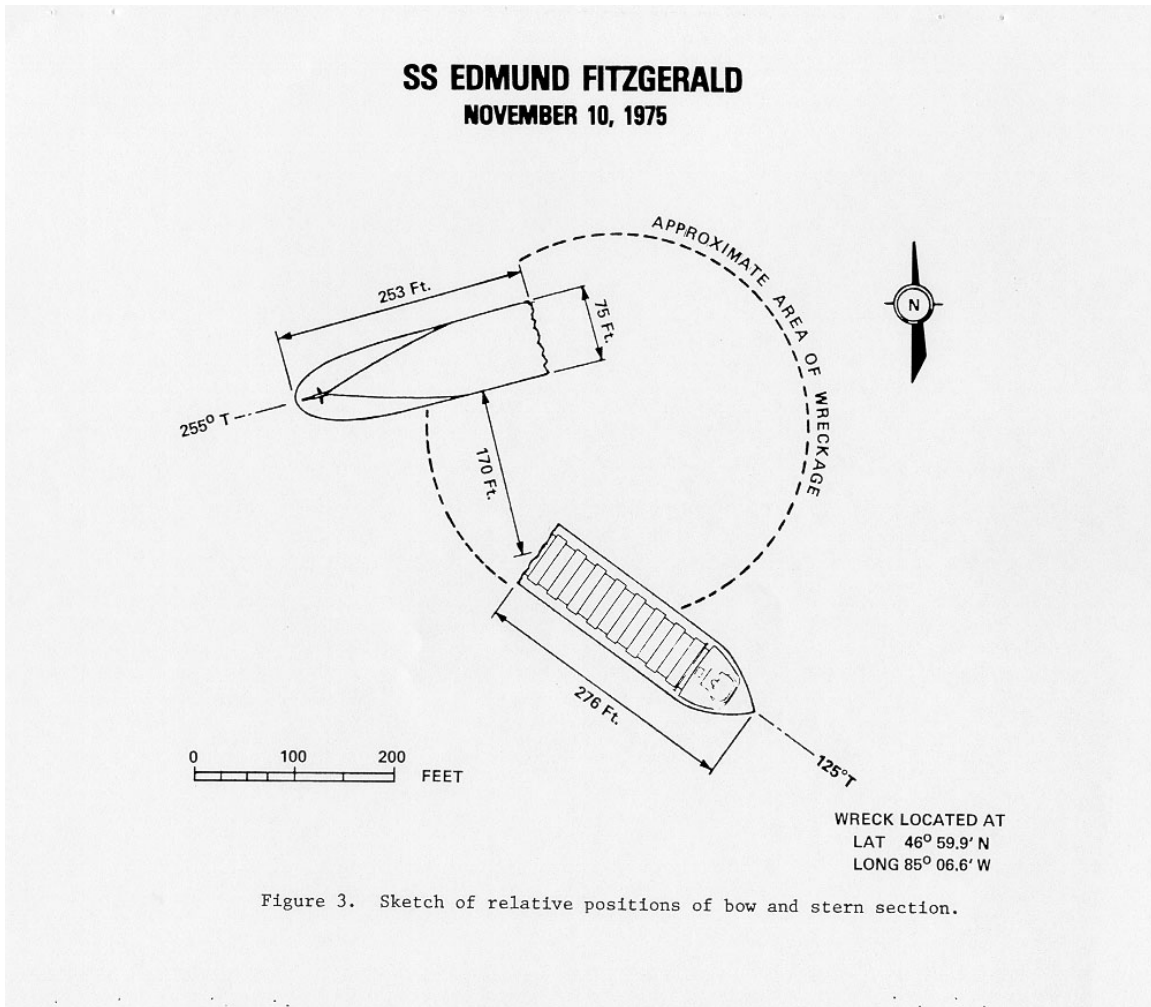
Figure 3: Sketch of the relative positions of the bow to the stern section

The wreckage lies approximately 17 miles northwest of Whitefish Point, Michigan. The wreckage consists of an upright bow section, an inverted stern section, and debris from a missing 200-foot midship portion. The bow section is 276 feet long, inclined 15 degrees to port from the upright,

Figure 3. Sketch of relative positions of bow and stern section.

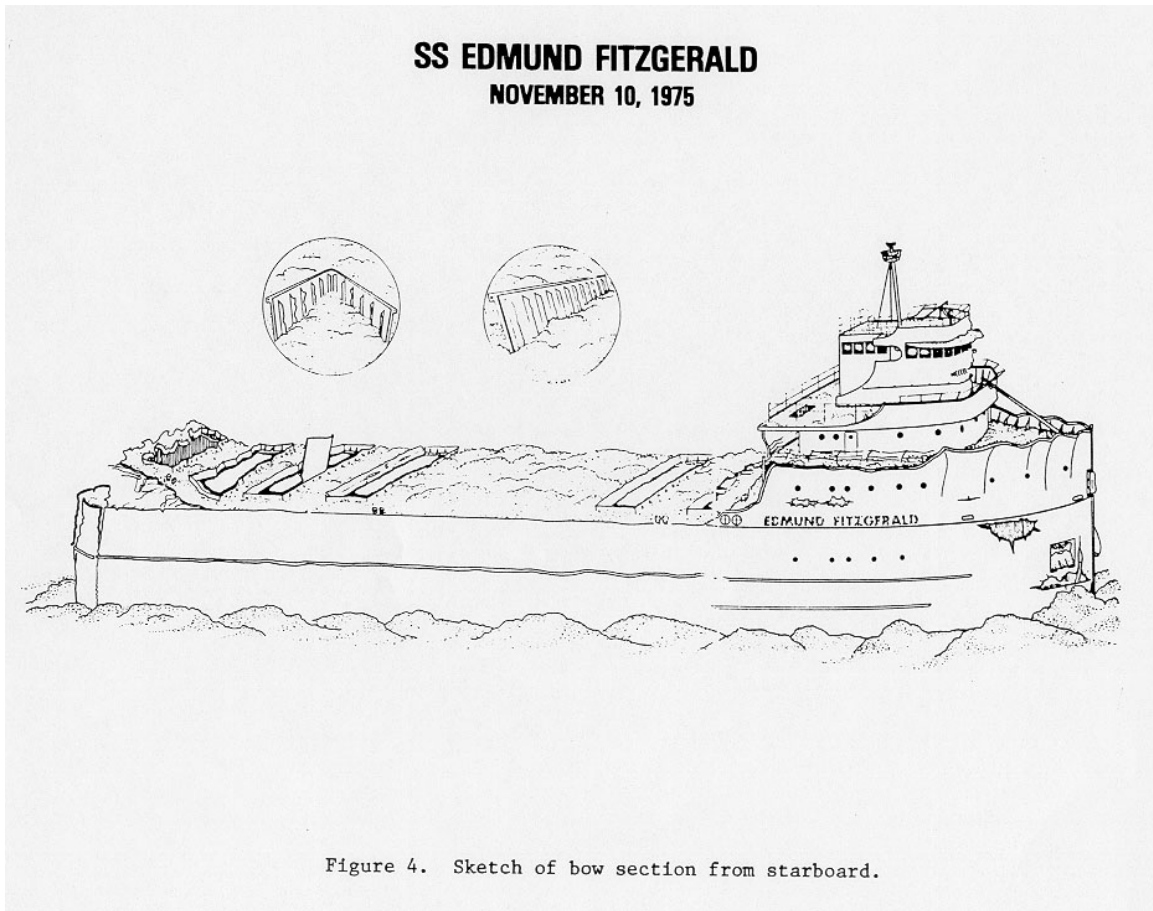
Figure 4: Sketch of bow section from starboard

There was extensive damage to the forward deckhouse and there were several holes in the bow shell plating. The rest of the shell plating extending back to the rupture was intact. The No. 1 hatch cover was entirely inside the No. 1 hatch and showed indications of buckling from external loading. Sections of the coaming in way of the No. 1 hatch were fractured and buckled inward. The No. 2 hatch cover was missing and the coaming on the No. 2 hatch was fractured and buckled. Hatches Nos. 3 and 4 were covered with mud; however, one corner of hatch cover No. 3 could be seen in place. Hatch cover No. 5 was missing. A series of 16 consecutive hatch cover clamps were observed on the No. 5 hatch coaming. Of this series, the first and eighth were distorted or broken. All of the 14 other clamps were undamaged and in the open position. The No. 6 hatch was open and a hatch cover was standing on end vertically in the hatch. The hatch covers were missing from hatches Nos. 7 and 8 and both coamings were fractured and severely distorted. The bow section abruptly ended just aft of hatch No. 8 and the deck plating was ripped up from the separation to the forward end of hatch No. 7.

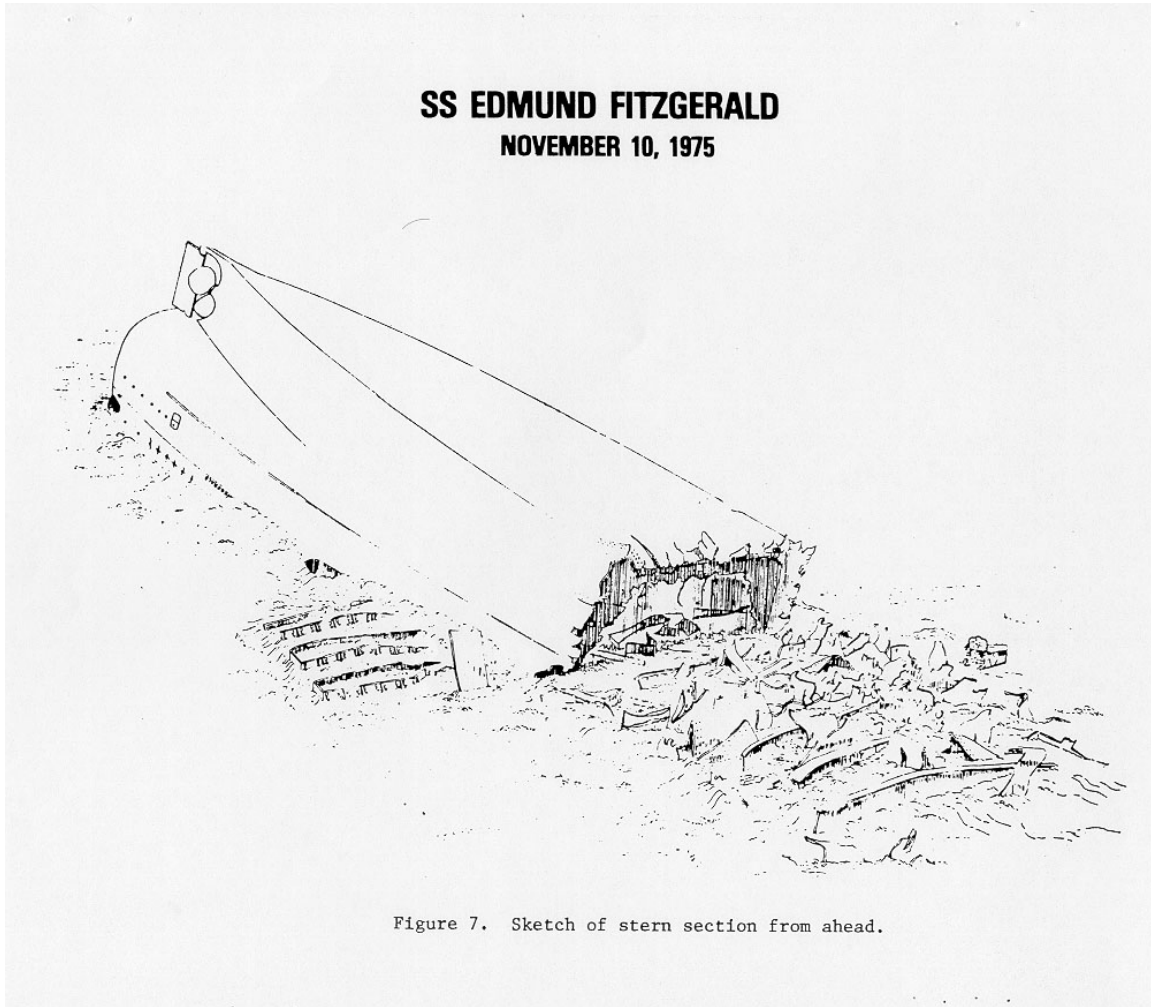
Figure 7: Sketch of stern section from ahead

There was mud—covered wreckage extending out from the ruptured end of the stern section, but no identification of what part of the ship it came from can be determined. Three hatch coamings and a hatch cover were lying next to the stern section. One of the hatch coamings bore the numeral 11.
