GULLY EROSION OF CULTURAL SITES

Joel Pederson,
Paul Petersen, Wally McFarlane
and ***GCMRC survey group***

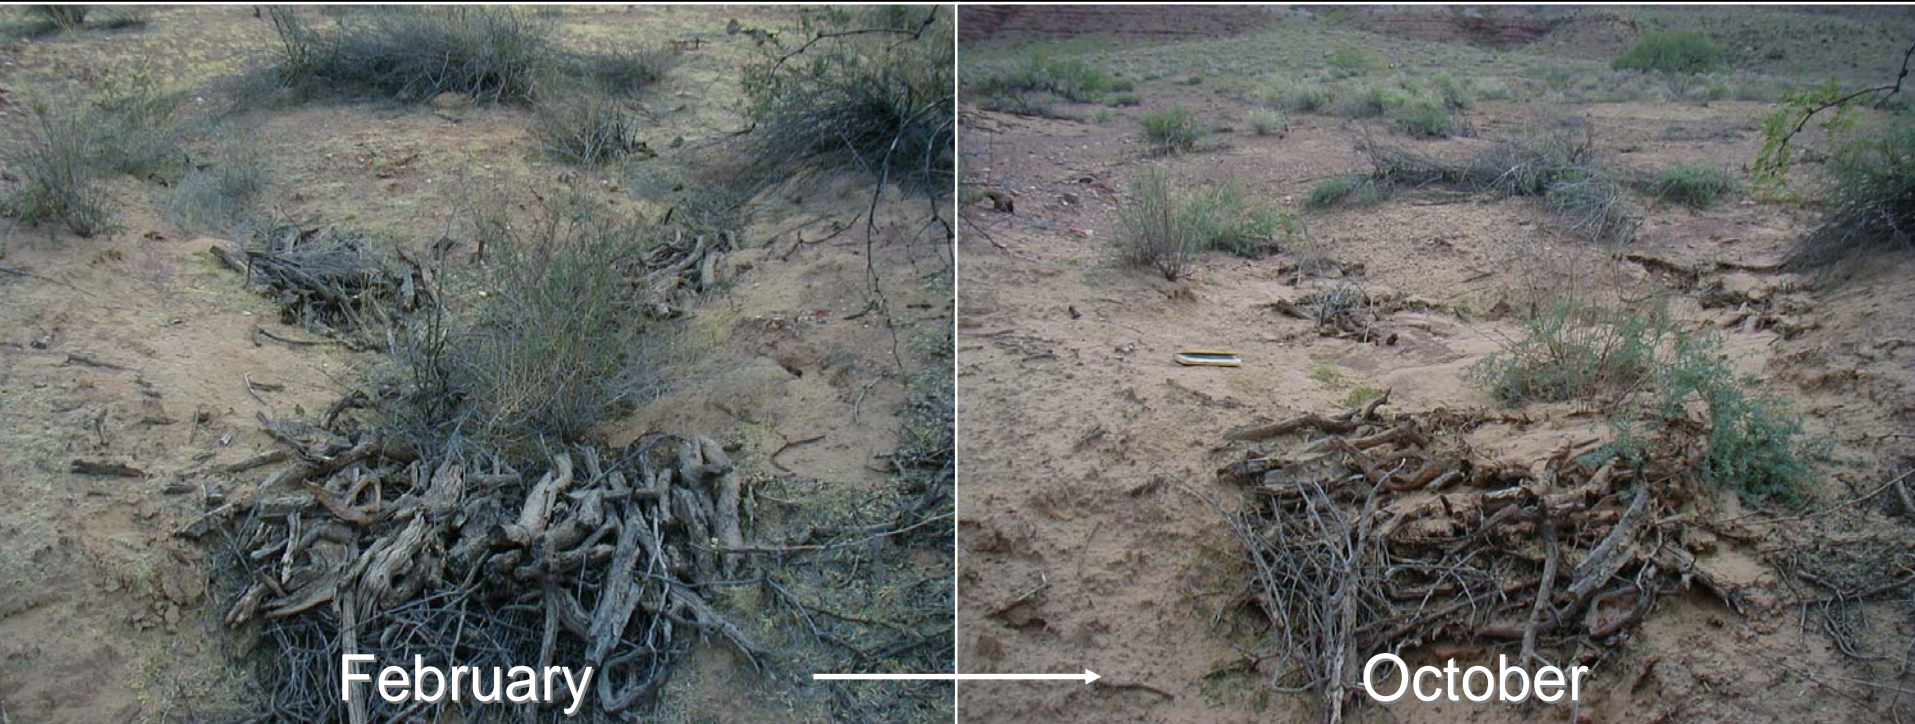
Are they effective?

after 1-year study = YES

- If maintained = damaged structures exacerbate erosion
- Wooden structures probably better than stone

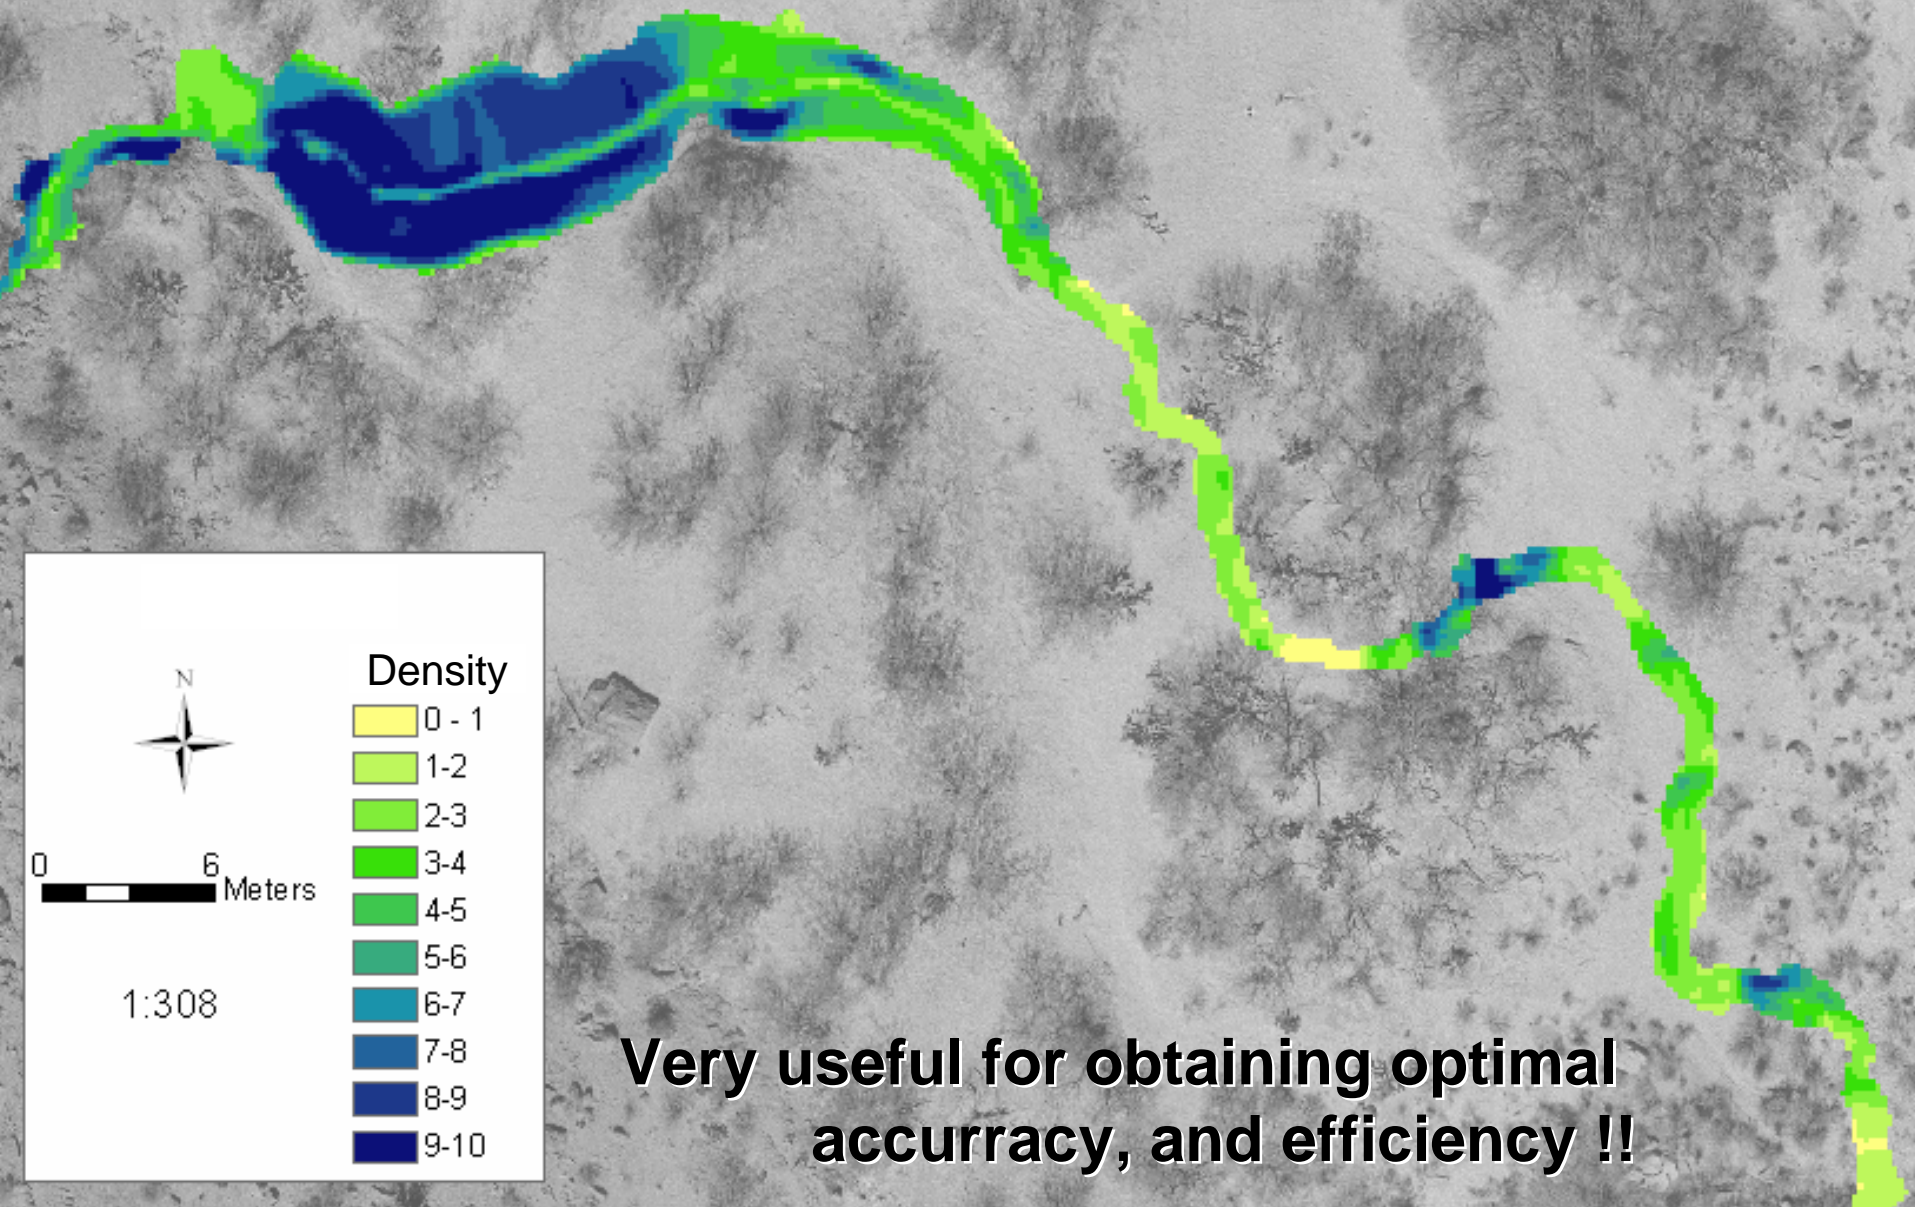
Very useful for obtaining optimal accuracy, and efficiency !!

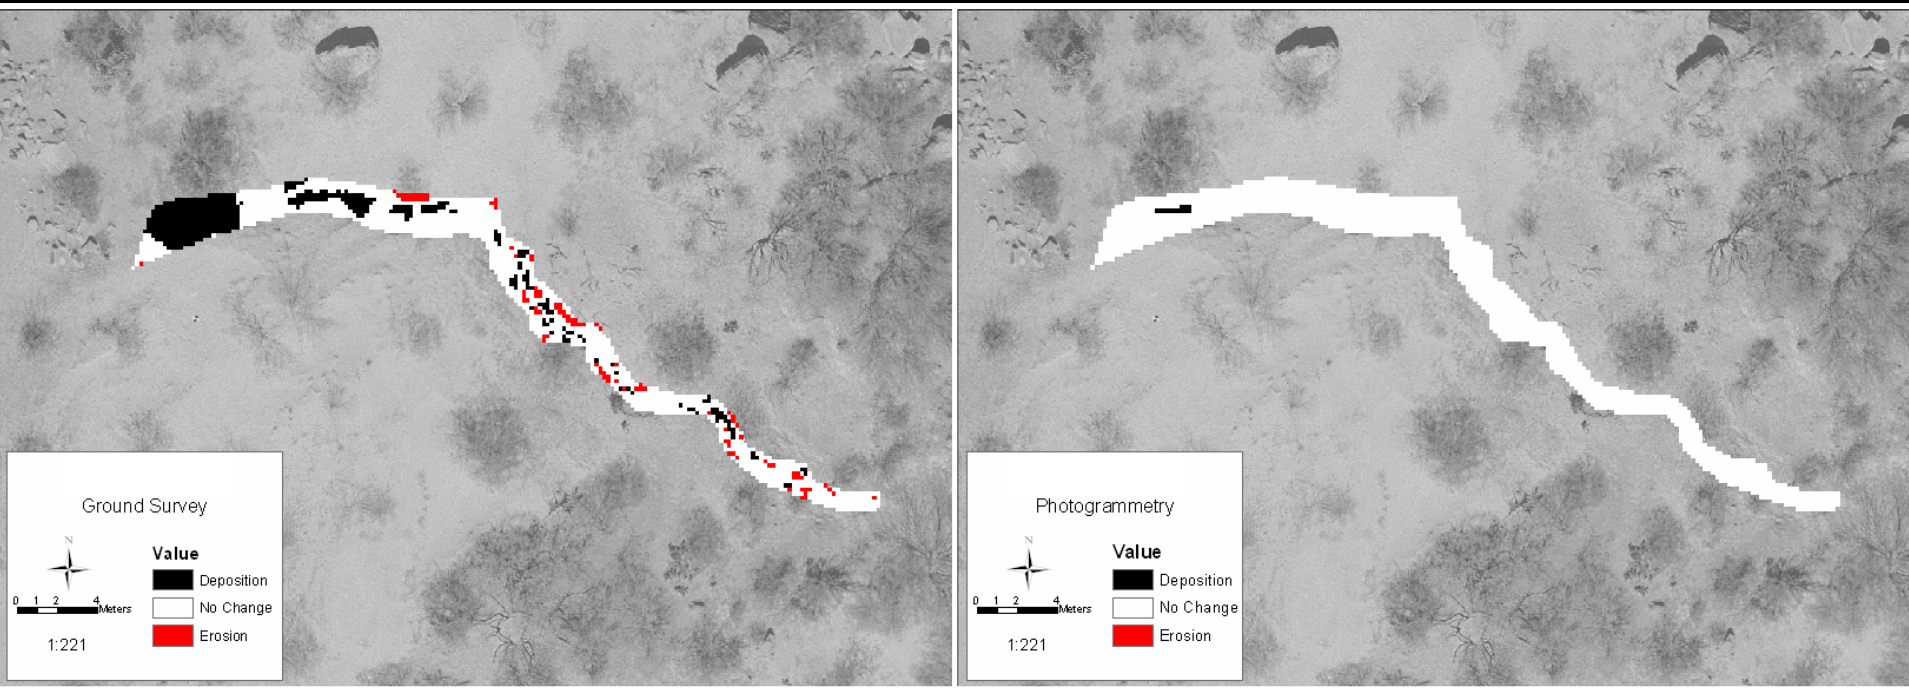
propagated error between two datasets = ~20 cm
best likely at this photographic scale = ~15 cm

Conclusion: Photogrammetry not yet good enough

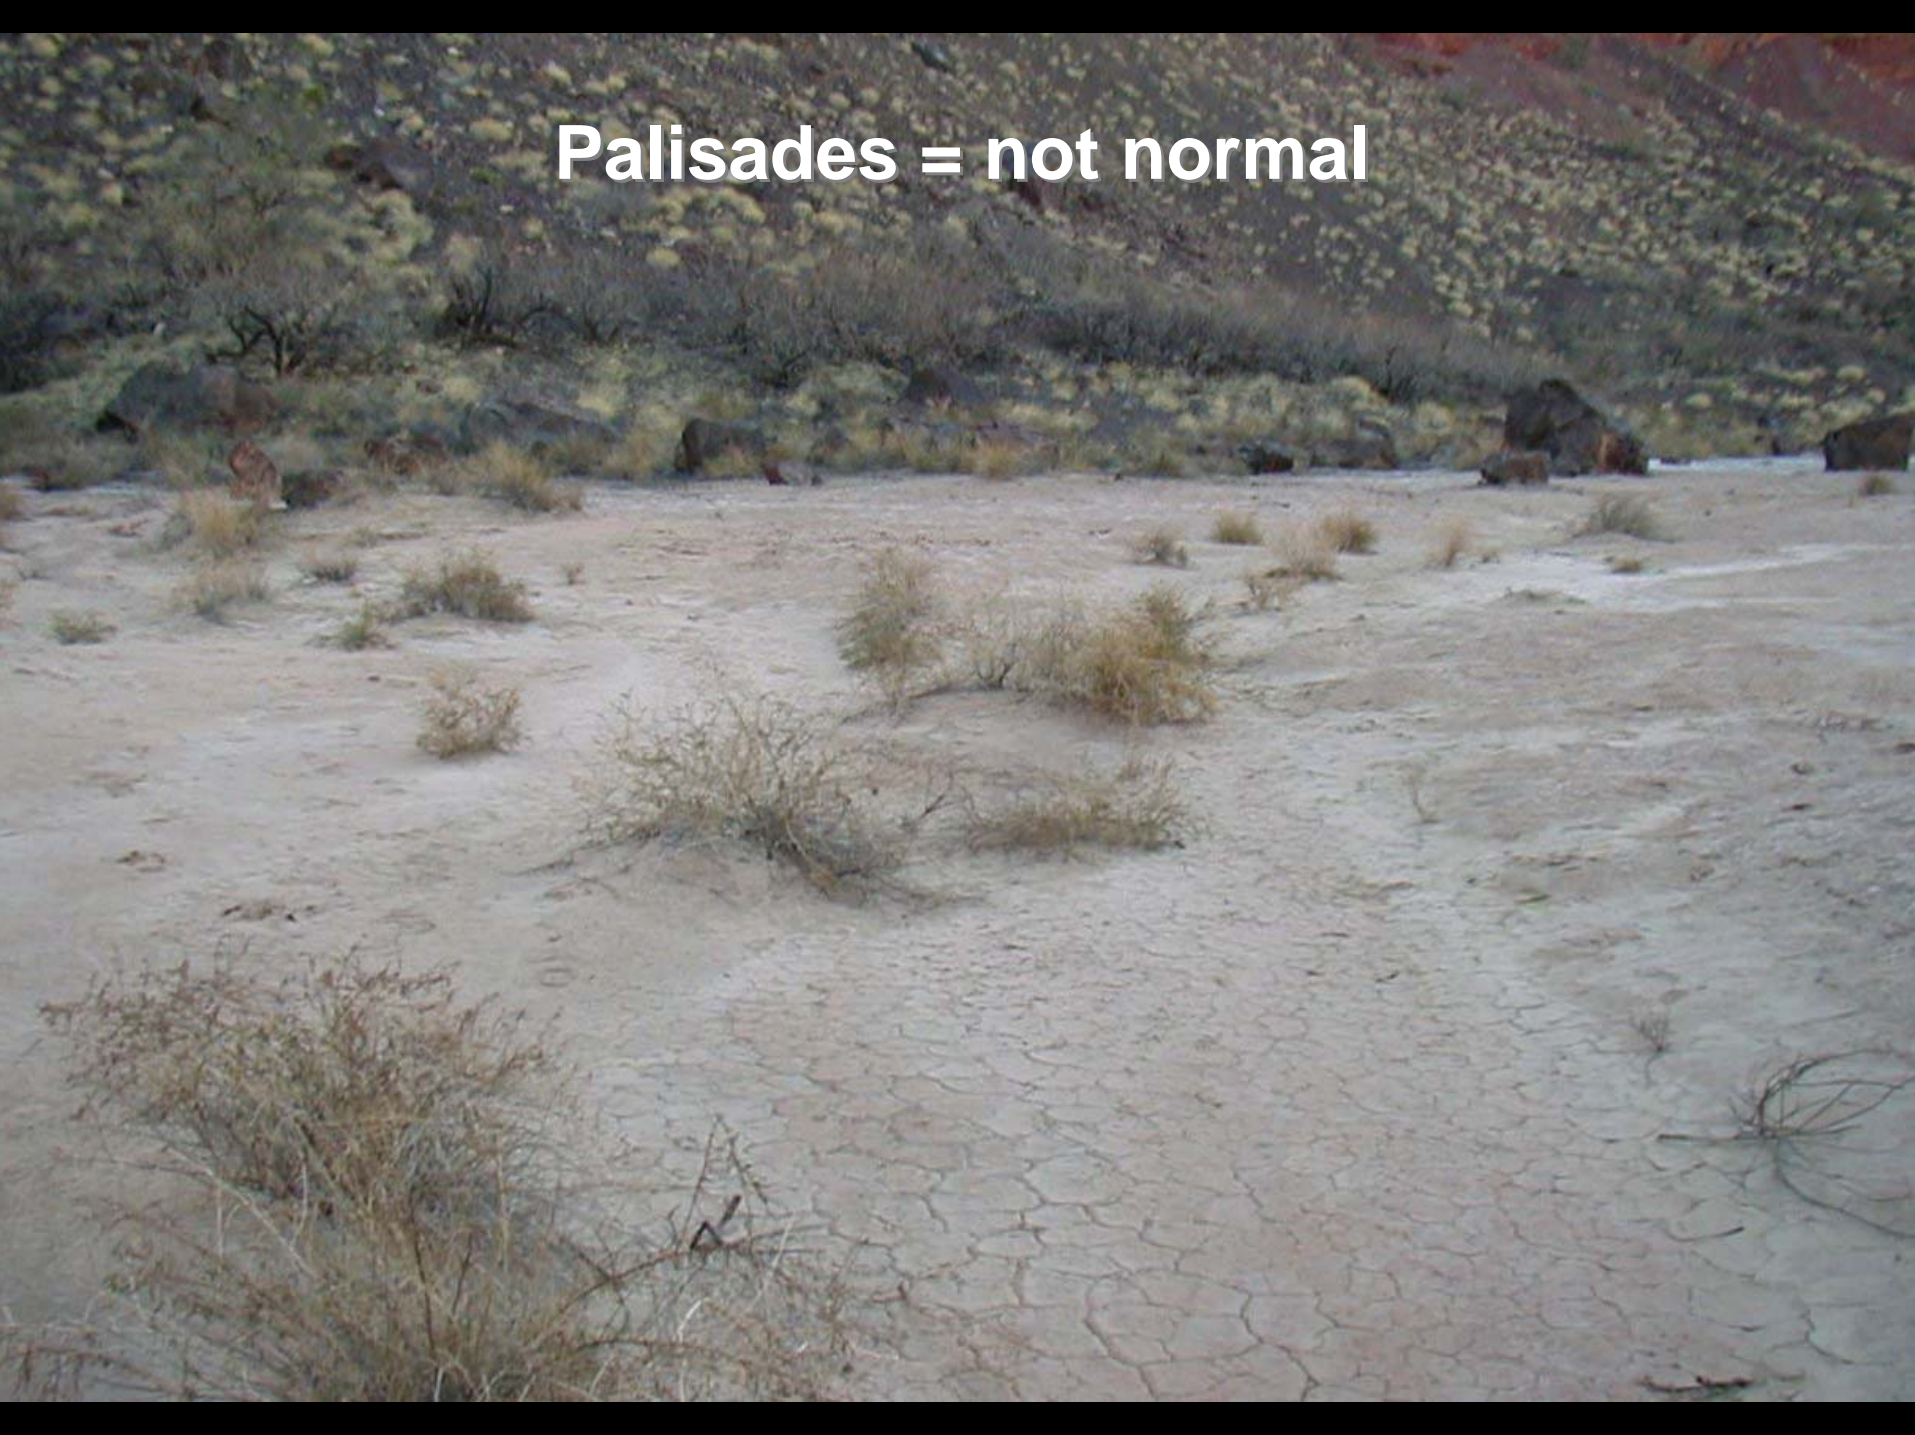
erosion, knickpoint formation, and checkdam failure correlate with high gradient
