U.S. Department  
of Transportation

Federal Railroad  
Administration

# Repair of Budd Pioneer Coach Car Crush Zones

## Rail Passenger Equipment Impact Tests

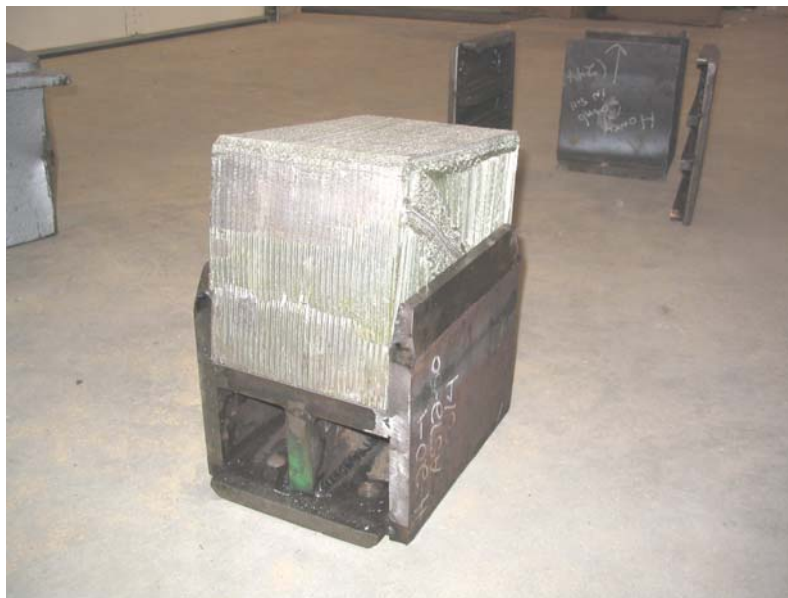
The buff lug hardware includes the buff lug, the shear bolts, the honeycomb absorber, and the honeycomb absorber support. The buff lug is a box structure that supports the draft gear before and after the push-back coupler is activated. The bolts that connect it to the sliding sill fractured (by shear), as intended, in all four car ends. The push-back coupler aluminum honeycomb absorber, which fits within the buff lug, crushed for each car end and could not be reused. In each case, the honeycomb jammed within the buff lug so that the lug had to be cut to remove the absorber for inspection. Therefore, all of the buff lugs also required replacement. The honeycomb absorber support was not damaged for any car end during the tests and could be reused. Figure 4 shows a photograph of one of the supports with the push-back coupler honeycomb absorber.

**Figure 4. Push-Back Coupler Honeycomb Absorber with Its Support Element After the Full-Scale Test**

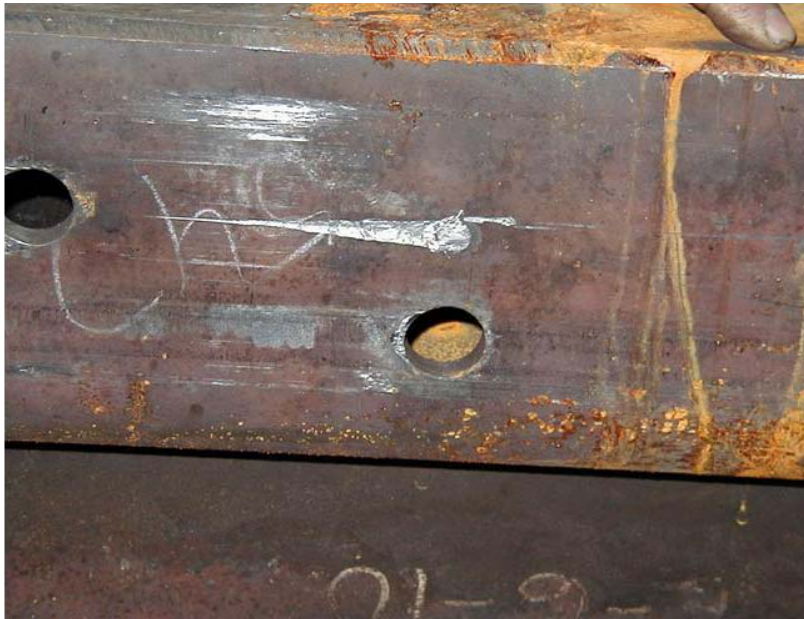
Deformation of the sliding sill occurred only at the bolt holes that connect the sliding sill to the fixed sill; the holes for connecting the buff lug to the sliding sill were not perceptibly deformed. The holes that did deform were elongated in the longitudinal direction by less than 0.010 in (0.25 mm) in every case. (The holes in the fixed sill showed greater deformation; see below.) Figure 5 shows an example of the holes after the test. The sliding surface was generally in very good condition, but burrs were in proximity to the deformed holes, requiring limited grinding.

**Figure 5. Bolt Hole in the Sliding Sill of One of the Crush Zones After the Test**

The holes in the sliding sill did not need modification or repair except for some grinding and polishing to provide smooth sliding surfaces.

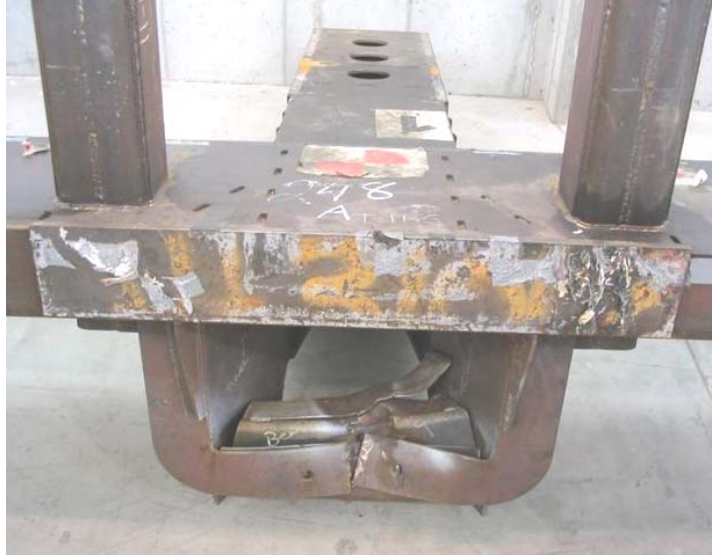
The bell mouth on each crush zone was severely deformed, as intended. Figure 6 shows an example. The damaged components included the face plate and the coupler carrier hardware (two channels and three springs). The sides of the bell mouth experienced no significant damage.

**Figure 6. Bell Mouth on End 248A After the One-Car CEM Test**

The bell mouth represents the most substantial repair for this set of components. The damaged coupler carrier components and the bottom portion of the face plate were cut away, leaving two straight, vertical edges of the face plate. The replacement components for the coupler carrier had the same design as before, and the face plate was restored by welding two pieces onto the remaining portion using a single bevel groove weld. Figure 16 shows the repair. This provided a bell mouth with the same strength as for the original crush zone.

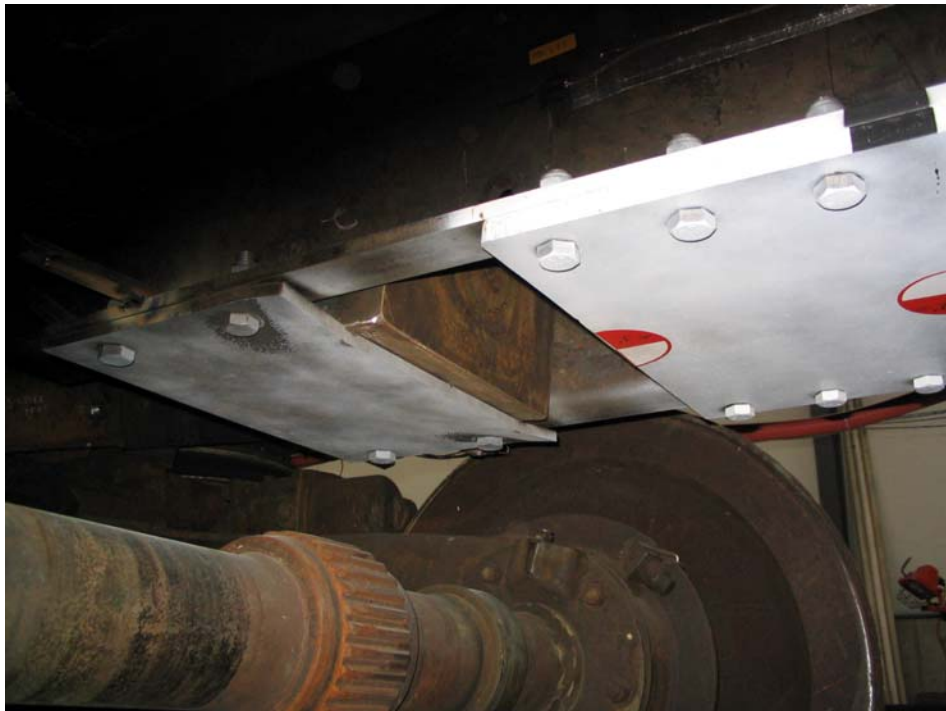
The cover plate below the bottom buff lug and push-back coupler absorber deformed, as shown in Figure 7. A combination of load eccentricity on the buff lug from the draft gear and asymmetrical deformation of the honeycomb absorber led to large loads on this plate. To avoid this deformation, the cover plate required a modified design.

**Figure 7. Cover Plate on the Bottom of the Sliding Sill Immediately Below the Buff Lug**

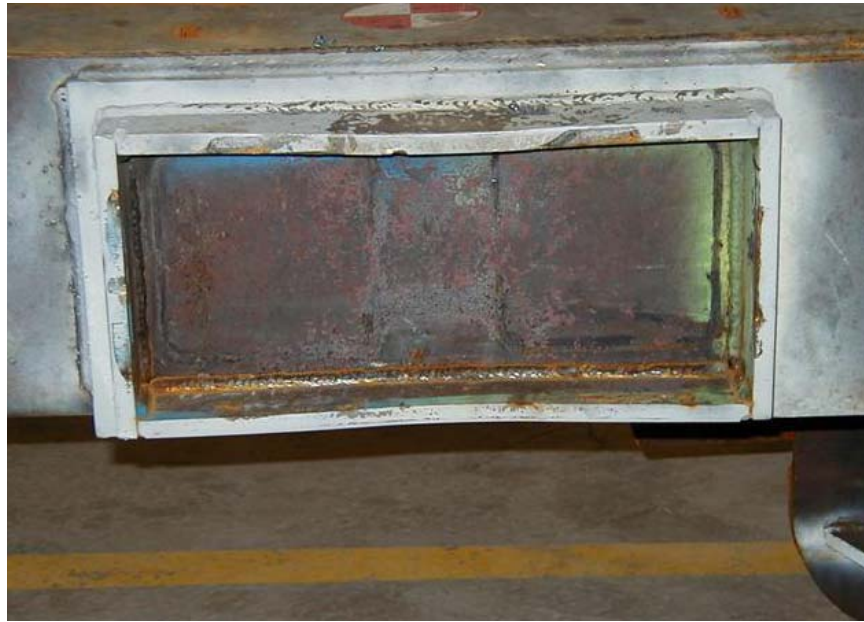
The rear (inboard) face of the end beam deformed as a result of the high load from the primary energy absorbers. Figure 8 shows a photograph of this area for one of the cars. The deformation is not very clear from the photograph, but after the frame members were removed, use of a straight edge indicated that the face had deformed inward by approximately 0.125 in (3 mm) at its center. The inside of the end beam, which includes reinforcing gussets, was not opened for inspection.

**Figure 8. Back Surface of the End Beam After the CEM Test in the Area at Which the Primary Energy Absorber Contacts**

The primary repair on the end frame was the stiffening of the end beam's rear face at the locations at which the primary energy absorbers contact. The collar on the back of the end beam into which the primary energy absorbers protrude was first removed on each side. The end beam surface was then built up with weld metal and ground as flat as possible. A 0.75 in (19 mm), A572-50 plate (or A36 in some cases), whose area was larger than the area originally bounded by the collar, was then welded onto the rear of the end beam; the rear thickness of the A710 (minimum yield strength, 75 ksi [517 MPa]) end beam is 0.375 in (9.5 mm). The decreased length of the primary energy absorber accounted for this added plate (see below). Figure 18 shows a photograph of this region, together with the new retention device and the primary energy absorber.

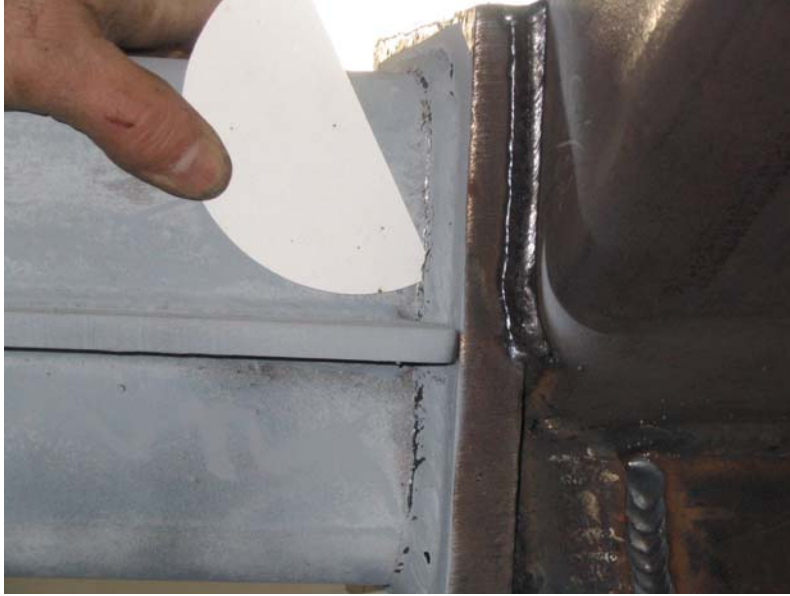
Figure 9 shows evidence of cracking between the sliding tube of the roof absorber and the back of the AT beam for car end 248A. A fillet weld connects the sliding tube to the AT beam.

**Figure 9. Crack at the Connection Between the Sliding Roof Absorber Tube and the Back of the AT Beam for End 248A After the One-Car CEM Test**

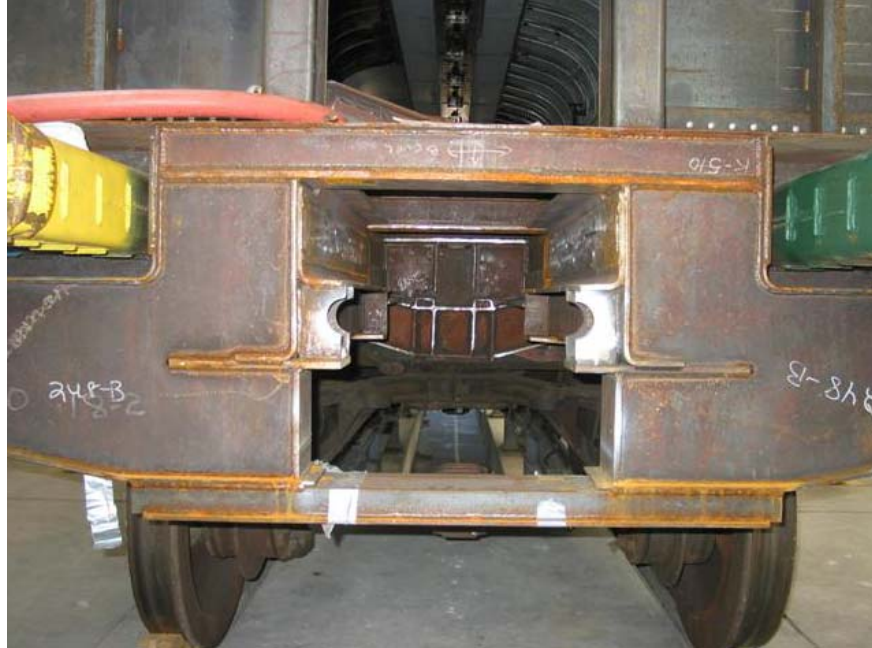
As shown in Figure 10, the fixed sill was in good condition after the test. The points of largest deformation were the holes that contained the shear bolts for the connection to the sliding sill. These holes elongated in the longitudinal direction of the car by approximately 0.030 in (0.76 mm), although variability occurred from hole to hole. As with the sliding sill, areas at the edges of the holes with burrs also required some grinding. After grinding, the sliding sill slid easily into the fixed sill for all four ends.

**Figure 10. Fixed Sill for Car 248B Before Repair**

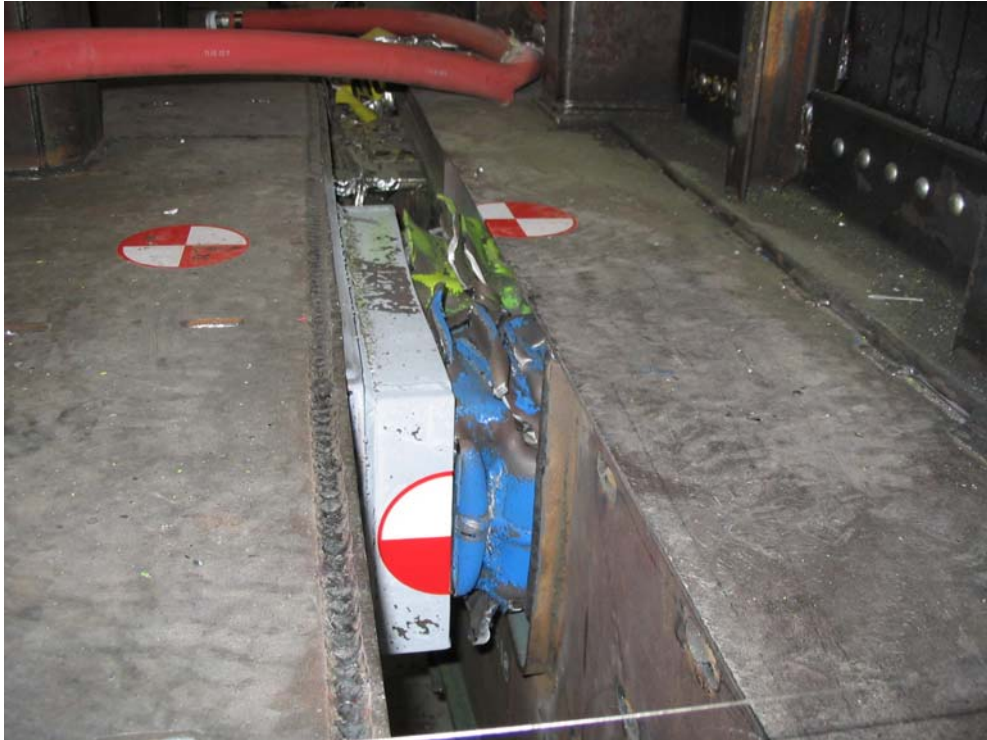
Figure 11 shows that the primary energy absorbers at the impacted end crush zones were almost completely crushed. The primary energy absorbers at the coupled ends of the two-car test also experienced permanent crush but of much lesser magnitude. Figure 12 shows the smallest amount of crush, which occurred in the absorbers on the trailing car at the coupled interface. Thus, all eight of the primary energy absorbers required replacement. The front reaction group, to which the inboard end of the primary energy absorber is welded, experienced no obvious damage for any end.

**Figure 11. Condition of the Primary Energy Absorbers After the One-Car CEM Test; End 248A**

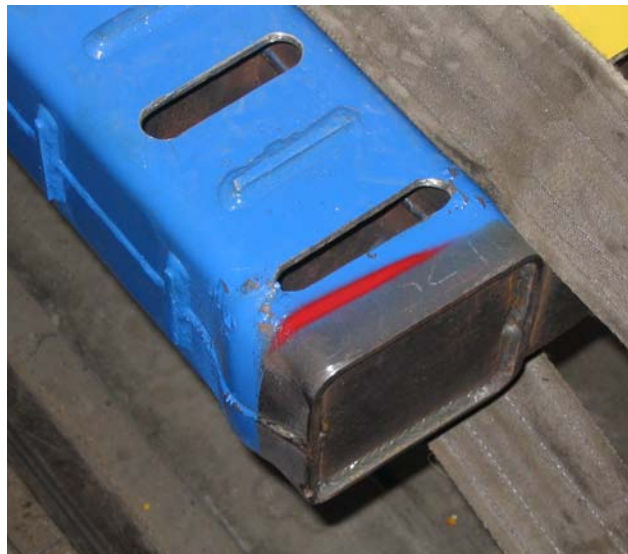
**Figure 12. Primary Energy Absorber from Car End 248B After the Two-Car Test**

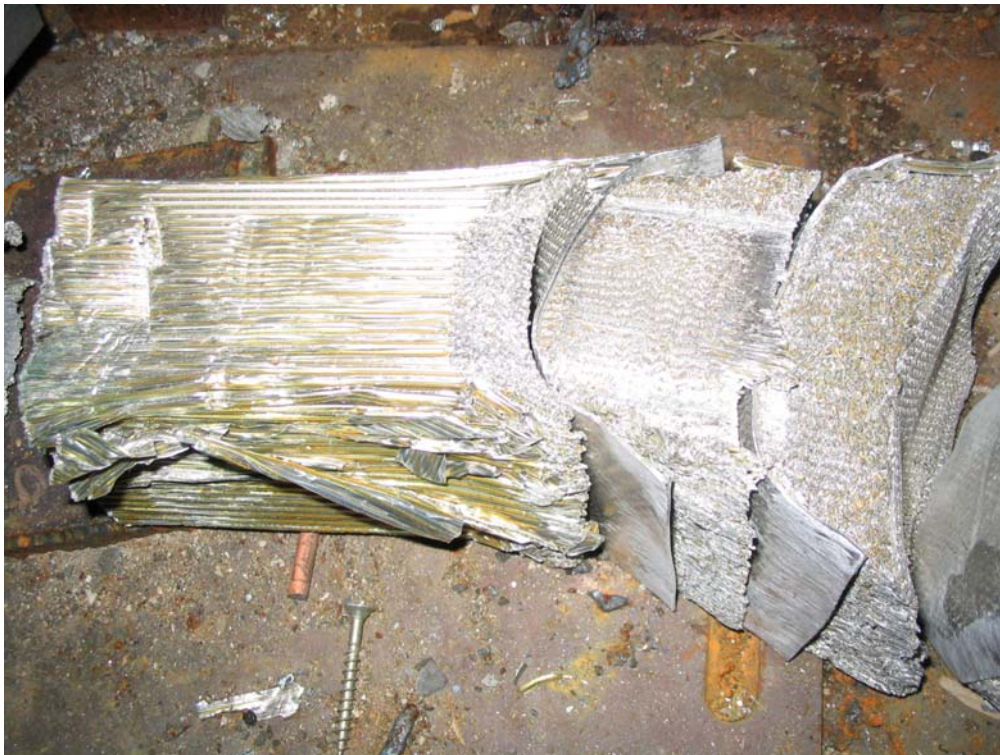
Figures 13 and 14 show photographs of some honeycomb roof absorbers. The absorbers in Figure 13 are from end 248A. The absorbers in Figure 14 are from end 244B; a few of these experienced a minor amount of crush. The research team saved and reused approximately 20 crush elements in the repair process.

**Figure 13. Roof Absorber Elements from End 248A That Experienced Substantial Crush**

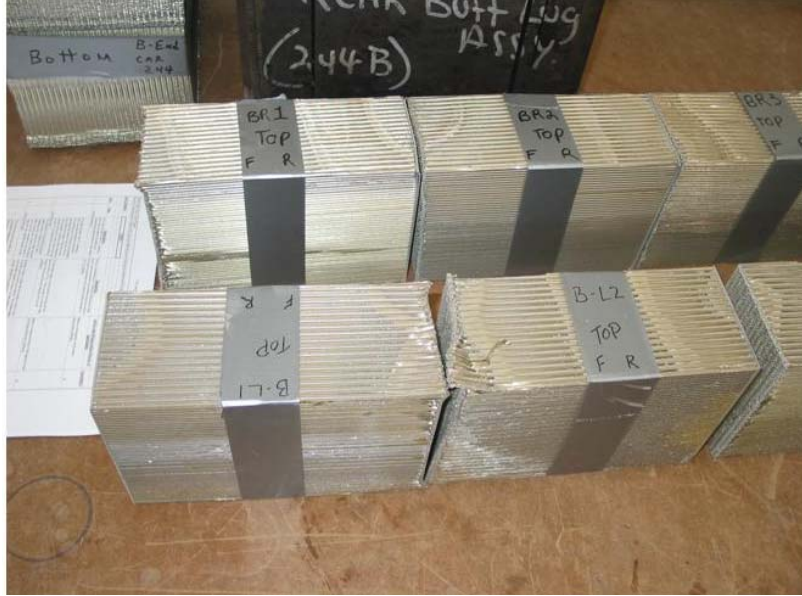
**Figure 14. Aluminum Honeycomb Roof Absorber Elements from End 244B After the Two-Car CEM Test**

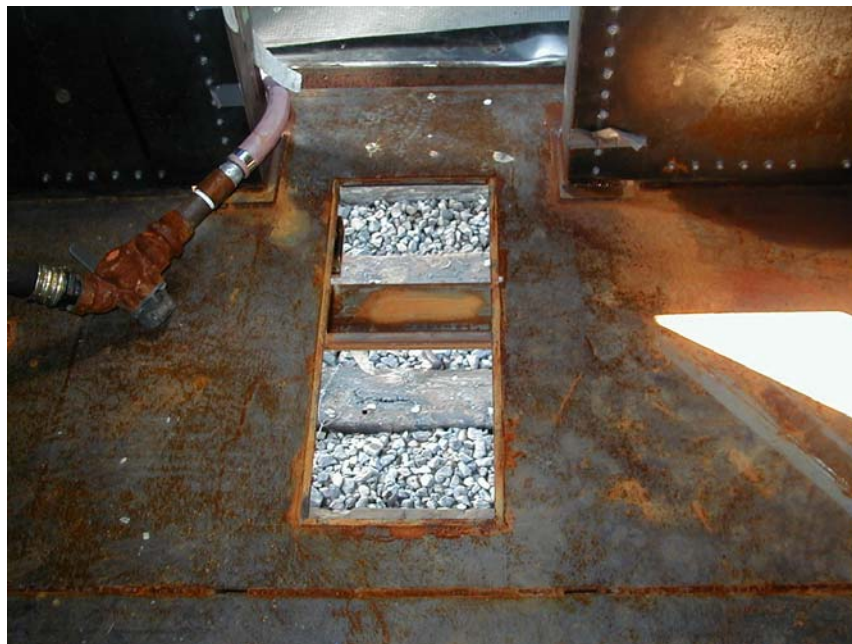
**Figure 15. Access Hole Cut in the Floor Plate in the Vicinity of the Sliding Sill/Fixed Sill Connection**

The repair included preparation of the cars for new components and modifications. The sliding components were first removed from the car as a single unit and placed in a special location for examination and repair; Figure 6 shows one such end. Several components were then cut from the car, including the primary energy absorbers, the bell-mouth face plate, and the coupler carrier. The surfaces to which these components had been welded were then ground flat. Floor plate sections were cut for access in the vicinity of the inboard ends of the primary energy absorbers and in the area in which the sliding sill connects to the fixed sill. Figure 15 shows the access hole.

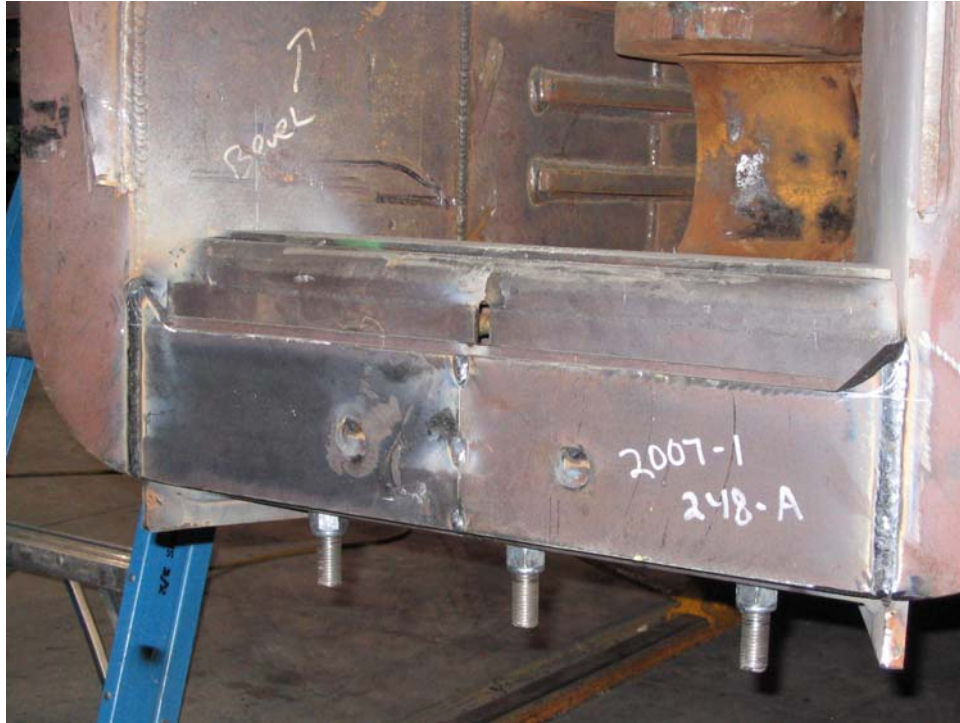
**Figure 16. Bell-Mouth Face Plate Repair**

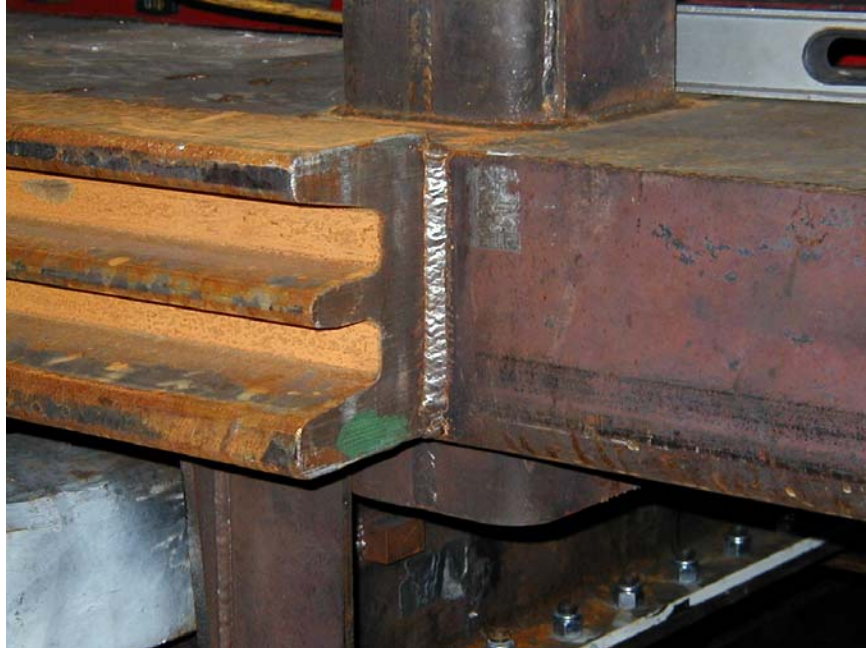
**Figure 17. Anticlimber with Chamfered Edge Welded to the End Beam**

Two of the ends, 248A and 244A, had flat plates in the place at which the ribbed anticlimber is normally situated. These flat plates were removed, and the remaining weld material was ground off of the end beam face. A slight depression (corresponding to the size of the original flat plate) remained in the end beam, and the edges of the new ribbed anticlimbers, which had the same geometry and material as used in the original 248B and 244B crush zones, were chamfered to ensure that good contact would occur between the rear of the anticlimber and the slightly depressed face of the end beam. Figure 17 shows the anticlimber welded in place.

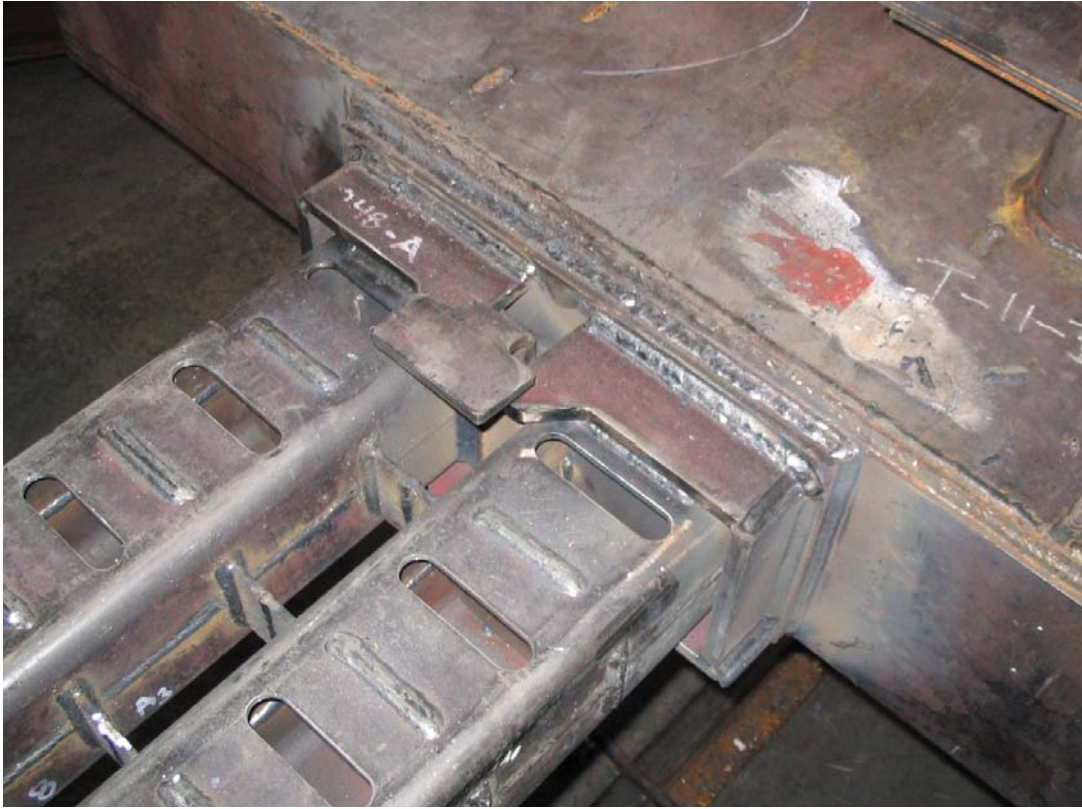
**Figure 18. Modified Inboard Surface of the End Beam in the Vicinity of the Primary Energy Absorbers and the New Retention Device**

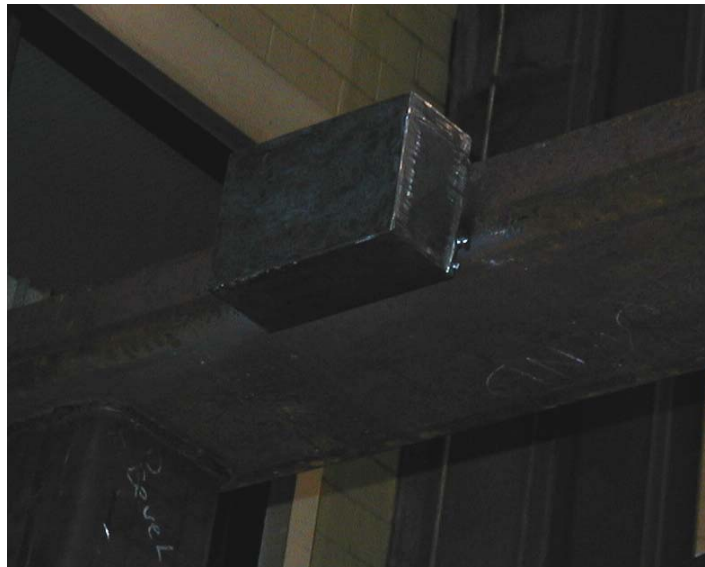
**Figure 20. Newly Added Center Spacer on the AT Beam to Reduce Its Bowing When Coupled Ends Collide**

The spacers on the outboard face of the AT beam were removed, and the AT beam face was ground smooth. New spacers were provided with a (vertical) height about 1 in greater than that of the original spacers. Researchers believed that this larger dimension would increase the certainty of car-to-car contact at the roof for the less controlled train-to-train test. An additional center spacer was also added to ensure that, on coupler push back, contact at the roof would occur in three locations instead of two, thus reducing the chances of bowing the AT beam and the corner and collision posts. Figure 20 shows a spacer welded to the AT beam. The spacers had a greater (longitudinal) length than in the original car 244 crush zones so that they could be machined during installation to ensure that proper contact would occur when the couplers push back. The final dimensions of the spacers also helped to compensate for the slight bowing of the corner posts and AT beam described earlier.

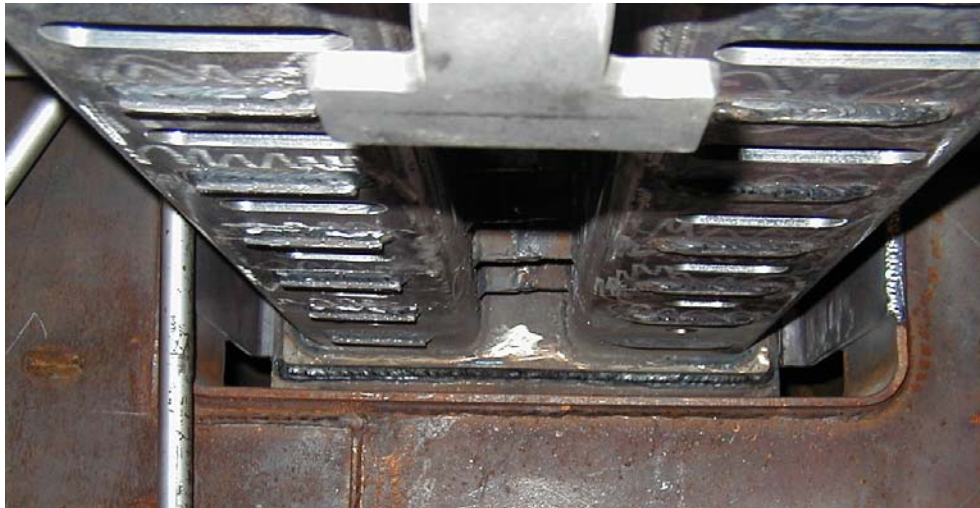
**Figure 21. Plate Welded at the Inboard End of the Primary Energy Absorber to the Front Reaction Group**

for the addition of a plate at the absorber's inboard end to facilitate reattachment to the absorber support structure. (Section 3.4 discusses the plate on the end beam.) A 0.75-in (19-mm) thick, A572-50 plate was also welded to the inboard end of the primary energy absorber (Figure 21). This plate was in turn welded to the face plate of the front reaction group. Researchers thought that this welding approach would provide a more feasible alternative than if the absorber tubes were welded directly to the front reaction group. In the original crush zones, that weld had been made in the shop before installation onto the car. Thus, the reduction in length of the crushable part of the primary energy absorber for the repaired cars was 1.5 in (38 mm). These repaired cars were near the end of the consist in the full-scale test, where the predicted crush was substantially less than 30 in (76 mm) of crush.

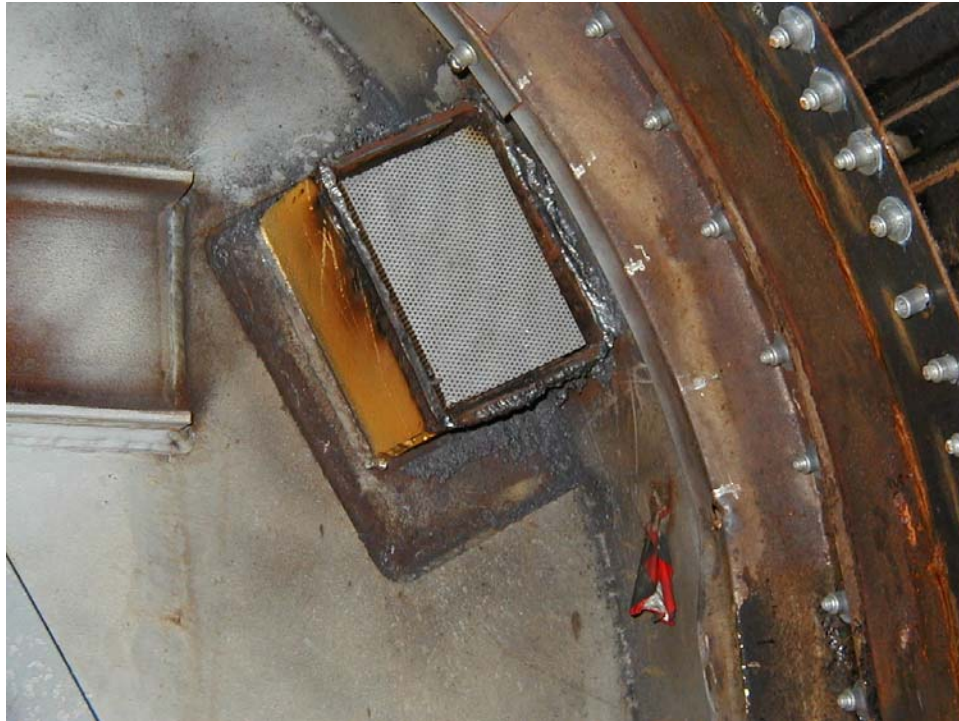
The rear plate of the roof absorber fixed tube required removal in order to extract the aluminum honeycomb cartridges. Figure 26 shows that the absorber tube deformed after the end plate was removed. In some instances, a section of the carline was also removed to allow extraction of the honeycomb cartridges. About one-half of the uncrushed honeycomb absorber cartridges were reused. The research team ordered the remaining required absorbers with the same specifications used for the original crush zone ends. Additional weld metal strengthened the regions at which a bulge had occurred in the fixed tube; the bulge remained untouched.

**Figure 26. Inboard End of the Fixed Roof Absorber Tube After Removal of the End Plate to Extract Absorber Elements**

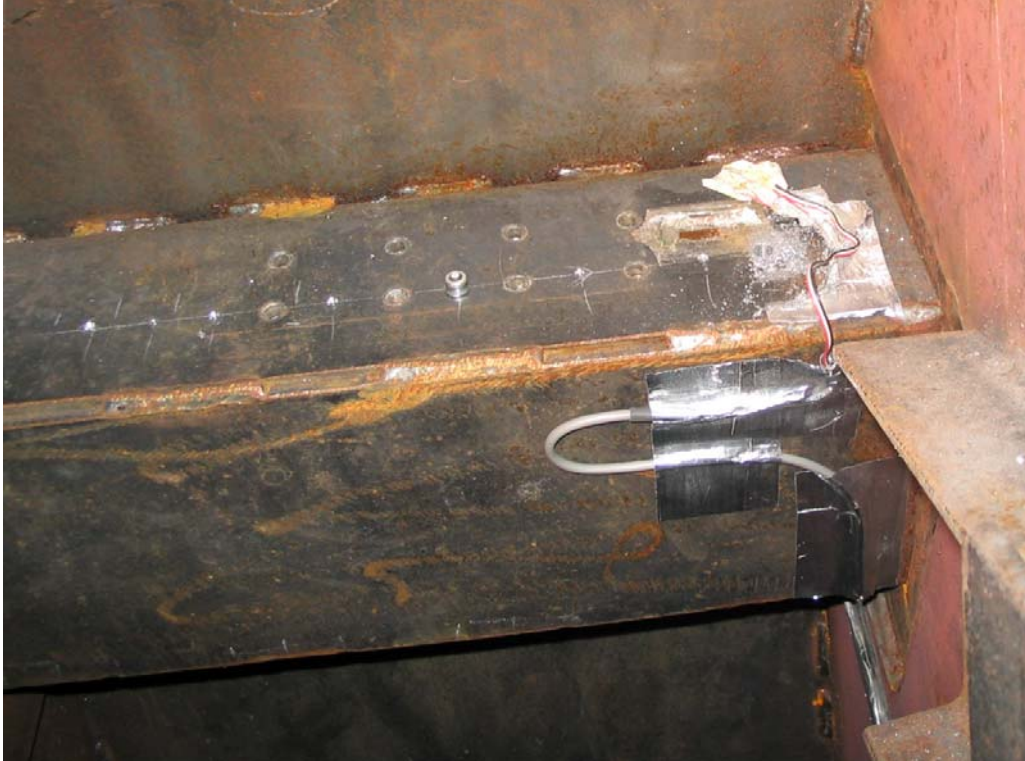
**Figure 27. Rivet Pattern for the Repaired Roof Absorber Shear Joint (Top Surface)**

Figures 27 and 28 show the locations of the new rivet holes for the connection between the fixed and sliding roof absorber tubes. The pattern is not as symmetrical as it is for the original configuration, but the rivet-to-rivet spacing is essentially unchanged, and the expectation is that the total shear strength of the joint will be close to that of the original. Researchers used the same type of rivets as for the original fabrication.

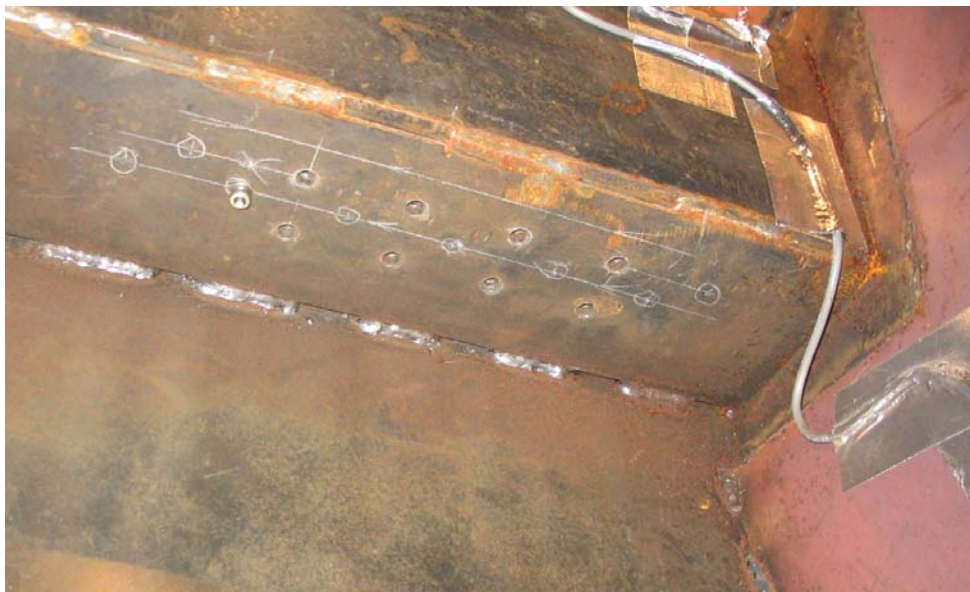
**Figure 28. Rivet Pattern for the Repaired Roof Absorber Shear Joint (Bottom Surface)**

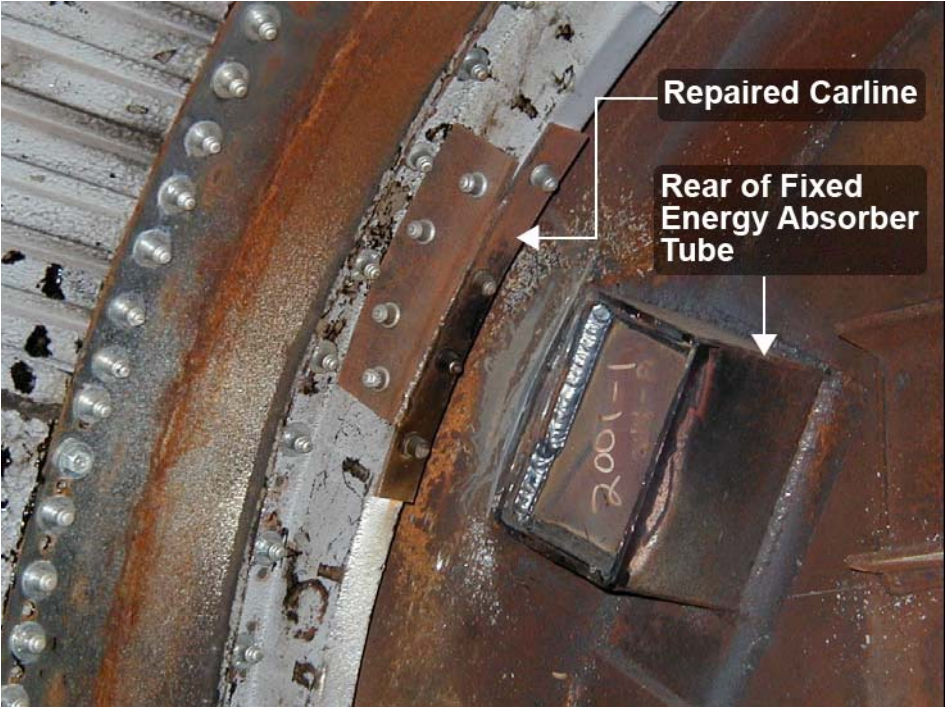
**Figure 29. Repaired End of the Fixed Roof Absorber Tube and the Repaired Carline**

The inboard end plate on the fixed tube was cut and welded within the end of the tube, about 0.75 in (19 mm) from the end. This ensured that a good weld could be made around the entire perimeter of the end plate since part of the outside of the tube was not accessible in the installed position. (Recall that the absorber had originally been fabricated, with its end plate, before

installation into the original crush zone.) Where removed, the carline section was Huck-bolted to the existing carline. Figure 29 shows the repaired roof absorber end and carline.
