JRC2008-63053

POST TEST REVIEW OF A SINGLE CAR TEST OF MULTI-LEVEL PASSENGER EQUIPMENT

Michelle Priante
US Department of Transportation
Volpe Center
Cambridge, MA

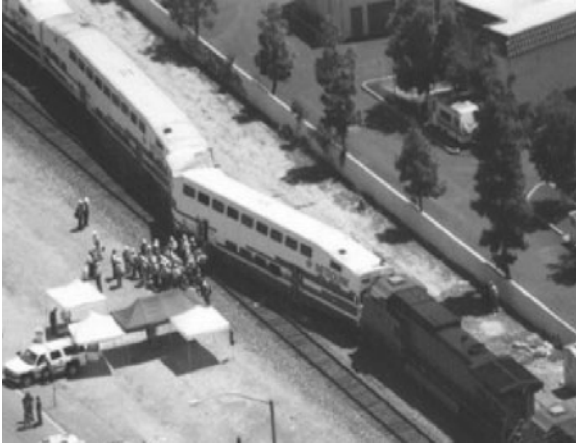
In a typical head-on collision, the impacted end of the car is expected to crush longitudinally, parallel to the tracks. However, in this case, the majority of the crush occurred towards the rear of the lead car in the passenger train and perpendicular to the tracks, as shown in Figure 2. Figure 3 shows the impacted end of the cab car, which had very little damage. The structural deformation occurred at the rear gooseneck. The lateral accelerations generated by this form of structural collapse aggravated the loss of compartmentalization of the occupants. These accelerations, combined with already severe longitudinal accelerations, made for a notably harsh occupant environment [4].

Figure 2. Damage to MetroLink Cab Car after Collision with Locomotive-Led Freight Train

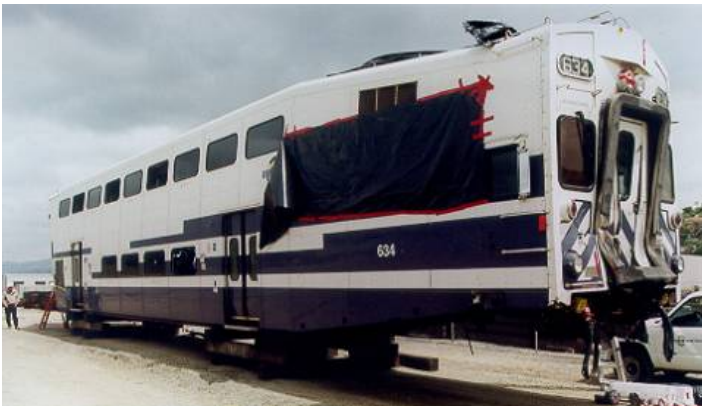
Figure 3. The Leading End of the Cab Car has Little Damage

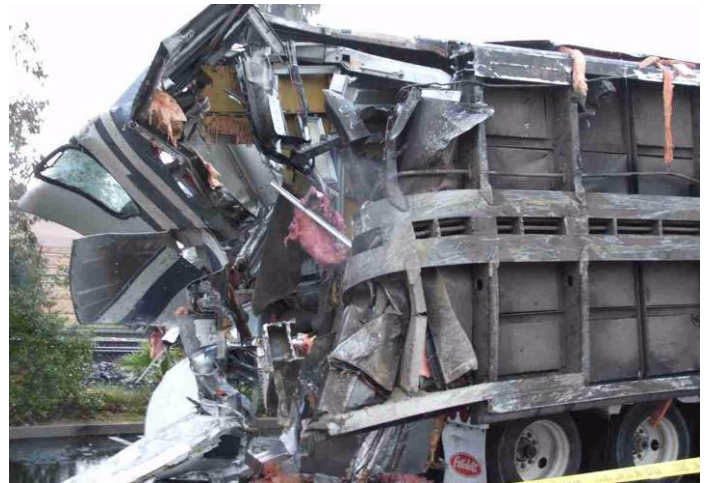
Figure 4. The Underframe of Cab Car Crushed up to the Gooseneck

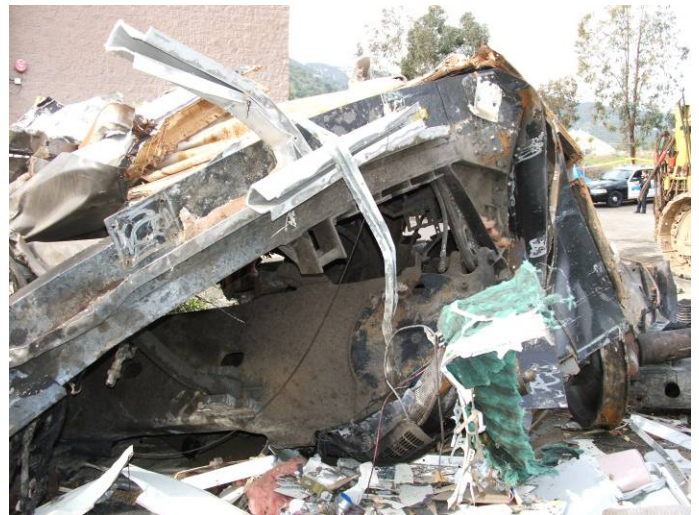
Figure 5. The Side Sill and the Crushed Gooseneck

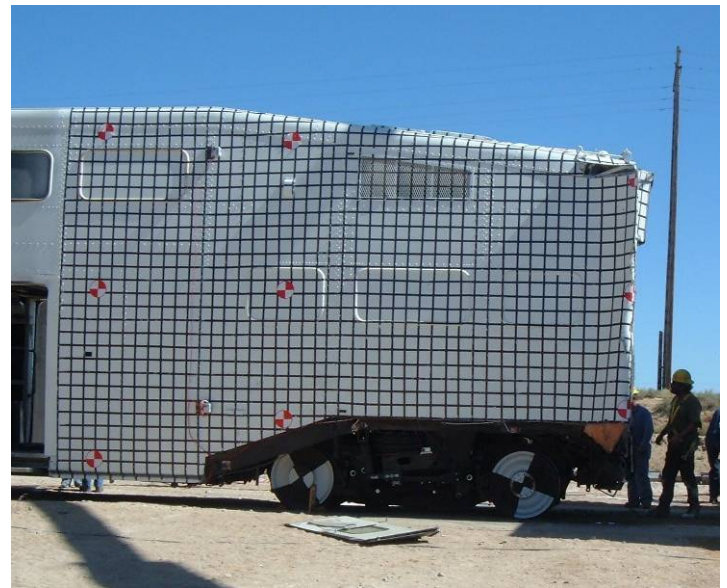
Figure 7 shows the impact end of the car after the test. Damage to the exterior of the car is on the paneling at the leading end, along the roofline and at the transition structure. There is damage at the truck connections, the center sill outboard of the bolster, and at the side sills. There are signs of failure initiation at the gooseneck.

Figure 7. Post-test Side View of the Impact End of the Car

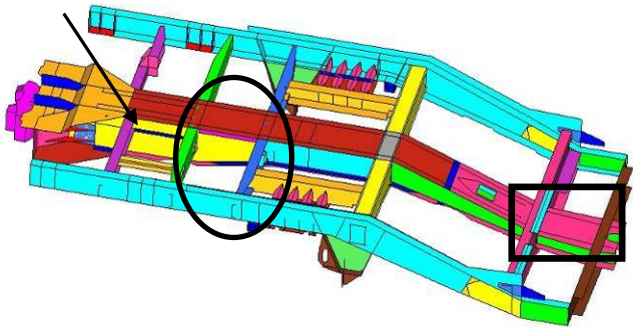
The underframe of the car crushed primarily at the center sill, just outboard of the bolster at the impact end. The circle in Figure 8 surrounds a change in height of the center sill. During the test, the bellmouth hit the wall and pushed the center sill back into the car. The first lateral member on the left side of the car separated from the center sill, as shown in Figure 9. The second lateral member stayed attached to the draft sill, but pushed backwards, as shown on the right side of Figure 10. The center sill stayed intact until the transition from the wide center sill section of the draft sill to the thinner section of the draft sill at the bolster.

Figure 8. Location of the Draft Sill Failure

The arrow in Figure 8 points to the location of a connection failure. When the draft sill pushed back, the lateral member on the left side completely separated from the draft sill. Figure 9 shows this separation.

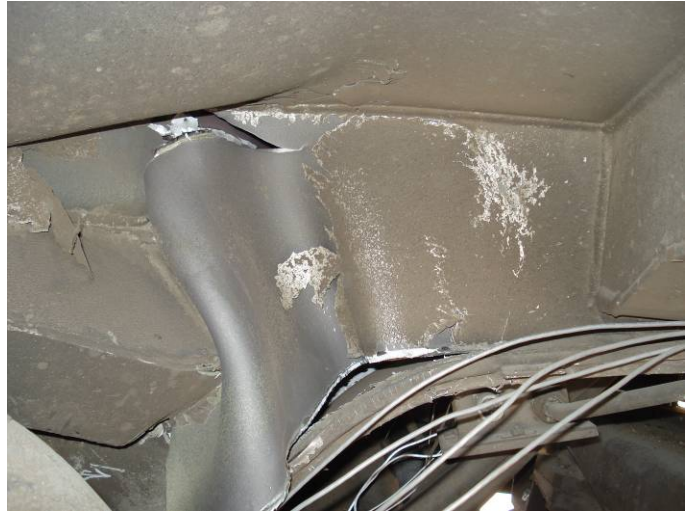
Figure 10. Right Side View of Draft Sill Failure

Figure 10 shows the failure of the center sill. In this failure the collision with the wall pushed the bellmouth back into the car. The circle in Figure 8 highlights the location of this failure. In the center sill, the sides separated from the top and bottom at the weld connections. The lateral member on the left pushed backwards. The lateral member on the right side of the picture is part of the bolster support. Figure 11 shows a bottom and right side sketch of the draft sill failure.

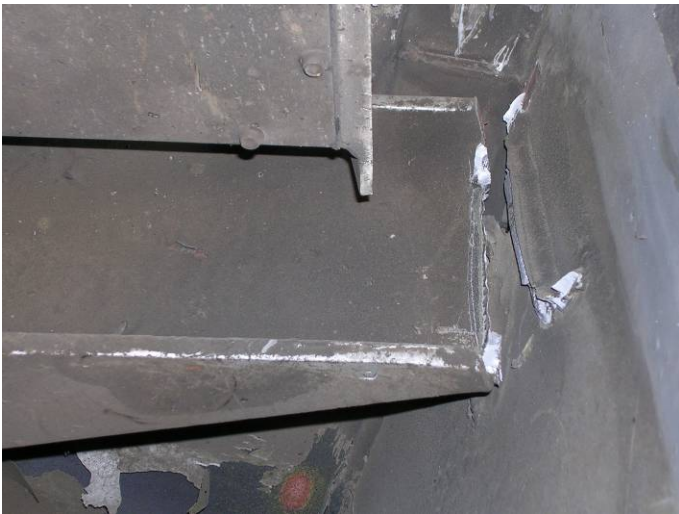
Figure 9. A Lateral Member Separates from the Draft Sill

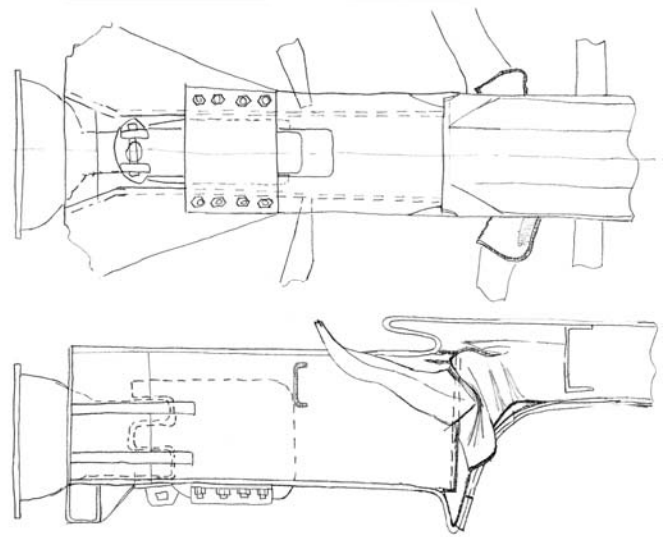
Figure 11. Bottom and Right Side Sketches of the Draft Sill Failure

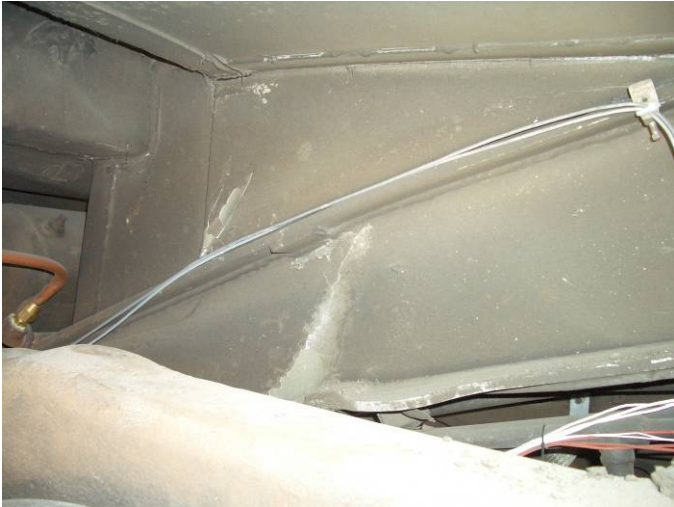
Although the gooseneck did not suffer total failure or major deformations, inspection after the test revealed evidence of the onset of failure at the location marked with a square in Figure 8. The partially-buckled area is shown in Figure 12.

Figure 12. Onset of Gooseneck Hinge

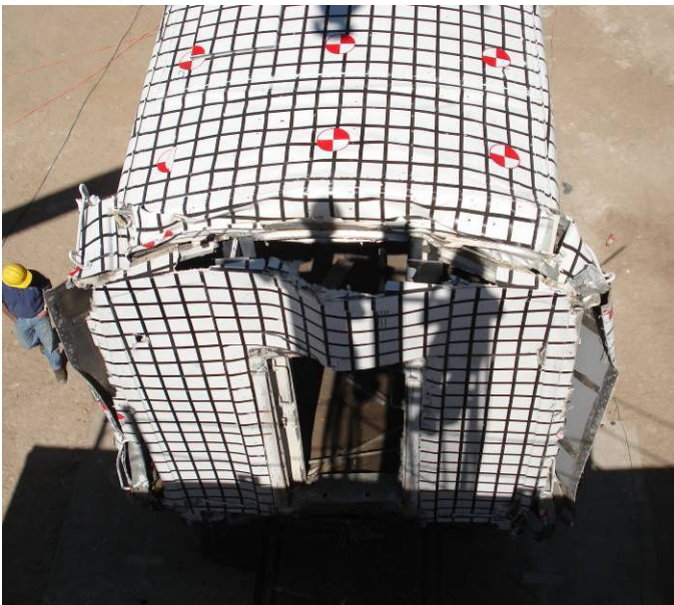
The collision with the wall damaged the fiberglass car exterior at the leading end of the car. Figure 13 shows the damage to the leading end. As is typical to allow for clearance in curves, the ends of the car are curved in plan. The end beam is crowned for curving. During the test, the wall flattened the leading end bow. The fiberglass cracked at the connections between the leading face and the side panels and the roof. The fiberglass also distorted on the right side of the car (as seen in Figure 13). Some of the rivets, particularly along the roofline and at the location of the gooseneck, popped out during or immediately after the test.

Figure 13. Damage to the Leading End of the Car

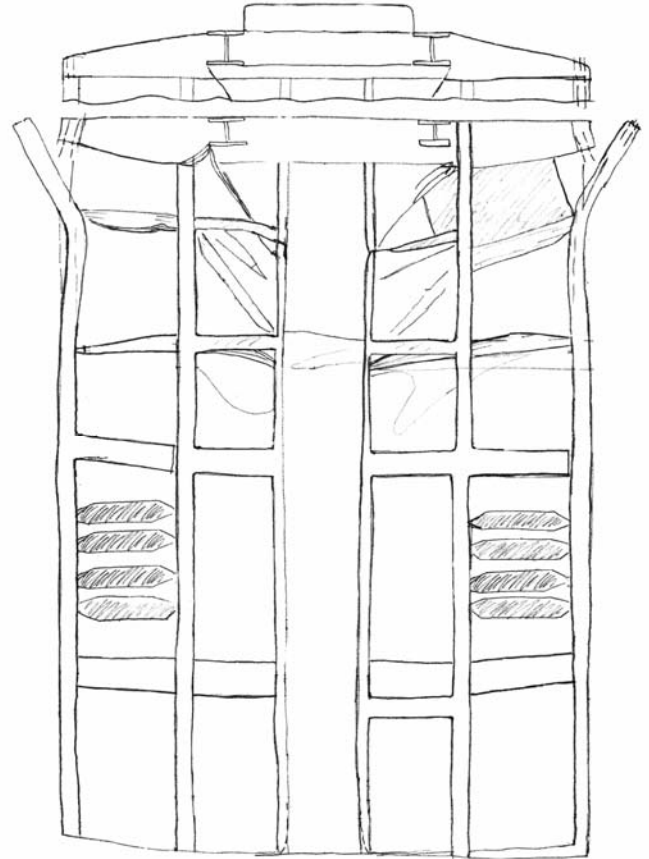
leading end. Figure 14 shows a top view sketch of the underframe. The side sills splay out laterally. It appears that the connection of the side sill to the first lateral member helped to stop propagation of the lateral deformation.

Figure 14. Sketch of the Side Sill Deformation

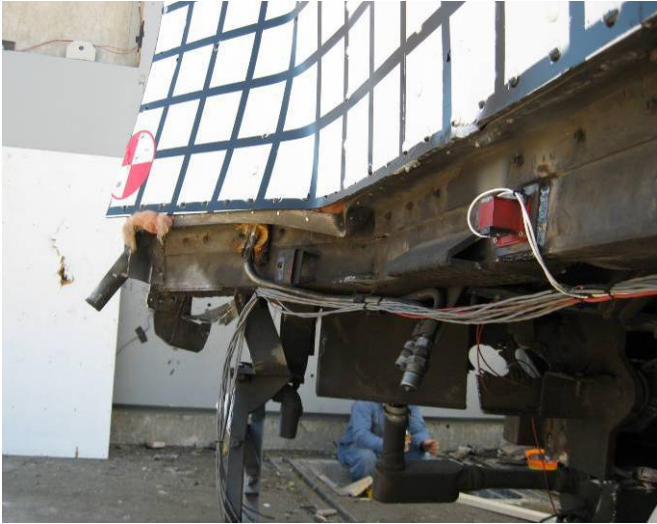
Figure 15 is a close up photograph taken of the left side sill. The leading end of the side sill moved laterally. Figure 16 shows a close up of the right side sill. The arrow points at the start of the side sill buckle. The buckle appears to start at the attachment to the lateral member, which can also be seen in the photo.

Figure 15. Side Sill Deformation at the Leading End

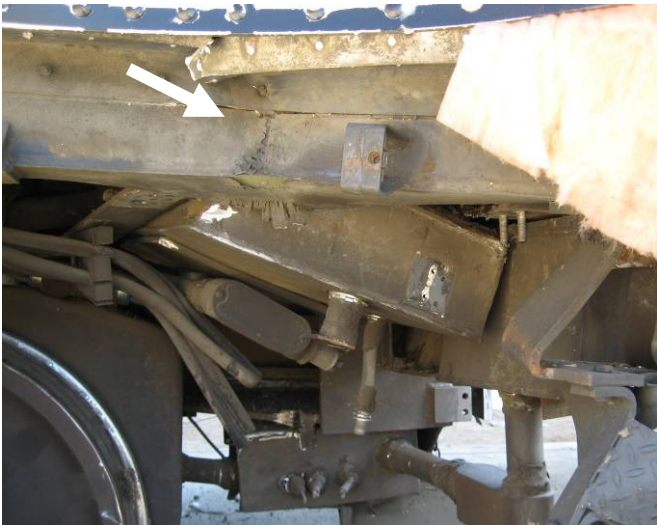
Figure 16. Lateral Buckle of the Right Side Sill

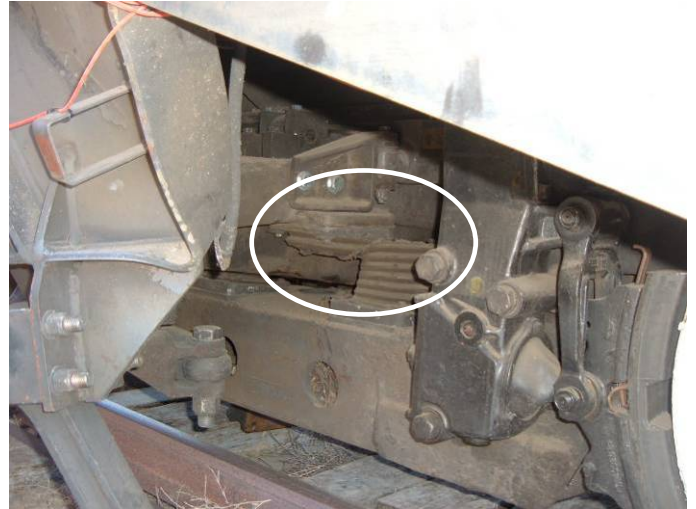
The truck attachments failed during the test. When the car stopped, the truck attachments broke and the trucks continued moving forward for approximately another six inches. Figure 17 shows the sheared primary suspension after the collision. Figure 17 shows the leading truck on the right side. The photograph looks backward from the impact end at the truck attachments.

Figure 17. The Leading Right Truck Attachments
