U.S. Department
of Transportation
**Federal Aviation
Administration**

ADVISORY CIRCULAR

43-16A

AVIATION MAINTENANCE ALERTS

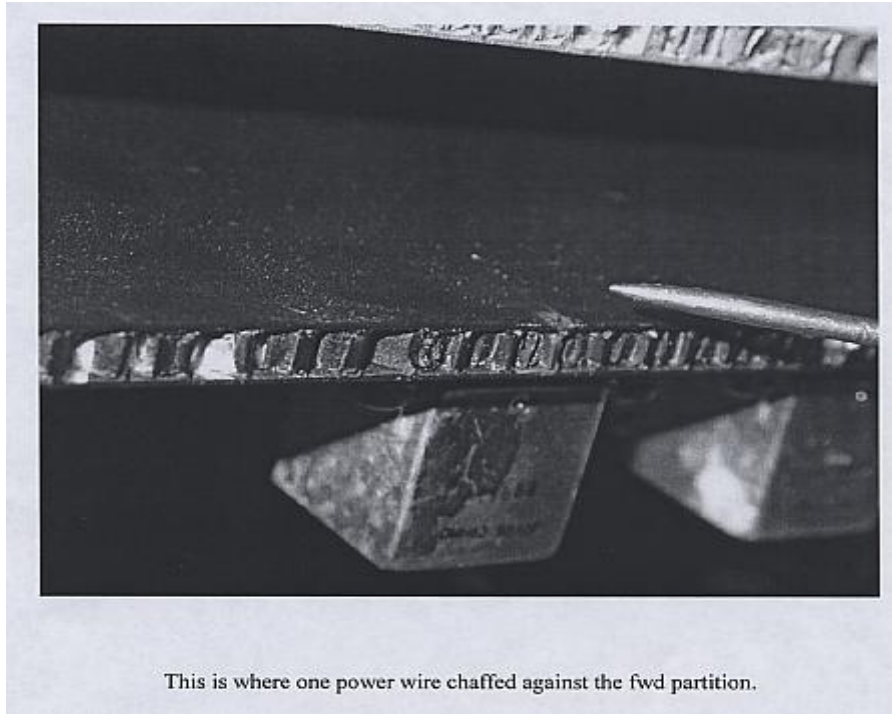
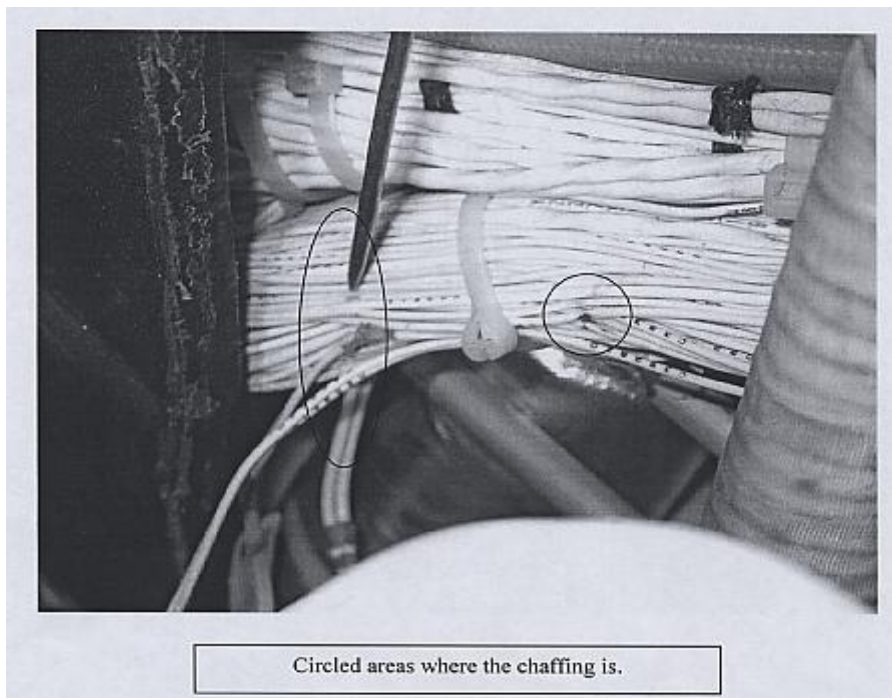
A repair station technician says, "The pitch-trim *(was found to be)* inoperative. *(I)* removed the right forward galley and the right forward partition. A wire bundle was found chafed behind the partition. I repaired three wires that were chafed *(completely)* through to the conductors. Clearance was provided between the wire bundle and the partition, and anti-chafe material was installed. At the time of the repair no other components had malfunctioned from the other two chafed wires." *(Primary wire P/N: C352B20.)*

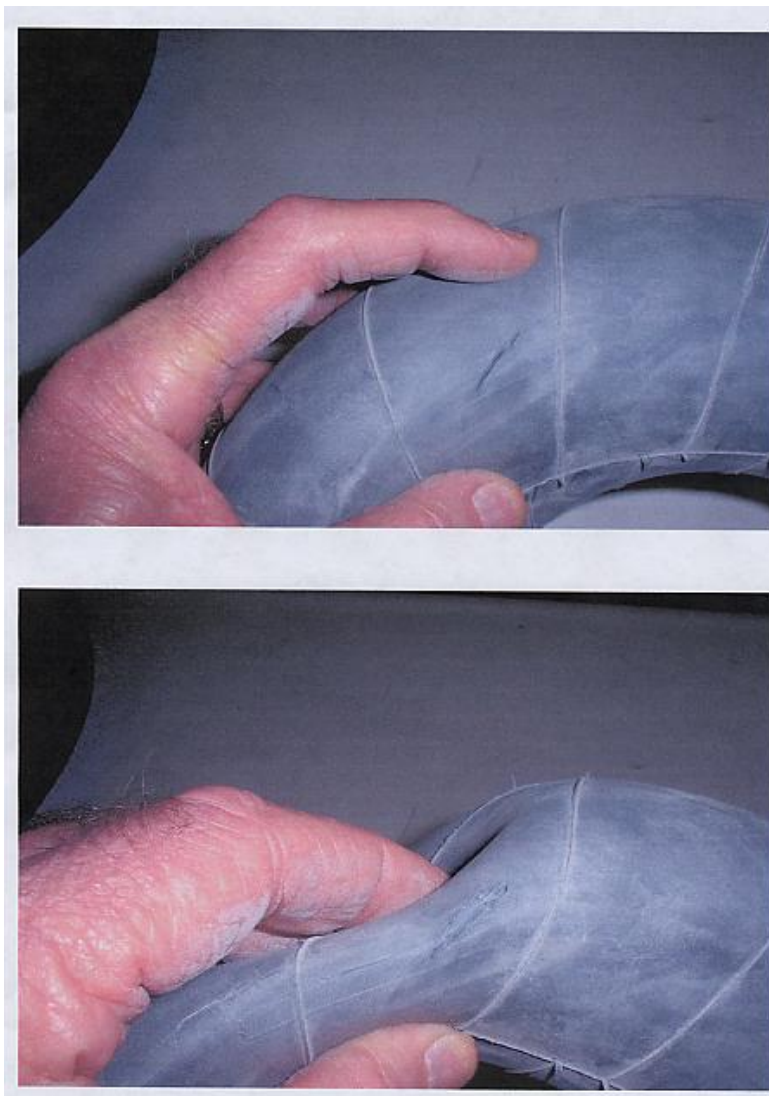
The Director of Maintenance for a repair station writes, "...this aircraft has experienced three landing gear tire tube failures. These failures all occurred in the sidewall of the tubes. There was no evidence of the tubes having been pinched or otherwise damaged during installation. Damage ranged from small, 1/8 inch splits to a large 1/2 inch split. Examination of the tube sidewalls evidenced what appears to be some form of 'weather checking' that normally appears on old rubber components. All (*of these*) tubes were of recent manufacture.

"One failure occurred on a G15/6.00/6 tube (P/N 302-246-401) with a total time in service of 123.0 hours. Two failures occurred on 5.00x5 tubes (P/N 302-013-400) at 125.0 hours and 112.0 hours, respectively. All were (*sent*) to the Goodyear Technical Center in Akron, Ohio for evaluation. This evaluation is currently in progress. Note: at each tube failure new tires were installed. The removed tires showed no evidence of defects which may have caused this problem. Attached are photos of the most recent failure."

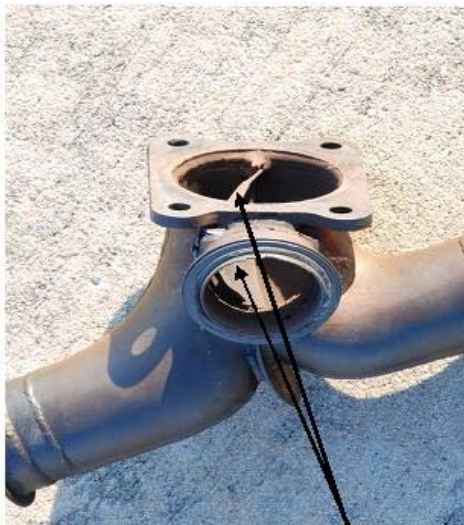
New evidence indicates exhaust system parts have failed after satisfactorily passing numerous inspections and being *signed off* with no discrepancies noted. The failures appear to be due to improper assembly of the exhaust system after engine or exhaust system inspection, repairs or overhaul. The improper installation resulted in the parts being preloaded (pre-stressed), eventually leading to fatigue failure. These failures had also gone undetected through multiple inspection cycles.

Photo 1: Wye, with failed internal baffle.

The owner, operator and maintenance community must be aware of the extreme importance of conducting detailed inspections per the AD, and taking the necessary corrective action. For example, when conducting the AD required pressure test, be sure all nacelle/cowling pieces, heat shields, inspection access panels (and the like) are removed. There should be a complete and unimpeded view of all joints and components being inspected or pressure tested. When conducting the required pressure test, be certain there leak-check fluid is being used. Be careful to not mask or miss serious problems by using a noisy, unregulated source of air in an attempt to listen for "hissing" from an exhaust joint.

It is extremely important all exhaust system components removed or replaced for any reason be installed carefully and without preload, using approved, accepted methods and techniques. Cessna has available service manual information and numerous service publications which address exhaust systems. These exhaust systems have a very good safety record if regularly and properly inspected, but the importance of these inspections to safety-of-flight cannot be overstated.

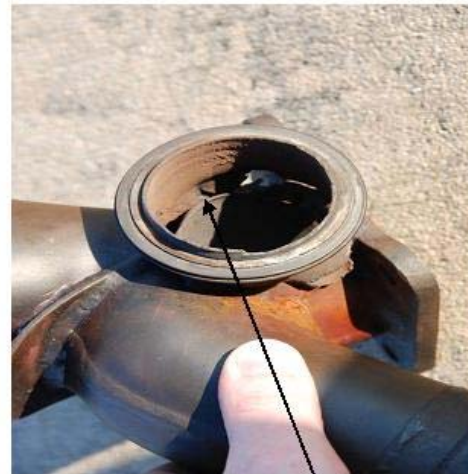
Photo 2: Wye waste-gate elbow attach flange fatigue failure.

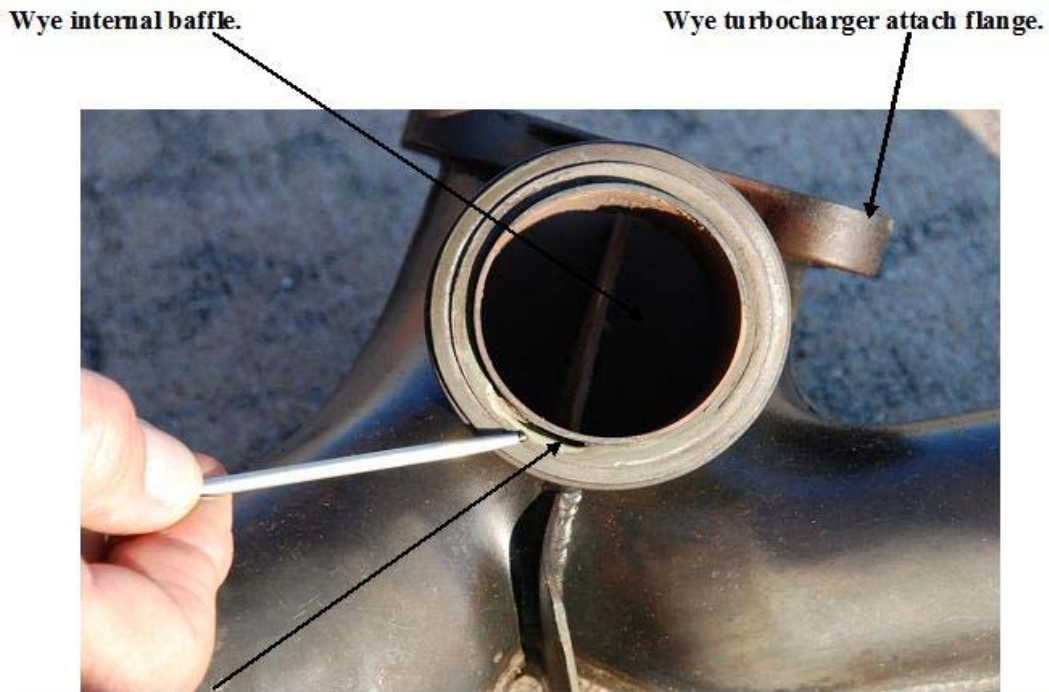
Photo 5: 3° deflection of the wye waste-gate attach flange due to preloaded installation and subsequent fatigue failure.

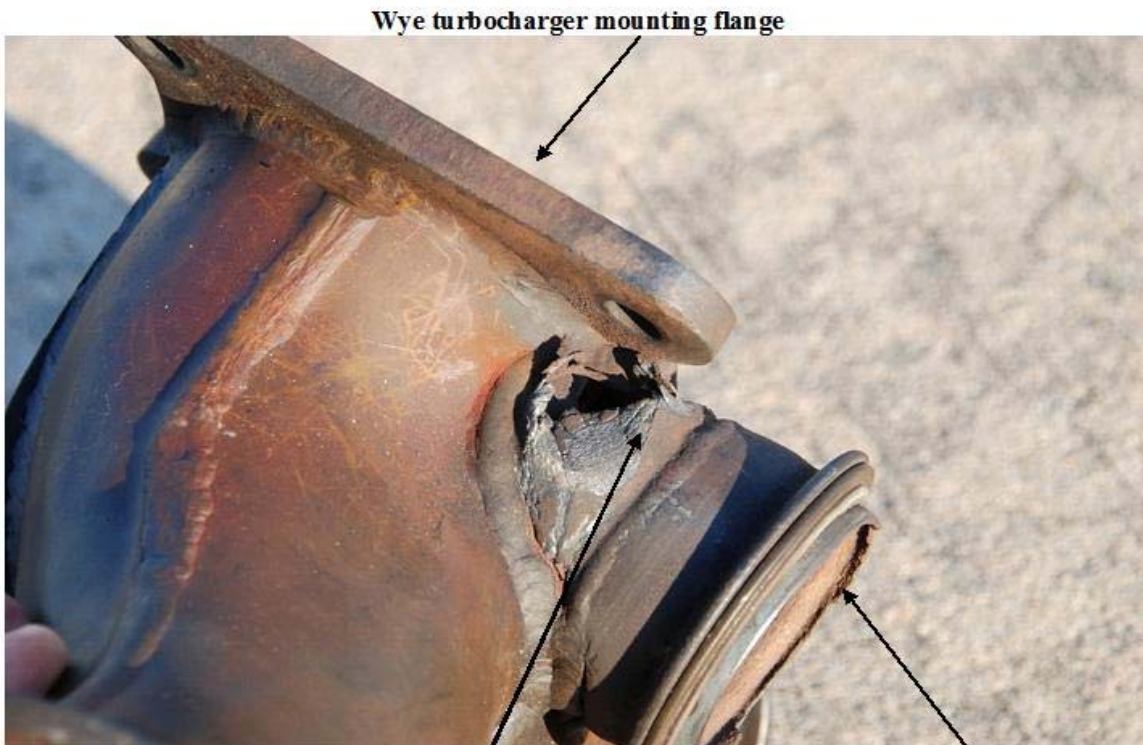
Photo 6: Wye failure and material blowout. Failed wye to waste-gate attach flange.

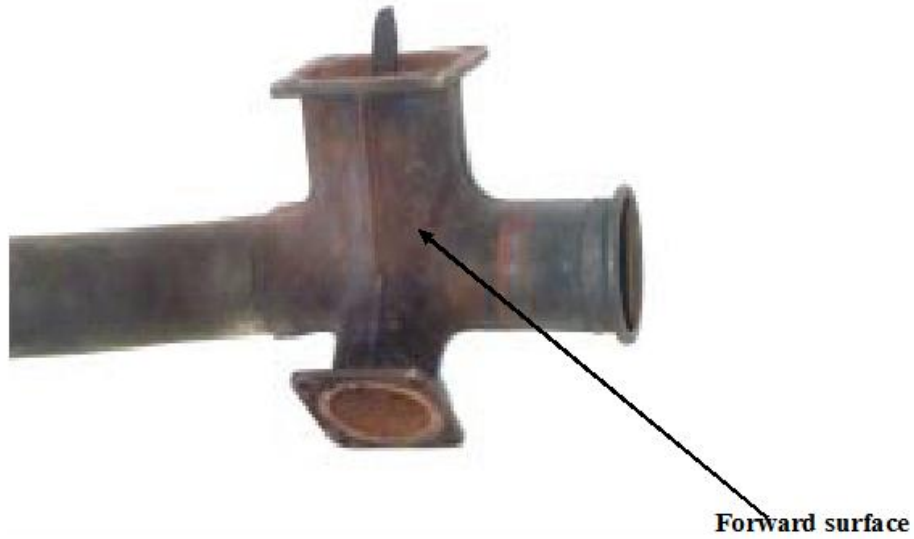
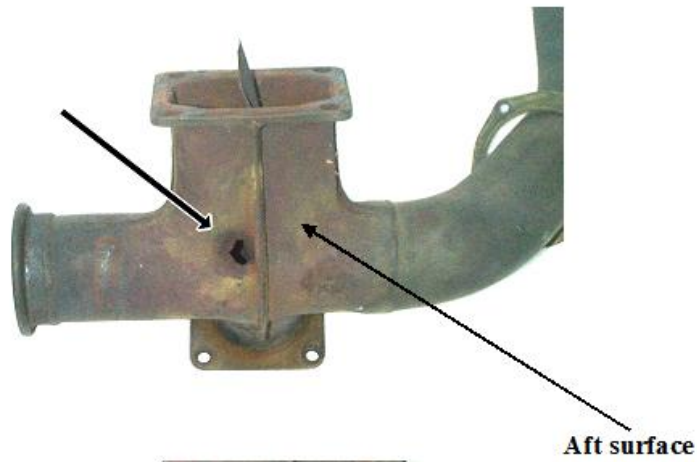
Another typical wye which appears normal until thorough inspection reveals a burn through hole on the aft side (arrow)

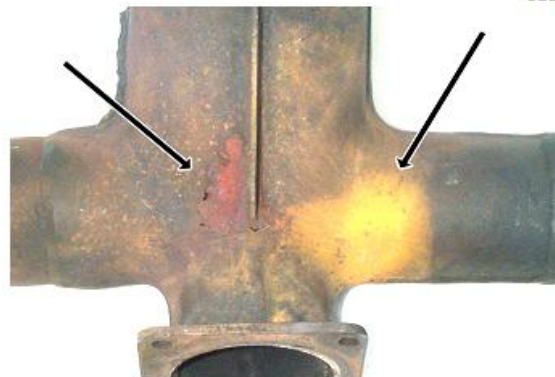
Another example of wye forward surface with pin holes through (left arrow) and staining (right arrow).

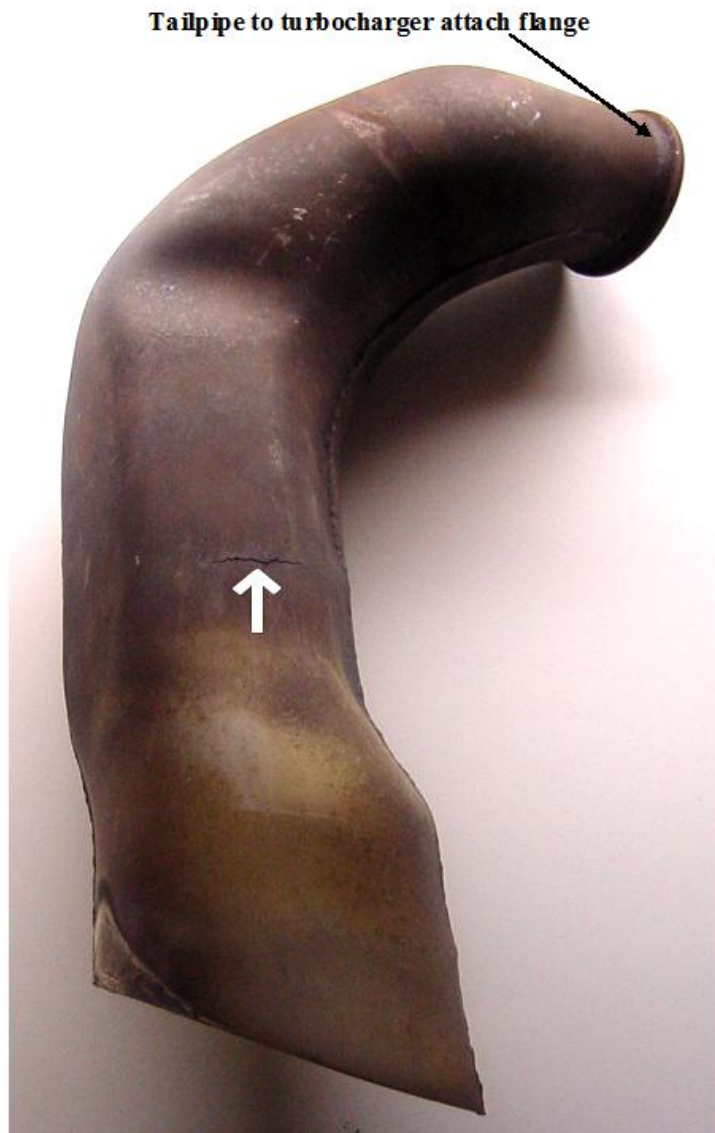
A tailpipe; with arrow pointing to crack through forward surface.

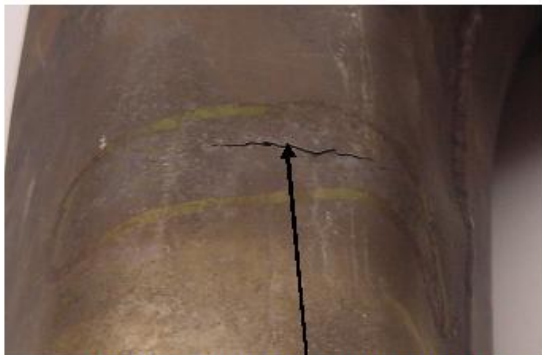
Crack through forward side of tailpipe.

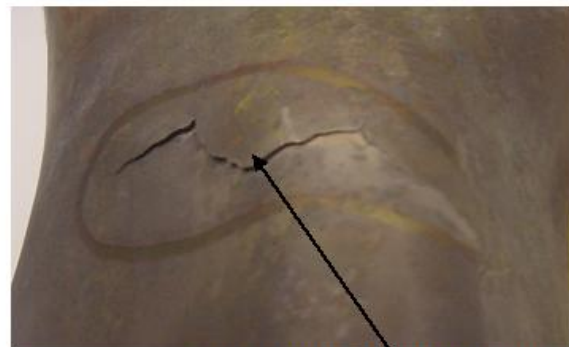
Crack through aft side of tailpipe

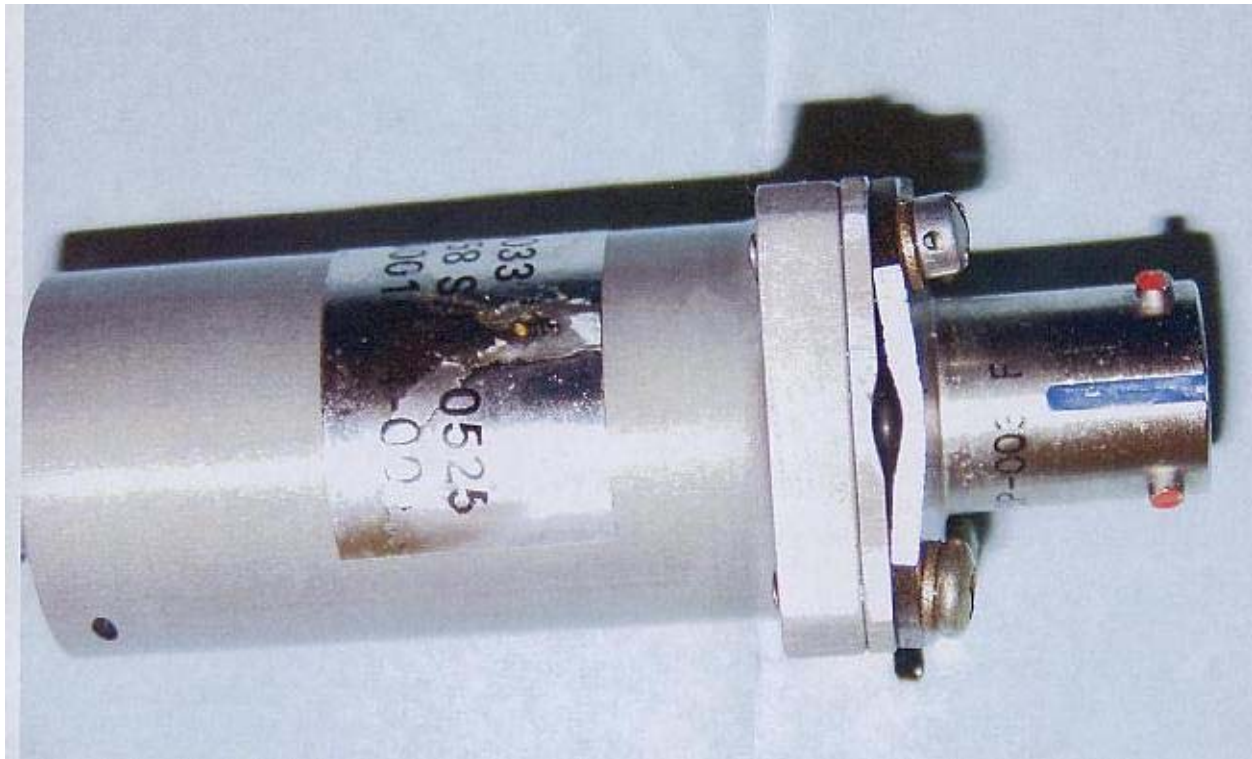
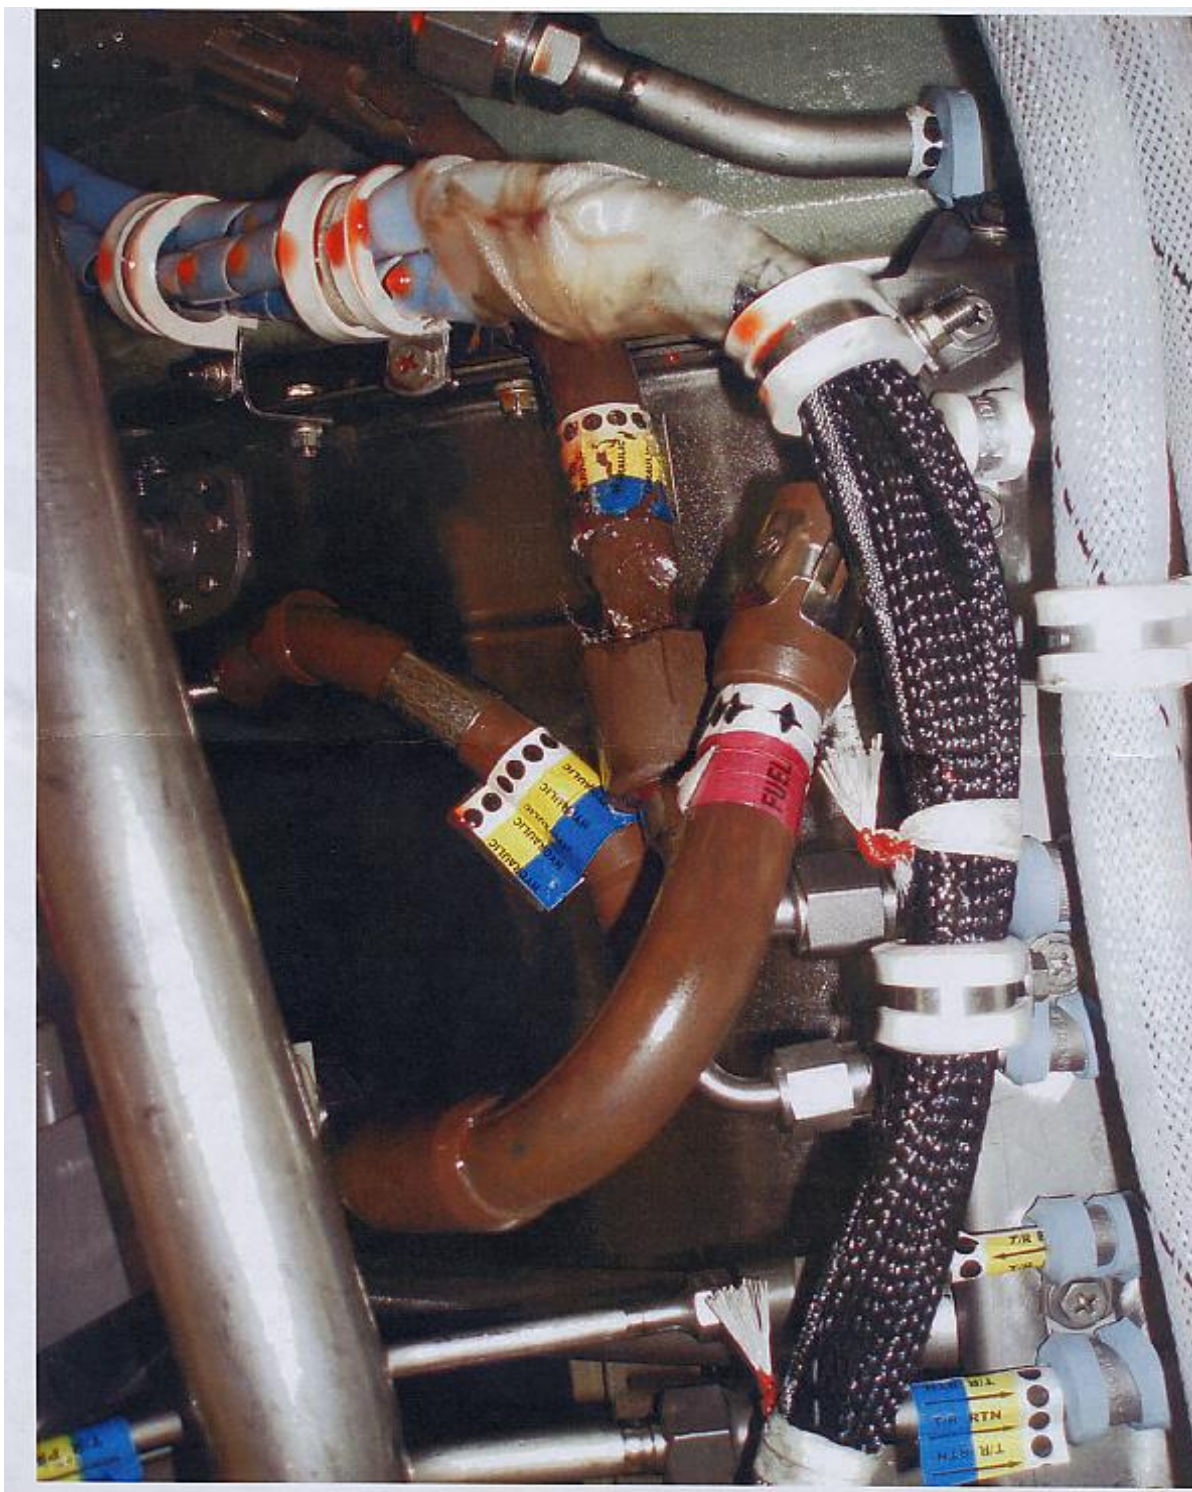
A mechanic describes the sequence of defect events which might have had an alternate ending. The story begins with the aircraft in final cruise condition. "Approximately 40 minutes into the flight at flight level 410...a white CAS (*caution annunciator*) advisory message appeared, indicating 'MAIN HYDRAULIC QUANTITY LOW.' The flight crew opened the appropriate crew checklist and flight manual, referencing the checklist (*heading*) 'Main Hydraulic Quantity Low.' *(Apparently...)* no action was required *(as none was provided for this entry.)* The pilot directed the copilot to refer to any abnormal procedures, or any emergency checklist procedures as a precaution for the loss of hydraulic quantity or pressure. The crew reviewed these procedures and continued in cruise. Approximately 15 minutes later (during descent) a white 'LEFT HYDRIAULIC PUMP LO' message began to appear intermittently, and hydraulic pressure fluctuations were noted on the pressure indication. Approximately 10 minutes later a drop in main hydraulic pressure to 70 psi *(and concurrent)* illumination of the 'MAIN HYDRAULIC PRESSURE' and 'SPOILER FAIL' messages were noted. The crew diverted to the designated alternate airport, completed abnormal checklist procedures, declared an emergency, and executed a safe landing. Inspection of the aircraft revealed the left main hydraulic pressure switch S9 *(P/N 7629001004-001)* had failed, allowing the hydraulic fluid to escape under pump pressure—until sufficient quantity was lost that cavitation resulted in both left and right hydraulic pumps. This cavitation apparently caused pressure spikes of sufficient force that both pump pressure output flexible hoses were ruptured. This caused the failure of both pumps and is suspected to have caused the landing gear control valve to also fail. This *(control)* valve was found inoperative during post-repair functional checks. The landing gear failed to retract when selected *(to the)* 'UP' position while the aircraft was on jacks and under pressure from a hydraulic power unit. Based on the damage

found on the S9 pressure switch, I believe the probable cause of the switch failure stems from pressure spikes within the hydraulic system, or an inadequate design of the switch assembly. Bombardier technical services was notified of the issue...they (*indicated an awareness*) of other switch failures. I would recommend a review of the hydraulic system be conducted to determine if pressure spikes are evident, especially during high flow/high pressure situations. I would also strongly urge Bombardier install hydraulic fuses in the supply lines to the 2 pressure switches (S8 and S9). I believe if a fuse had been installed this switch failure would have resulted in only a very small loss of hydraulic fluid, and the crew would have managed the indicated CAS message as a possible switch failure (given pressure indications from a separate transducer would have indicated normal pump output). This failure resulted in a repair exceeding \$36,000.00 and 5 days out of service. If a hydraulic fuse had been installed (and functioning correctly) the repair costs would have been approximately \$2,000.00 with 1 or 2 days out of service. Photos of the S9 pressure switch and ruptured hydraulic hoses are attached."

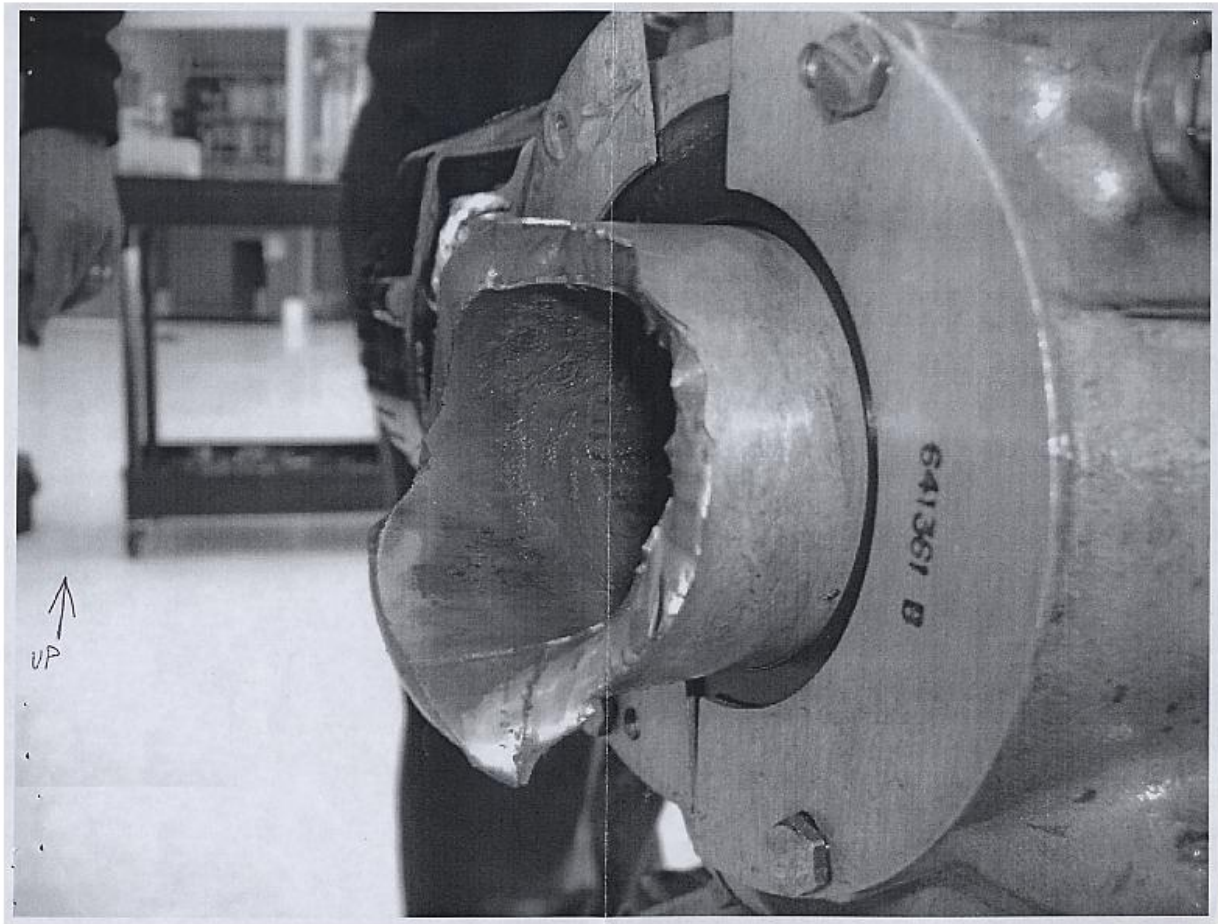
"The crankshaft broke," says this mechanic, "just aft of the propeller mounting flange" (*Crankshaft P/N: 649900*).
