FIRE ISLAND LIGHTHOUSE AND KEEPER'S DWELLING

Fire Island National Seashore
Patchogue, New York

Historic Structure Report
Volume 2

**THE KEEPER'S DWELLING:
CURRENT APPEARANCE AND CONDITION**

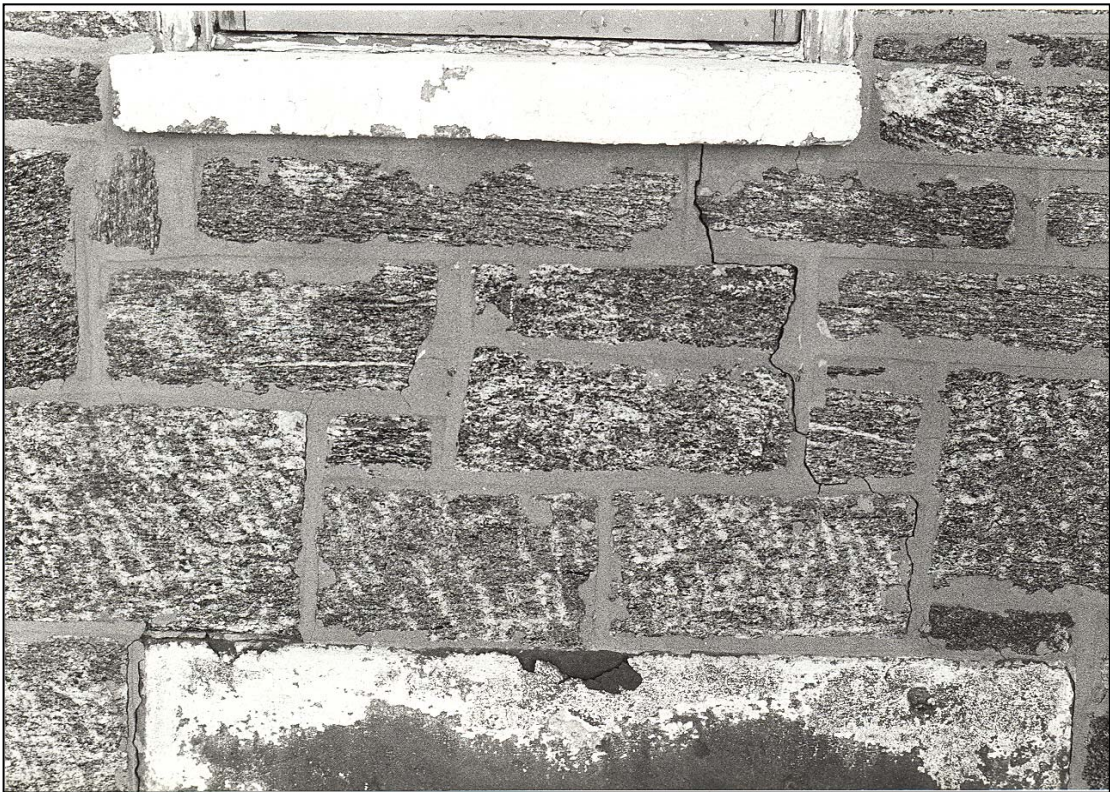
The entire wall, except for the upper 2 feet, appears to have been repointed with Type-IV mortar. Four cracks are extant: at the first-story center window, right corner and upper left corner; at the window above, right corner; and at the first-story outer window, below center.

Figure 230. Dwelling exterior: south wall, masonry cracks (1983).

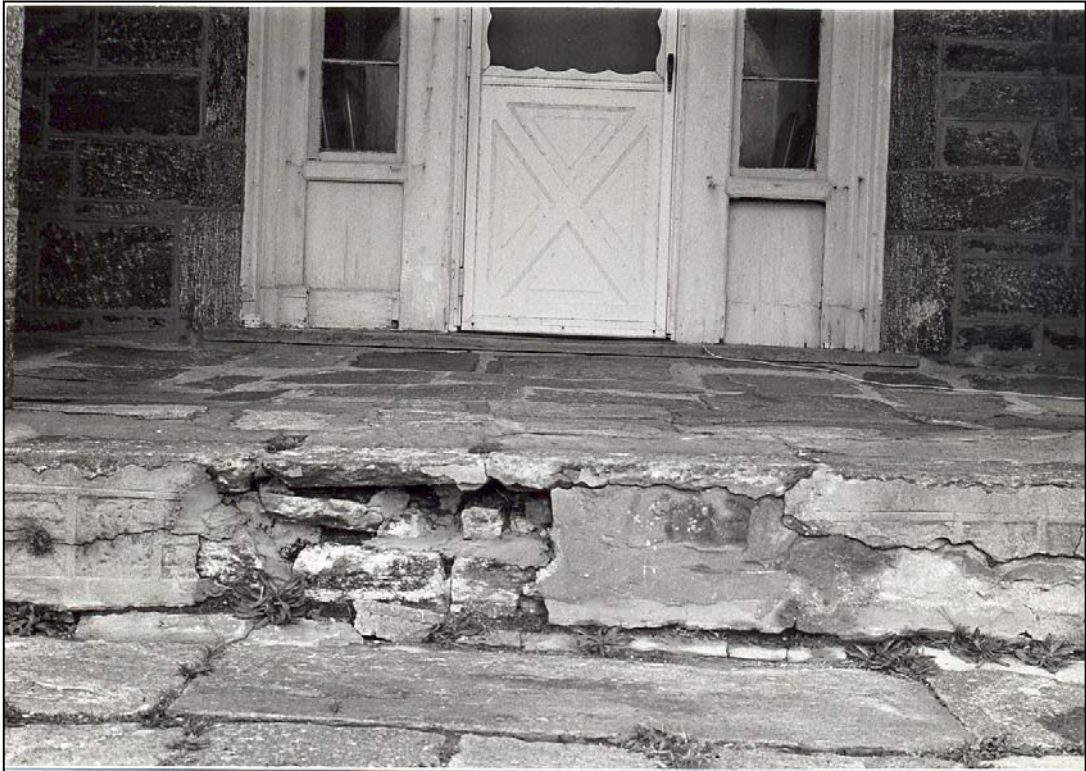
Figure 232. Dwelling exterior: south pavilion, deteriorated steps (1982).

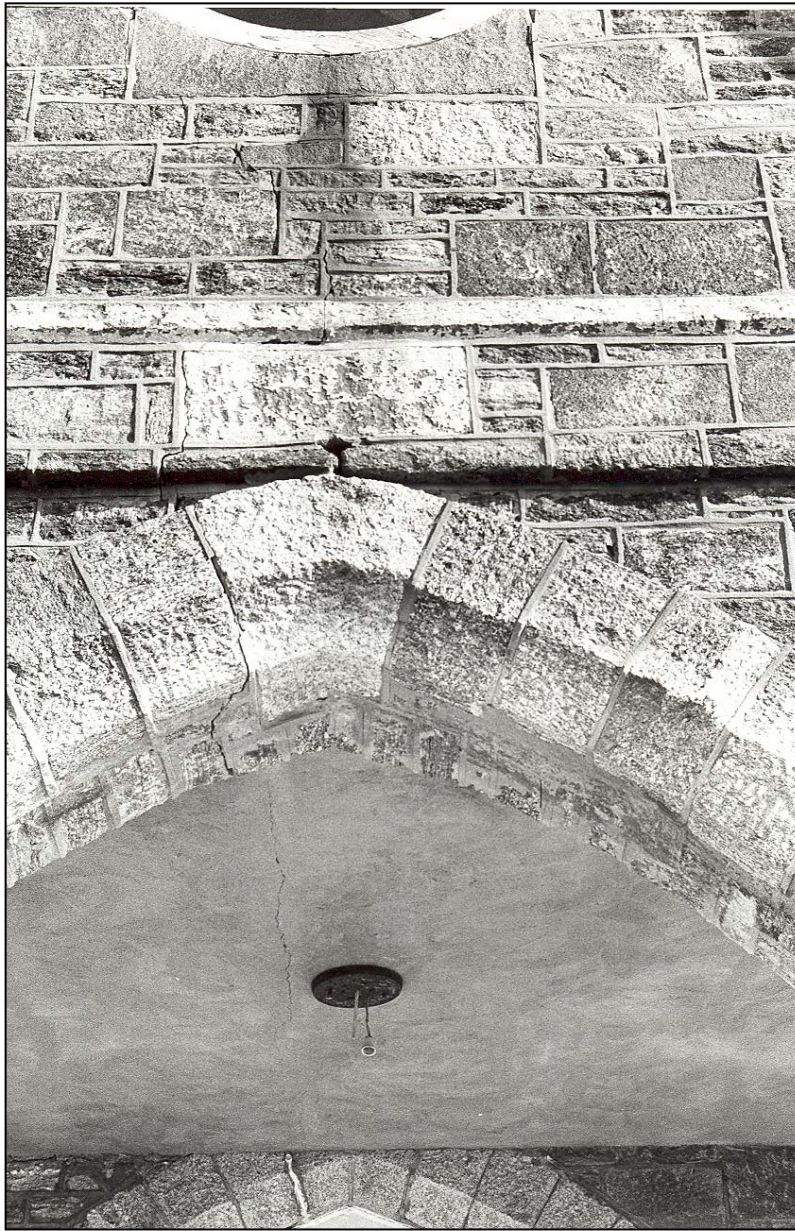
Figure 233. Dwelling exterior: south pavilion, ceiling crack (1983).

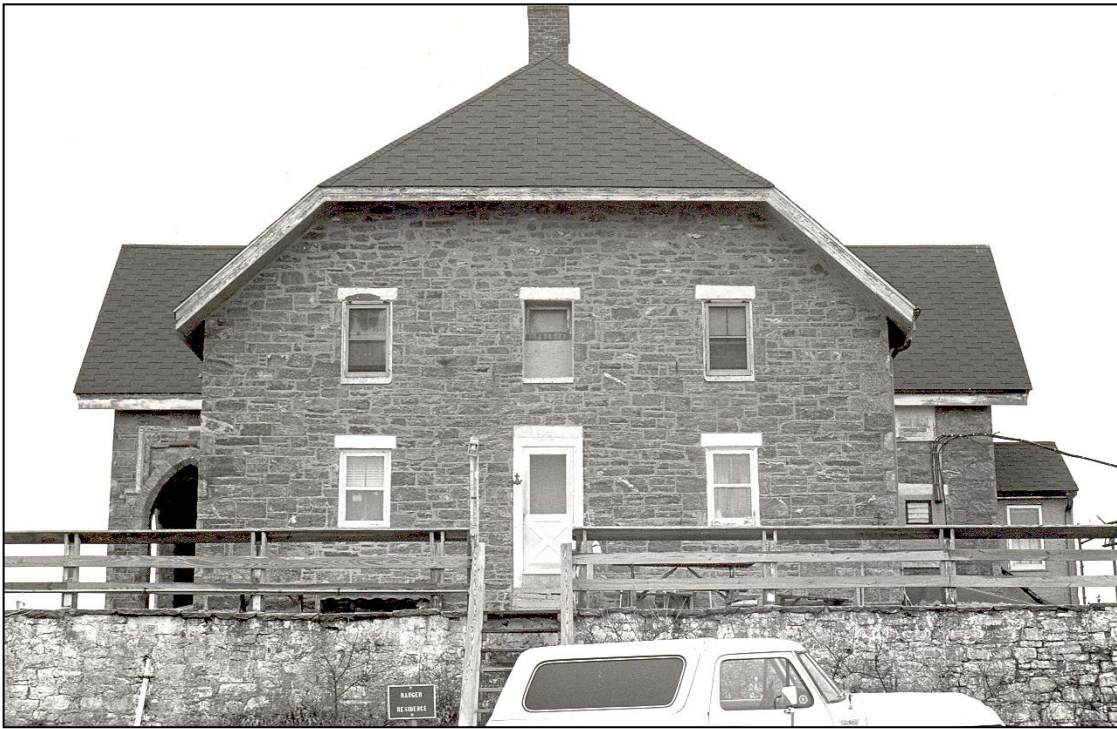
Figure 235. Dwelling exterior: east wall with Type-III mortar joints (1982).

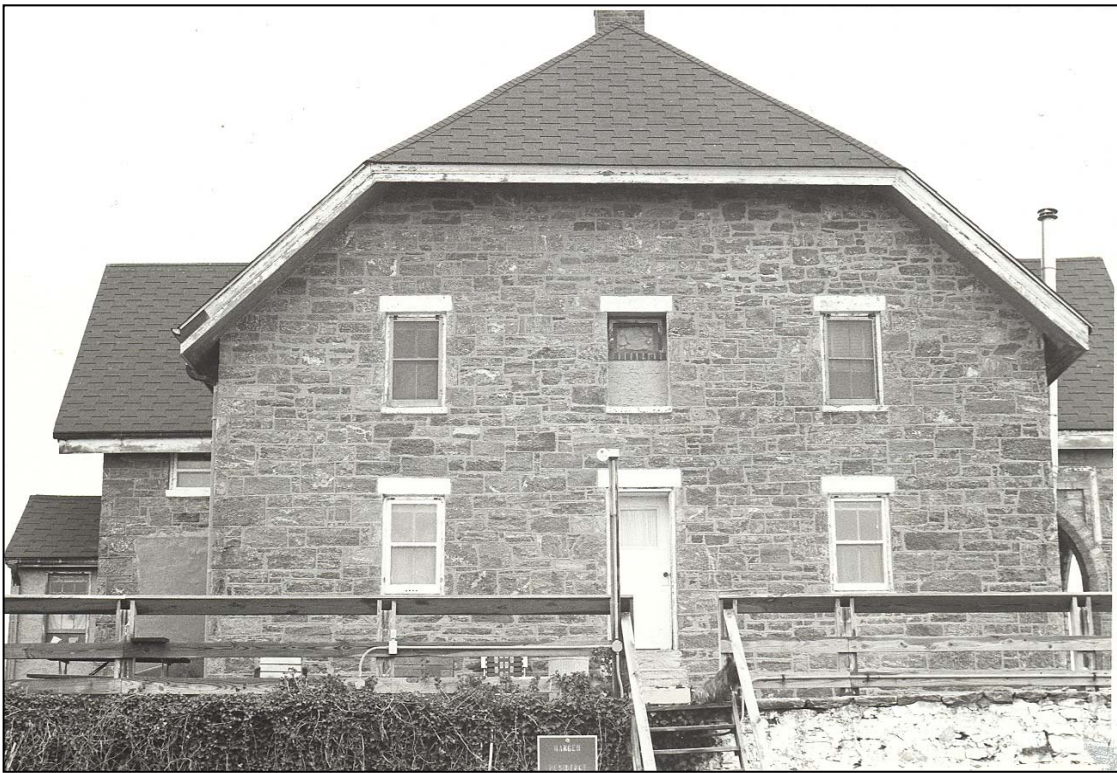
Figure 236. Dwelling exterior: west wall with Type-IV mortar joints (1982).

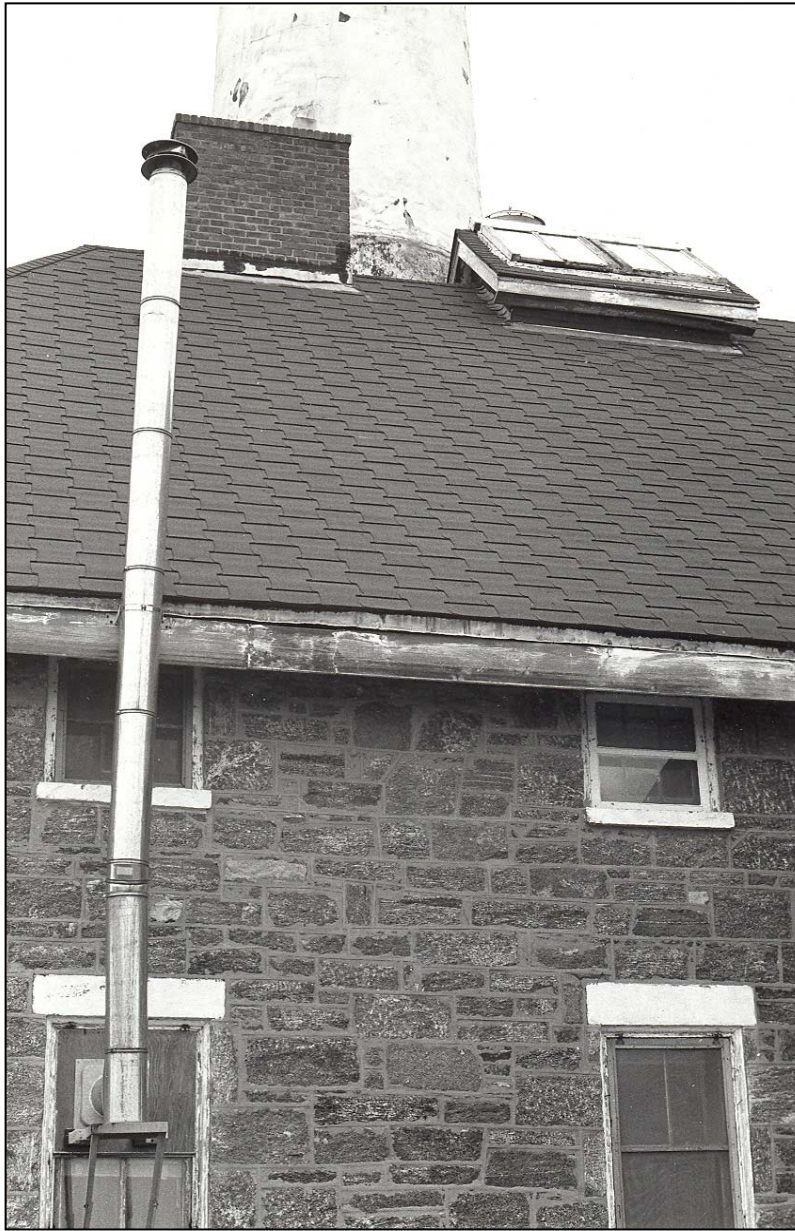
The condition of the chimneys, including flashing and pointing, needs more investigation. The cement bed for the flue liner is partially missing from the west chimney, and the resultant cavity is full of debris.

The skylight is located on the roof ridge, approximately 2 feet east of the west chimney. The skylight was constructed based on a drawing dated April 3, 1931, entitled "Fire Island Light Sta. Bathrooms Water and Sewer Systems," sheet 1 of 3. Details of the design may be ascertained from this drawing (fig. 221), and from the specifications for the work (App. C-143). The wooden frame appears to have been inadequately maintained. The frame is deteriorated, and the lights require repairs. Further investigation is necessary.

Figure 239. Dwelling exterior: south wall, with west chimney and skylight (1982).

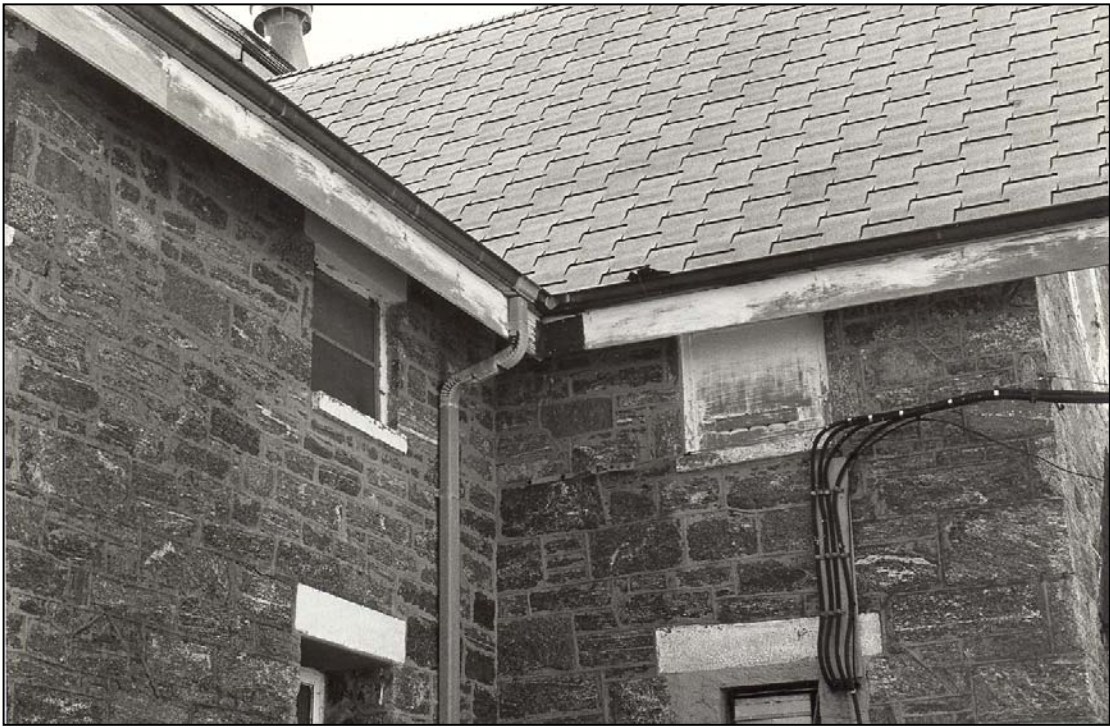
The metal gutters are beyond repair. They are so badly corroded in some areas that the bottom no longer exists. The downspouts require repairs.

Figure 240. Dwelling exterior: Dwelling exterior: east junction of north wall and pavilion, with gutters, downspout, and fascia boards (1983).

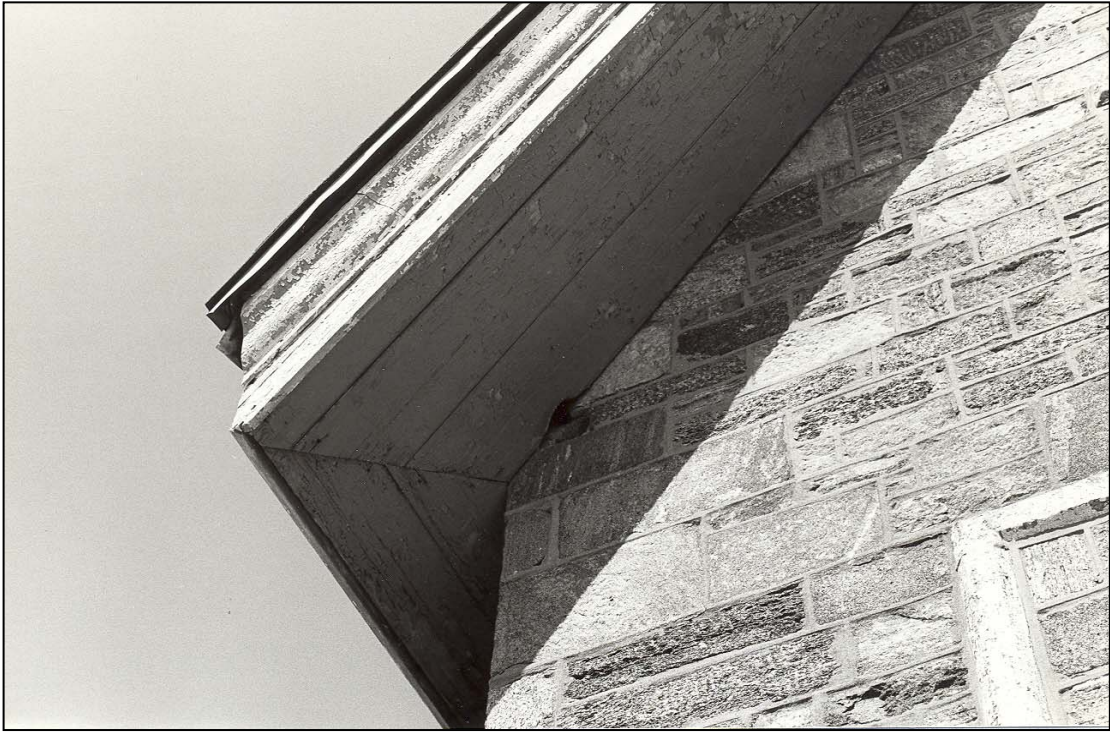
<i>South Pavilion</i>	The soffit of the gable end of the pavilion roof resembles that of the main roof, except that it is five beaded boards wide. One board on the left side, near the peak, is loose. On the right side, also near the peak, a section of soffit boards has been replaced by a piece of plywood. The fascia and crown molding are intact, but their white paint is deteriorated. A copper drip edge has been bent down over the crown molding.

Figure 243. Dwelling exterior: Dwelling exterior: south pavilion, soffit and fascia boards with crown molding and drip edge (1983).

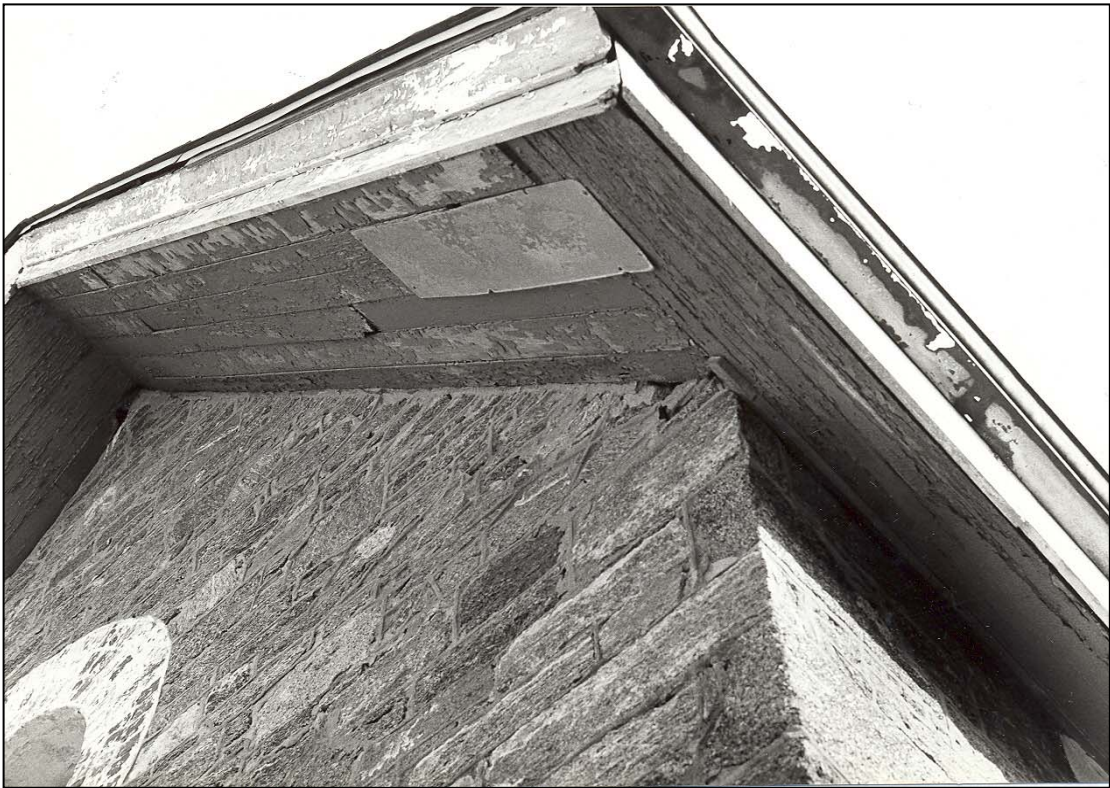
- North Pavilion* The left side of this pavilion's gabled peak has a soffit seven beaded boards wide, while the right side's soffit consists of six slightly wider boards. On the right side, near the lower end, a section of the soffit boards has been replaced with a piece of metal. As with the south pavilion, all of the fascia and its crown molding remains in place. A copper drip edge extends up under the roof shingles, and is bent down over the crown molding.

Figure 244. Dwelling exterior: north pavilion, soffit and fascia boards with crown molding and drip edge (1983).

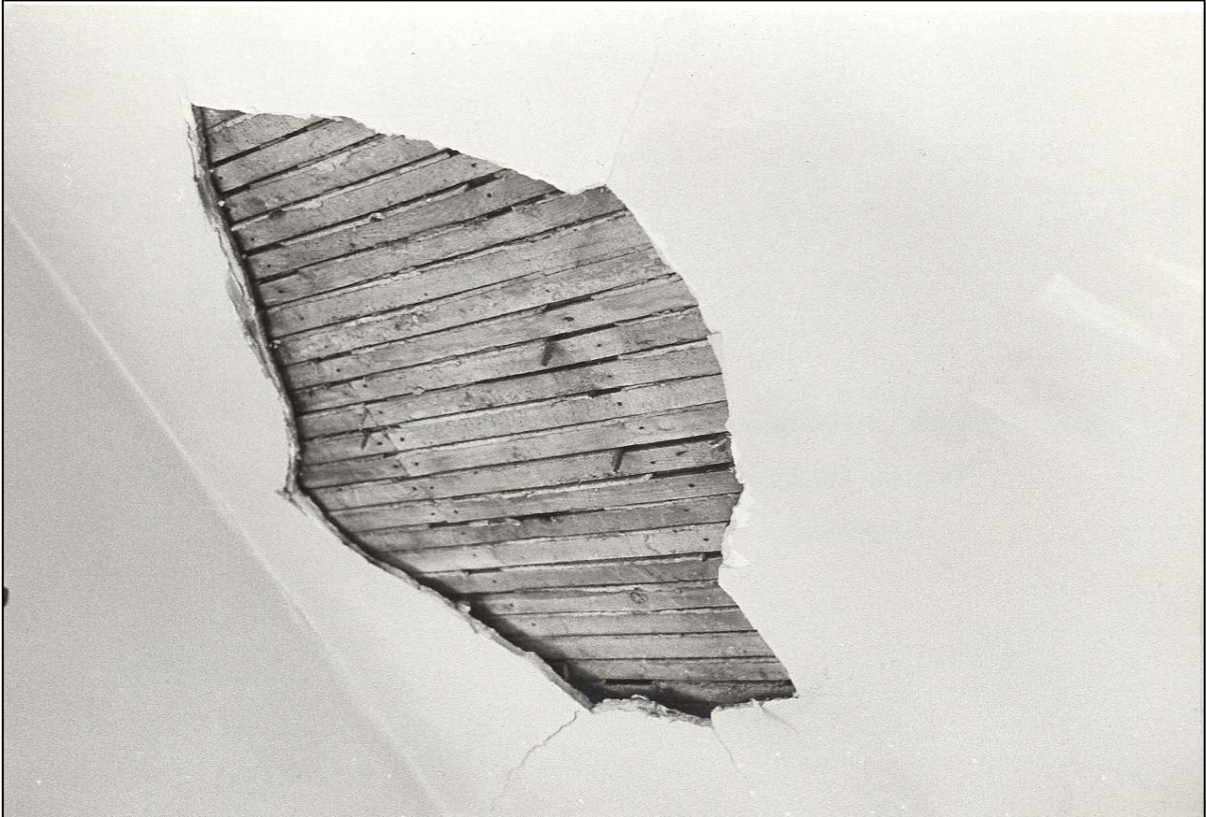
Figure 323. Dwelling interior: northwest bedroom, hole in plaster ceiling (1983).
