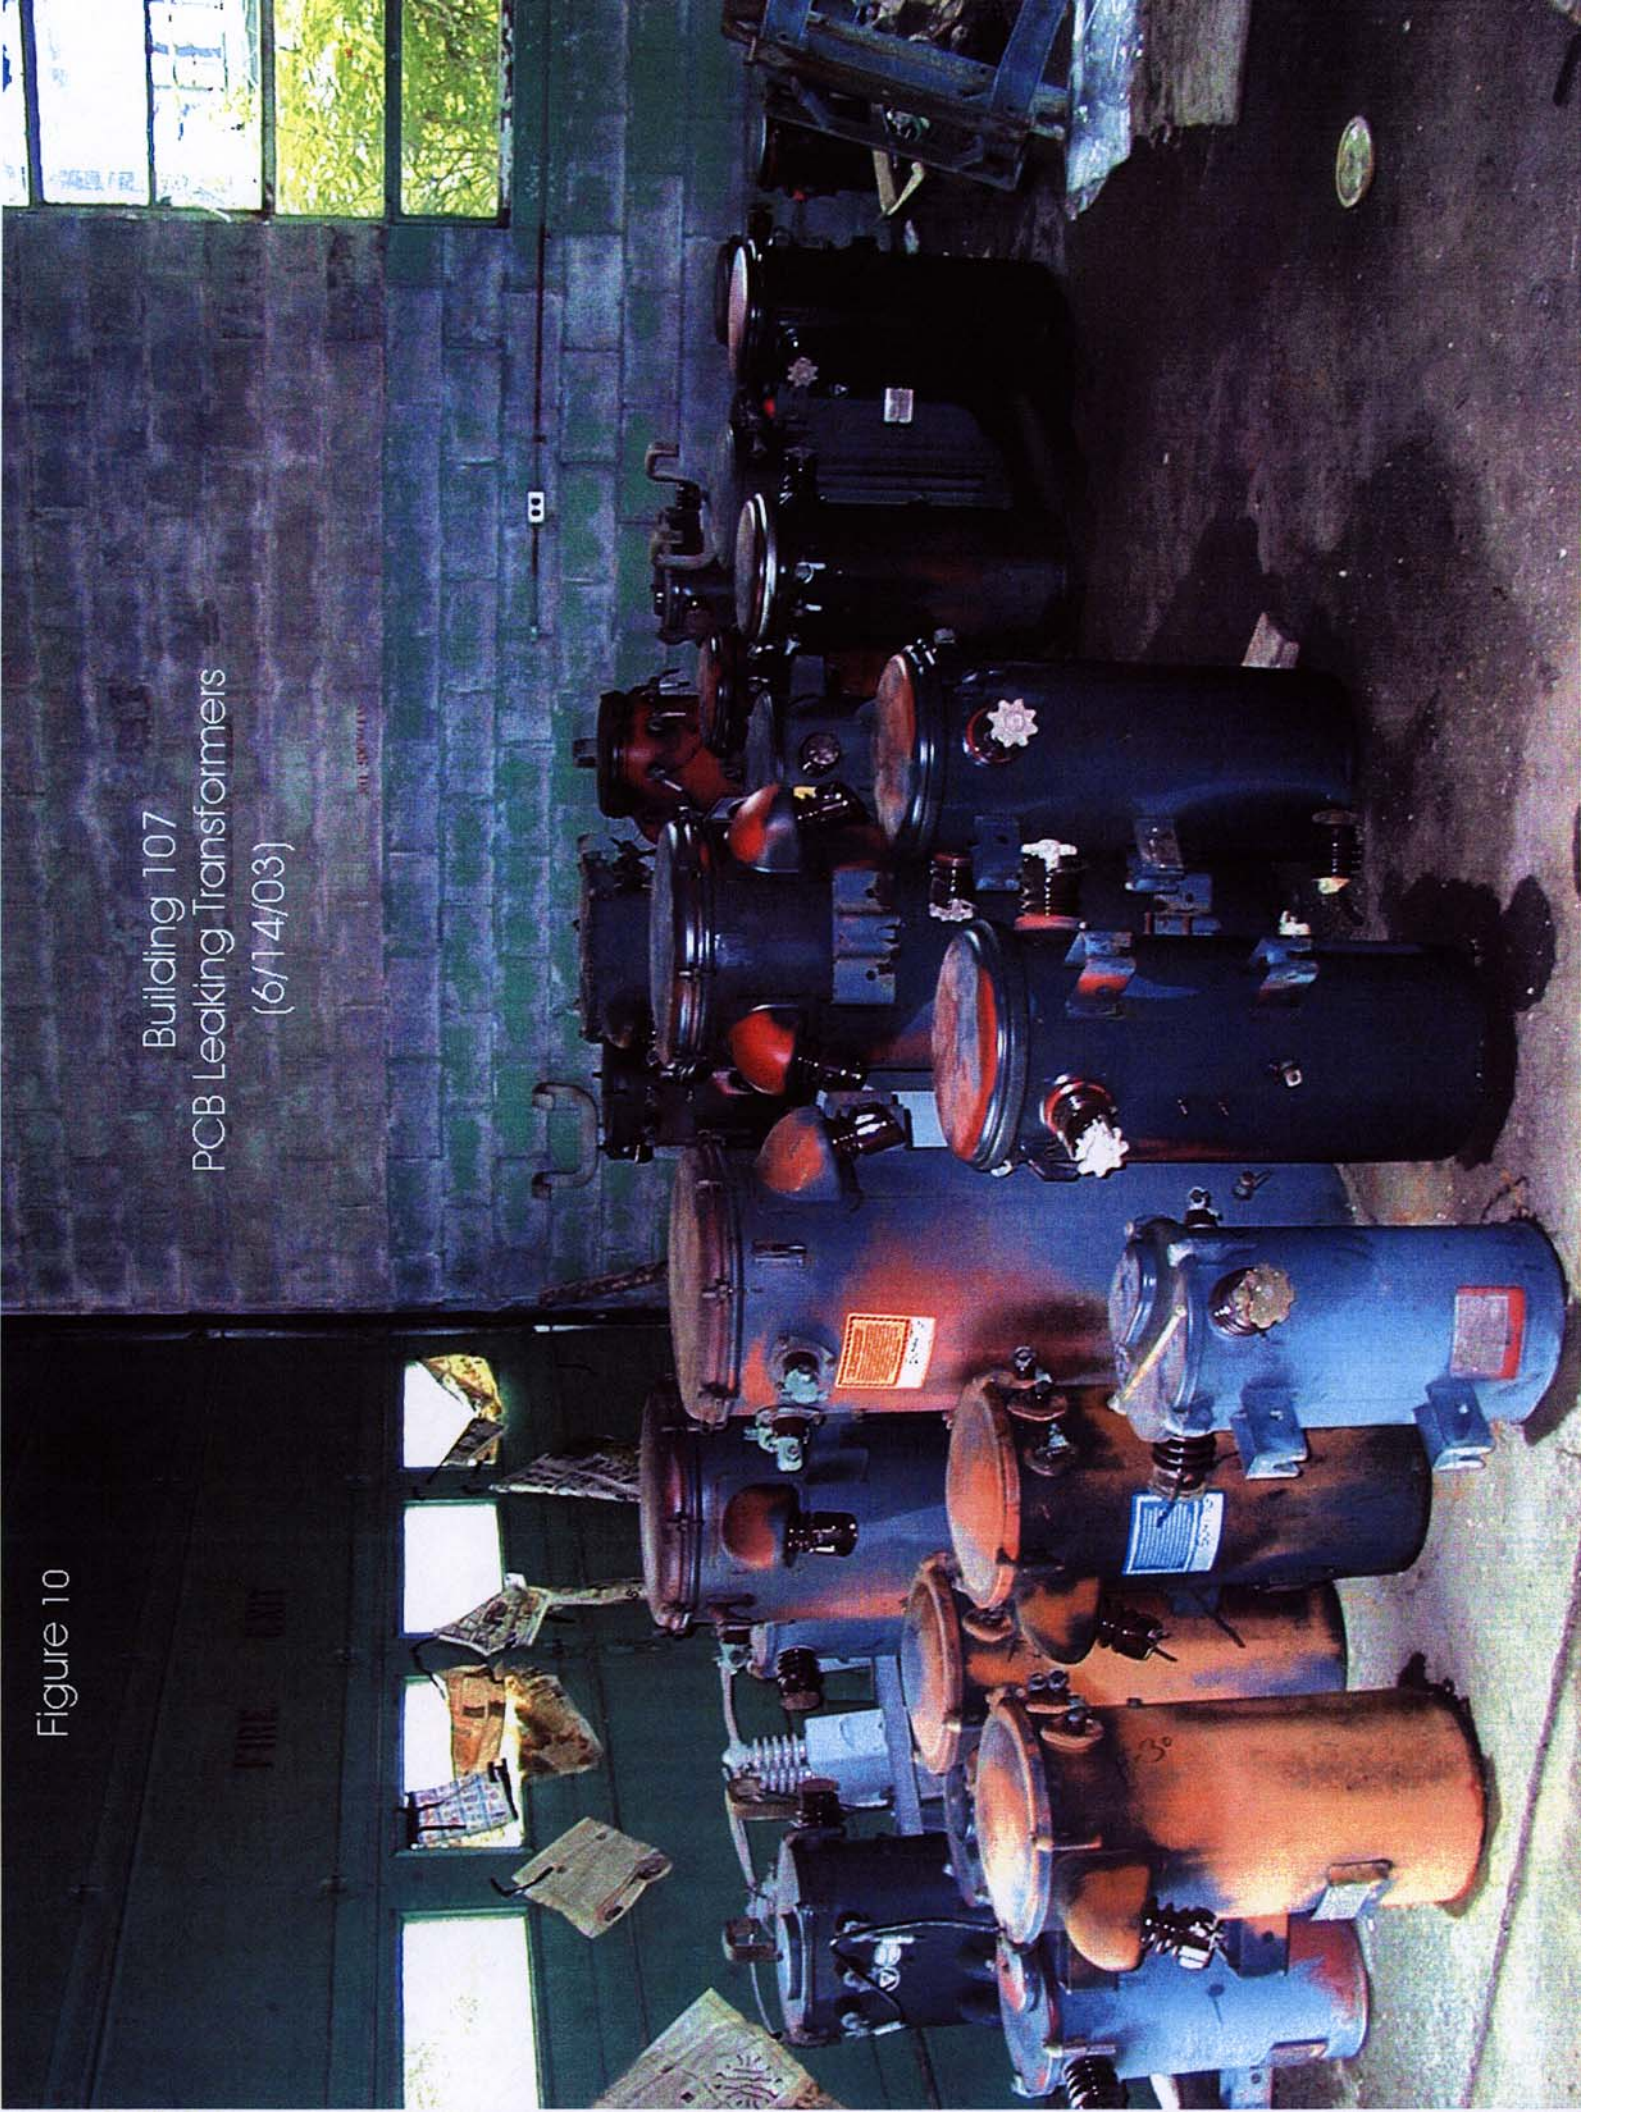
Figure 10

Building 107
PCB Leaking Transformers
(6/14/03)
